**REPUBLIC OF BULGARIA
MINISTRY OF TRANSPORTATION, INFORMATIONAL
TECHNOLOGIES AND COMMUNICATIONS**

**Directorate
„Unit for investigation of accidents in the aviation, maritime and rail
road transport”**

FINAL REPORT

**Investigation of very serious marine accident, occurred on 29.11.2010 in
Black Sea, in the territorial sea of Republic of Bulgaria, with motor
vessel “Karam 1” and motor tanker “Alessandro DP”**

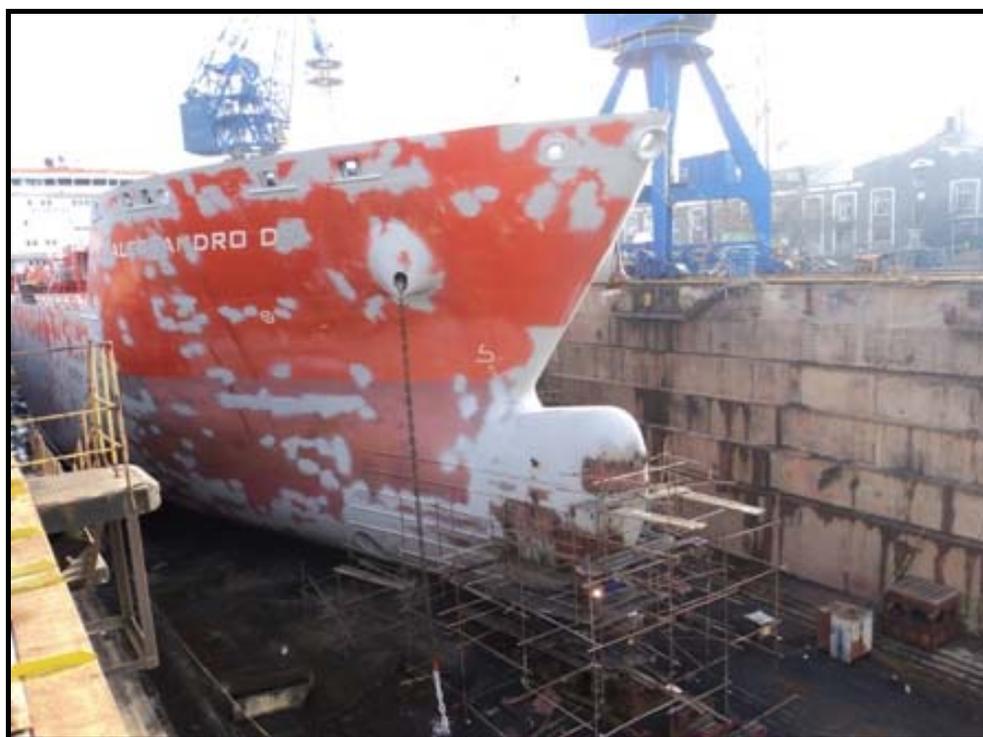
m/t “Alessandro DP” after the collision seen at the dry dock in Varna

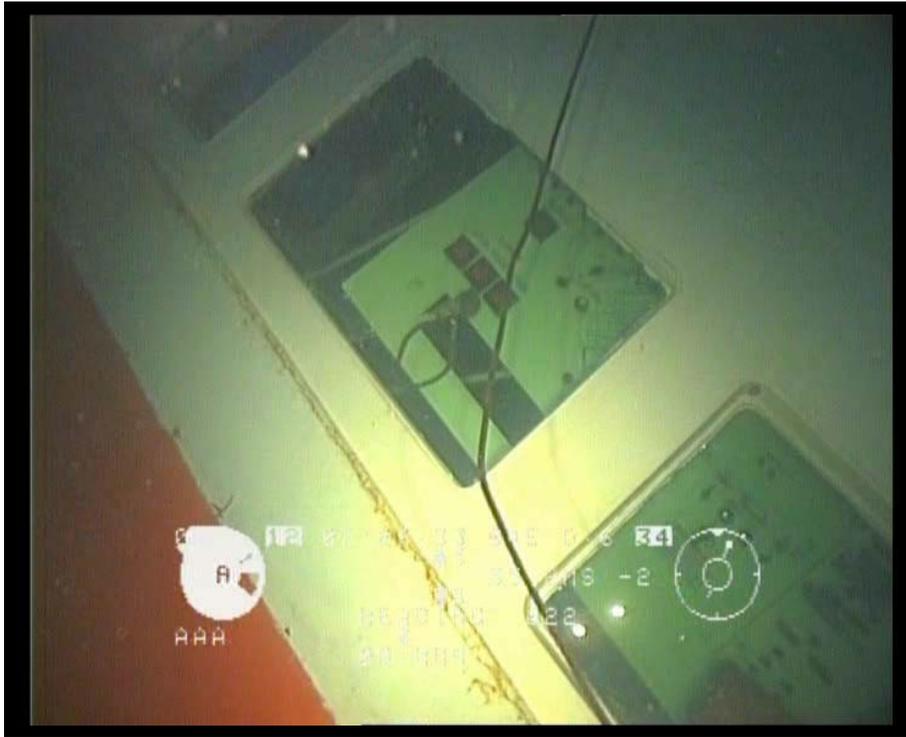
The navigation bridge of m/v "Karam 1"

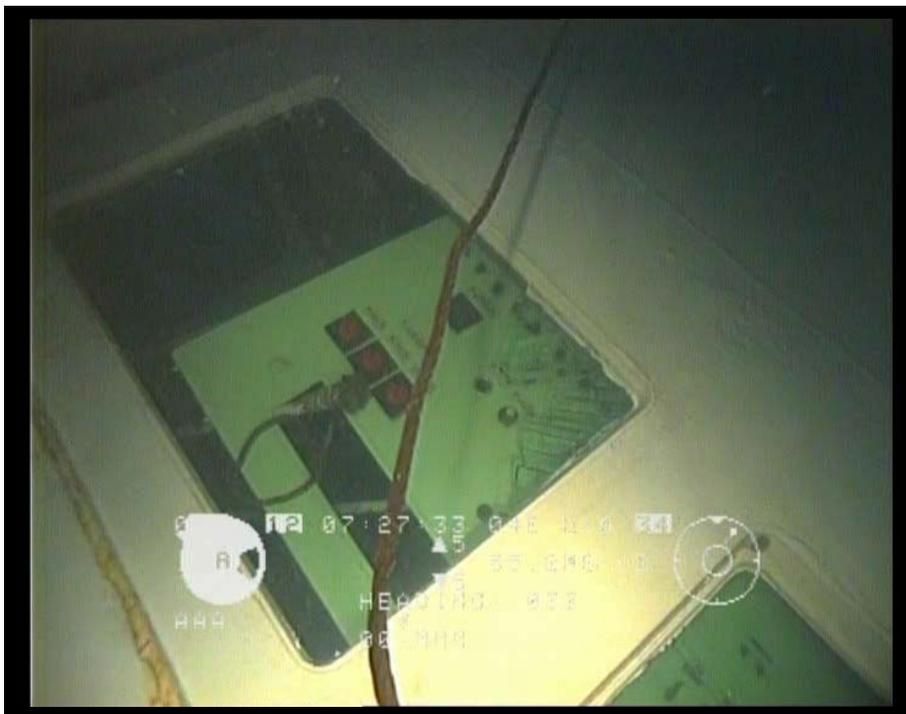
The navigation bridge of m/v "Karam 1"

Clearly is seen the broken window of the porthole.

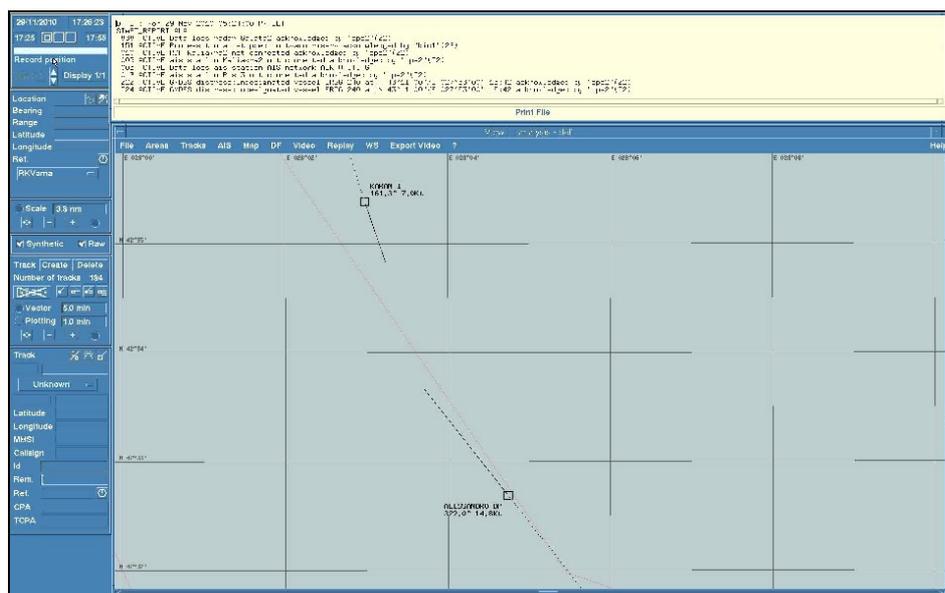
Fig.1

From the situation shown on Fig. 1 at 17:26:5 h, when the distance between the two ships is 3 nm it was clear, that no one from the two ships does not changes its course. If the officers on duty were following the change in the list, which is obligatory when the courses are crossing each other, they would found out that even without change in the course the passing will be performed with the starboards at a minimal distance of 2,5 cables.

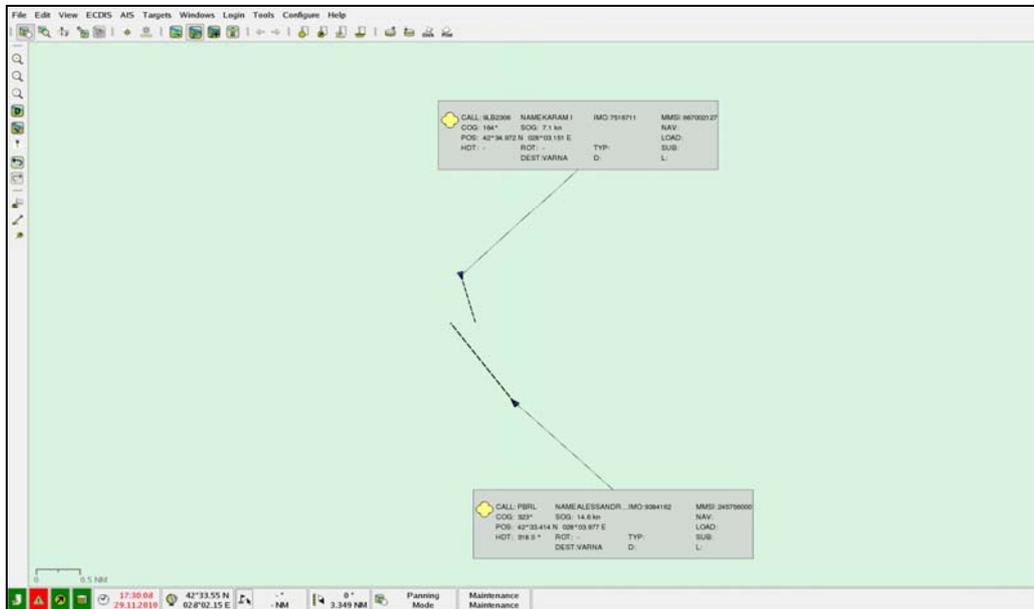
At 17:30:00 h at a distance of approximately 1.8 nm as seen on Fig. 2 both ships continue their sailing without change of the course or speed. And once more without change in the course, the captains checking the change in the list would find out that the passing would be performed at a distance with the starboards.

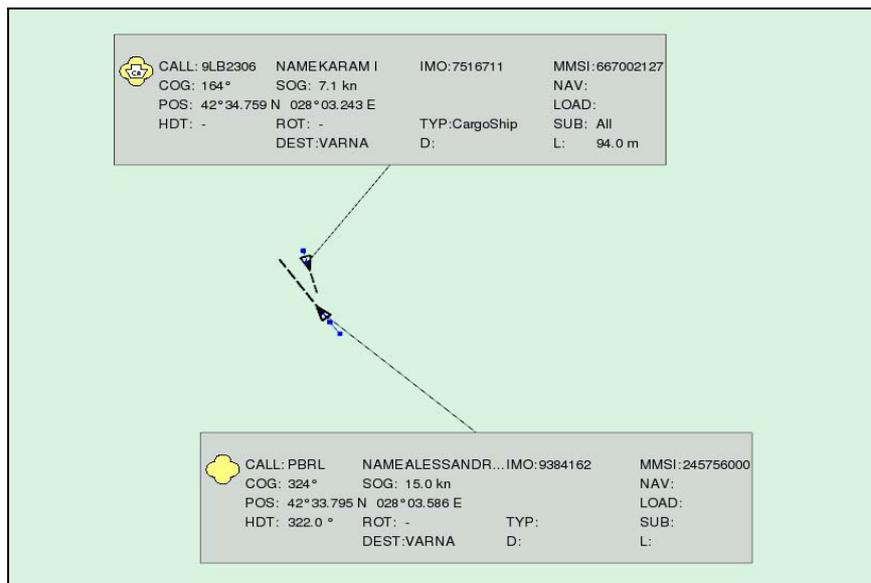
Fig. 3

At 17.32.02 h at a distance of 1,3 nm (see Fig. 3) the ships still are without change in the course and speed. M/v “Karam” observes m/t “Alessandro DP” on his course, and

“Alessandro DP” observes both board lights of “Karam 1”. In case of right evaluation on the situation and the change in the list and in such mutual location the passing would have happened with the starboards at a distance of approximately 2 cables.

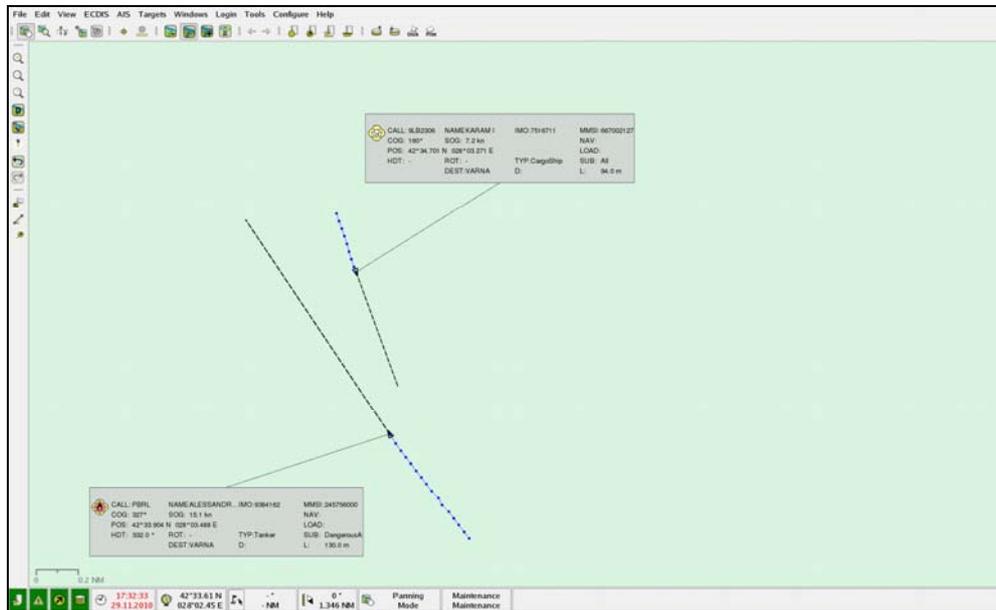
Fig. 4

At 17:32:33 h at distance of 8 cables as seen on Fig. 4, when from “Alessandro DP” were observing only the green board light of “Karam 1”, the on-duty officer on the watch started turn starboard, and the on-duty officer on board “Karam 1” changed the course with some degrees to portside as seen on Fig. 5. In such a case of approach under 1 nm its obligatory the change to manual control, that in fact was not performed in time.

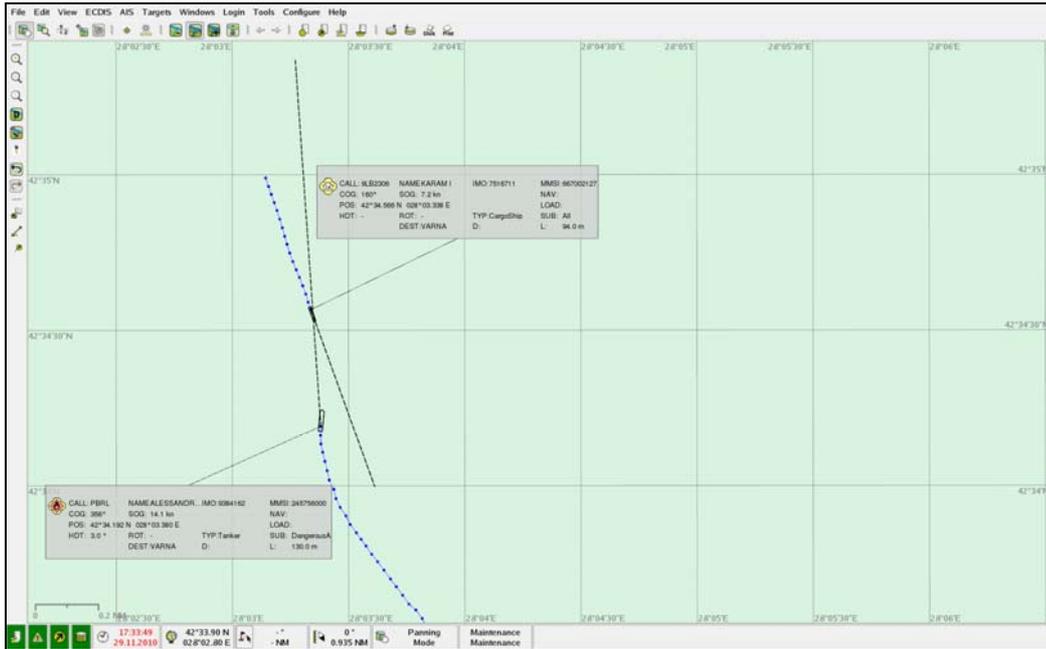
In the so created situation the process went out of control as seen on Fig. 6 and after that followed the collision at full speed at 17:35 h seen on Fig. 7.
