FINAL REPORT

on
investigation of a serious incident with Ka-26 helicopter, reg. LZ-6013,
owned by Balkan Agro Aviation Ltd Air Operator, town of Vratsa,
occurred on 02.04.2004

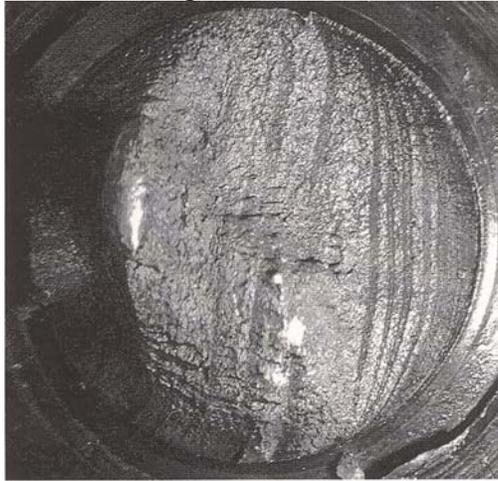
Фиг. 2.1.

The breaks of the studs with fatigue cracks are shown on the Fig. 2.1 & 2.2.

The fatigue crack on the stud, which broke is shown on the fig. 2.1, comprises more than half of its cross section, and the fatigue crack on the stud, which broke is shown on the fig. 2.2 - about 1/3 of the cross section.

The brakes of the piston rod bracelet and on the other studs were provoked as a result of inadmissible stresses. The possible pattern of inadmissible stresses on the studs and bracelet destroyed matched the general bending and shearing, preceded by fatigue destruction of one of the two studs, for which material fatigue was found.

Having in mind the above mentioned, the conclusion should be done, that the destruction of the first cylinder assembly was a result of the firmness loss of the assembly as a result of fatigue destruction of one of the studs.

In order to avoid the occurrence of similar events of destruction of M-14V26 destruction it should be expedient to perform nondestructive test (color crack detection) of the studs of the engine cylinders during the overhauls.

5. A non-destructive test should be included in the repairing methods for M-14V26 engine overhaul (color crack detection) of the fixing studs of the cylinder to the engine housing.
