# FINAL REPORT

Investigation of Aircraft Accident with An-12 aircraft, registered LZ-BRP,  
owned by Air Operator Bright Aviation Services, occurred on 01.01.2004 at  
Tehran Airport, Islamic Republic of Iran.

The materials on the aviation occurrence have been classified under state file number 01/01.01.2004.

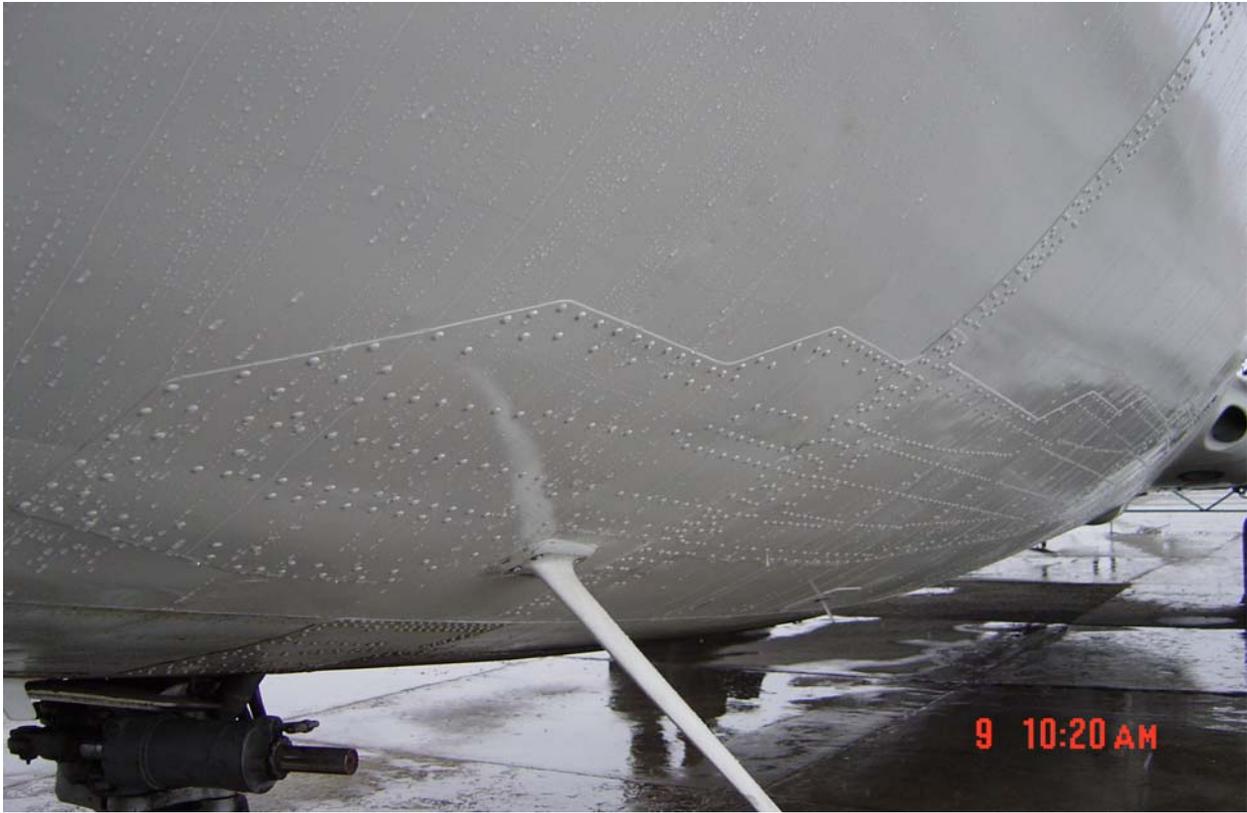
**Fig. 3**

- Tearing and crippling of the pressurized part of the fuselage from 6<sup>th</sup> to 13<sup>th</sup> strength ribs;
- Tearing and crippling of the non-pressurized part of the fuselage from 13<sup>th</sup> to 19<sup>th</sup> strength ribs;
- Deformed skin supporting elements between 6<sup>th</sup> and 19<sup>th</sup> strength ribs.

- The skin intactness of the lower left-hand part of the fuselage between 6<sup>th</sup> and 19<sup>th</sup> strength ribs was restored (vide Fig.3);
- In the torn area the skin was strengthen from inside by additional L-shaped aluminum ribs;
- The partition wall in the pressurized part of the cabin was additionally strengthen by L-shaped aluminum profiles (vide Fig. 4)]
- After the technical flight the aircraft was transferred to Letetz workshop and it was liable to repair after the damage.

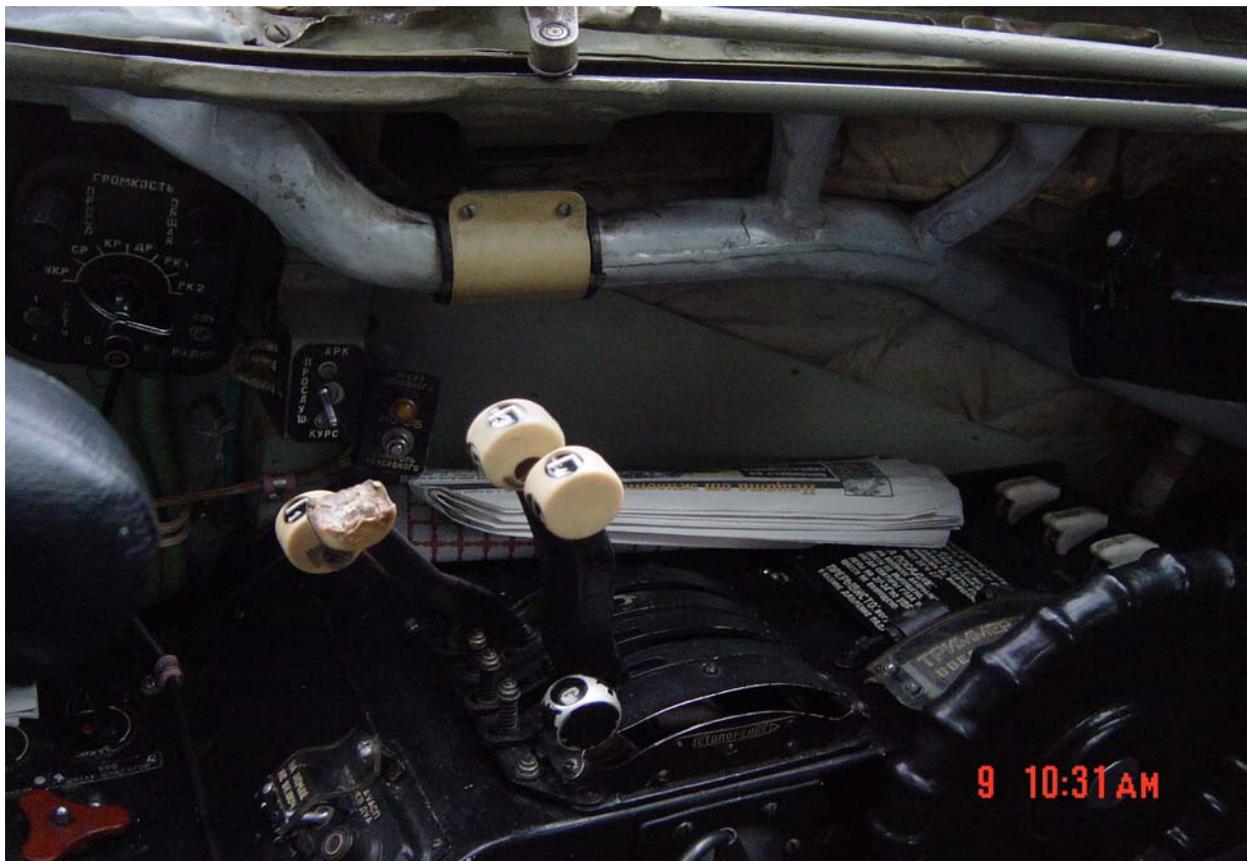
**Fig. 6**

There were no deviations of the estimated parameters during the take-off from Bam Airport, climb, en-route flight and descend for landing. After the phase "Descent for landing" during the aircraft flare-out and touch-down the piloting pilot (aircraft commander) inadvertently put the power levers of engines No 1 & No 2, installed on the left-hand half-wing, into 0°-position according UPRT – "ground idle". The power levers of engines No 3 & No 4, installed on the right-hand half-wing, were on 16° according UPRT – "in-flight idle" (vide Fig. 6).

The aircraft movement trajectory, described by the center of gravity is formed by the acting forces and moments. In case of above shown position of power levers there was a presence of difference between engine No1 & No 2 on the left-hand half-wing and engines No 3 & 4 on the right-hand half-wing, conditioned by the principal of operation of the turboprop engine AI-20.

During engine power reduction from 16° UPRT to 0° UPRT with constant aircraft speed (200...220 km/h in case), the propeller pitch is changing (lessening), which led to respective lessening of their angle of attack. In the mentioned range from 16° UPRT to 0° UPRT the angle of attack at this speed moves from about zero values to negative values and the propeller turns to regime of deceleration. In this regime the engine works at idle and the power is not enough to rotate Propeller – Compressor – Turbine system and the lacking energy is taken from the air, which attacks the propeller vanes. As a result of this engines No 1 & No 2 on the left-hand half-wing, working at ground idle - 0° UPRT created negative thrust.
