FINAL REPORT

**investigation of a serious incident with Diamond DA 42 aircraft,
registration No LZ-ASH, operated by air operator Air Scorpio, realized on
27.09.2007 at Gorna Oryakhovitsa Airport.**

2008

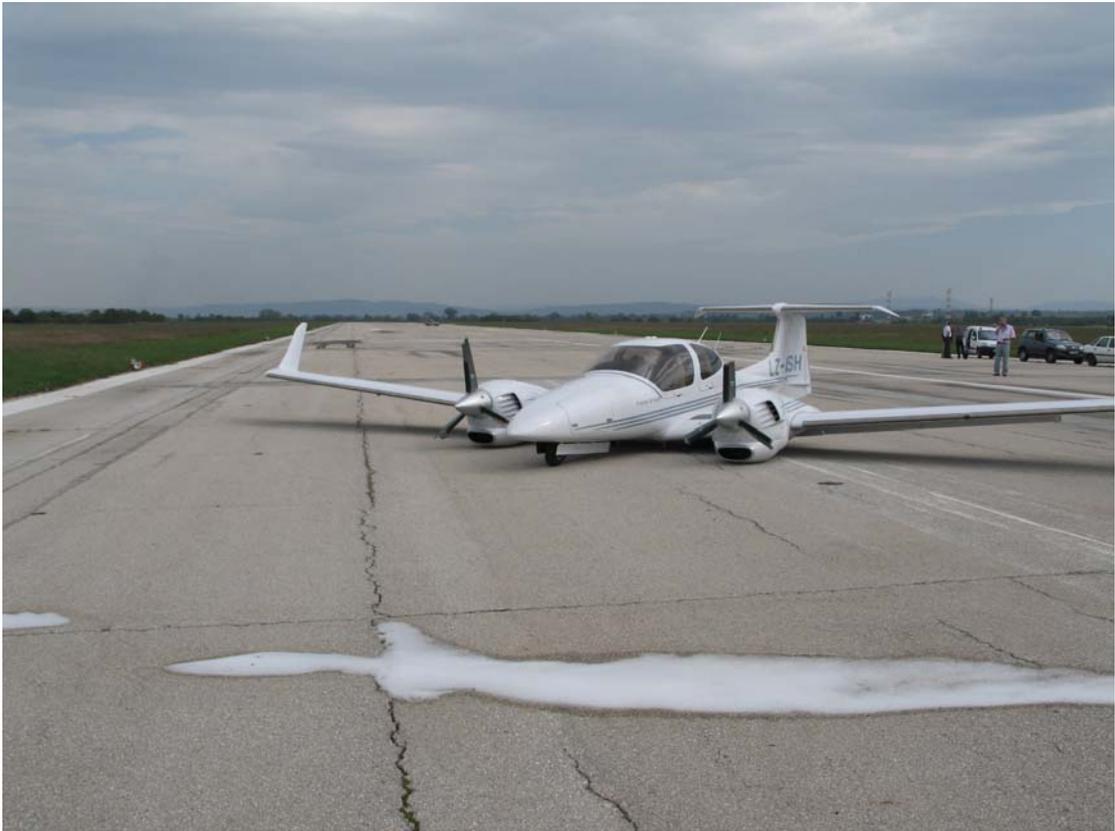
Figure 1

On Figure No 1&2 of Enclosure No 1 the general aircraft view after the realization of aviation occurrence is given.

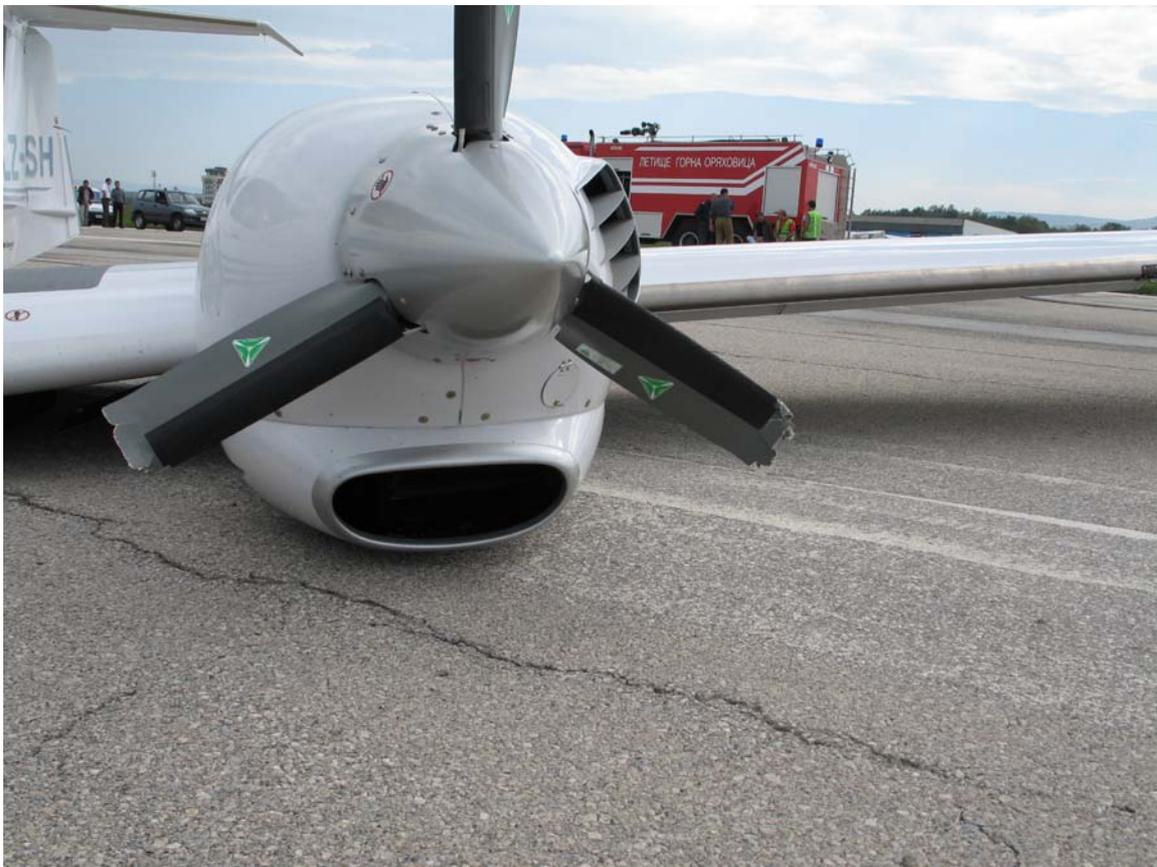
- Destroyed No1 engine propeller blades;
- Flat tire and filing of the wheel cover of left-hand main landing gear.
- Destruction (filing) of the composit coating of the bottom surface of engine nacelle of No1 engine;
- Destruction (filing) of exhaust tube of No1 engine;
- Destruction (filing) of the breather tube of No1 engine;
- Worn-out (filed) left-hand step;
- Filing of the bottom surface of the tail bumper;
- Worn-out (filed) right-hand step;
- Destruction (filing) of the composit coating of the bottom surface of engine nacelle of No2 engine;
- Destruction (filing) of exhaust tube of No2 engine;
- Destruction (filing) of the breather tube of No2 engine;
- Blown tire and filing of the wheel cover of right-hand main landing gear.
- Destroyed propeller blades on No2 engine;

The aircraft damages are shown on Figure 3 to Figure 7, Enclosure 1.
