FINAL REPORT

investigation of an aviation occurrence with P92 Echo-S airplane,
reg. No LZ-BAT, owned by Cabelcommerce Ltd, Sofia, occurred on
02.07.2004 in the area of Dolna Banya Airfield

The materials about the aviation occurrence investigation have been classified under state file number 05/02.07.2004.

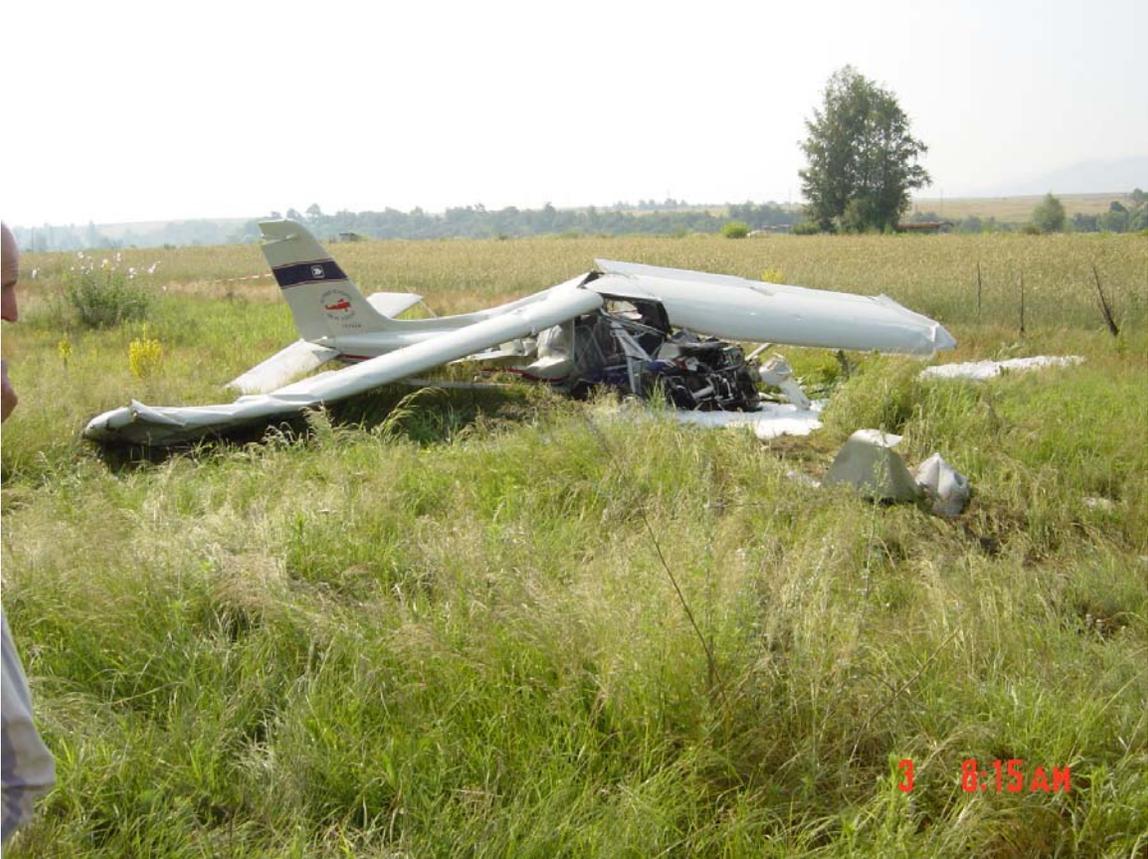
Fig. 1

The pilot received injuries with fatal outcome and the aircraft was fully destroyed (Fig.1).

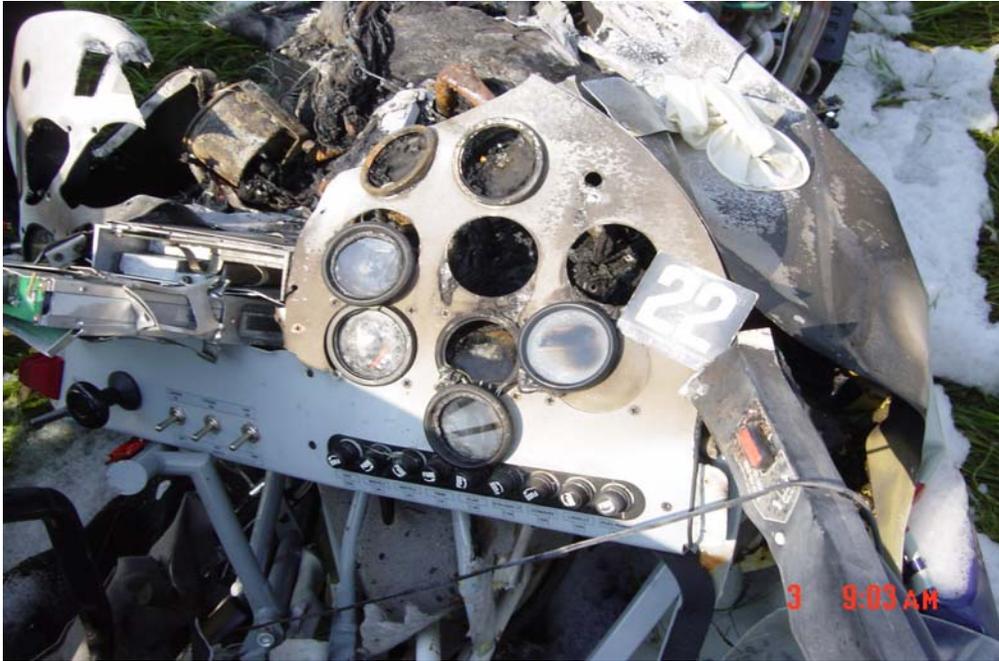
Figure 2

Aircraft cockpit was badly deformed and the engine was displaced back axially at about 35...40 cm. As a result of the engine fire arisen the instruments of the right-hand part of the console were burnt (Figure 2).

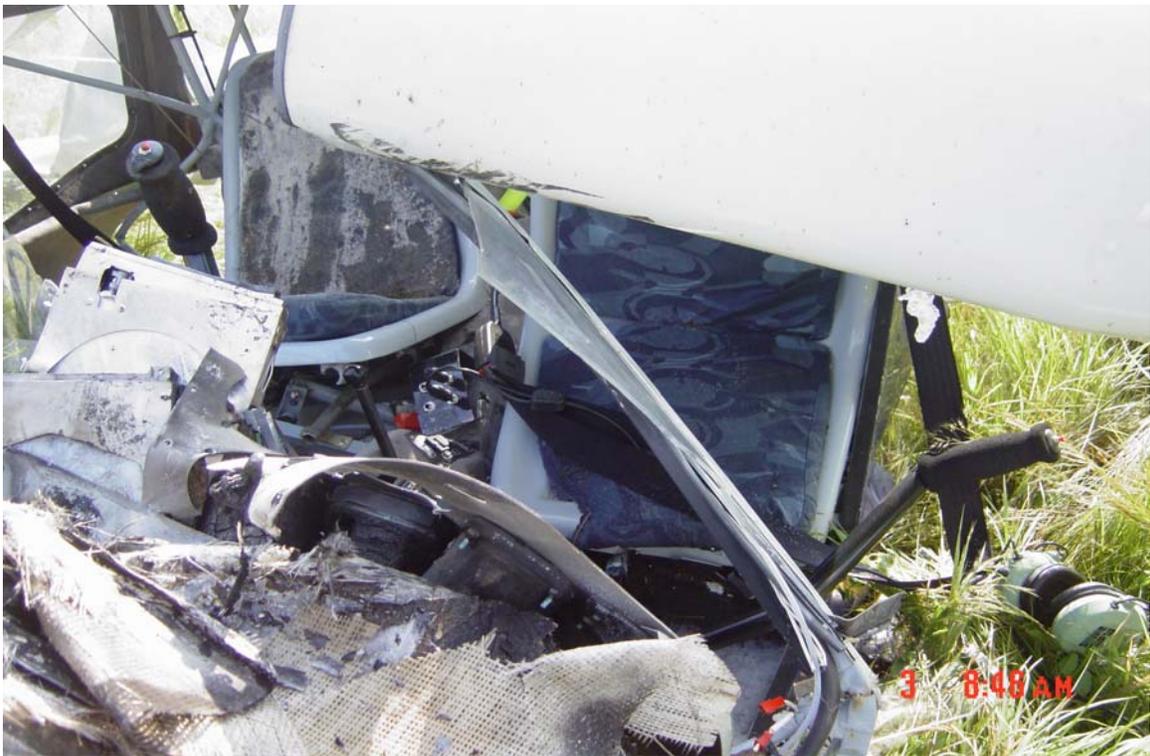
Figure 3

The left pilot seat was very deformed and inclined forward, but it wasn't torn from the main fixing assemblies (Figure 3).

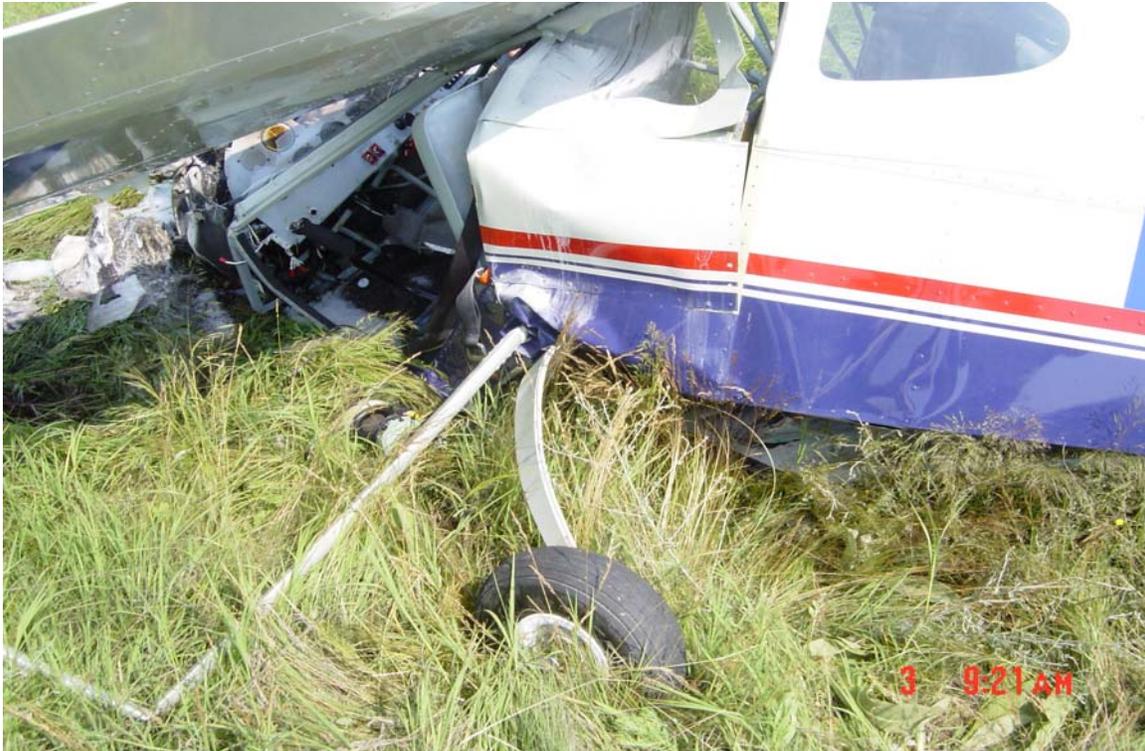
Figure 4

The attachment point of left-hand main landing gear was very bent and deformed together with the fixing assembly of the left-hand strut support (Figure 4).

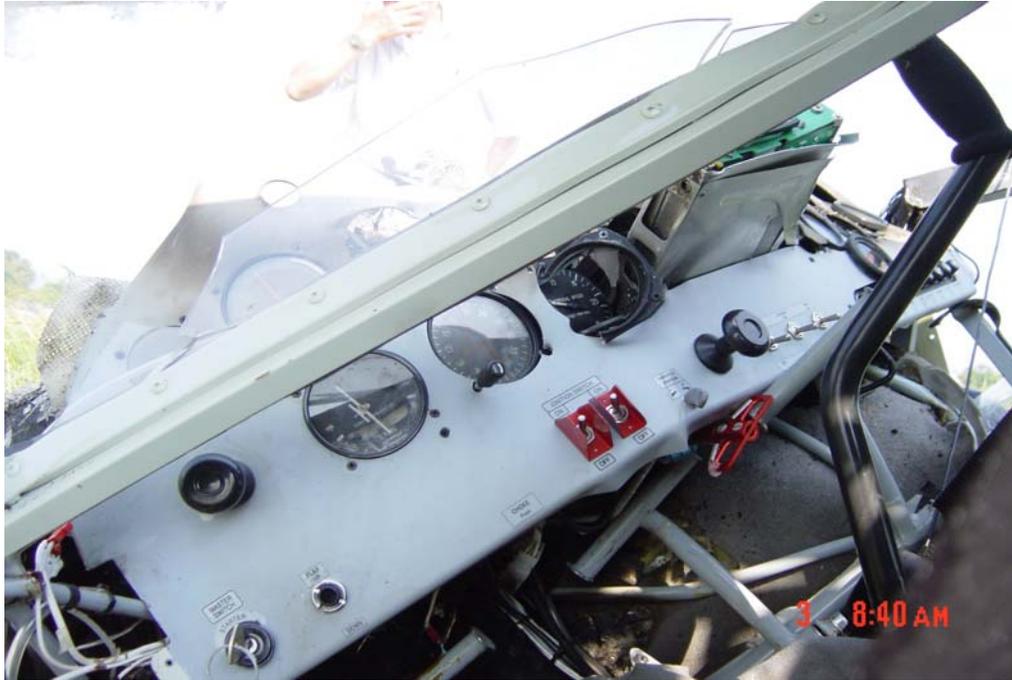
Figure 5

Aircraft cockpit was badly deformed and the engine was displaced back axially at about 35...40 cm. As a result of the engine fire emerged the instruments of the right-hand part of the console were burnt out. From the aircraft instrumentation (Figure 5), placed at the left-hand part of the console, the following instruments were well preserved: speed indicator, showing 0 km/h, because the tube for pressure to the aneroid was torn; the compass, showing CC=210°, slide slip indicator with a ball at end left-hand position and rate-of-climb indicator, showing vertical speed of 350 ft/min (about 2 m/s).

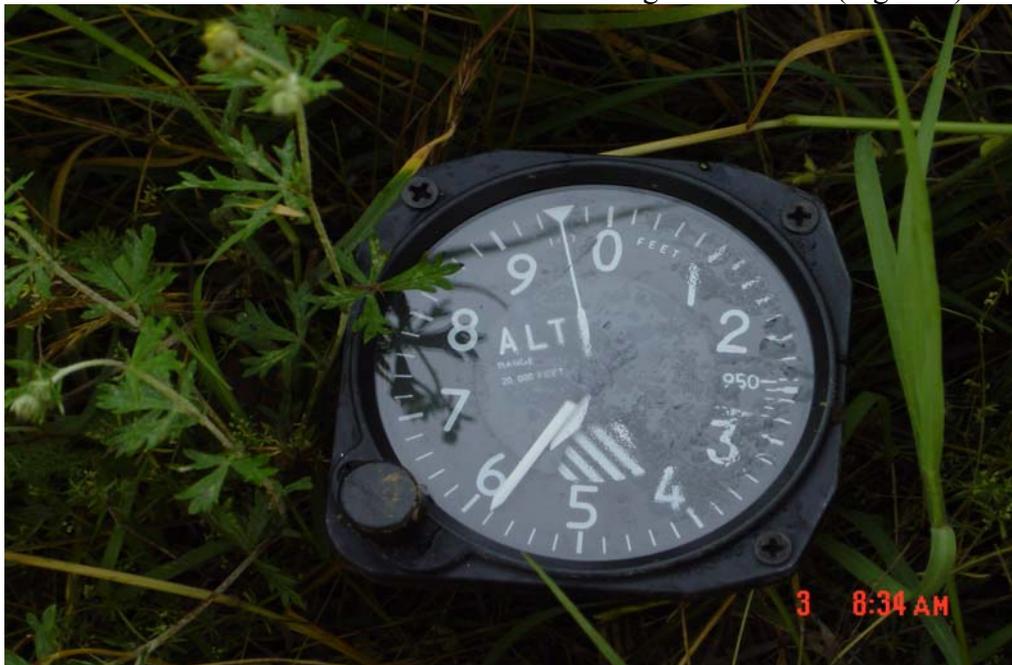
Figure 6

Aircraft gyroscope horizon and altimeter were found at a distance of 4.5 m from the cockpit in aircraft flight direction at the moment of the second impact. An altitude of 5580 ft was fixed on the altimeter and the altimeter setting was 951 hPa (Figure 6)=

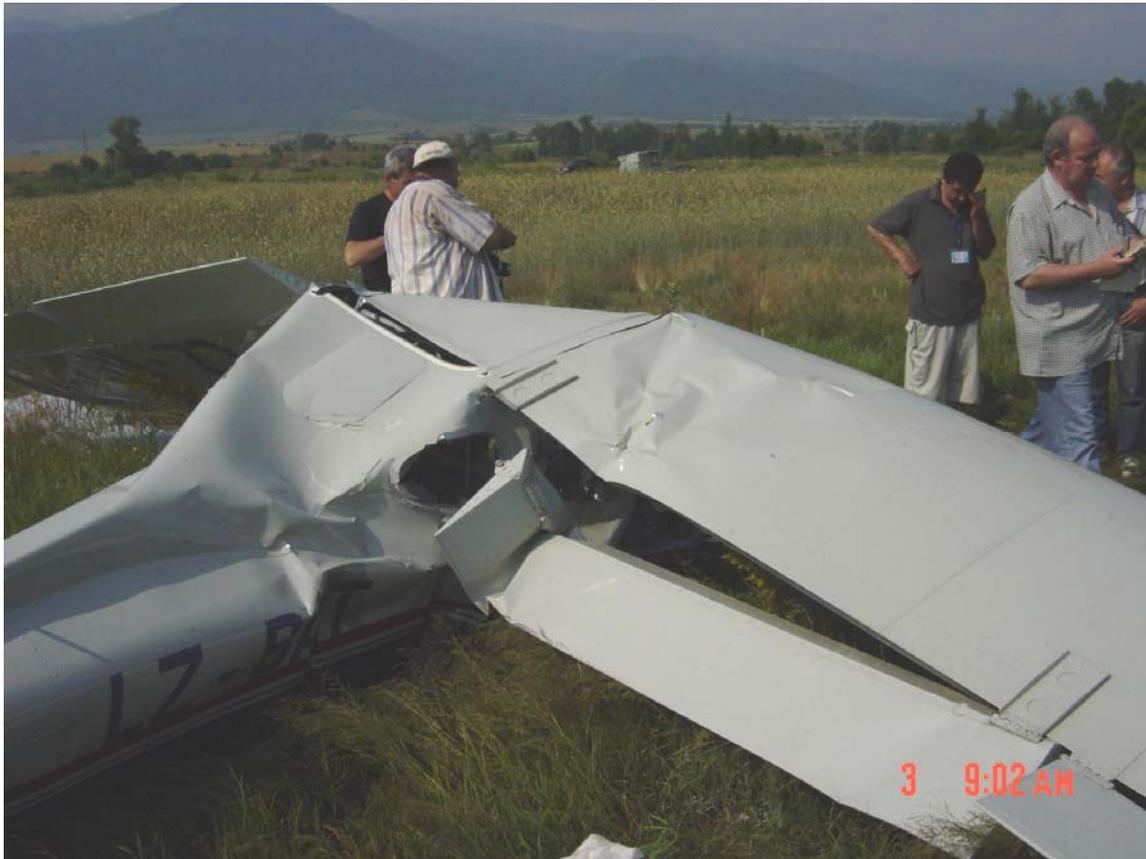
Figure 7

The damages of the aircraft were described in Para1.3 and part of them was shown on Figure 7.

The fuselage was deformed and the cockpit truss construction was destroyed. The front and aft bearing walls were bent.

Fuselage longitudinal bearing elements were twisted to the left. The fin and rudder were intact, without visible deformations. The horizontal stabilizer and elevator hadn't any residual deformation.

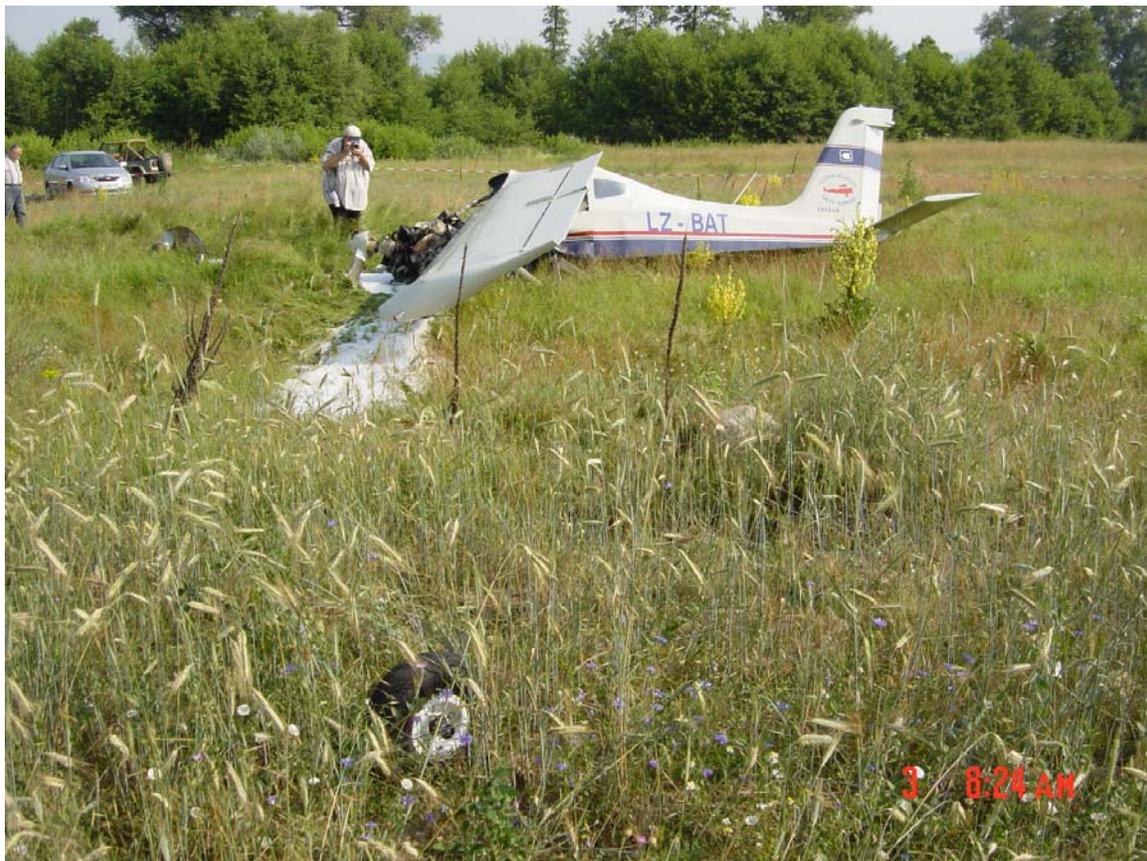
Figure 8

The right-hand main landing gear was torn from the fixing assembly and the Commission found it at 4.7 m from the end of the left-hand half-wing, as it was shown on Figure 8.

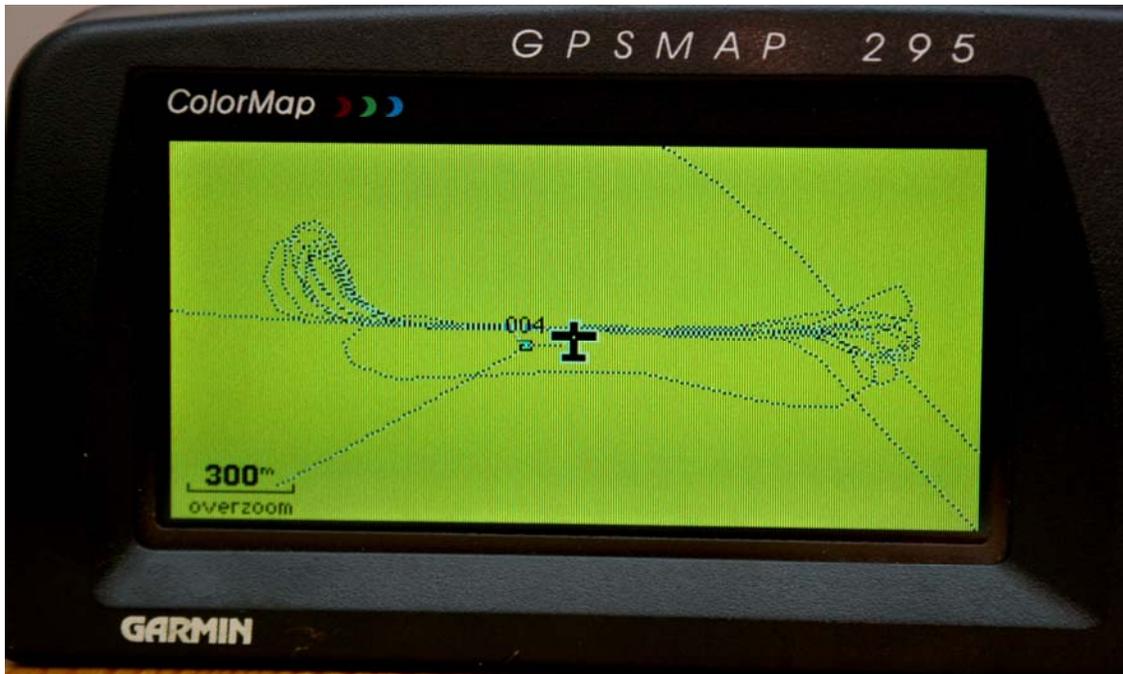
Figure 9

During the initial inspection of the scene of the air accident the Commission found out the aircraft GPS receiver at 10 m from the aircraft. During the investigation it was established that it was operable and that gave the Commission the possibility to restore on the display the graphical pattern of the last flight (Figure 9). This pattern coincided with the elements, described by witnesses and actually confirmed the nature of the flight and the elements fulfilled.
