FINAL REPORT

**Technical investigation of railway accident –
fire occurred during movement of electrical locomotive No 44085.9, which
serviced fast train No 3622 in Sahrane railway station on 16.06.2016**

September 2016

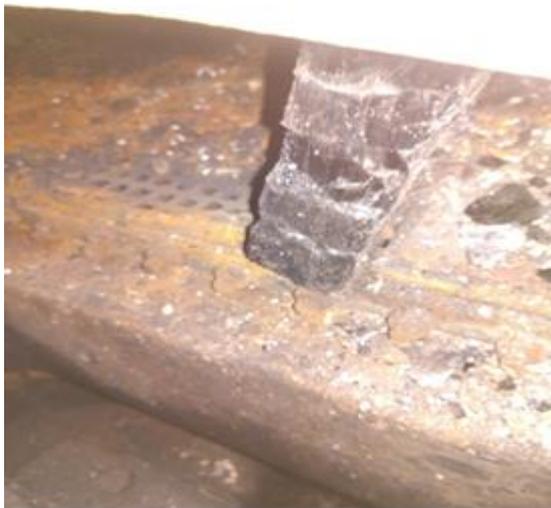
Фиг. 1

The Investigation Commission considers that the cause for the fire of locomotive No 44-085.9 is the presence of a wooden piece under the bearing grid of the smoothing reactor of the auxiliary machines, which is located on the oil cooling radiator of the traction transformer (Fig. 1 and 2). The grid itself was repeatedly welded on the same place due to a fatigue of the material as a result from the presence of vibrations in the grid during operation. **After the consecutive tear of the welding the same was not restored, and instead of that in the repair point was placed a wooden piece from pine, which served as a support of the grid during operation (Fig. 5).**

1. Immediate check of the fire-extinguishing and fire-alarming installations for their current working order, as well as of the main protections of all the operative locomotives.
2. Strengthening the control over the operating inspections of the locomotives in the main and turnover depots, as well as in the operational service points.
3. Conducting periodic training sessions of locomotive personnel regarding the structure and operation of the fire-fighting installation of locomotives and actions to be undertaken in case of fire.
4. Accomplish modernization of locomotives of 44 and 45 series by means of introducing new fire alarm and fire-extinguishing installations with automatic action and more effective firefighting agent.
5. Remake of the existing fire-fighting installation of the locomotives and adding of extra smoke and flame sensors in danger zones.

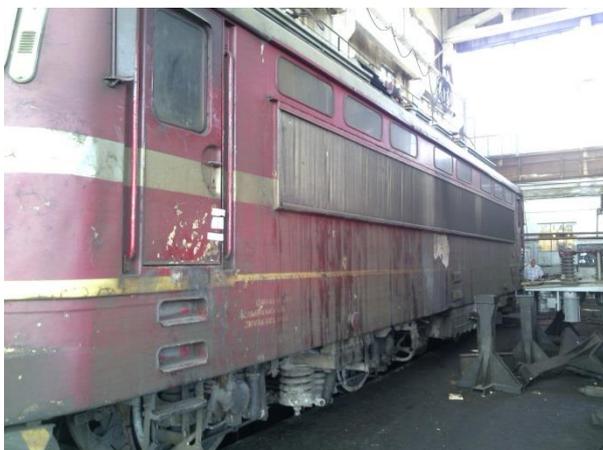
Fig. 3

The accident investigation Commission got acquainted in details with the condition of the locomotive set on fire, with the circumstances preceding the fire as well as with the actions of the train and traffic crew. During the inspection was found that at the beginning the fire occurred in the middle of the engine compartment, and more precisely in the high-voltage chamber (HVC),

then it spread to the roof of the locomotive and burned almost all the equipment mounted on the inner side of the roof, such as cables, insulators, etc., and part of the equipment mounted on the upper side of the roof. The flames affected the underroof equipment, then advanced downwards led by the air-blast caused by the cooling fans and fired a part of the flooring and for this reason occurred a burned spot from the right side of the locomotive body shell in movement direction (Fig. 3 and 4).

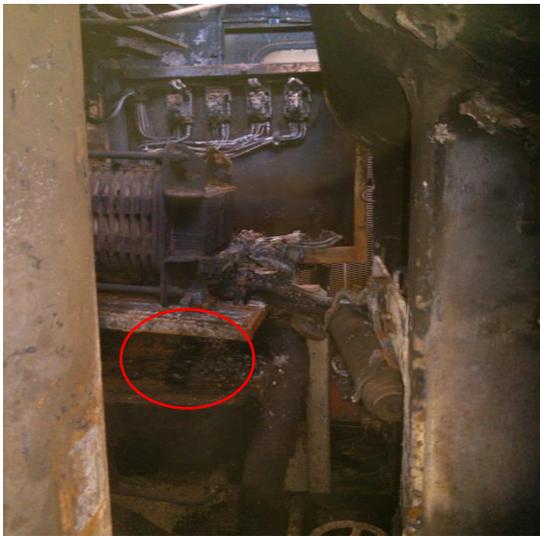
Fig. 5

That initially directed the Commission to search for the cause either in the locomotive power supply from the main air switch (MAS), or in the components for powering the electrical dynamic brake, which are located next to the smoothing reactor of the auxiliary machines (engines) of first group. However, based on the circumstances, that the locomotive run in traction regime, and did not use the mentioned electrical stop, that version was declined. Searching for the fire outbreak, the Commission directed to the group of oil cooling of the traction transformer, because of the trails left by a high temperature fire. Above that group is located the smoothing reactor for auxiliary machines of the locomotive first traction group. **Namely under the grid of that smoothing reactor was found a completely charred wooden piece, but with its form and dimensions kept, placed as a jamb to support the grid in question (fig. 5).**

That circumstance, together with the explanations of the locomotive crew, that during the firing sensed a smell of burning wood, unambiguously confirmed that the primary source of the firing was namely that found wooden piece. The work of the smoothing reactors is accompanied with the emission of significant amount of heat, and their working temperature reaches up to 170°C. For that reason the smoothing reactor of the auxiliary machines is installed on the radiator of the oil cooling heater of the traction transformer, and together with it is cooled by the mounted under the body shell horizontal engine-fan. Over time, the heat was accumulated in the wooden piece (Fig. 2), which led to the specific for the wooden material condition of combustion—*smoulder*, which from its side caused ignition of the wooden piece itself. The emergence of an open fire in the area of the oil radiator to cool the oil in the traction transformer caused the ignition of the oil residues on the radiator itself, the dirt and dust located in the engine compartment, as well as on a later stage, of the insulation of the cables and the rest of the electrical equipment components. Particularly disturbing is the fact, that the fire protection installation of the locomotive did not

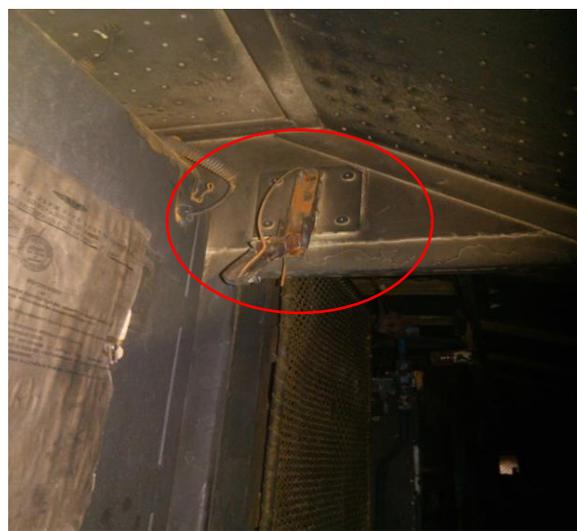
Fig. 6

operate, nevertheless it was activated by the locomotive crew (Fig. 6 and 7), and that caused further expansion of the fire.
