**NATIONAL AIR, MARITIME AND RAIL ACCIDENT
INVESTIGATION BOARD**

FINAL REPORT

**FIRE IN BALLAST TANK OF M/V "BELLONA" AND DEATH OF A
WORKER DURING SHIP REPAIRS ON 14.12.2021**

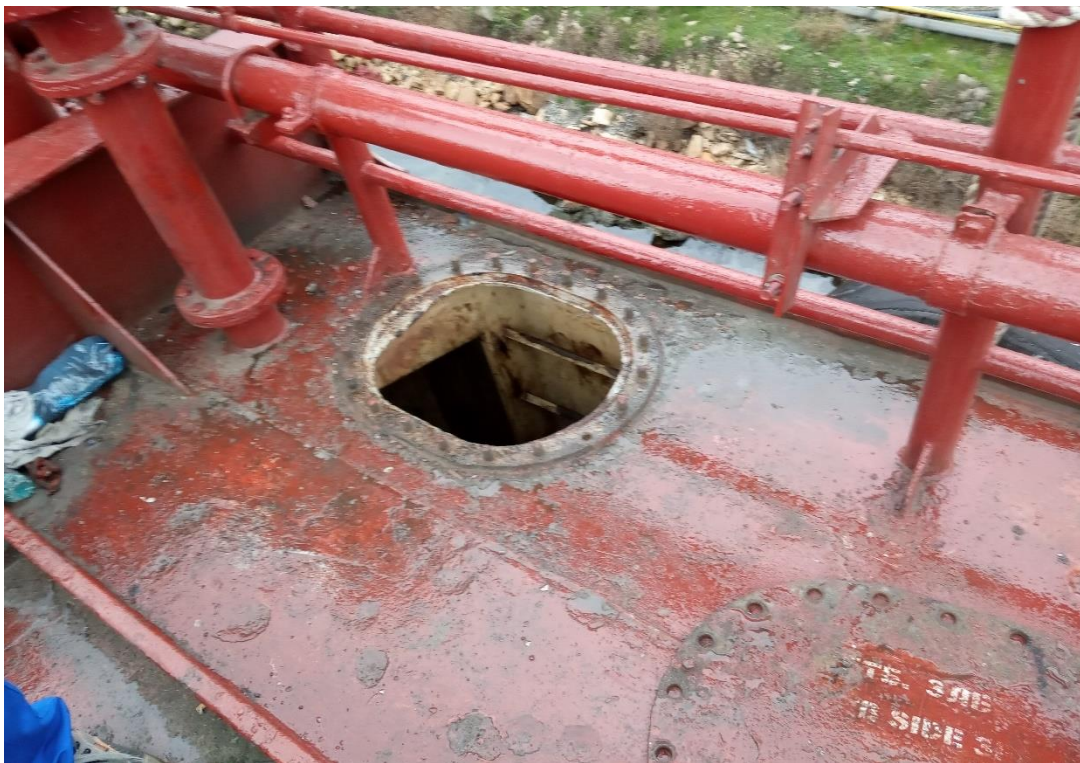
Fig.2. Manhole of ballast tank No. 3 – port side

On 14.12.2021 the *m/v "BELLONA"* was located in the ship repair yard "MTG Delfin" JSC for class repair. On board the ship different repair activities were carried out. "MTG Delfin" JSC has concluded a contract with a subcontractor company "Galera 07" LTD. Part from the activities were assigned on workers from this one company. On 13.12.2021, two workers carried out hot works related to dismantling and replacement of a ballast valve from the pipeline in ballast tank №3 P/S (**Fig.2**).

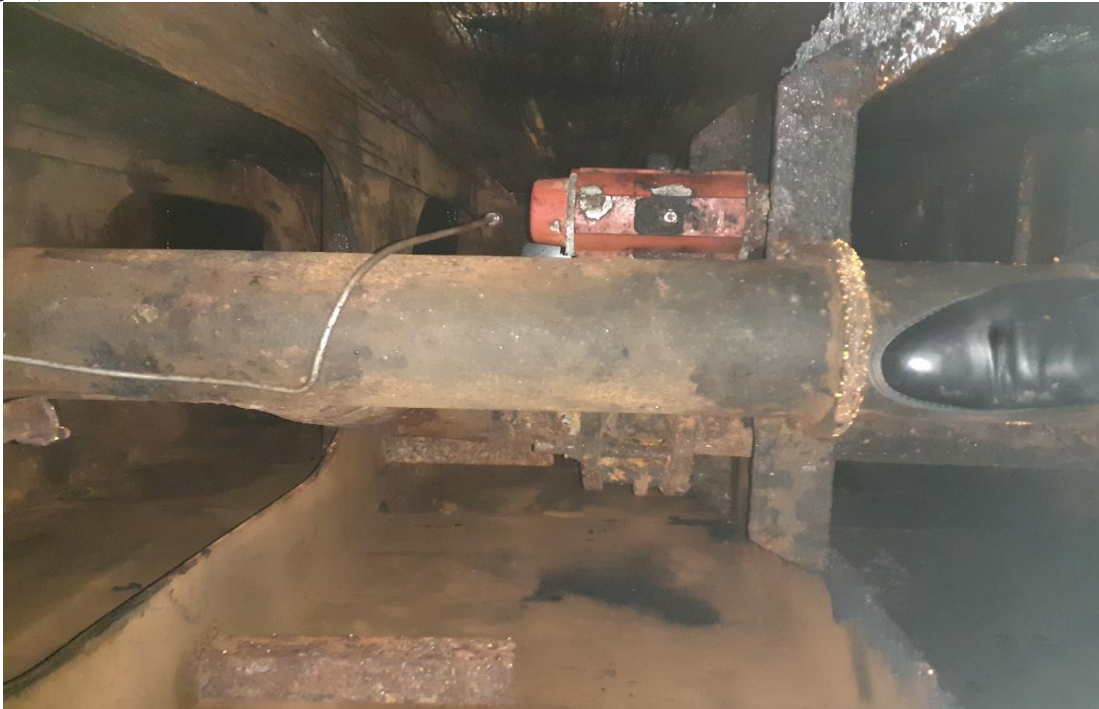
Fig.3. General view of the studs of the ballast pipe (top view)

The workers cut with gas-oxygen cutter the nuts on the studs of the flange joint of the valve (Fig.3).

On 12.12.2021, it was decided, by using a gas-oxygen cutter, to cut the nuts of the studs from the flanges, holding the ballast valve in place. This was due to the fact that because of strong corrosion, it was very difficult, almost impossible to unscrew them with a wrench.

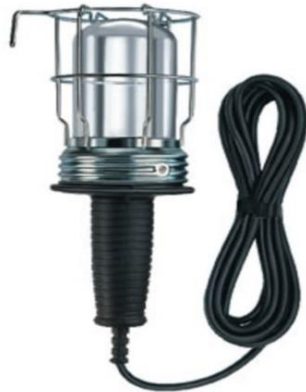
Fig.5. Portable 24 V lamp

3.4.2. The use of this type of lighting (garland) was determined by the possibility of better illumination of the workplace. At the same time, the contacts of the electrical panel are not unnecessarily occupied in case of single, safe portable 24V lamps.

Then, to achieve a similar degree of illumination, several such lamps would be needed. It would also create unnecessary cable clutter in the tank's already limited space. However, this does not negate the requirement that the bulbs of the garland, as well as itself, be designed for work in a potentially fire- and explosive-hazardous environment. Measuring the atmosphere is a necessary initial condition for hot works, but the possibility of gas leakage - methane or oxygen - must always be considered. Oxygen, unlike methane, is not combustible, it supports combustion as an oxidizer. The dangerous thing about it is that in an environment rich in oxygen (**over 24%**) the workers' materials, clothes, hair, etc. are saturated with oxygen. This sharply reduces their ignition temperature and they become highly flammable.

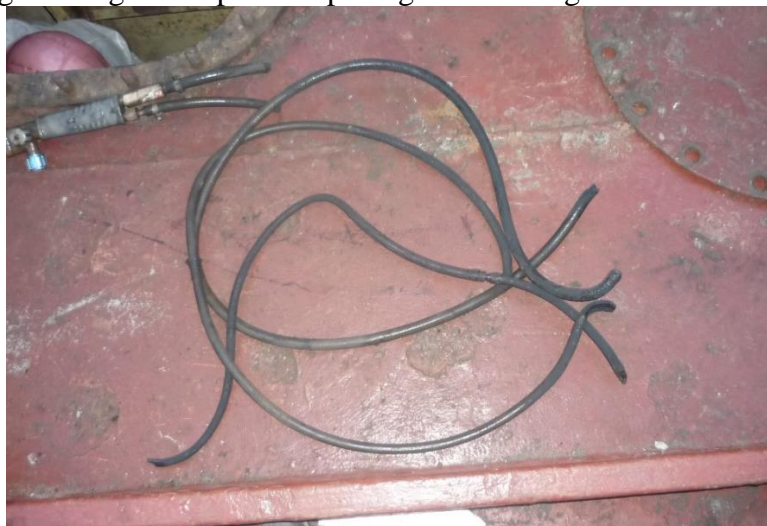
Fig.6. The remains of the hoses on the deck

The results of the performed fractographic, defectoscopic and traceographic microscopic examination showed the presence of destructive damage concerning 100 % of the section of the inner rubber layer, 100% of the frame (textile braid) and incomplete destruction of the section of the outer rubber layer.

Microscopic examination in laboratory conditions of the combustible gas (methane) hose in its undamaged part of the fire proved a number of defects such as - operational "filling" contamination, a "passage" of microcracks in the tension zone, a "passage" of microcracks near the longitudinal color marking.

At the time of the accident, the hose carrying combustible gas (methane) to the cutter was technically defective, with the development of a destructive failure and leakage/pressure release of flammable and explosive fluid inside the ballast tank. The combustible gas hose was unsafe for intended use in enclosed or semi-enclosed rooms/spaces.

3.4.3. Examination of the remains of the hoses indicates that the oxygen hose was in good condition before the fire. Structural deformations were found along the methane hose with partial local destruction of the hose. That is, it was a potential gas leak hazard. It was likely that such a leak began shortly after it was hung on the bulkhead of the tank. The reason for this could be its strong bending and exposure/opening of its damaged sections.

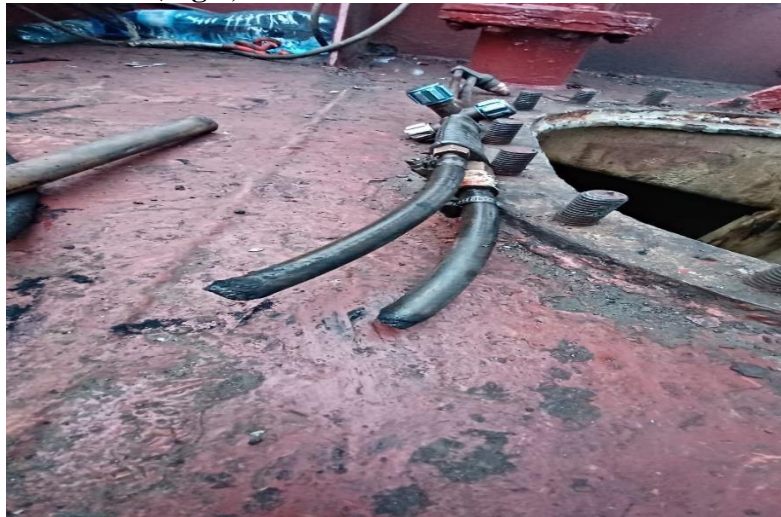
Fig.7. The used gas cutter, after removing from the tank

The examination of the cutter in laboratory conditions showed the presence of a defect, thermal-metallurgical damage of the metal, located at 125÷135 mm. from the regulation valve for the combustible gas and at 210÷220 mm. from the place (tip) of the outlet of the gas mixture. The results of the research gave reason to consider that the defect in depth did not reach the internal opening of the cutter, with a developed crack, that is, there is no possibility of gas or combustible mixture under pressure leaking into the tank.

These facts gave reason to claim that it was not a defect of the type of leakage of metal elements of the cutter, i.e. without a cause-and-effect relationship with the occurrence of the fire. Therefore, the cutter at the time of the fire was operational, but in a "defective condition" compared to the regulatory requirements as new one.

3.4.4. As already indicated, when removed from the tank and during the inspection, the taps of the cutter were closed(**Fig.7**).

This means that no gas/oxygen could have inadvertently leaked out of it.

Despite the mentioned in item 3.2.3. malfunctions during its examination in laboratory conditions, the cutter was considered to be functional, suitable for use, although not quite upright compared to new one. Similar deformations could occurred during its use - impacts, heating, etc.
