**REPUBLIC OF BULGARIA**  
**NATIONAL AIR, MARITIME AND RAILWAY TRANSPORT, ACCIDENTS**  
**INVESTIGATION BOARD (NAMRTAIB)**

**FINAL REPORT**  
**from**

**investigation of railway accident – fire in fast train № 2613 during motion between the stations  
Kaspitchan and Provadiya on 03.11.2022**

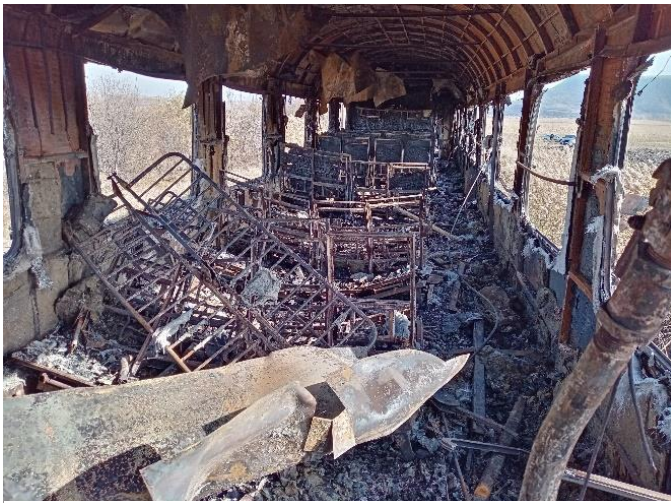
**Fig. 1.5. Condition of the internal part of passenger coach № 50522974242-2 after the fire.**

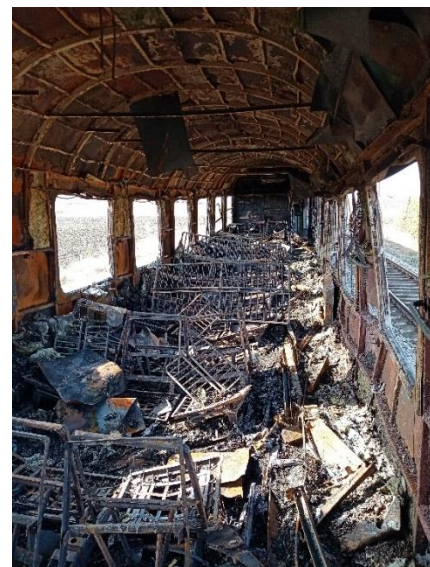
**Fig. 1.8. Condition of the internal part of coach № 50521974003-0.**

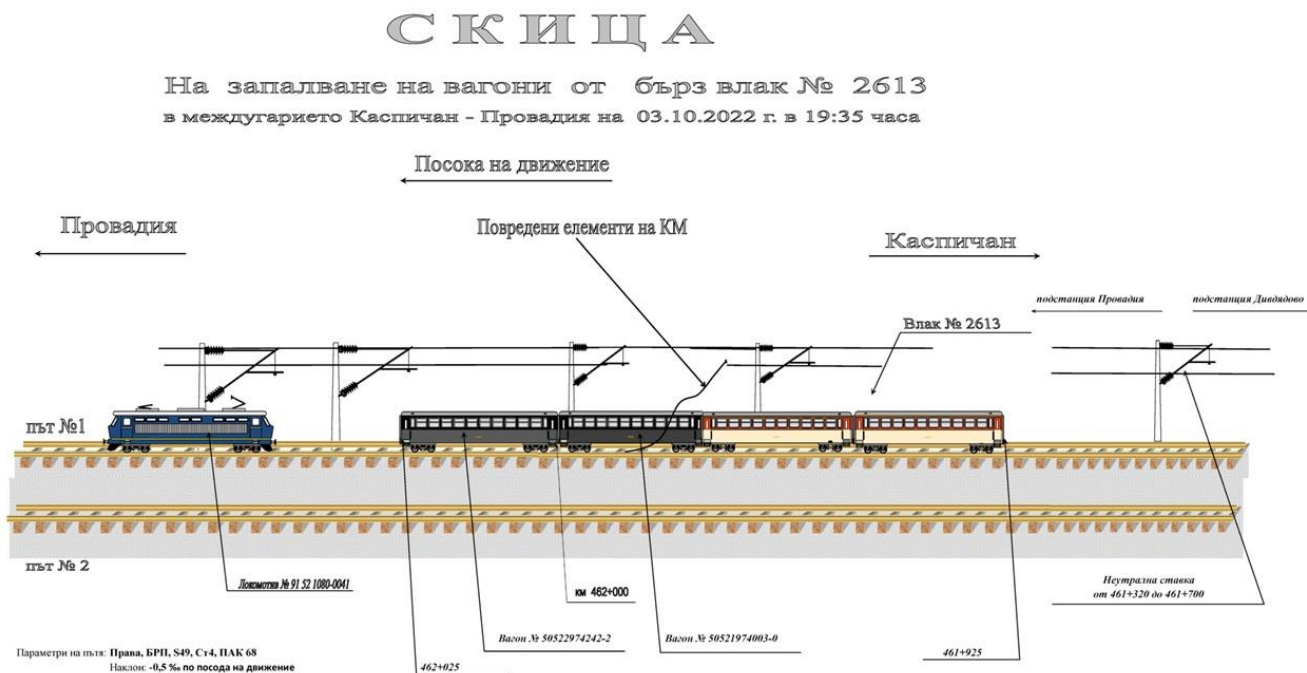
Along Kaspitchan - Provadiya interstation on track No. 1 at km 462+000 at 19:35 p.m. during the movement of FT No. 2613, a fire broke out in the second coach (first class) and subsequently spread to the first coach (second class) next to the locomotive, as well as on the two coaches, the equipment in the salons burned completely (fig. 1.9).

**Fig. 1.9.-Scheme of burning of the coaches of FT 2613 along Kaspitchan-Provadiya interstation**

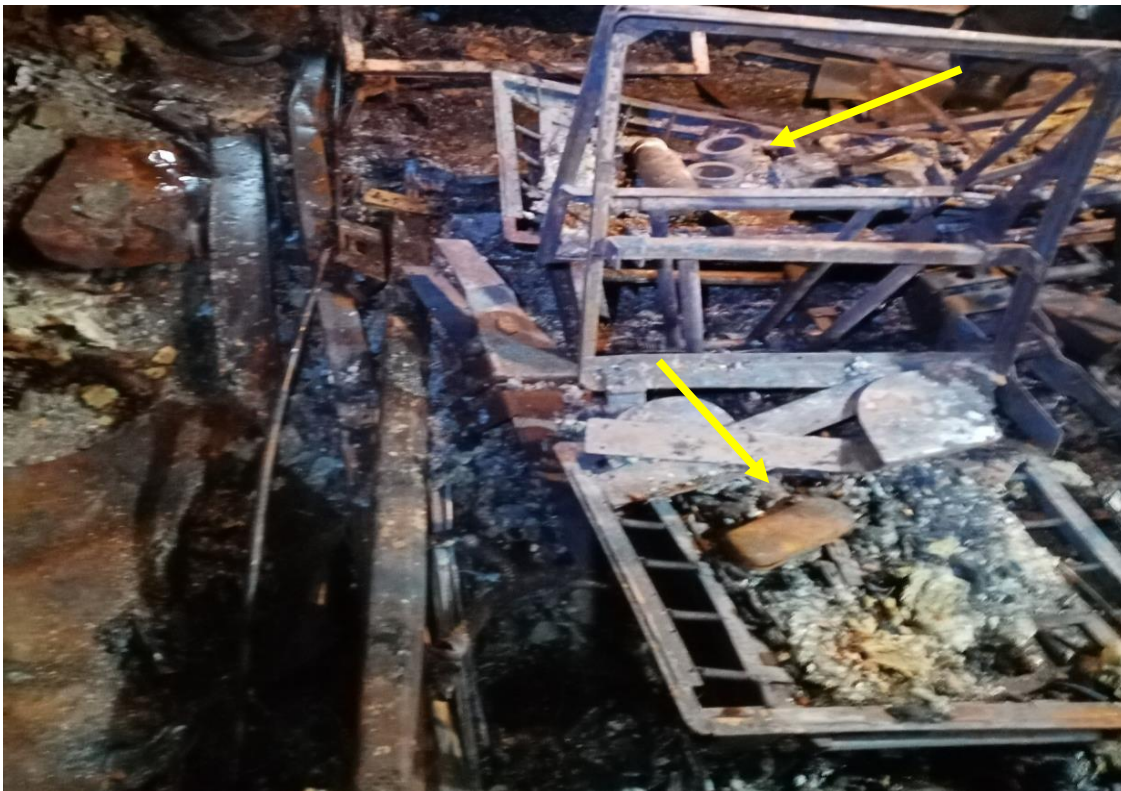
**Fig. 3.4.**

Personal belongings and luggage of the passengers traveling in the second coach No. 50521974003-0 A4 were burned due to heavy smoke and the rapid spread of the fire in the coach, this forced the passengers to leave quickly the coach without taking their personal luggage (fig. 3.4).

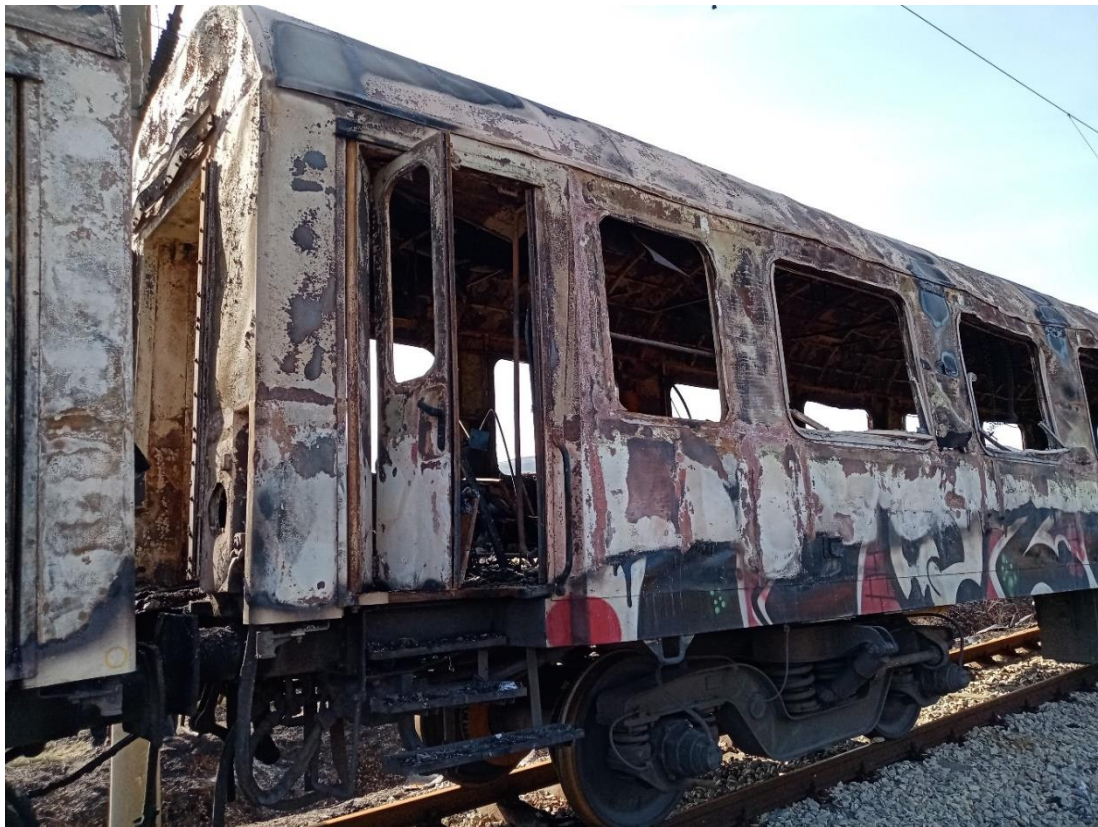
**Fig. 4.10.**

Based on the clues found at the ignition site, it was established that the source was located in the area of the first toilet in the direction of travel of the second coach of the train (the first-class coach No. 50521974003-0 - Fig. 4.10).

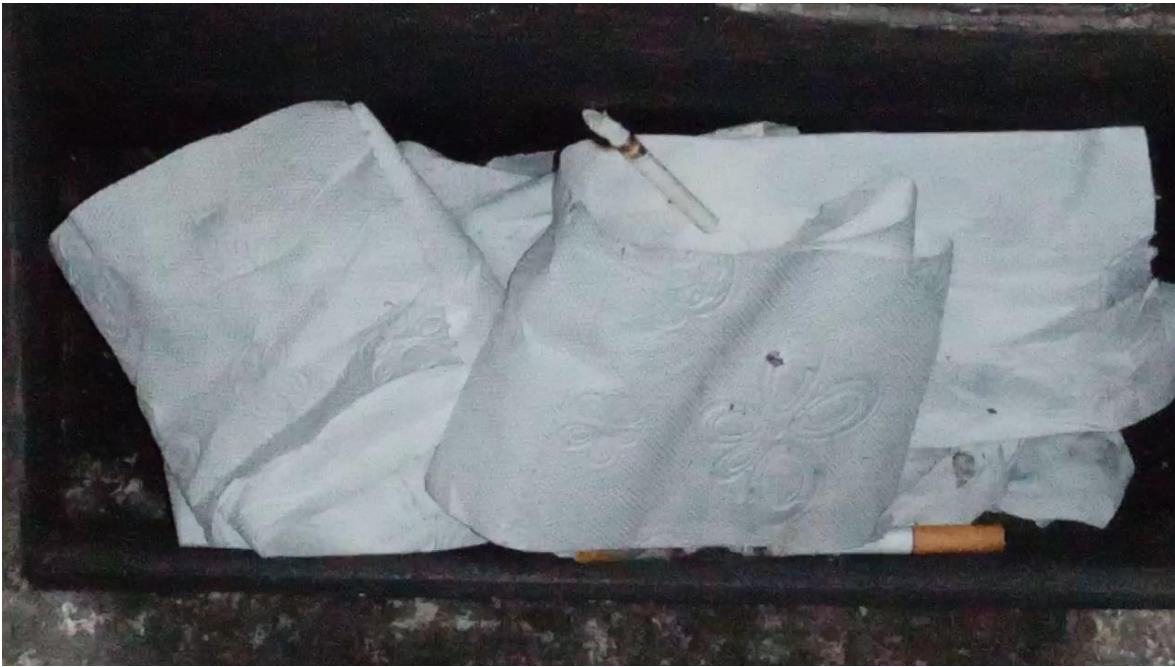
**Fig. 4.11.**

During the inspections, all possible options were investigated and analysed, including intentional or unintentional ignition from an external source of the toilet paper in the bin. The last version was categorically rejected after experiments involving elements of the sanitary unit device (Fig. 4.11).

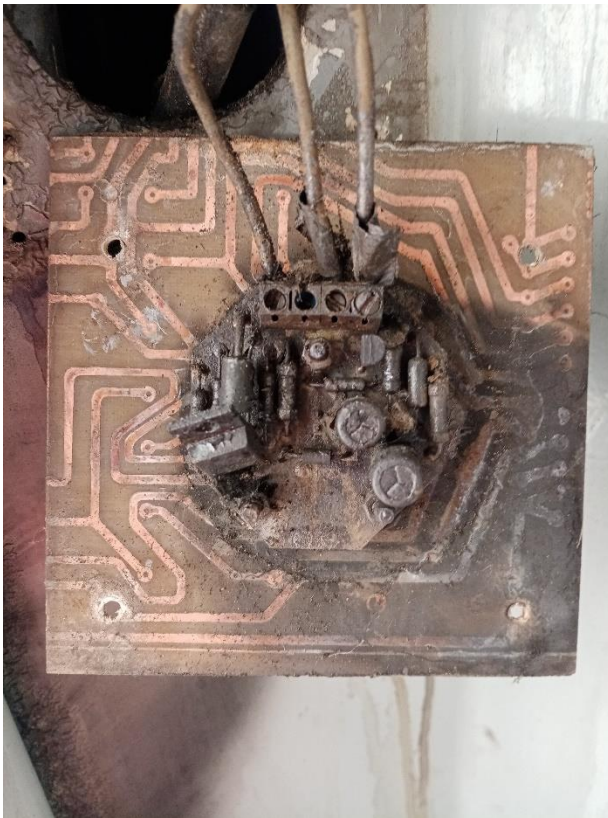
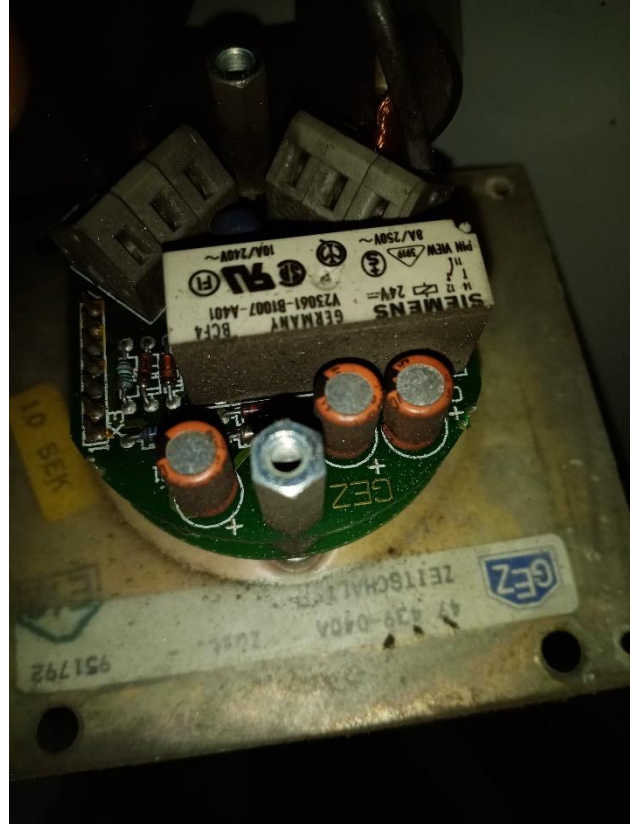
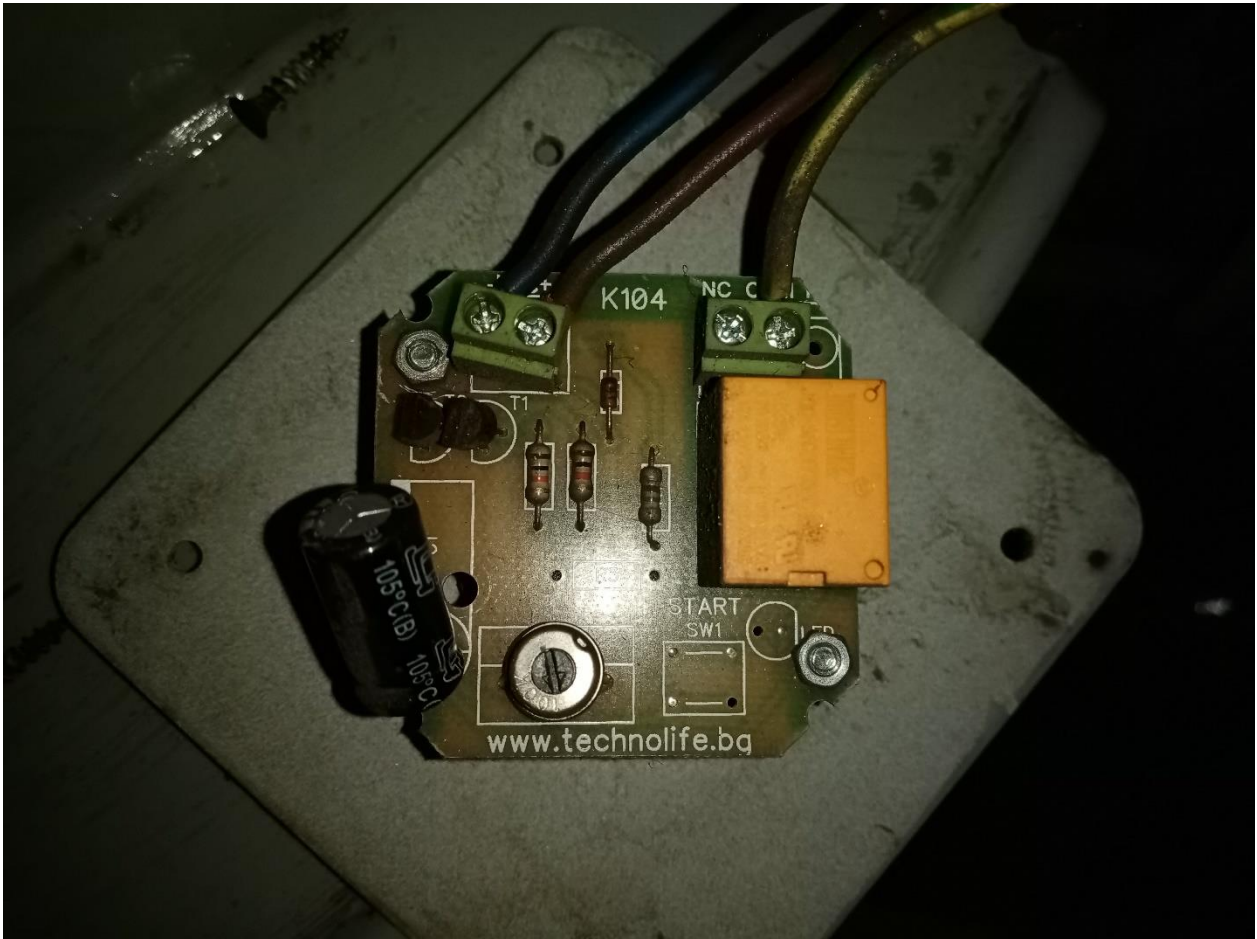
the device and functions of the control buttons, as well as the condition of the buttons in the burned coach No. 50521974003-0 and found that the probability of ignition from them was minimal. These buttons were activated relatively rarely and their duration of operation was short – on the order of a few seconds (20 seconds for the sink and 15 for the toilet). It is necessary to add that very small currents passed through them (of the order of 0.4-0.5 A), as well as the fact that when inspecting that node at the opposite end of the burned coach and in other coaches no traces of heating and operation with increased currents and temperatures were found (Fig. 4.16, 4.17, 4.18);

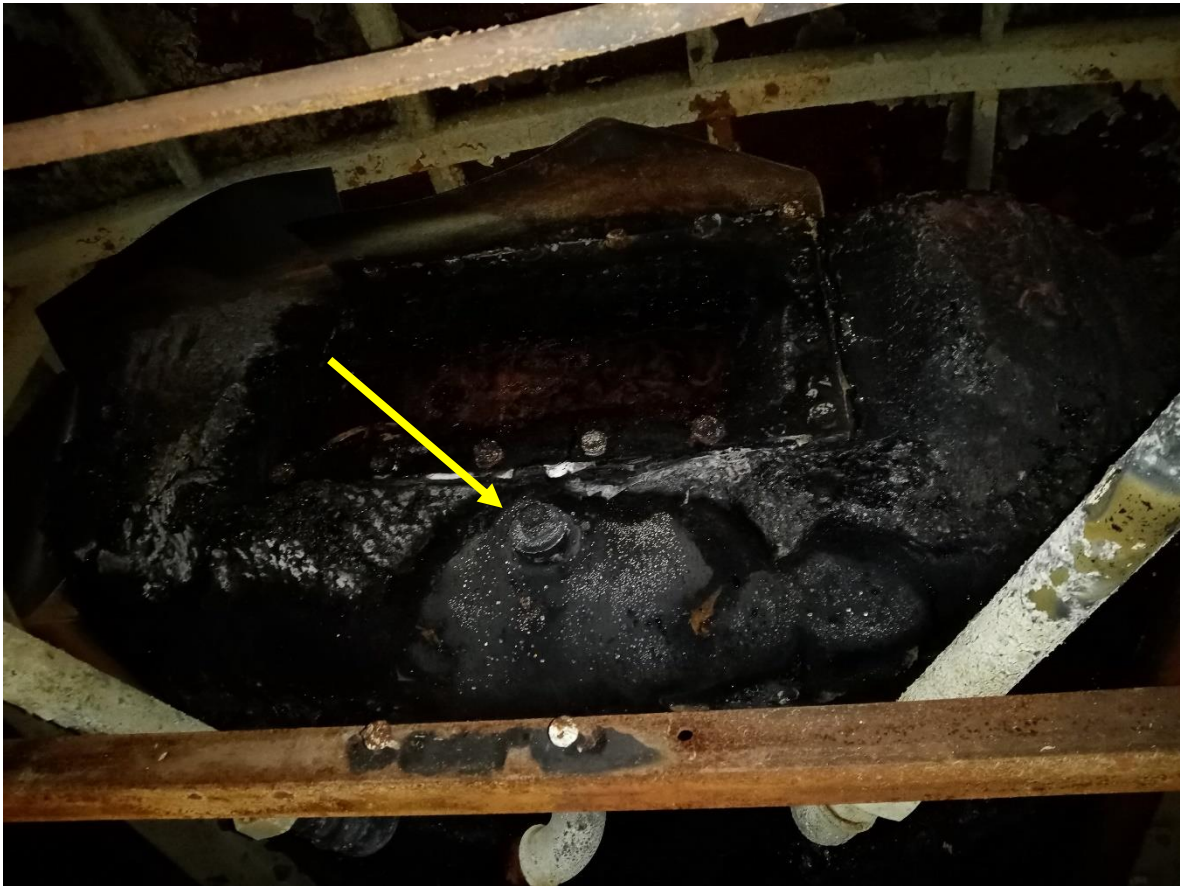
- **Water tank heater** - that tank was located directly under the roof of the coach and it stored water for the toilet unit - toilet and sink. It is one of the largest consumers of electrical current and a potential source of ignition. It is powered by a voltage of 220 V and a current of about 0.2 A flows through it. The Investigation Commission carried out detailed inspections of the burned coach and found that its tank was not equipped with a heater, therefore, in that case, the cause was automatically eliminated (Fig. 4.19);

**Fig. 4.19. The arrow shows the outlet in which the heater is installed. In the specific case the outlet is closed with plug, because no heater was installed.**

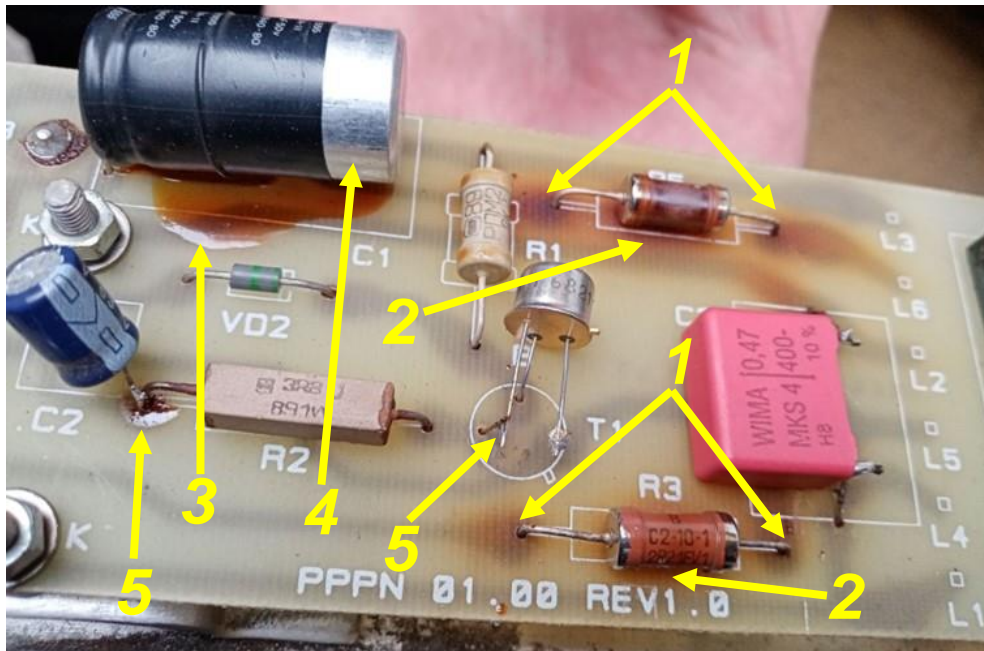
**Fig. 4.22. Power supply board**

- In the area of connection of resistors R3 and R5 to the board, unacceptable overheating was detected, detected by the dark brown colour at the soldering points and under the resistors themselves (Fig. 4.22, pos. 1 and 2)

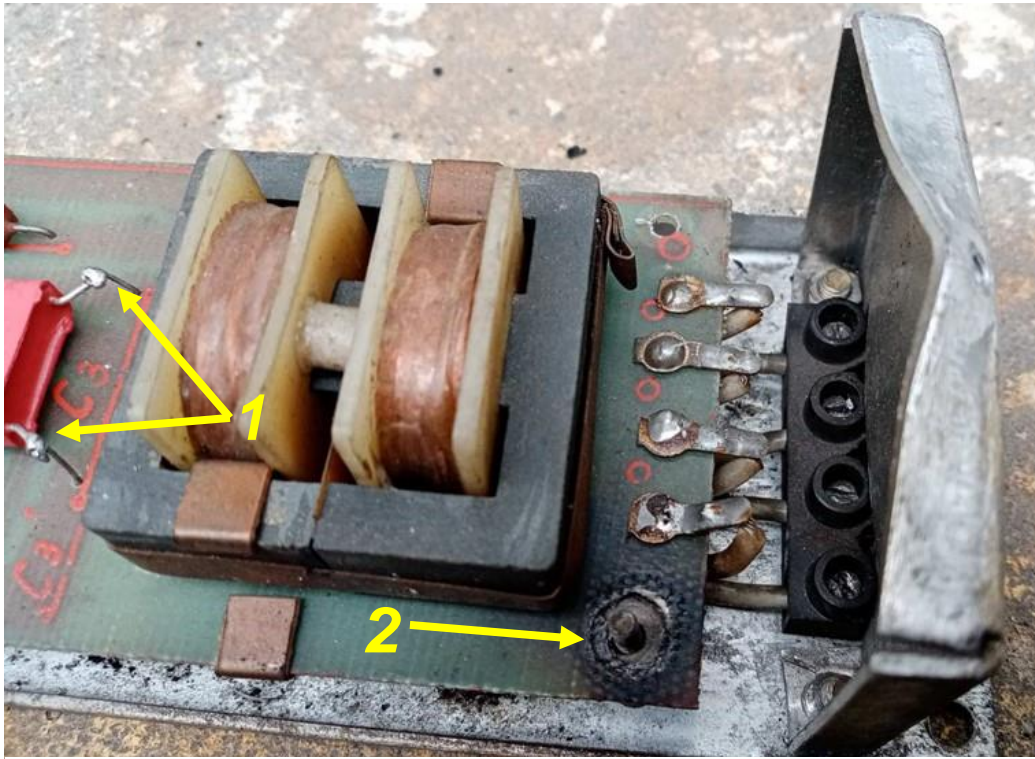
**Fig. 4.23. Power supply unit board**

- The strong burning of the hole for attaching the board to the housing of the power supply unit, which is a sign of the flow of large currents and heating to high temperatures.

- Condenser C1 has apparently punctured and its electrolyte has leaked, and its aluminium case has moved out of the insulating body, most likely due to improper technical specifications.

- The Condenser C1 has apparently punctured and its electrolyte has leaked (fig. 31, item 3) and its aluminium housing has moved out of the black insulating body (fig. 31, item 4).
- During the inspection, it was found that when replacing individual elements of the power board, soldering was not done in the holes of the board (which is the correct way of soldering), but to the terminals of the removed damaged elements (fig. 4.22, pos. 5, Fig. 4.23, item 1).
- A strong scalding of the hole for attaching the board to the power supply unit housing was found. That again was a sign of large currents flowing, and heating to high temperatures (Fig. 4.23, item 2).

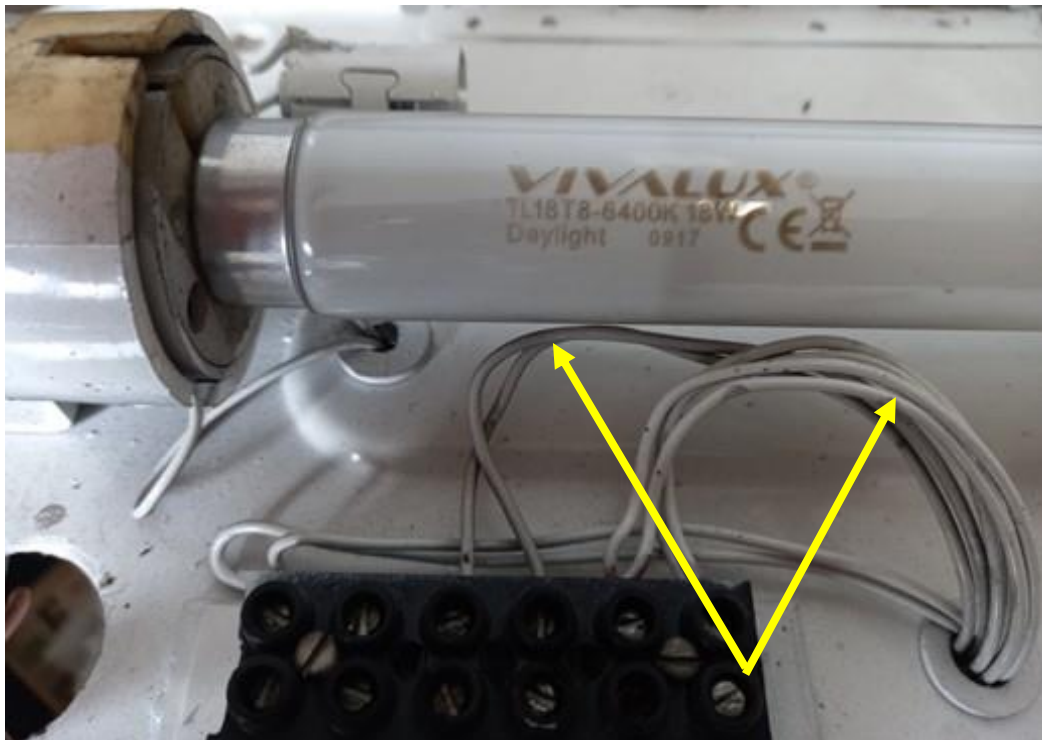
**Fig. 4.24. Lighting fixture**

- During the installation of the lighting unit, the bundle of wires was not flanged (bandaged), but was also painted with white paint, which on the one hand worsened their normal heat exchange, and on the other led to a deterioration of their insulating qualities due to the aggressive components contained in the paint.

- During the installation of the light fixture, the bundle of wires was not bandaged, but was also painted with white paint, which on the one hand impaired their normal heat exchange, and on the other hand led to a deterioration of their insulating qualities due to the aggressive components contained in the paint (Fig. 4.24).
