**REPUBLIC OF BULGARIA**  
**NATIONAL AIR, MARITIME AND RAILWAY TRANSPORT, ACCIDENTS**  
**INVESTIGATION BOARD (NAMRTAIB)**

**FINAL REPORT**

**investigation of railway accident – fire in locomotive № 91520044202-7, serviced international fast train № 464 between the stations Zmeyovo – Tulovo on 01.12.2023**

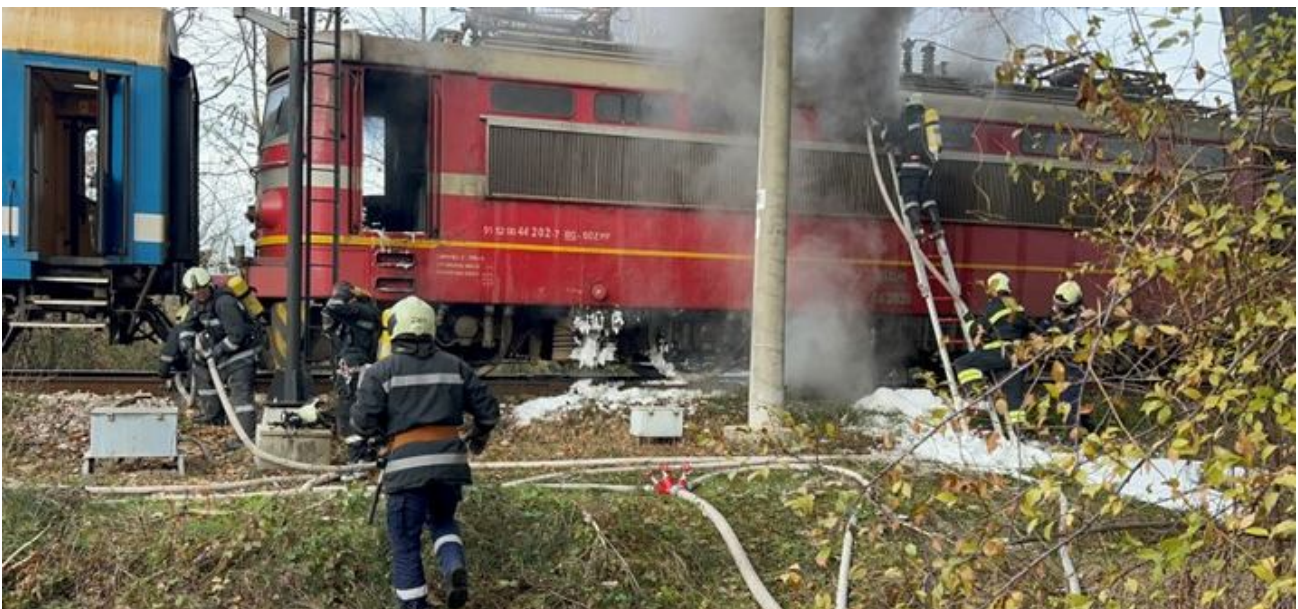
**Fig. 1.1. Locomotive № 91520044202-7 with IFT № 464 at km 226+642 between the stations Zmeyovo and Tulovo**

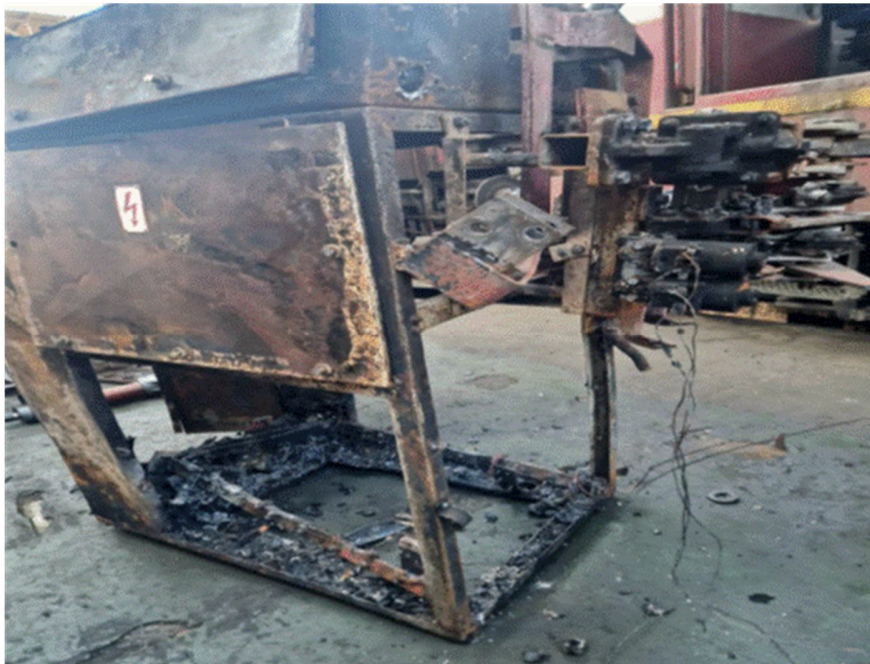
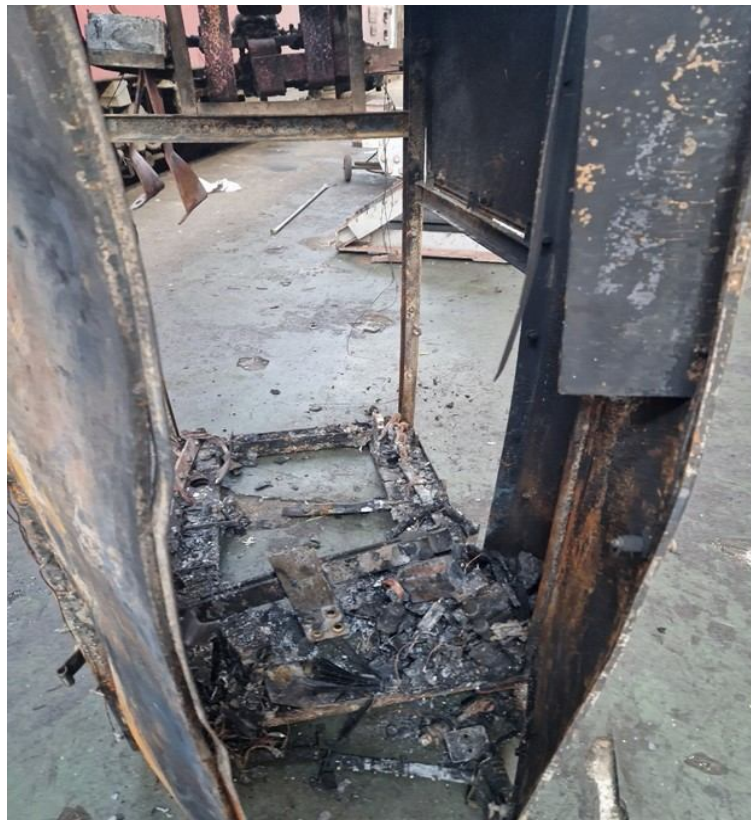
**Fig. 4.7. Rectifying group 022**

**Fig. 4.8. Image of the rectifying group 022**

- After the dismantling of the rectifying group 022 – (fig. 4.7 and fig. 4.8), it was found that totally melted the cooling bodies of the diodes of the rectifying group, and the auxiliary rectifiers 221 are totally destroyed as well 221;
- From the performed inspection of the auxiliary rectifier 221, feeding engine compressor 235 and engine-fans 222 and 223 it was found that it was destroyed, the temperature there were the highest. Probably the source for the fire occurrence is rectifier 221;

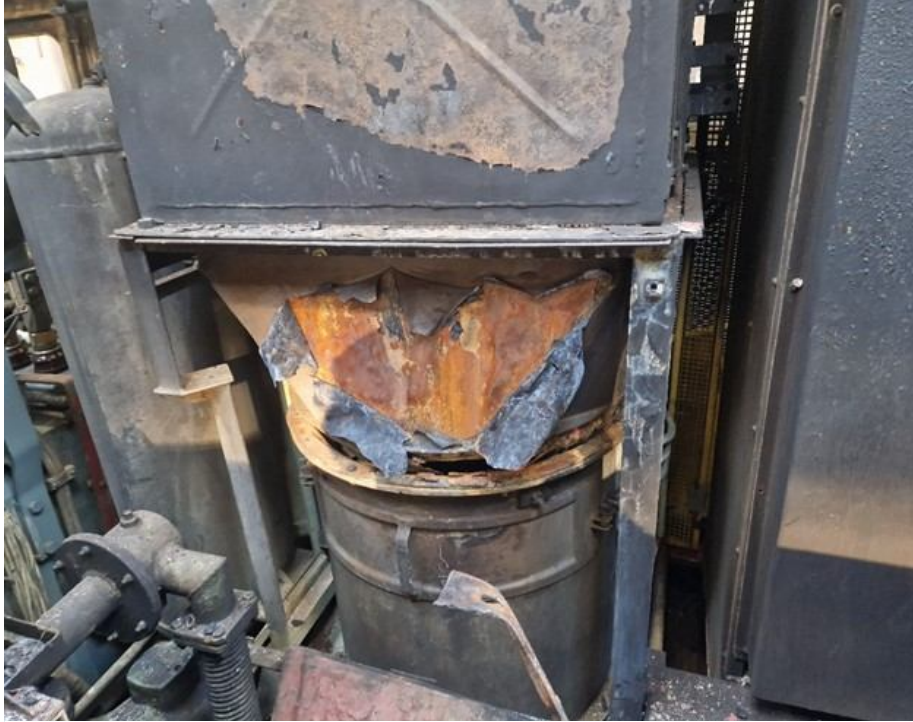
**Fig. 4.9. Image of the brake fan**

- After the inspection it was found that the engine fan of the brake resistor of fig. 4.9 was externally burnt. From the figure it is evident that the paint was burnt and the bellows of the fan was ignited;

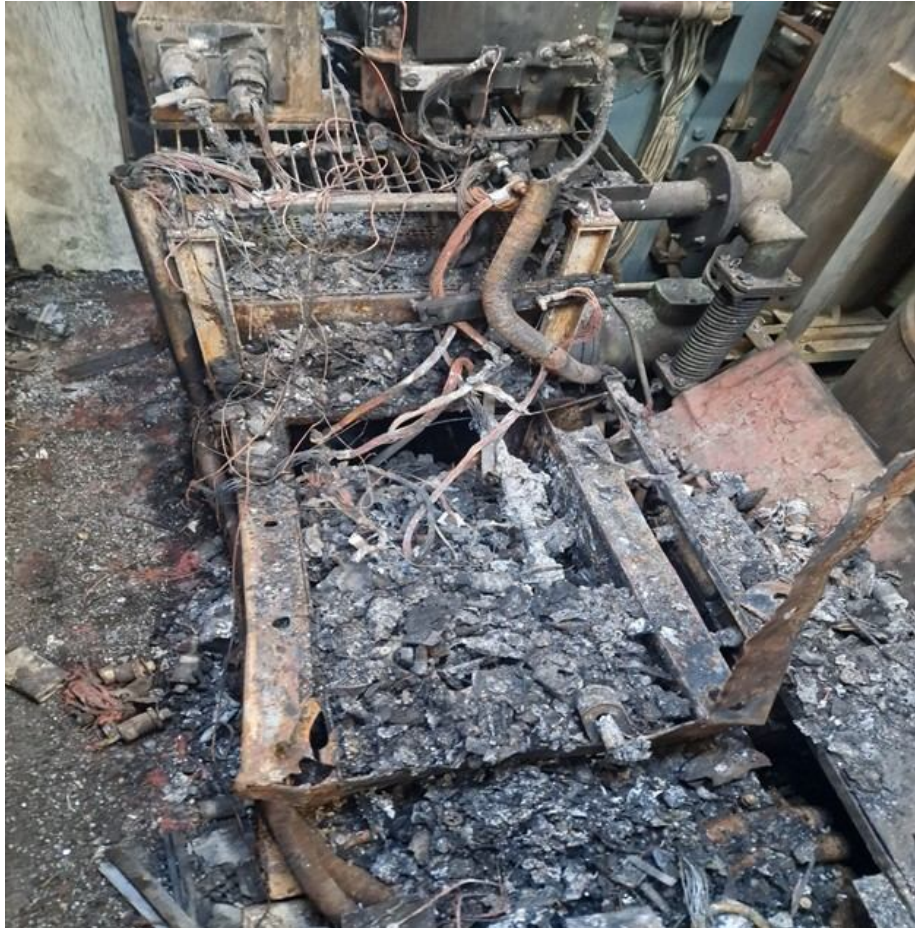
- The aggregates around the rectifier group 022 were also burnt. In fig. 4.10 the remains of the rectifier diodes are visible;
- On fig. 4.11 remains of the melted power cables of the engine compressor are visible. Melt is also visible at the end of the cable. The motor-compressor power cable melted due to the high temperature and it is very likely that the fire started from there;

**Fig. 4.10. Image of the base of the rectifying group 022**

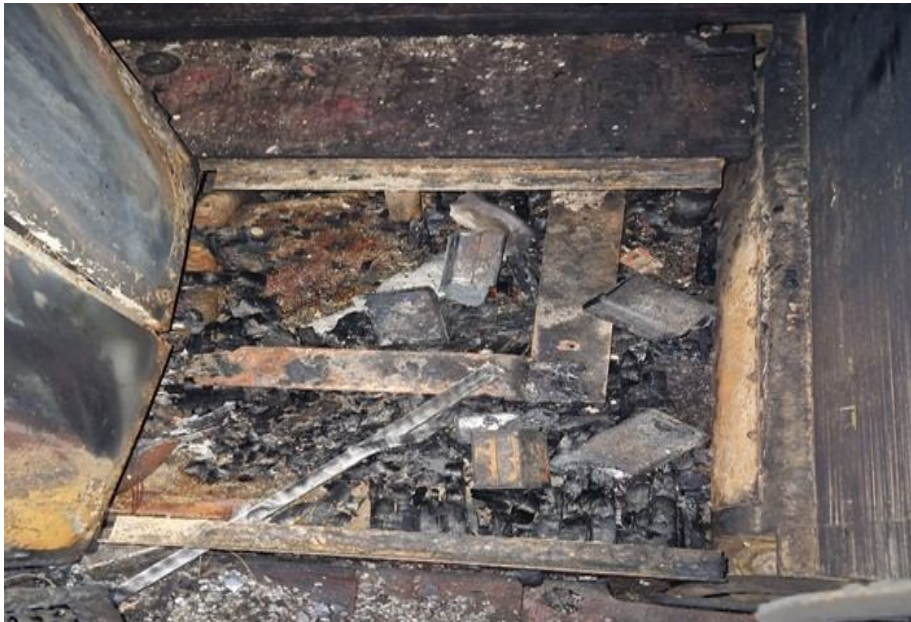
- **Occurrence of an explosion in the capacitors of the R-C groups of the auxiliary rectifier 221, which supplies the motor-compressor 235.** The occurrence of the explosion in the capacitors (Fig. 4.12) occurred because of an increase in temperature in the power unit of the engine-compressor. It has risen due to not cooling the rectifier group 022. The location of the power auxiliary unit 221 is at the bottom of the rectifier group 022. It was cooled after the rectifier diodes 022 were cooled. The R-C groups of the power and auxiliary units 022 and 221 are for protection against external and internal overvoltage. The construction of the capacitors that participate in the R-C groups are metal boxes filled with liquid electrolyte. As the temperature increases, it expands and causes the capacitor to explode. The hot electrolyte falls on the heated surfaces of the rectifier diodes and on the power unit of the auxiliary rectifier, which leads to the ignition of the auxiliary rectifier. Initially, thick black smoke was formed, impenetrable due to the lack of oxygen, and subsequently ignited.

**Fig. 4.12. Image of the burst capacitors.**
