NATIONAL AIR, MARITIME AND RAILWAY TRANSPORT, ACCIDENTS INVESTIGATION BOARD (NAMRTAIB)

FINAL REPORT

investigation of significant railway accident – run over of two employees by locomotive №98522051522-7, between Inspection point № 4 and Iliyiantsi station on 07.11.2023

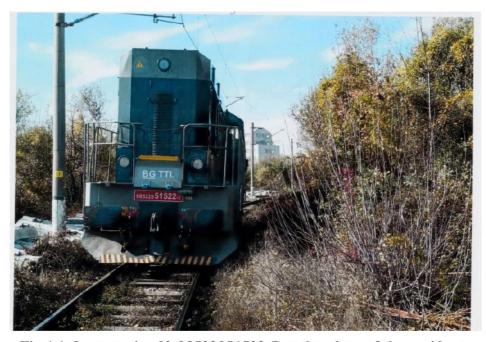
Fig.1.1. Locomotive № 98522051522-7 at the place of the accident.

Around 10:12 a.m. at km 0+320, the locomotive hit and killed two workers working in the interstation one after the other.

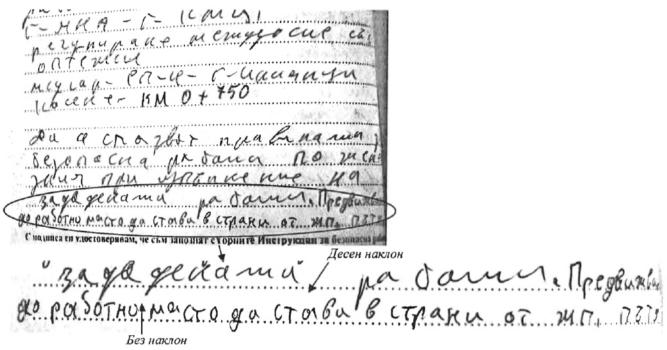
Fig. 2.6. Text of sheet 41 from the expertise

- "It was found the difference within the inscription of the phrase, consisting the text of sheet 41 "The movement to the place of work to be performed beside the rail track", which probably is ought to its additional inscription on the page." (Fig. 2.6)

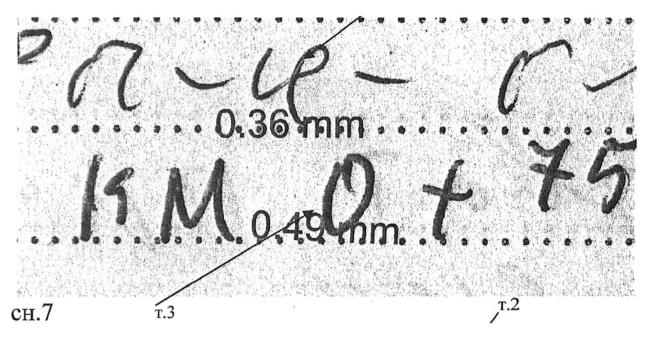
Fig. 2.7. Added text with kilometre

- "It was found a change in the pressure and the inclination within the inscription of the text of sheet 41 "KM 0+750" compared to the rest of the handwritten text, which probably is due to its additional inscription on the page." (fig. 2.7)

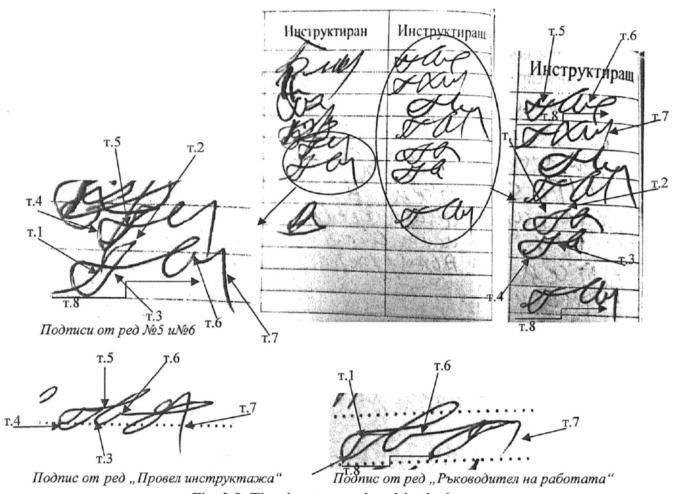
Fig. 2.8. The signatures placed in the boxes

- "The signatures placed in the boxes "Performed the instructions", "Supervisor of the work", "Instructing" and "Instructed" – line N_{2} 5 and N_{2} 6 are placed by the same person." (fig. 2.8)

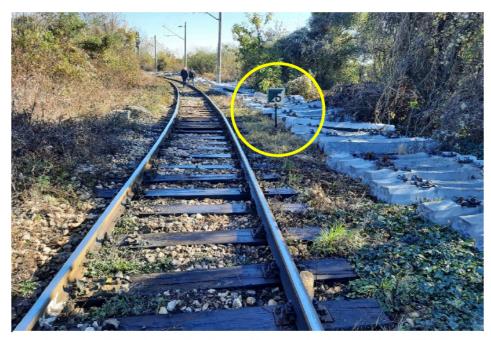
Fig. 3.4. Signal "Beginning of the restriction" at km 0+170.

PAK-68I. In the area before the accident from km 0+170 was placed a portable signal (plate) for Beginning of the reduction 25 km/h) (fig. 3.4).

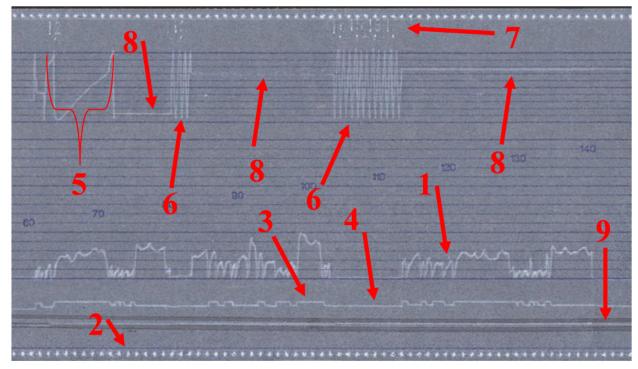
Fig. 4.7. General overview of the speedometer tape of the locomotive № 98522051522-7 from the day of the accident.

The grey lines at the lower end of the tape indicate the end of the tape and do not record data (Fig. 4.7, item 9).

As it has been already noted, the clock of the recording apparatus was not calibrated and the time registrations did not correspond to the actual astronomic time (fig. 4.5, fig. 4.7, pos. 7). In addition, the minute diagram (see Fig. 4.5) does not record the time when the locomotive is moving.

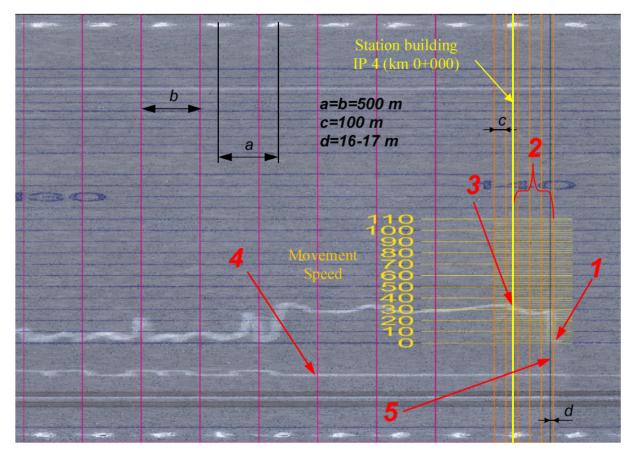
Fig. 4.8. Illustration of decoding the speedometer tape of a locomotive № 98522051522-7.

The last movement of the locomotive was recorded in fig. 4.8, pos. 1, after which the tape was removed. According to the testimonies of the witnesses and according to the documents reporting the movement of ST No. 10891, the accident occurred at 10:12 a.m. The analysis of the movement of locomotive No. 98522051522-7 was made from that moment back to its passage through IP 4. From the moment of holding with the direct brake of the locomotive to its final stop, the locomotive travels about 16-17 meters. At the time of detention, the locomotive was moving at a speed of about 28-29 km/h. About 150 meters before the arrest, the speed was 25-26 km/h

Time travel cannot be counted accurately due to incorrect registration in the minute chart area. The movement of the locomotive was carried out with the long part of the locomotive forward (fig. 4.8, pos. 4).

Vertical lines are additionally drawn on the tape image for easier orientation and calculation of distances (Fig. 4.8). Distance \bf{a} is recorded by the speedometer and is equal to 0.5 km (500 m) of the distance travelled by the locomotive (see also Fig. 4.5). The additional grid is plotted so that distance \bf{b} is equal to distance \bf{a} . On top of the first additional grid, a second one is drawn, in which the distance between the vertical lines accounts for a distance travelled of 100 m (section \bf{c}) for a more precise calculation of the distance travelled.

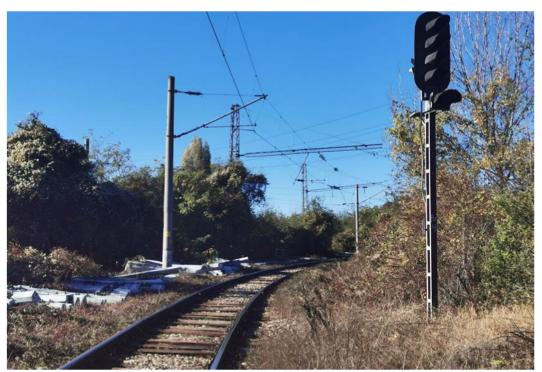
Fig. 5.1. Part of the interstation IP 4 – Iliyantsi

On 07.11.2023, a work group for the railway section Sofia North of three workers arrived by road transport in the area of Inspection point 4 around 09:45 a.m. The group moved in the direction of the Iliyantsi station in the siding, as new reinforced concrete sleepers have been arranged on the right near the rail track to carry out the renewal of the rail track. To the left, the rail track is overgrown with bushes, tall grass, and felled tree trunks. The benches on both sides of the rail track for pedestrian movement have been obliterated, and for these reasons, the three workers moved on the siding in the direction of Iliyantsi station (Fig. 5.1).
