**Aircraft, Maritime and Railway Accident Investigation Directorate
Maritime Accident Investigation Unit**

FINAL REPORT

**Investigation of very serious marine casualty –
capsizing and sinking of *m/v „ELLAND”***

on 08.02.2014

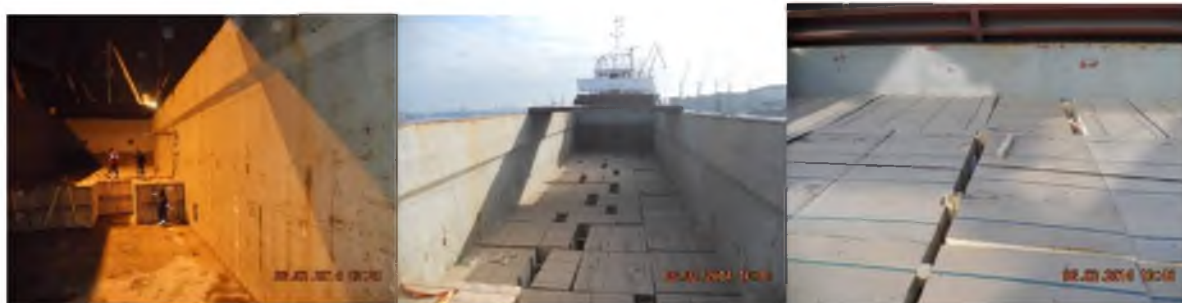
Fig. 2. Stages of loading and consolidation of the cargo in the hold.

The cargo loaded in the cargo hold was perfectly arranged and fortified, as it was evident from **Fig. 2**. The cargo loaded on the deck was also well arranged and fortified as shown in **Fig. 3** and particularly in **Fig. 6**, when the ship was already abandoned by the crew, and its s/b side was in the water. Therefore, the ship had not received any additional list moment by a load shifting. Load shifting was not a cause for the capsizing and sinking of *m/v "ELLAND"*.

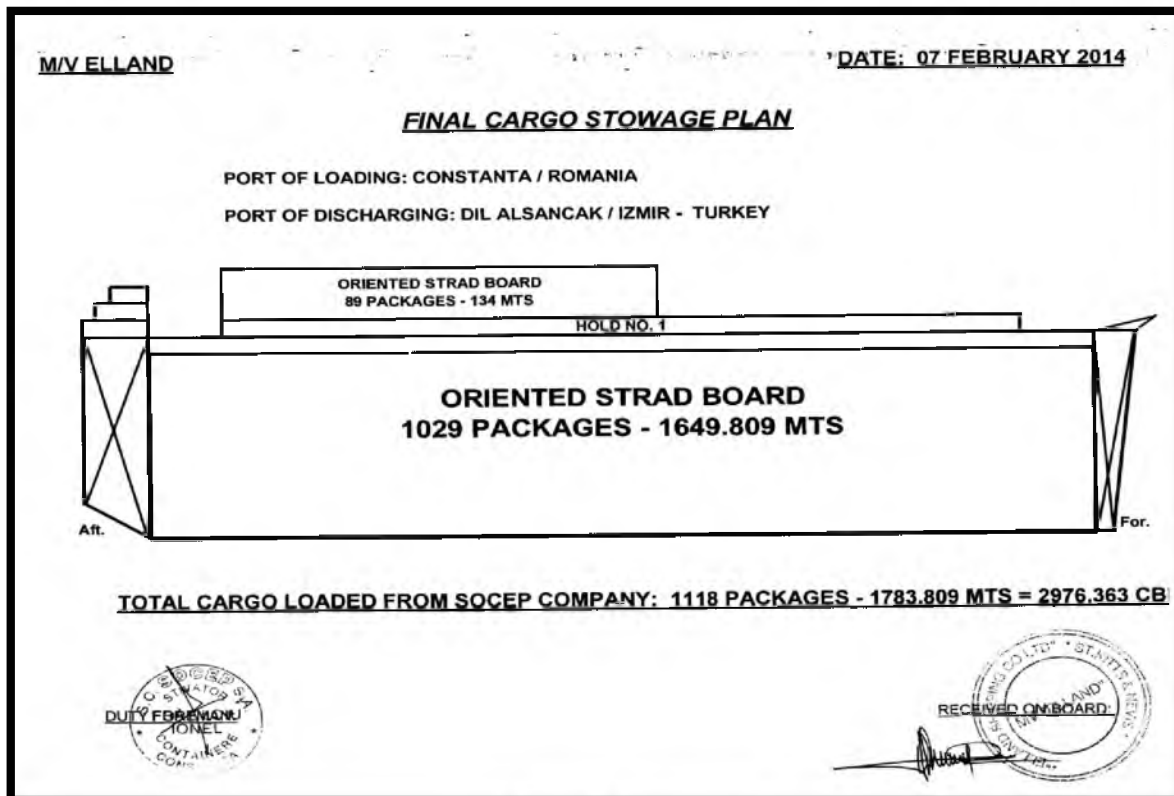
Fig .4 Cargo plan

At 1430 on 07.02.2014 *m/v "ELLAND"* sailed to port of Izmir, Turkey, loaded as follows: 1649,809 tons "Oriented Strad Board" in 1 029 packs in the cargo hold, and 134 tons "Oriented Strad Board" in 89 packs on the deck (**Fig. 4**).

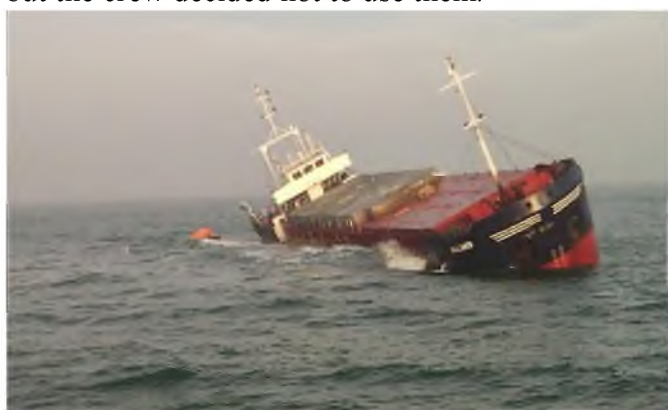
Fig. 6 The listed *m/v ELLAND*

The crew had made unsuccessful attempts for an hour to start up the diesel generators into the engine room. During this time, the ship began to heel to the right and at 2030 the list reached 20° the the s/b side and was increasing (**Fig. 6**).

The right thing to do at the last moment was to cut out the OSB's tackles on the deck and to allow them to freely fall into the sea for improving the initial stability, and then to straighten the list by ballast loading in the wing ballast tanks №. 6 (left/right) with the emergency fire motor-pump. To start up the diesel generator and to return the ship to Constanta for unloading.

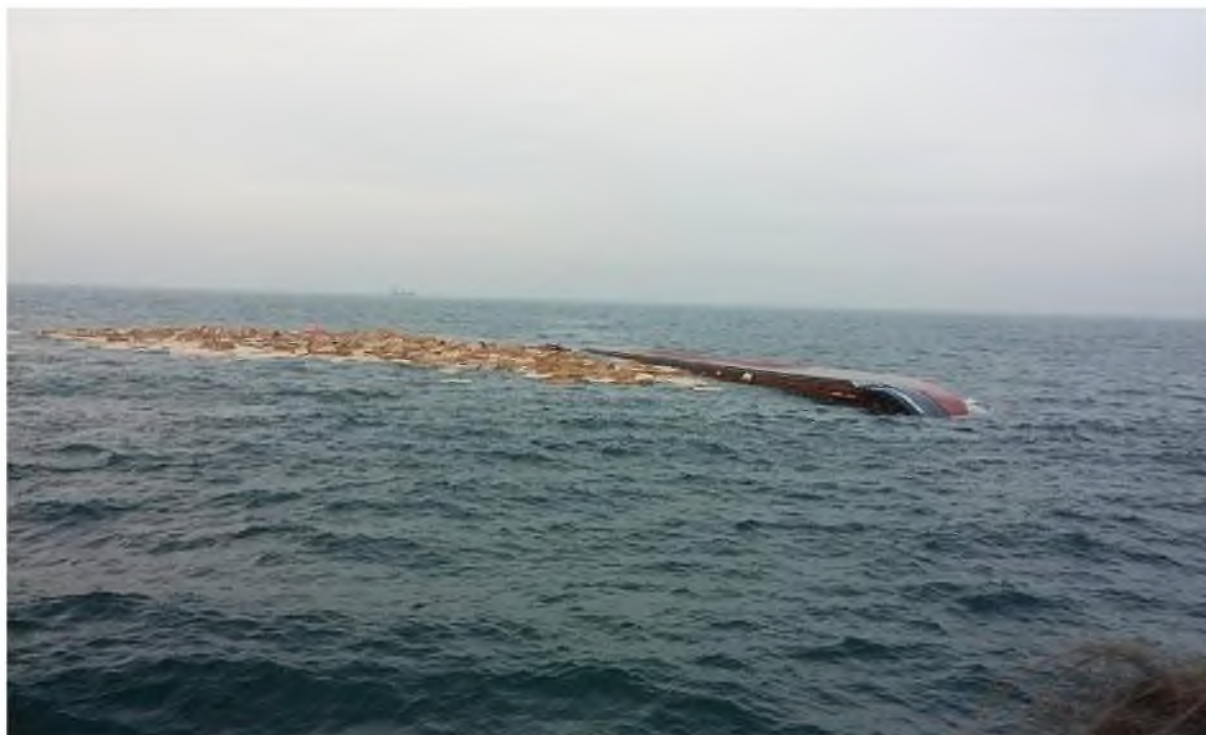
Fig. 7 Sinking of "ELLAND"

At 1635 on 08.02.2014 *m/v "ELLAND"* capsized and sank at the point where it was anchored, with coordinates 43°43',5 N; 028°45',5 E. (**Fig. 7**)

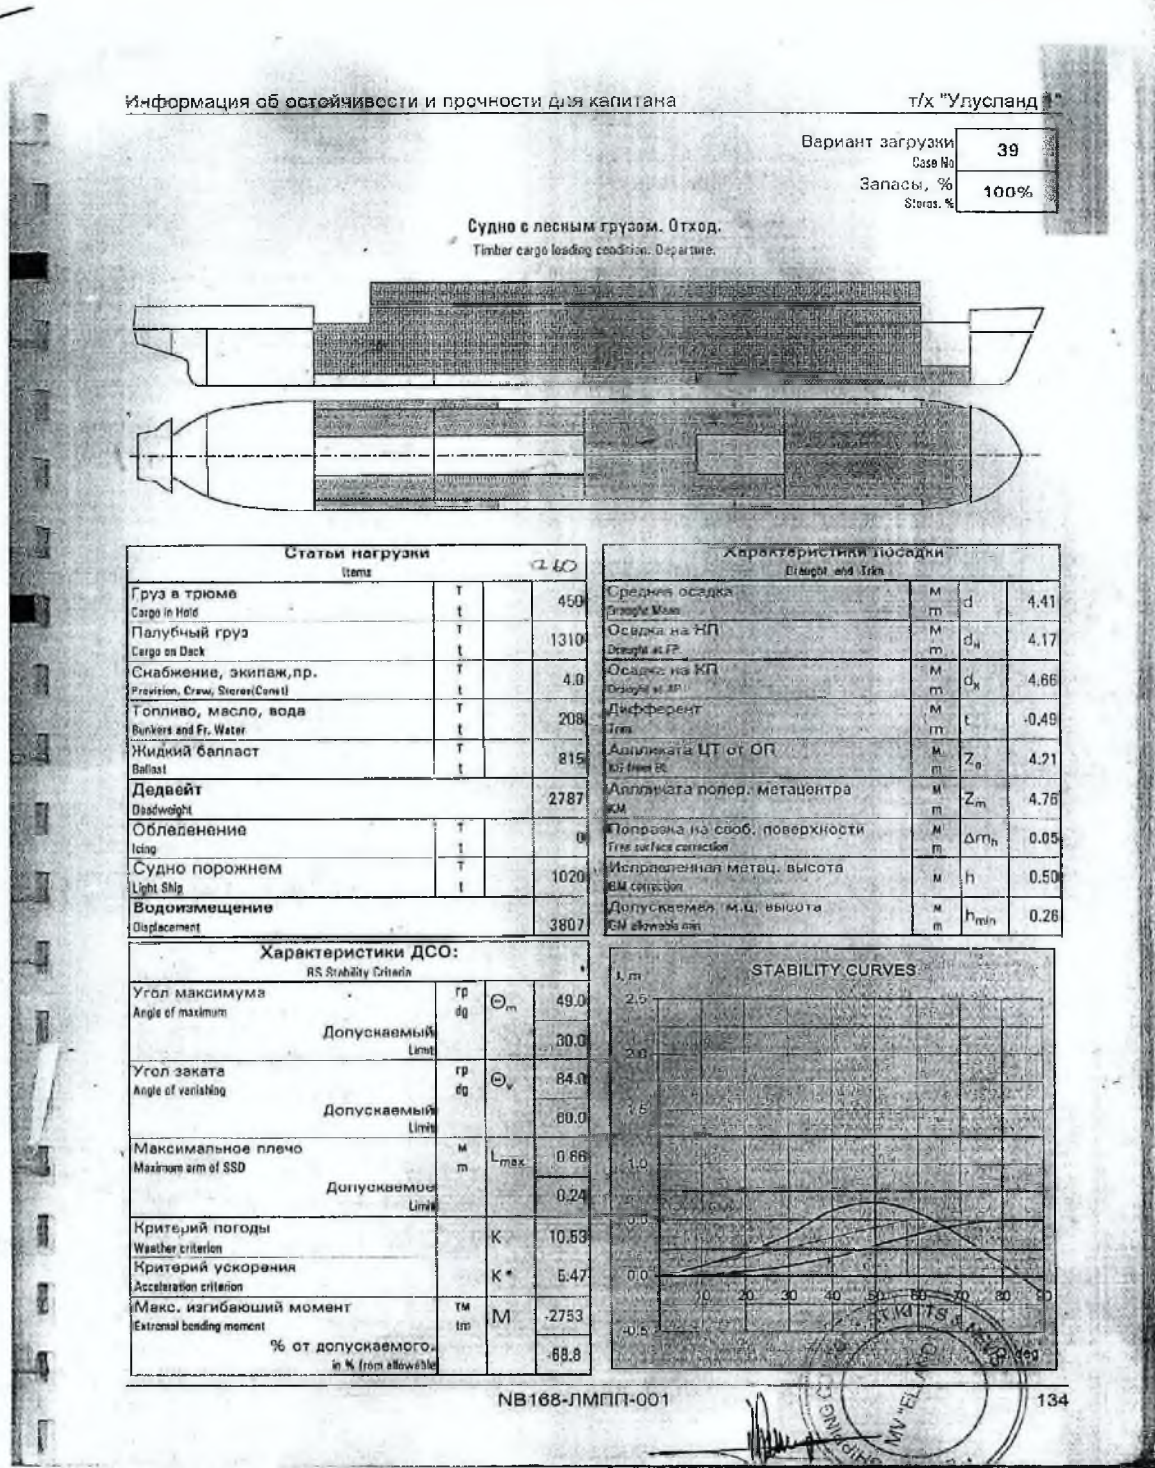
Fig. 8.1. Types of load № 39 (1)

"Types of load № 39" describes a full shipload. Which makes 1,760 t of timber in the hold and on the deck (on the hatch cover of the hold), that is, almost identical to the loaded quantity (1783,8 t). In fact, 1649.8 t were loaded in the hold and 134 t on the deck. The "crew and supplying" values were identical and negligibly small. "Stock fuel and water" according to the "Types of load №39" were given as a total amount of 208 t. In fact, the stocks were diesel fuel oil 10 t and 13-15 t of drinking water, a total amount of 25 t.

The calculations of the metacentric height performed by the ship's captain prior to loading (**Fig. 8**) were totally unprofessional and formal. The quantity of the ballast was **814.6 t** as was the case with the attached “Type of load” № 39 scheme, i.e. 100%. Simple calculations based on the ship's draft (according to the average draft of **4.41 m**, and in fact the ship sailed with a **3.80 m** average draft) showed that the actual ballast was a maximum of **450 t**, assuming the deadweight for **0 t**. Furthermore, the formal character of the metacentric height calculation was also apparent from the fact that in the attached type scheme №39, the quantities of deck cargo and cargo in the hold did not correspond to the actual ones. The "Fuel and water reserves" values for the type of load were given a total of **208 tons**, and the real value was **183**

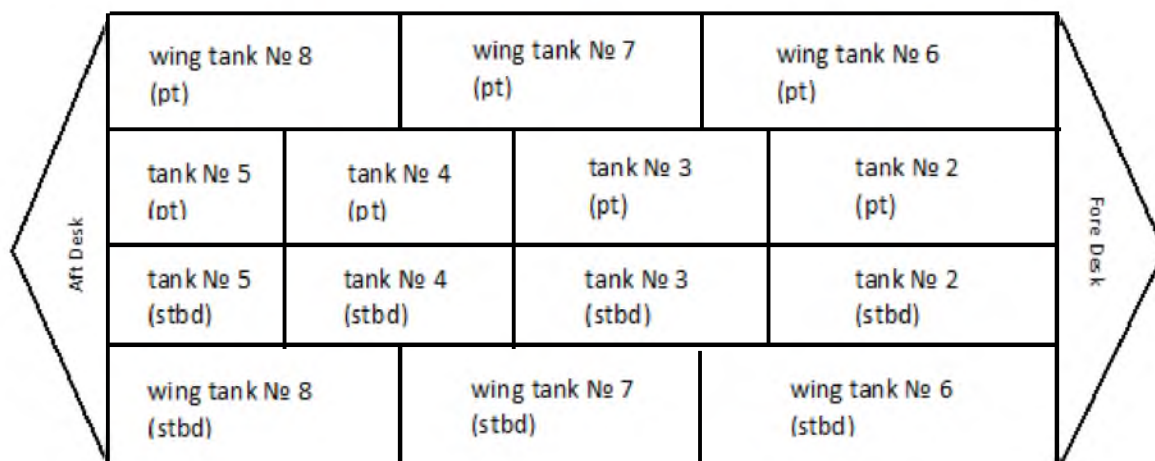
Fig. 9. Layout diagram of ballast tanks

The deficient ballast was basically in the double bottom, which had made the ship unstable. The ballast tanks (bottom and wing), were not filled at 98-100%, as it was required to avoid overflowing, i.e. to eliminate the free surfaces. The captain was aware of the inadequate amount of the ballast. Proof of insufficient bottom ballast was the listing of the ship on the pier at Constanta port, while loading the cargo on deck and the ship lost its stability. The captain had accepted some ballast in bottom tanks to straighten the ship - probably in №. 4 and №. 5, claiming that all bottom ballast tanks were "pressed". This was not the case, because the calculations show that the total ship's ballast was **447.7** t, and 100% ballast only in the bottom tanks makes **597.8** t at a water density of 1.025. At a water density of about 1,007 as is in Constanta/Agigea area, 100% ballast in the bottom tanks makes **587.3** t.

From the analysis of the evidence, it was clear that the reception of the ballast was chaotic and that the double bottom above tank №. 5 had been broken. This resulted to the existence of a large free water surface, which subsequently had led to the ship's listing a few hours after sailing.

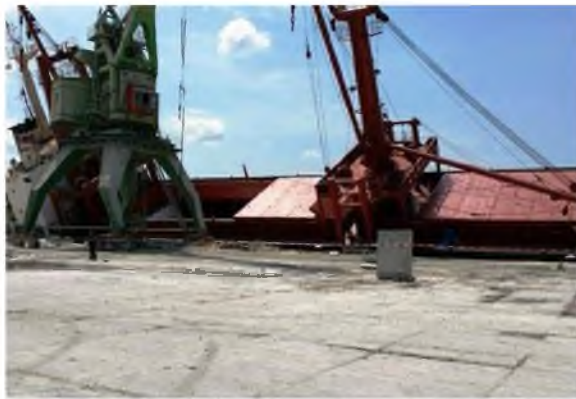
Fig. 10. The listed "MOHAMMED H" on the quay

Just three months after the accident, on May 11, 2014, the ship "MOHAMMED H"

(IMO No 8605193) received a heavy listing when loading bags with soda at the 14th pier at the port of Varna - West.

The accident was caused by a rough failure to follow the intermediate states of the stability in the cargo operations, resulting in a negative stability.
