REPUBLIC OF BULGARIA
NATIONAL AIR, MARITIME AND RAILWAY ACCIDENTS
INVESTIGATION BOARD

FINAL REPORT

**Investigation of railway accident – derailment of direct freight train
№ 30610 between the stations Shivatchevo – Tvarditsa on 12.03.2021**

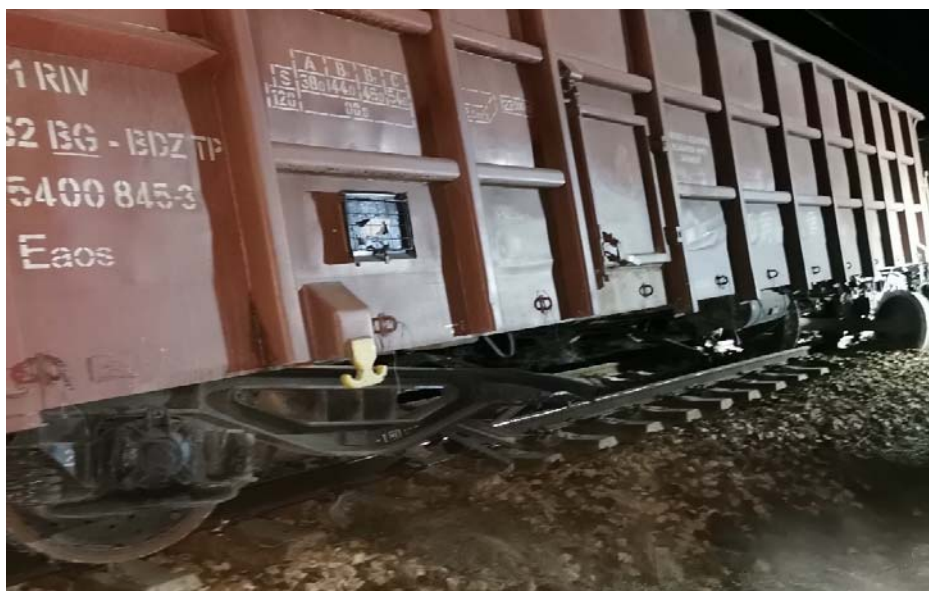
On 12.03.2021 at 16:16 p.m. from Sliven station departs DFT № 30610, consisting of 17 full wagons, 68 axles, 1323 tons, towed by an electric locomotive № 46032 with a locomotive driver and an assistant locomotive driver. The train route is in the direction Sliven - Dabovo - Tulovo - Karlovo - Pirdop. At 16:54 p.m. the train passed Shivachevo station without stopping, the traffic manager on-duty monitored the passage of the train through the station and did not notice any irregularities on the rolling stock. Between the stations Shivachevo and Tvarditsa about km 257⁺¹⁶⁰ the locomotive driver found a decrease in the pressure in the main air duct of the train, turned off the MAD of the locomotive and the train stopped at 17:04 p.m. After the inspection performed by the assistant locomotive driver, it was established that the 16th car in a row from the beginning of the train had derailed with the two wheel- sets of the first bogie (Fig. 1.1).

Fig. 1.1. Derailed the first bogie of wagon № 31525400845-3 along Shivachevo – Tvarditsa interstation

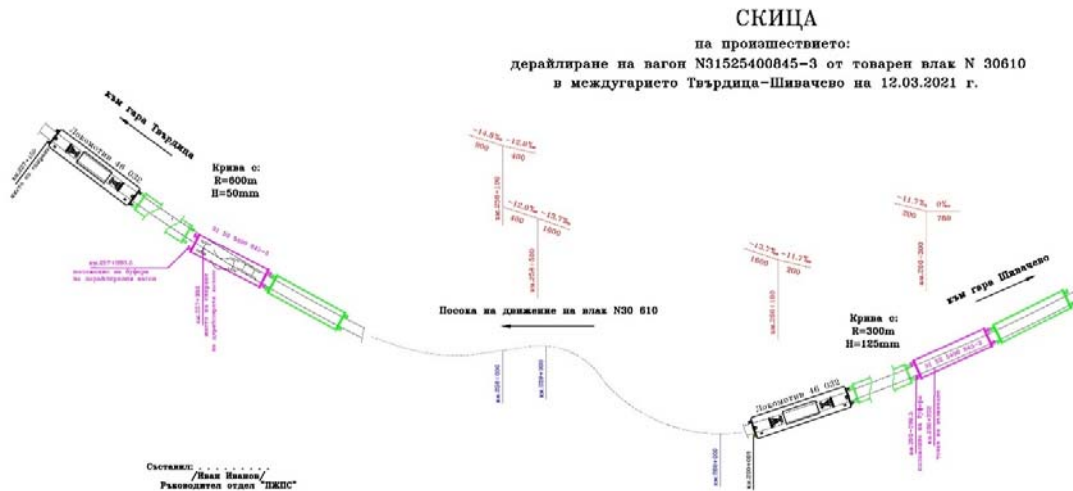
The derailment of the wagon from DFT № 30610 occurred between the stations Shivatchevo and Tvarditsa at 17:04 p.m. on km 260⁺³⁰², where first occurred derailment to the left of the second wheelset, and subsequently of the first wheelset of the first bogie of 16th train wagon (fig. 1.2).

Fig. 1.2. Scheme of the accident – derailment of wagon № 31525400845-3 along Shivatchevo – Tvarditsa interstation on 12.03.2021.

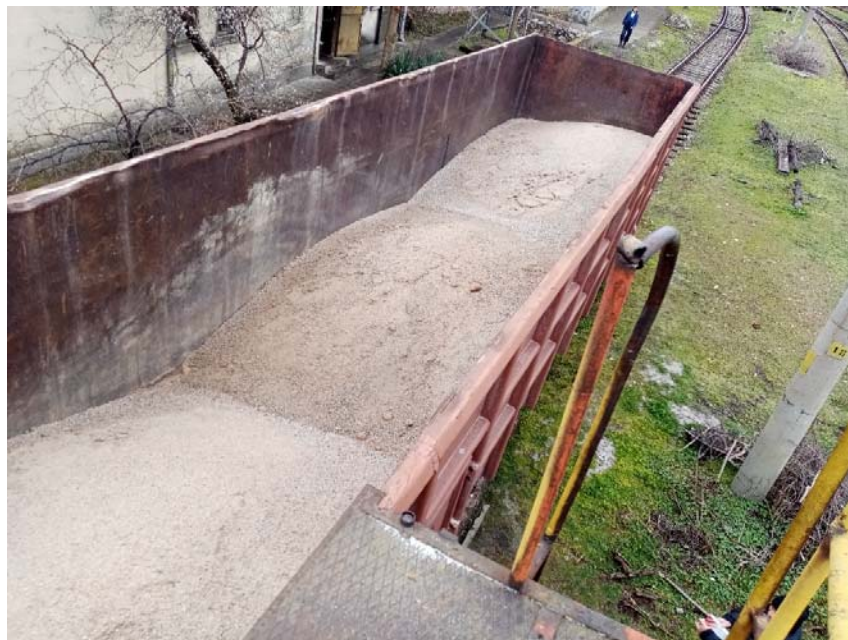
As determining factor for the occurrence of the accident was established irregular (asymmetrical) loading of the derailed wagon with respect to its longitudinal axle (fig. 1.3).

Fig. 1.3. Layout of the load in the wagon № 31525400845-3

The direct cause of the accident occurrence was the uneven distribution of the bulk load in the body shell of the wagon, which led to derailment of the second wheelset of the first bogie of the 16th train wagon, in the following sequence: raising the left wheel of the second wheelset on the left rail, collapse of the right wheel in the track gauge and subsequent collapse of the left wheel on the outer part of the rail.

Recommendation 3 proposes that BDZ-Cargo Ltd. controls the process of loading the wagons when transporting bulk cargo.

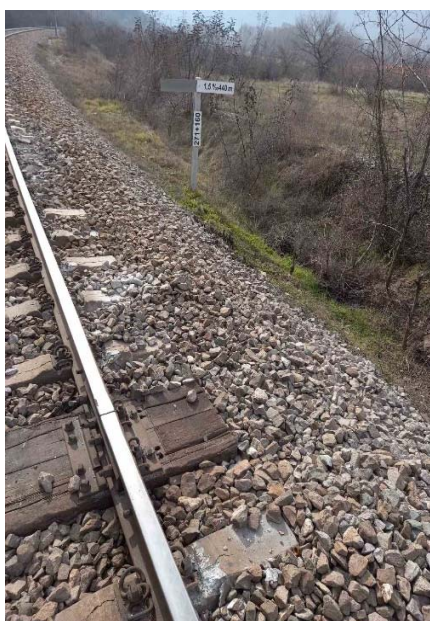
After the detaching and towing the non-derailed wagons from the DFT № 30610, the derailed 16th wagon and non-derailed 17th wagon remain in place. The 16th wagon № 31525400845-3 is placed on the rail track. Upon arrival of the locomotive for towing the two wagons at Tvarditsa station, their self-movement in the direction of Shivatchevo station followed. The profile of the track follows downhill 14 ‰, due to which their speed increased significantly and followed by re-derailment of the 16th wagon № 31525400845-3 at km 271⁺⁰⁵⁰ in the interstation Shivatchevo - Gavrailovo. As a result of the wagon re-derailment, was destroyed rail track for 440 meters (Figs. 2.1 and 2.2).

Fig. 2.1. Point of rederailment of 16th wagon

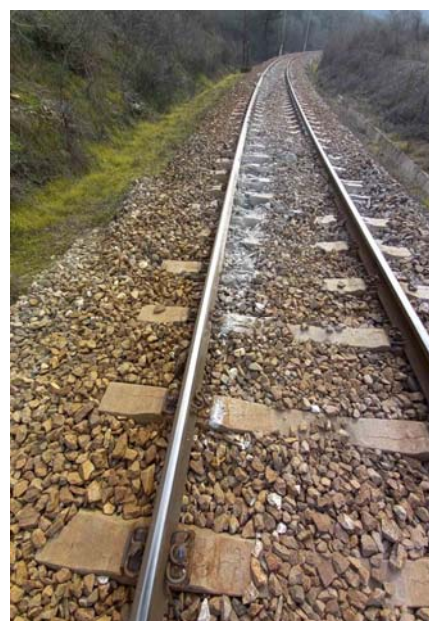
Fig. 2.2. Rail track condition after the rederailment of the 16th wagon

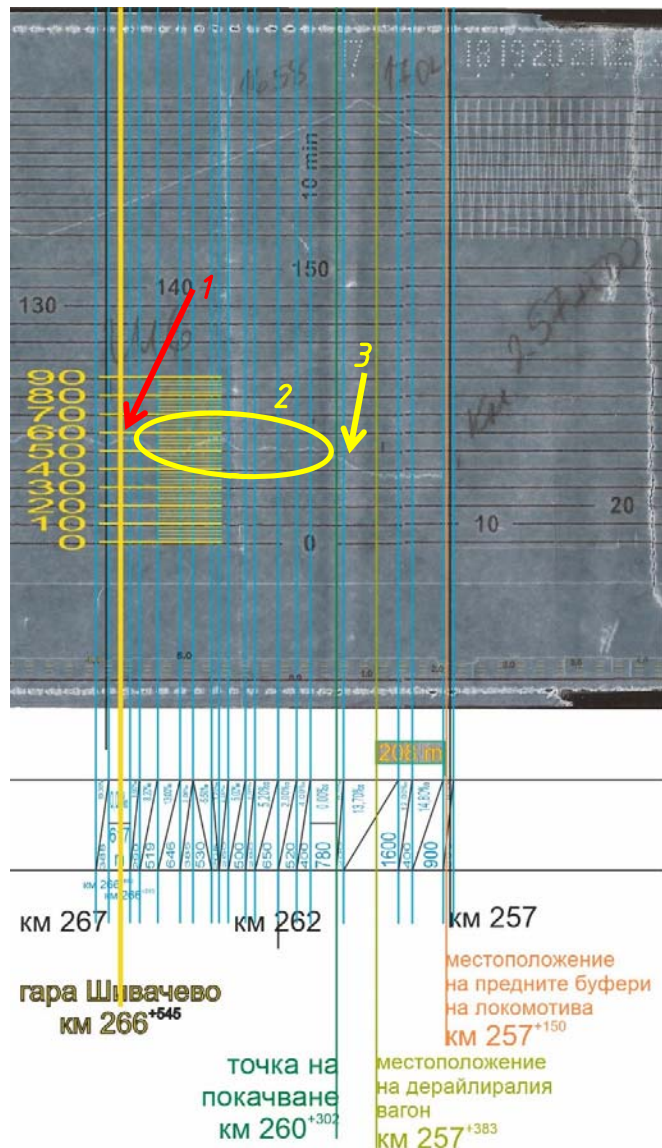
After passing Shivatchevo station the speed of DFT № 30610 changes between 57 and 49 km/h (Fig. 4.5, pos. 2). The speed varies within such wide limits due to the diverse profile of the track along the section. In this mode, the train travels 5950 meters. This happens at 4:58 p.m. The speed is 50 km/h and from that moment, it starts to decrease gradually, passing 2000 meters, reaching 38 km/h (Fig. 4.5, pos. 3). The decrease in speed is due to the movement of the train in uphill 13 ‰. From km 257⁺⁰⁰⁰ the speed of the train is set at a constant value of 37 km/h until the moment of derailment.

Fig. 4.5. Registration of movement of DFT 30610 from Shivatchevo station to km 257⁺¹⁵⁰.

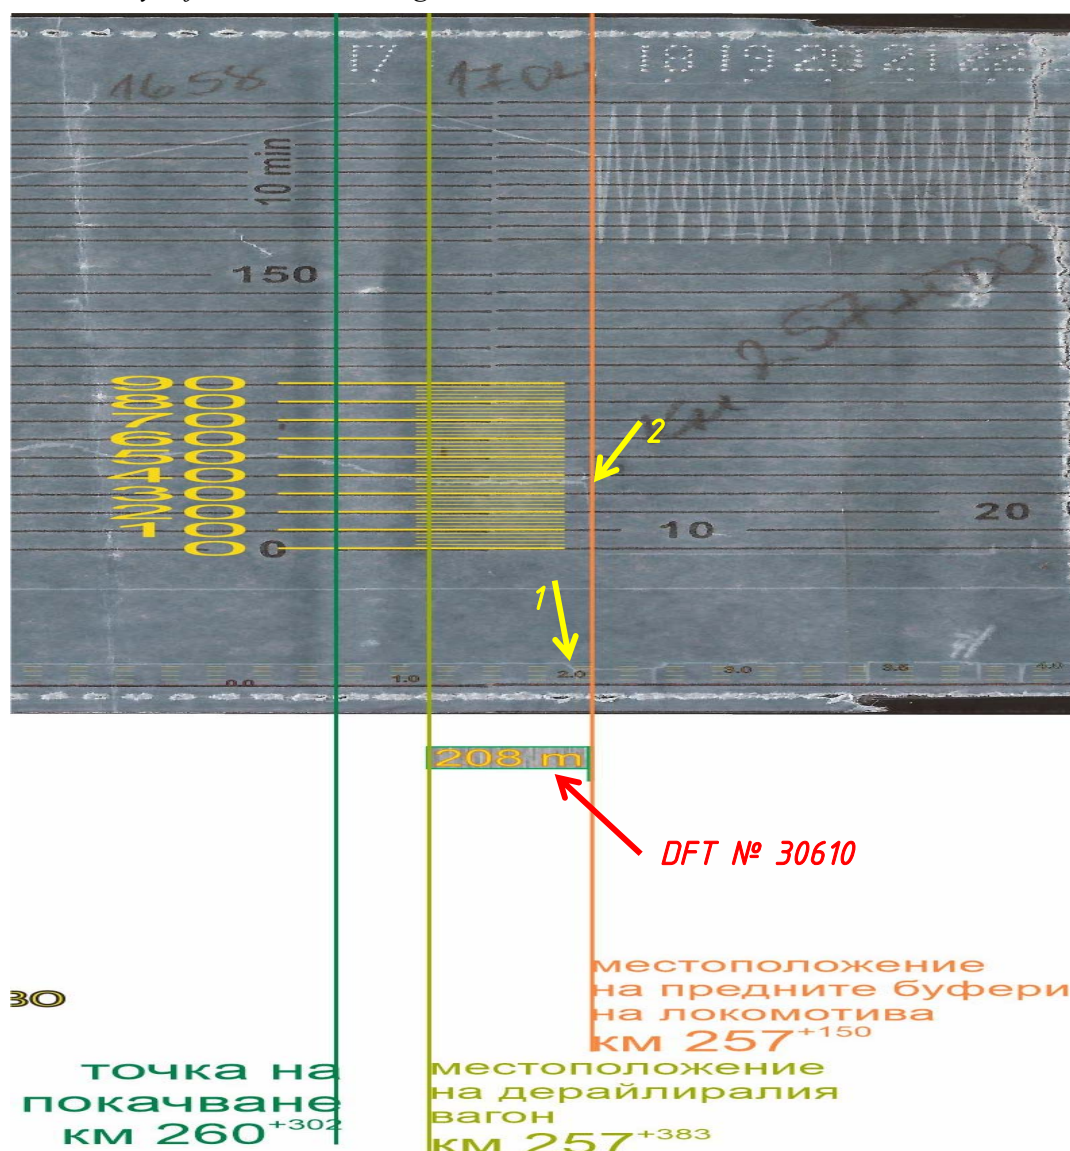
At 17:03, when the locomotive is located at km 257⁺⁴⁵⁰, the pressure in the main air duct begins to decrease (Fig. 4.6, pos. 1). The reduction of the pressure in the main air duct is due to the splitting of the train because of the derailment of wagon № 31525400845-3. After another 200 meters, the speed of the train decreases to 0 km/h, and the train stops (Fig. 4.6, pos. 2). The front buffers of the locomotive are located at km 257⁺¹⁵⁰, and the derailed wagon - at km 257⁺³⁸³.

Fig. 4.6. Registration of movement of locomotive of DFT 30610 from Shivatchevo station to km 257⁺¹⁵⁰.

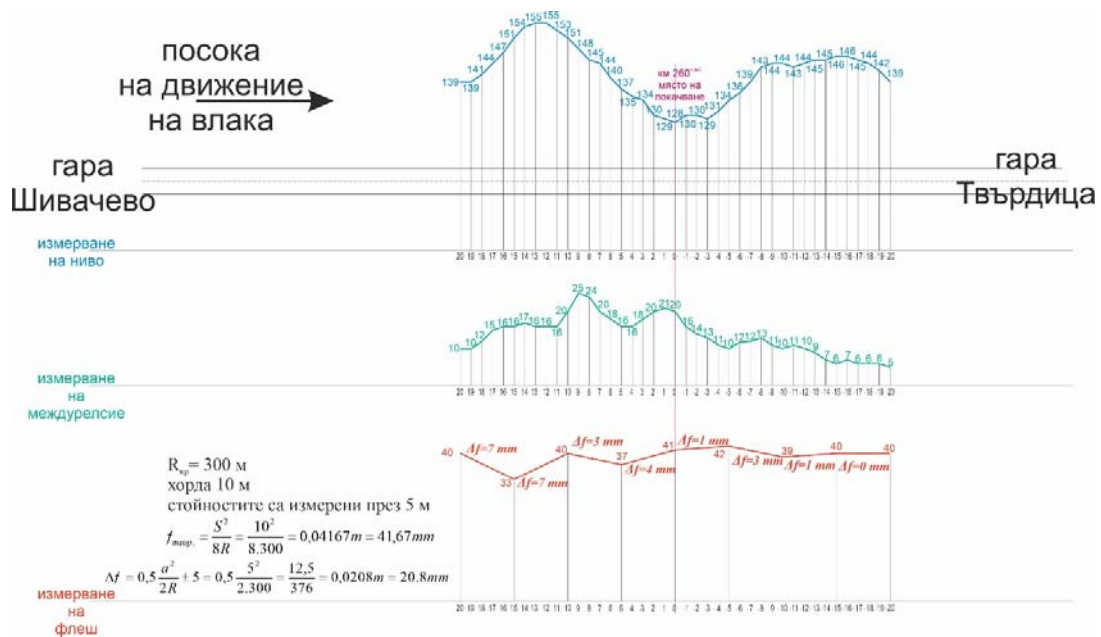
Fig. 4.7. DDiagrams of the values of separate track parameters along Shivatchevo-Tvarditsa interstation, measured on 12.03.2021.

the task force to perform measurements for hidden failures/twists of the rail track in the area of derailment of the wagon; therefore, no records of measured hidden failures/twists are reflected in the Statement of findings (Fig. 4.7, Diagram of rail track measurement under level).

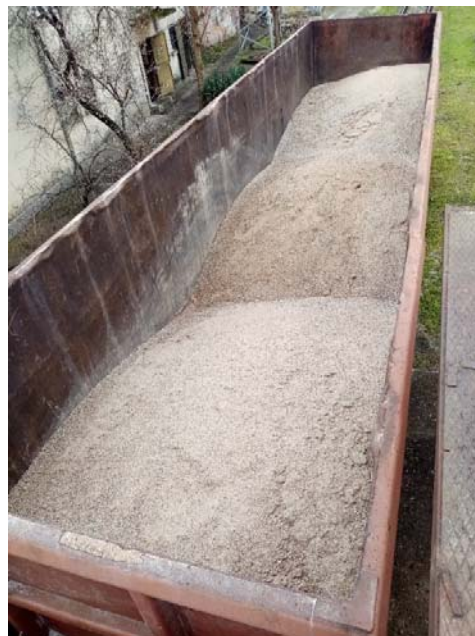
Fig. 5.1. Distribution of the load in 16th wagon № 31525400845-3

After the inspection, it was found that the load in these wagons was unevenly distributed along the transverse and longitudinal axes of the wagons, as most of it was located in the right longitudinal half of the wagons in the train movement direction (Fig. 5.1).

- Recommendation 3 proposes that „BDZ-Cargo“ Ltd. controls the process of loading the wagons when transporting bulk cargo.

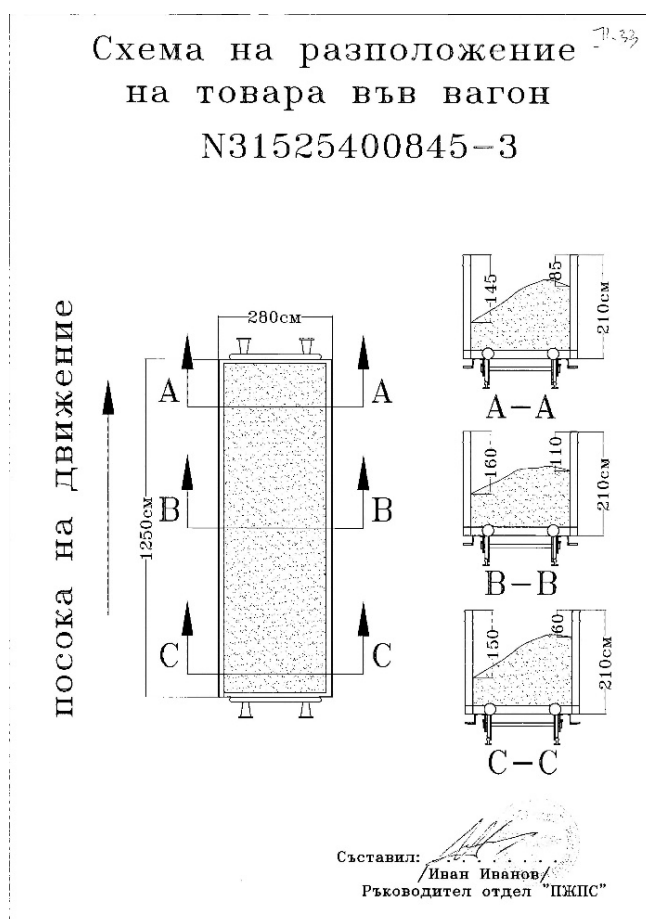
Fig. 5.2. Scheme of load layout in 16th wagon № 31525400845-3

Therefore were found non-compliance with the requirements of Art. 46, para. 3, item 1 of the 2nd and 3rd wheel-sets of the 15th wagon; on the 2nd, 3rd, and 4th wheel-set of the 16th wagon (derailed) and on all the wheels of the 17th wagon.

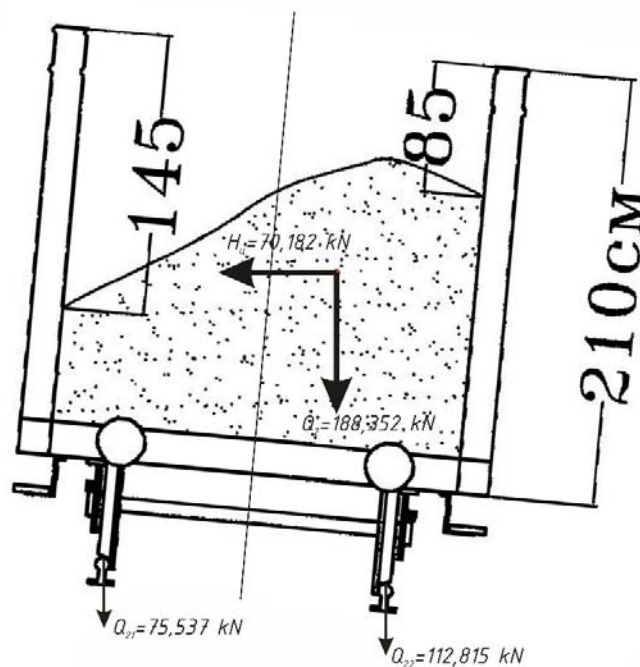
Fig. 5.3. Distribution of the forces acting on the second wheel-set of the first bogie of wagon № 31525400845-3

second wheel-set is located (Fig. 5.3). The center of mass is shifted to the right of the longitudinal axle of the wagon in the direction of train movement, which is logical given the results obtained when measuring the load on the individual wheels (Table 1). The measurements also show that the right wheel is loaded 49% more than the left one.

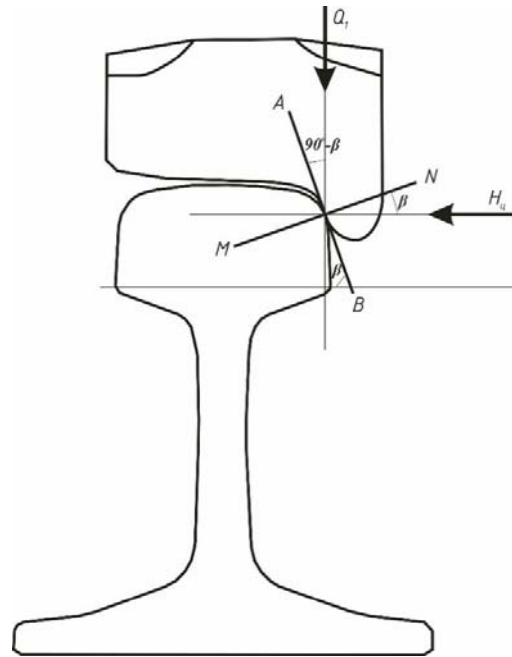
Assuming that $\beta=70^\circ$ and $Q_2=1,49Q_I$, $H_u/Q_I=0,93$ is obtained. For stable movement it is necessary to fulfill the condition $H_u/Q_I \leq 0,8$. Therefore, the horizontal transverse force caused by the centrifugal force in the movement of the train in the curve has a greater influence than the vertical load acting on the wheel, which violates the condition of stable wheel movement and leads to derailment of the respective wheel. These results, combined with the lower value of the level of the rail track (which is within the permissible limits) at the point of ascent (Fig. 5.5: 0.128 m (Fig. 5.5, pos. 1) compared to the first wheel - 0,13 m (Fig. 5.5, pos. 2) and the third wheel-set - 0.144

Fig. 5.4. Forces, acting in the contact point wheel-rail

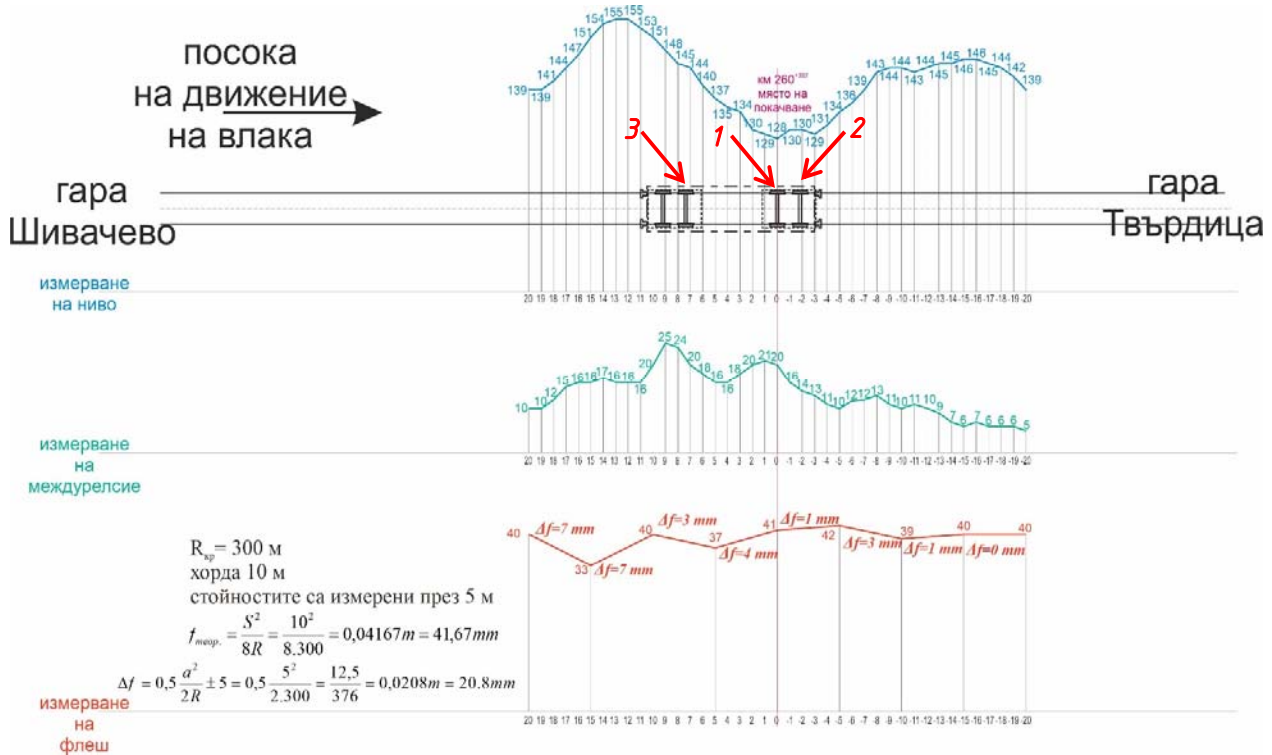
m (Fig. 5.5, pos. 3) have contributed to the rise of the wagon on the rail head at the specified point and its subsequent derailment.

In conclusion, the Investigation Commission considers that the main cause for the derailment of the second wheel-set of wagon № 31525400845-3, 16th in a row in the composition of DFT № 30610 along Shivatchevo – Tvarditsa interstation, is the uneven load of the wagon. This has led to a displacement of its center of mass, as the load was unevenly distributed on the individual wheels (the load on the left in the movement direction was less than the load on the right one). The combination of movement in right curve with a small radius, low speed and deviations in the level of the rail track, has contributed to the rise of the left wheel on the second

Fig. 5.5. Layout of wagon № 31525400845-3 with respect to the track
