REPUBLIC OF BULGARIA
NATIONAL AIR, MARITIME AND RAILWAY ACCIDENTS
INVESTIGATION BOARD

FINAL REPORT

**Investigation of railway accident – fire in electric locomotive № 44094.8,
occurred while servicing fast train № 3621 between the stations Chernograd –
Aytos on 28.09.2020**

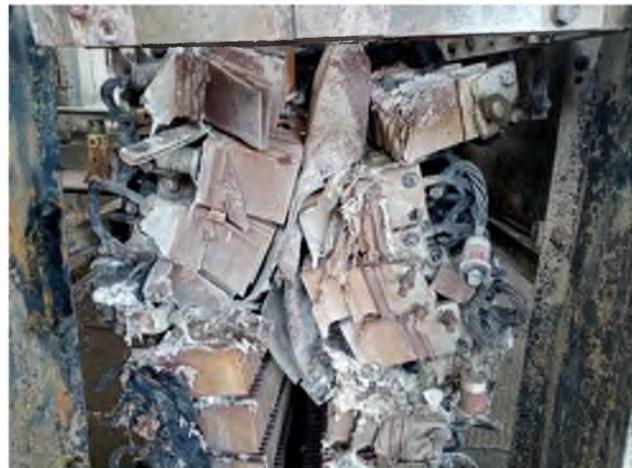
Fig. 2.1

- Severely damaged insulation pads of the rectifier elements of rectifier group 020 (rectifier of the first traction group). Molten diode coolers at the bottom of the rectifier group (Fig. 2.1);
- Terminal board of the second traction motor (TM) - badly burnt, including the cable insulation of the second traction motor (Fig. 2.2);
- The connecting rubber pipe of motor pump 238 has been burnt but not destroyed. Most likely from a secondary fire flame in rectifier group 020;

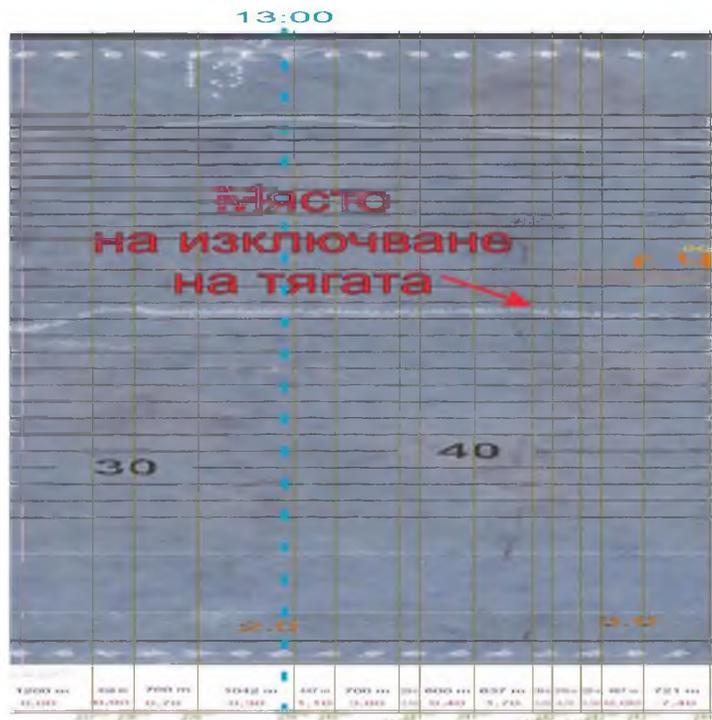
Fig. 4.3

During the movement in this interval of km 242⁺⁸¹⁵ the train enters in Chernograd station at a speed of 120 km/h at 13:02 p.m. At this speed, the train moves for 1985 meters from km 243⁺³⁴⁸ to km 245⁺³³³ for 1 minute (Fig. 4.3).

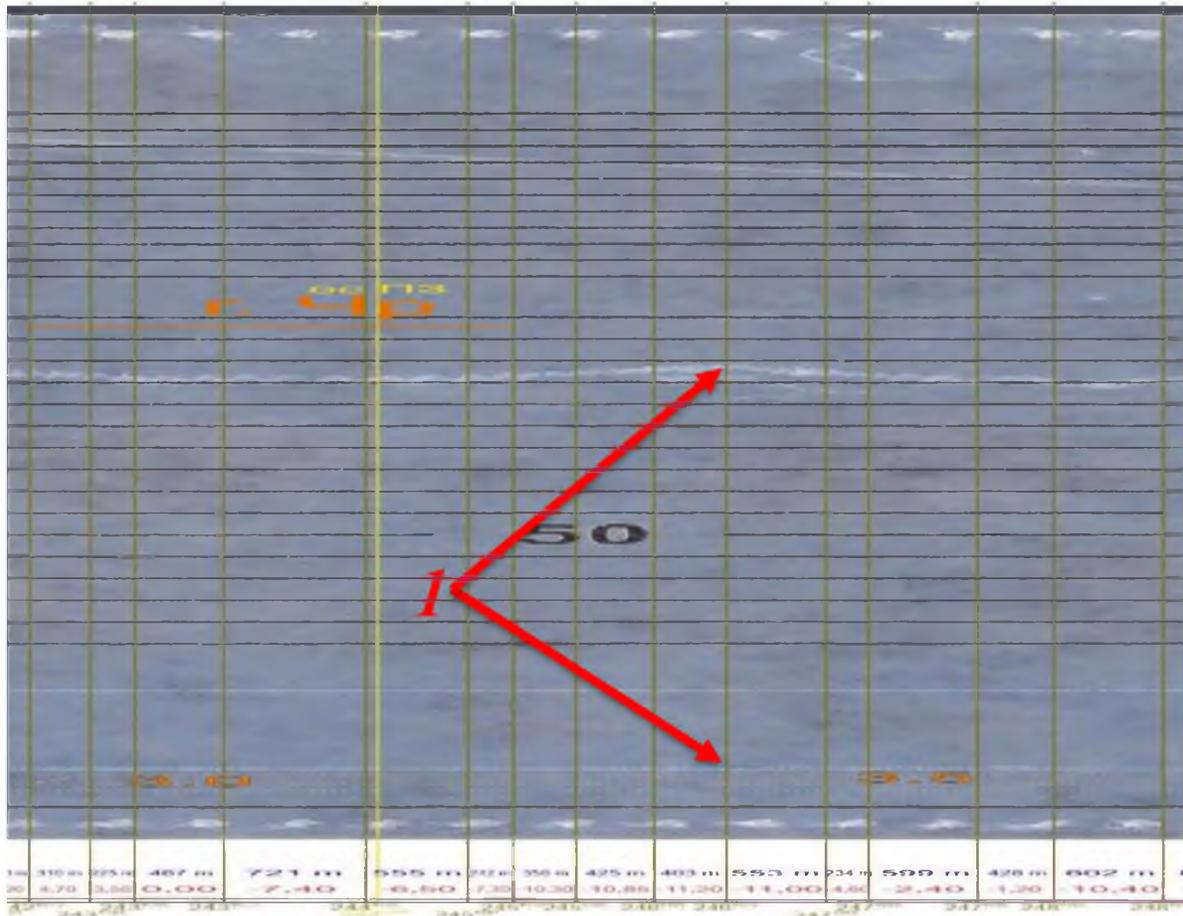
Fig. 4.4

From km 245⁺³³³ at 13:02:50 p. m. the train moves by inertia, but the speed starts to increase due to the increase of the longitudinal slope of the road. The speed reaches 128 km/h at km 246⁺⁵¹² at 13:03:30 p.m. At this point, the locomotive driver applies the automatic train brake to prevent the section from exceeding the maximum permissible speed by reducing the pressure in the main air conduct by 0.4 bar to 4.6 bar for about 10 seconds, then loosens the brake and restores it up to 5.0 bar (Fig. 4.4). The speed starts to decrease, reaching a value of 117 km/h at 13:05 p.m. from km 246⁺⁵¹² to km 250⁺⁰⁰⁰ for 3.5 km in 1 minute and 40 seconds. From km 249⁺⁶⁶⁰ to km 252⁺⁸⁰⁰ the speed fluctuates between 117 and 120 km/h when driving by inertia, traveling about 660 meters

in 1 minute and 20 seconds (Fig. 4.4, pos.1).

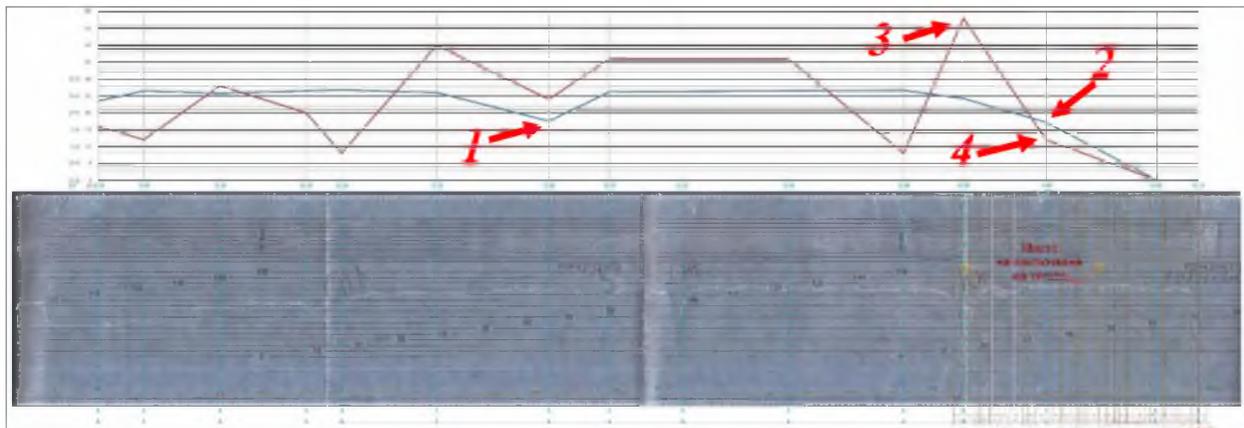
Fig. 4.6

The maximum measured **average** value of the current consumed by the locomotive is 48.0 A at 12:55 p.m. (Fig. 4.6, pos. 3), which corresponds to the moment of departure of the train from Karnobat station. Then the second lowest **average** current value of 12.0 A was measured for the second time (Fig. 4.6, item 4) when the train is already in the area of TS Karnobat, terminal Chernograd, track № 1. This can be explained by the fact that the train is moving at high speed and the values of the traction current are low, after which it switches to inertia mode and logically the traction current decreases even more. At the same time, the auxiliary machines (especially the compressors) continue to operate and load the rectifier units. Reduced voltage values lead to increased current during the operation of auxiliary machines, which increases their operating time, combined with the lack of cooling. This mode of operation has led to an increase in the temperature in the rectifiers of the auxiliary machines and to their ignition. At the end of the

An important factor for raising the temperature is the operation of the locomotive with reduced voltage in the catenary (Fig. 4.6), which leads to increased operating currents, which are known to cause intense heating of the wires and devices through which they flow and worsen the conditions for operation of auxiliary machines and devices, in other words, the parameters of the voltage in the catenary at 13:00 p. m. at the time of the fire in the locomotive were violated.

Recommendation 3 proposes SE NRIC to inspect the facilities and devices for traction power supply, related to the detection and elimination of faults leading to low supply voltage in the catenary during the movement of trains in the section Zimnitsa - Aytos.

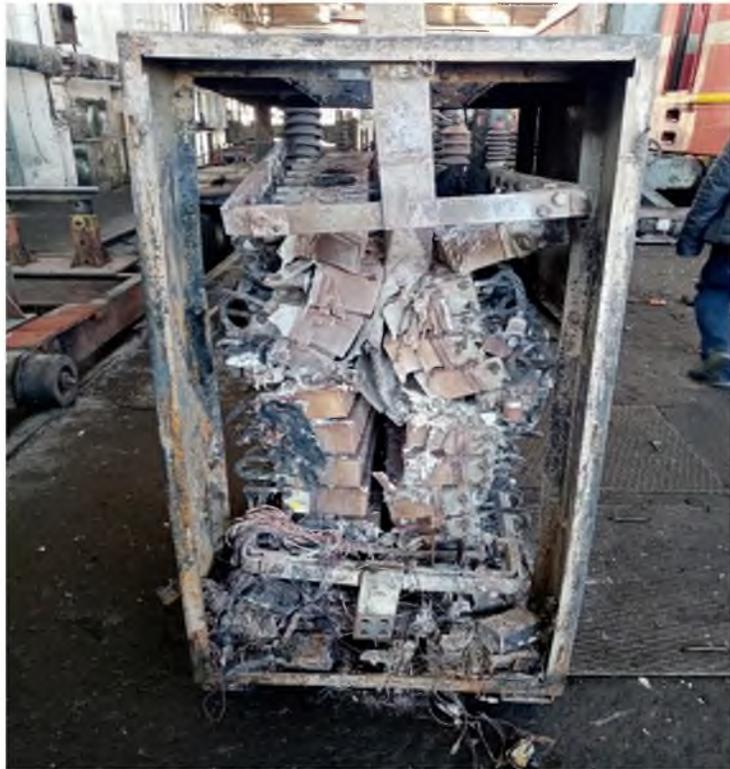
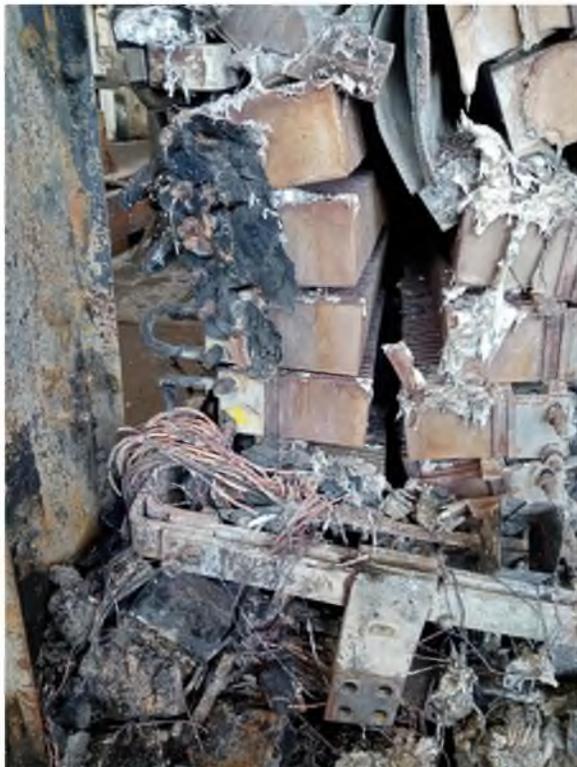
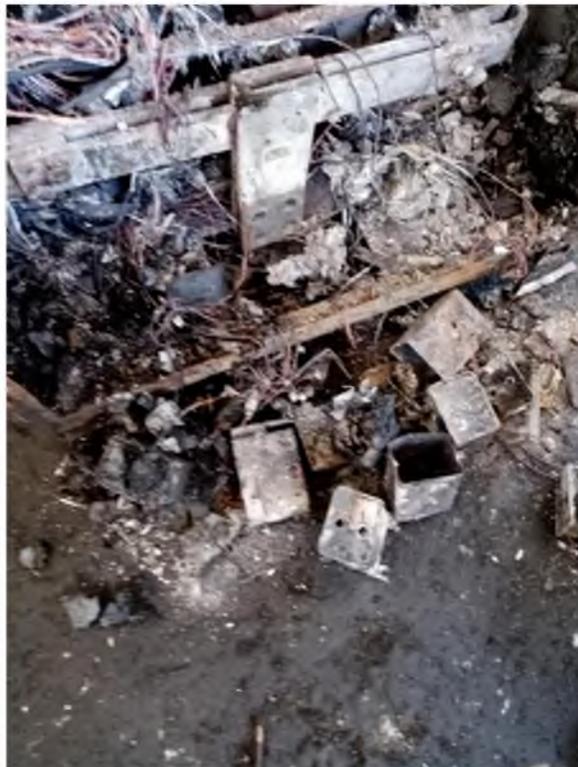
It was found that the rectifier unit of the first group was almost completely burned, as the traction rectifier has fused diodes and cooling radiators to them. The Commission also found that the initial ignition source was located at the lower end of the rectifier cabinet, where the rectifiers of the auxiliary machines are located, and more precisely on the rectifier side of the compressor motor of the same group (Fig. 5.1). The conductors were with burnt insulation and in a brittle condition, proving the presence of temperatures of $800\div 900^{\circ}\text{C}$ (Fig. 5.2). The condensers had swollen and broken housings, apparently due to high pressure inside them, caused by self-ignition due to the developed high temperature (Fig. 5.3). It was obvious that the fire occurred and developed in the lower part of the rectifier unit, on the rectifier side of the motor-compressor.

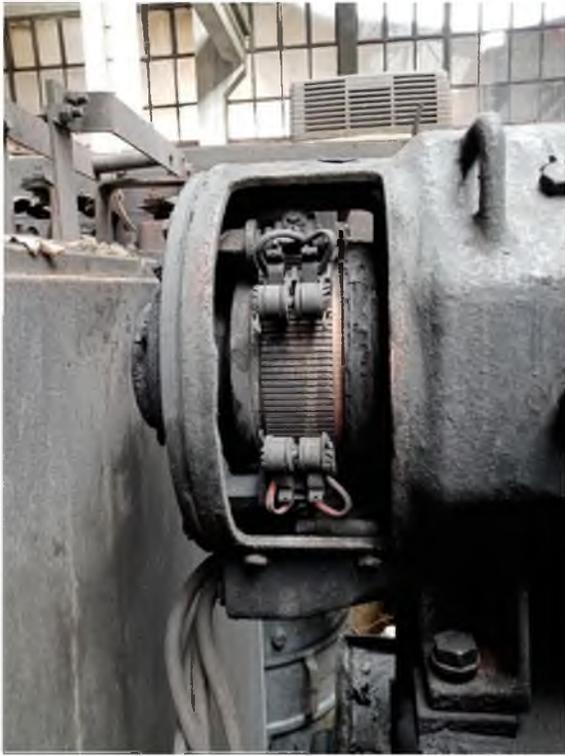
Fig. 5.5

The Commission also carried out in-depth inspections of the other units of the locomotive's engine compartment. It was found that the engine-compressor of the first group is unusable, but recoverable, with a smoky manifold/collector. The compressor was removed from the locomotive for further inspections. During the additional inspections performed on this unit, it was found that the damage was due to the high temperature during combustion and due to the water, by

which was put out the fire. There were no signs of a short circuit or ignition source on the compressor motor (Fig. 5.5). The commission also inspected the horizontal hopper fan cooling the rectifier unit of the first traction group and found that it was also undamaged due to the timely actions of the locomotive crew and the impossibility the fire to spread on this unit (Fig. 5.6).

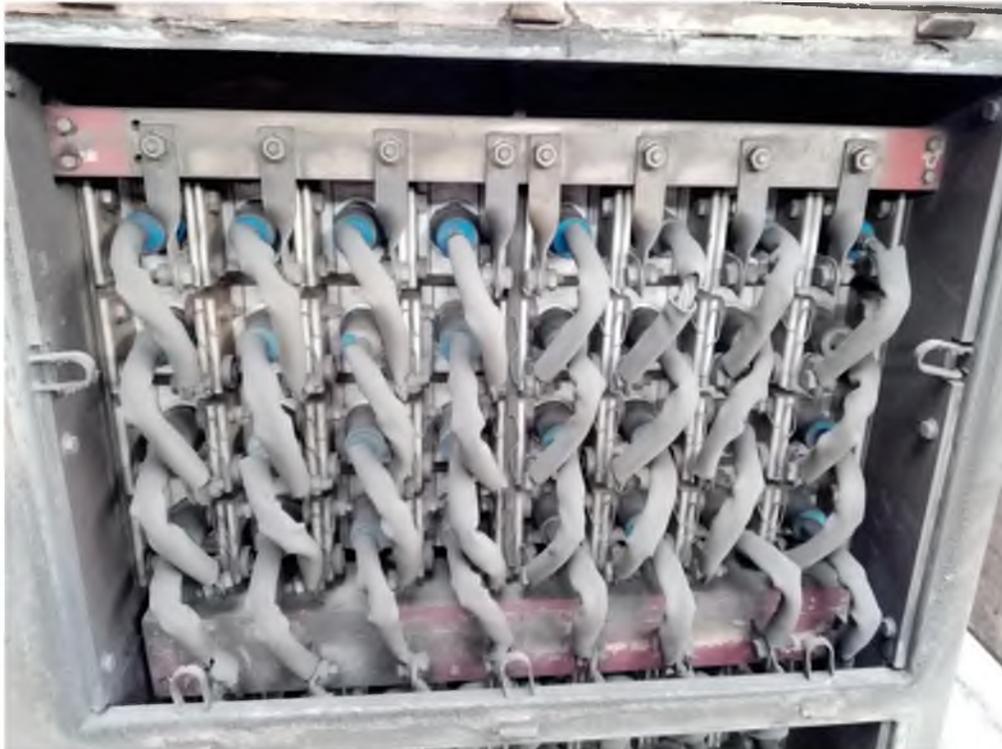
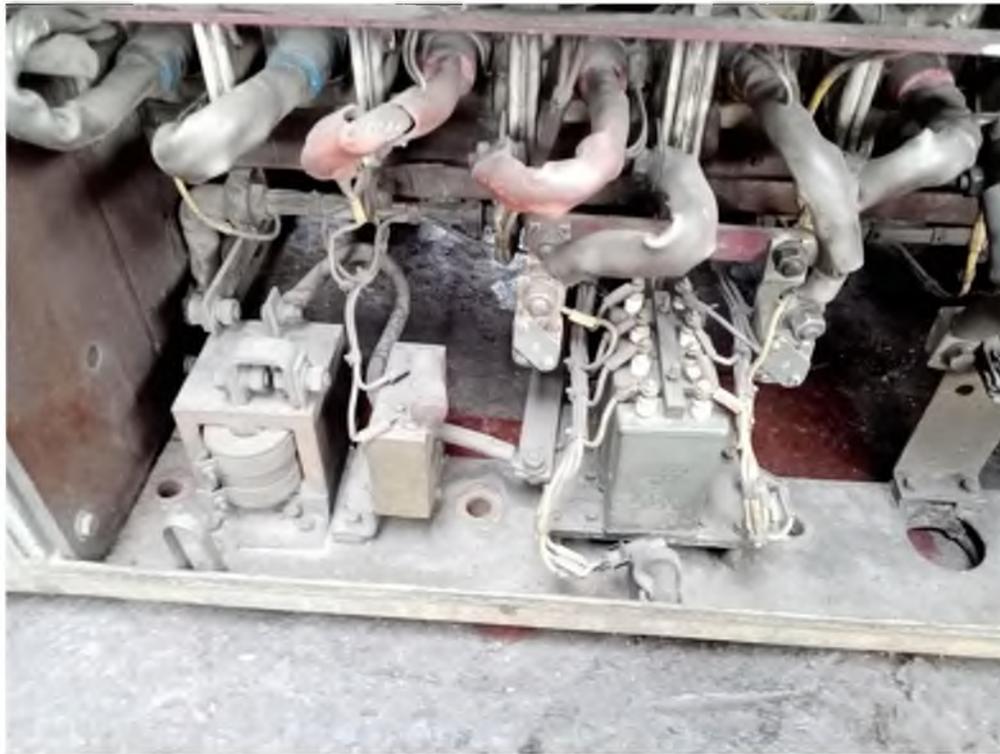
The Investigation Commission carried out a detailed and in-depth inspection of the rectifier unit of the second traction group. It was established that there were no damages on this rectifier unit - the locomotive crew found the fire that occurred early and took measures to limit it, thus preventing even greater damage to the locomotive. At the same time, keeping in good condition the rectifier unit of the second group allowed the Commission to inspect and analyse its condition and the causes that led to the ignition of the locomotive (Fig. 5.7 and 5.8).

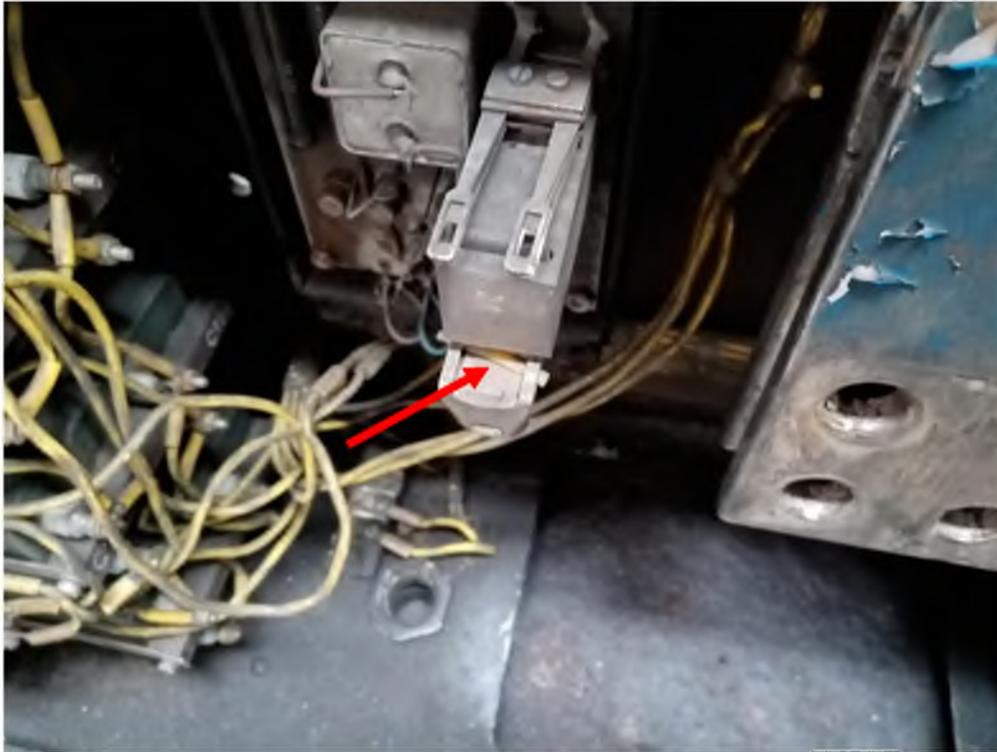
Fig. 5.9

In the course of the investigation, the Commission also found a breach of the safe operation of the locomotive - the exclusion of important protection, which ensures that the locomotive does not remain without cooling during operation. It was found that on the coil of the control relay Y3 is placed an object - which keeps the relay on, regardless of the signals it receives. Relay Y3 is a control relay that receives voltage from the auxiliary rectifiers of the fans. It turns off the traction mode of the locomotive below (143V) and participates in the cooling control circuits of electrical machines and rectifier groups (Fig. 5.9). In this way, the relay remains switched on continuously, regardless of whether the cooling is normal, and this creates a precondition for the locomotive to operate without sufficient or even without any cooling of electrical machines and apparatus. The operation of the locomotive without the necessary cooling leads to an excessive increase in temperature in the individual units and in the engine compartment as a whole, which leads to melting of the cable insulation, damage to the capacitors, leakage of their electrolyte, which in turn becomes a catalyst for ignition of the rectifier unit.

In this regard, it is necessary to emphasize that in this series of locomotives the cooling fans of the electric machines are switched on automatically during the traction mode of the locomotive, but are switched off manually by means of a button on the control panel, i.e. the subjective factor (the locomotive driver) is the one that assesses

the degree of cooling and whether further operation of the fans is necessary when switching off the traction mode.

It is very common practice for locomotive drivers to switch off the fans immediately after switching off the traction mode of the locomotive in order to prevent the gust of strong air current and increase the noise level in the control cabin. Violation of the working conditions of locomotive drivers is a precondition for the deterioration of their health, which is the main reason for their actions. However, this shutdown is accompanied by a further increase in temperature in the cooled machines and appliances, and especially in the rectifier units, which have so far operated at full capacity, their heating is very intense and at the time of shutdown they continue to radiate heat. This heat is distributed in the closed cabinet of the rectifier unit, including the rectifiers of the auxiliary machines. The above leads to intense heating of the rectifiers of auxiliary machines and the rectifier unit as a whole and in certain circumstances the capacitors do not withstand the high temperatures, burst and the spilled electrolyte ignites from the heated surfaces of the cabinet walls, igniting the wire insulation, which is in it.

Recommendation 2 proposes that BDZ PS Ltd. limit the access for forced “impact” of an electronic relay for voltage control of the Y3 fans, by obligatory sealing and performing periodic scheduled control for serviceability and functionality.

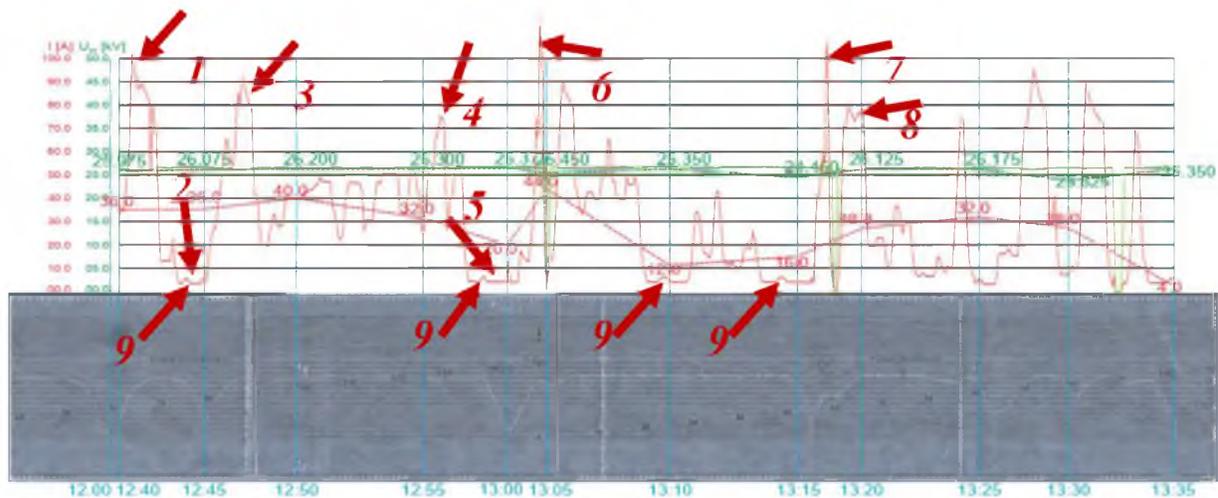
Fig. 5.10

On 12.02.2021 an experimental trip was made along the route of FT № 3621 with a locomotive № 44198. In the locomotive were installed devices measuring the voltage in the catenary and the current consumed by the locomotive during its movement, all data were recorded after which were analysed in depth and detail. The measurement of the values of the alternating voltage in the catenary was performed with a certified multifunction device "Fluke 430 Series SN": DM9311111, which also performs harmonic analysis of voltage and current in one phase, scanning with a frequency of 4 kHz, applying a computational algorithm - fast conversion of Fourier. The device allows digital recording of current and voltage curves with a scanning frequency of 2.5 Hz, which is determined by high accuracy (<0.5%). The recordings made by the devices are at every 5 seconds and give a clear and detailed picture of the change of the above-mentioned parameters. The data were taken and recorded using the software product Power Log Classic 4.6, after which they were processed and compared with the speedometer tape of the locomotive, which provides accurate information about current and voltage data both in time and in location and speed of FT № 3621. Due to the large volume of data, only the data from 12:40 p. m. to 13:35 p. m. were analysed - time during which the train is in the same section where the accident with locomotive 44094 was realized on 28.09.2020, namely the section of Zimnitsa station to Vladimir Pavlov station (Fig. 5.10).

In the interval from 12:00 p. m. to 12:25 p. m. the average values of the voltage in the catenary is over 26 000 V at **average** values of the consumed current for the same interval from 4 to 28 A (Table 2). At 12:30 p. m. the **average** value of the consumed current is 24 A at an average value of the voltage in the catenary 25 950 V. In the next moment of measurement at 12:35 p. m. was reported the lowest one.

During the movement of the train in some places local current peaks are observed, caused by the operation of the motor-compressors, and the consumption does not fall to zero value due to the fact that the train heating is constantly switched on (Fig. 5.10, pos. 9).

Throughout the movement in the observed section, the voltage in the catenary is maintained in the range of 26 to 27 kV, except for the values measured at 12:35 p. m. (15 350 V) and at 13:45 p. m. (2 625 V) (Table 2). The average values of current and voltage read by the locomotive electricity meter for intervals of 5 minutes generally show the same trend with voltage values slightly lower than those measured with the help of the device.
