FINAL REPORT

from
**Technical investigation of railway accident –
fire occurrence during movement in electrical locomotive No 44096.6, which serviced
fast train No 80290 in Chernograd - Karnobat interstation on 14.09.2016**

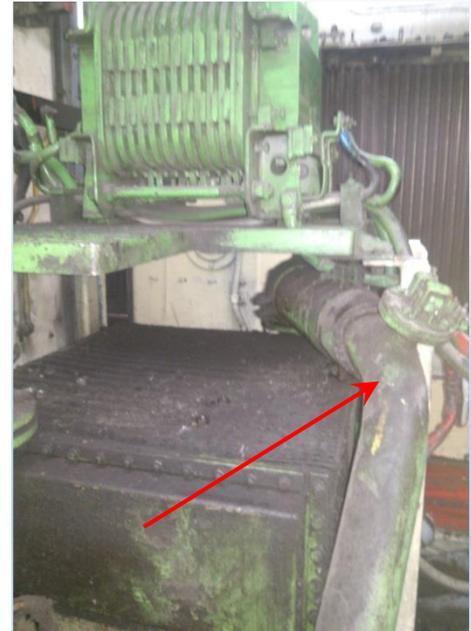
Fig. 1

After the performed number of detailed inspections and indepth analysis of the facts and taken to an account the written explanations and statements of the locomotive crew as well as the fast development of the events, the Investigation Commission came to the conclusion that the original cause for the lighting of a fire in locomotive No 44096.6 was a rupture of the rubber joint, which served the oil circulation from the ATP to the transformer located over the radiator for cooling the oil in the transformer (fig. 1).

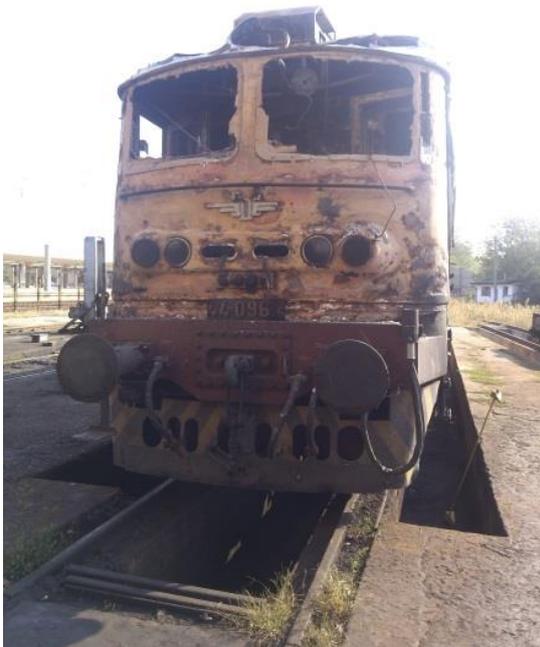
Fig. 2

In the course of the investigation, the Commission performed several detailed inspections to the burned locomotive in Plovdiv locomotive depot, it got acquainted in details with the documentation referring the ignition and conducted detailed interrogations to the operational staff involved in the specific case on all the actions undertaken by the locomotive and traffic crews before and during the fire (fig. 2).

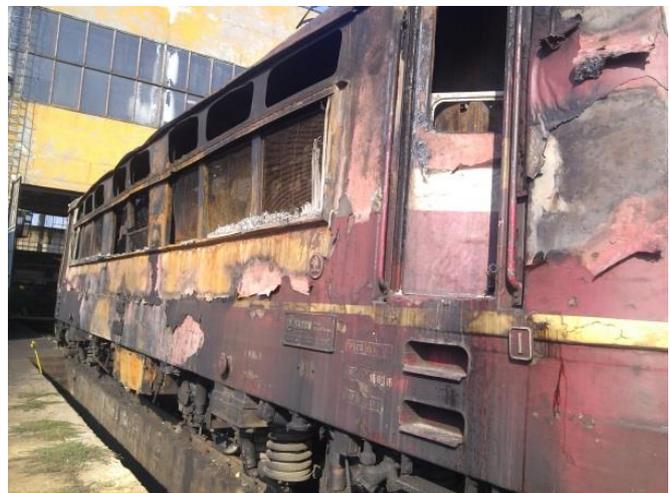
Fig. 3

During the inspections was found that the fire destroyed almost all the aggregates and nodes of the locomotive to an extent, from which their recovery was impossible (fig. 3 and 4). The first signs for ignition were the presence of smoke smell from the engine compartment of the locomotive (evident from the explanations of the locomotive crew).

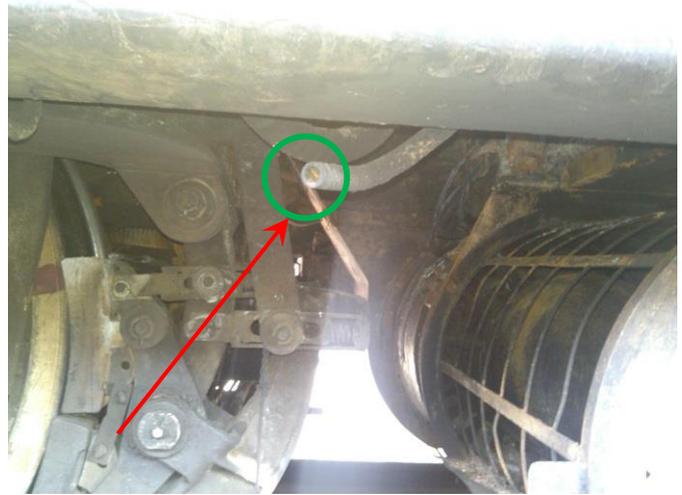
Fig. 5

Important moment from the explanations of the locomotive driver was the part in which he explained that during the extinguishing of the locomotive in the area of the fans under the body shell he noticed oil leakage from the drainage pipe on (fig. 5).

2. During each small periodical repair (SPR), it shall be performed inspection to the condition and density of the oil cooling contour of the locomotive transformer with focus on the connecting rubber compounds.

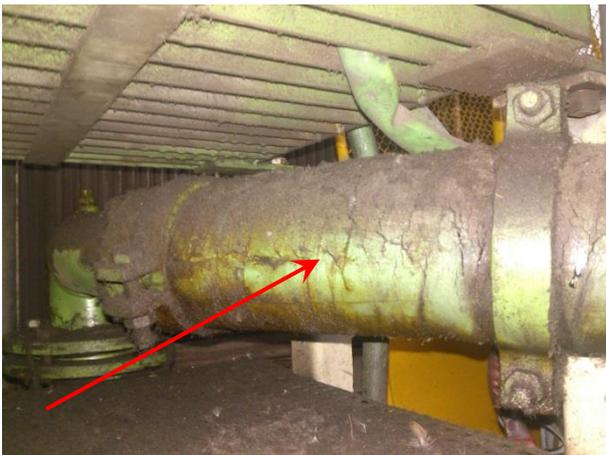
Fig. 6

The cracking of the rubber compound is an event with rather insignificant probability and should not happen during the locomotive operation. The Commission, however performed an inspection to some locomotives of the same series and found that there exist also other locomotives on (fig. 6), within which is clearly seen that these rubber compounds are not in good

condition, they are old, cracked and rheumy, which confirms the reviewed version as the most probable for the locomotive ignition.

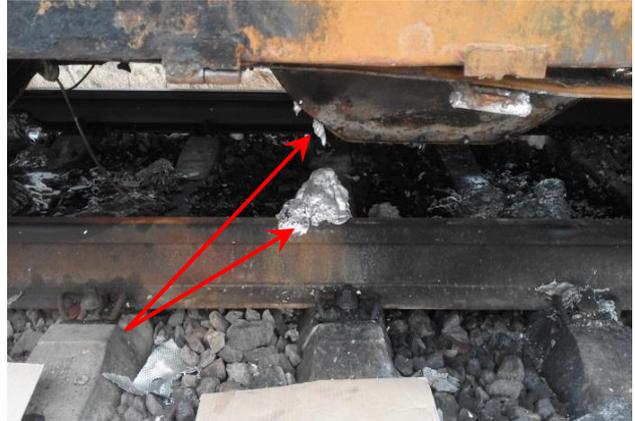
Fig. 7

As a result from the oil ignition, the temperature in the engine compartment increased to values (minimum 800°C), which led to melting of the ATP body shell, aggregate located next to the fire ignition – the cooling radiator of first traction group, which body shell was manufactured in allumina. Because the ATP is full with oil, approximately 200 liters during the melting of the bodyshell the oil from it ignited from the high temperature and increased additionally the force of the fire. This hypothesis is confirmed from the allumina melt, found under the locomotive on the two rails on (fig. 7).

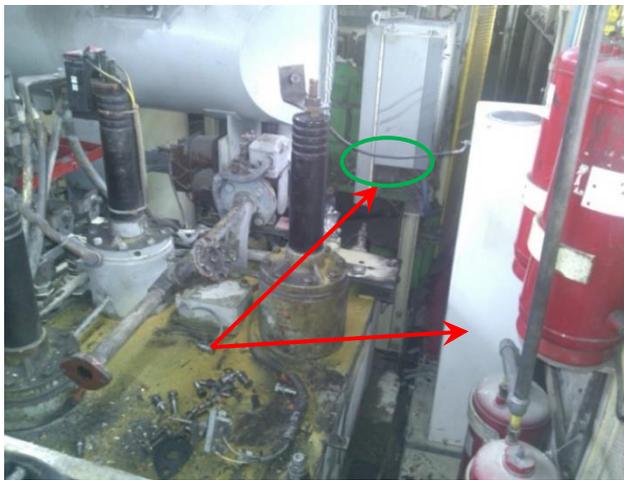
Fig.8

The frequent cases of locomotive ignition impose also an analysis of the probability a source of ignition spark to be different node or aggregate, located in the high-voltage camera. In this line on fig.8 are shown the voltage measuring transformer of the new electronic electrical meters installed within the period 2014 - 2015 (the vertically located on the floor white parallelepiped), the insulator at the entrance of the ATP and the cable connection in-between. It is possible due to strong vibrations occurring during the movement of the locomotive and insufficient length of the cable connections, which connects them, it is possible the cable to be taken out from the cable nozzle. In that case during the movement of the locomotive, the free edge of the cable within touch with metal parts cause voltaic arc, (having in mind the high voltage – 25 kV and earthed body shell parts on the

1. To be examined the behavior of the voltage transformer of the installed in the electrical locomotives of 44 and 45 series electronic electrometers during movement. To be assessed the risk from occurrence of hazards as a result from irregularities and the connection of the electrometers.
