FINAL REPORT

from
technical investigation of railway accident – derailment of freight train No 50505 during
transit passing through Petarch station on 28.08.2016

January 2017

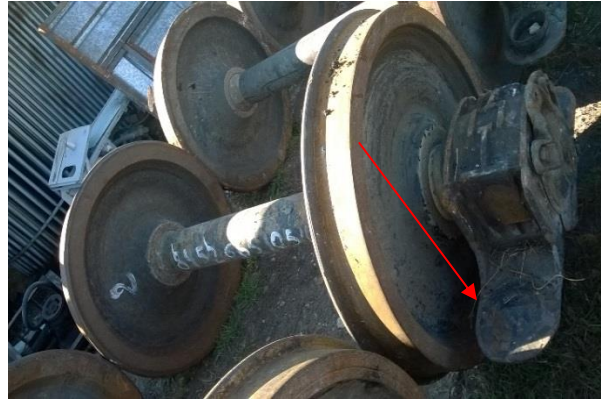
Fig. 5

During the moving away from the track the derailed fourth wagon caused additional external pressures on the traction rod, which overloaded it and the same torn in an avalanche way. During the inspection of the derailed fourth wagon was found that from the first bogie of the second wheelset was detached the clamp of the axle box spring, which held the internal and external springs for the wing of the left axle box (Fig. 5). During the inspection on site, the springs of the left axle box were not found (were missing).

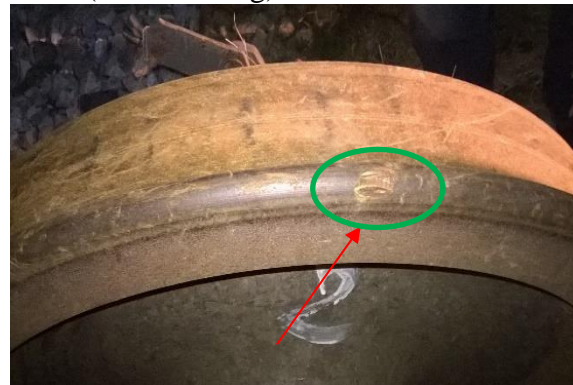
Fig. 6

There were caused serious damages and undercuts on the top/surface of the wheels flanges (Fig. 6) to both wheelsets of the first bogie. During the inspection of the track on the place of derailment was found that there were no missing or loosened fastenings as well as unfit/unusable sleepers. There were no found one-sided or twist subsidence. Based on the performed measurements of track were calculated the transitions before and after the place of derailment.
