RAILWAY ACCIDENT INVESTIGATION UNIT
AT THE MINISTRY OF TRANSPORT, INFORMATION TECHNOLOGY AND
COMMUNICATIONS

FINAL REPORT

technical investigation of railway accident –
derailing of freight train Nr. 90570 on point Nr. 5 upon entrance in
Hitrino station on 10.12.2016

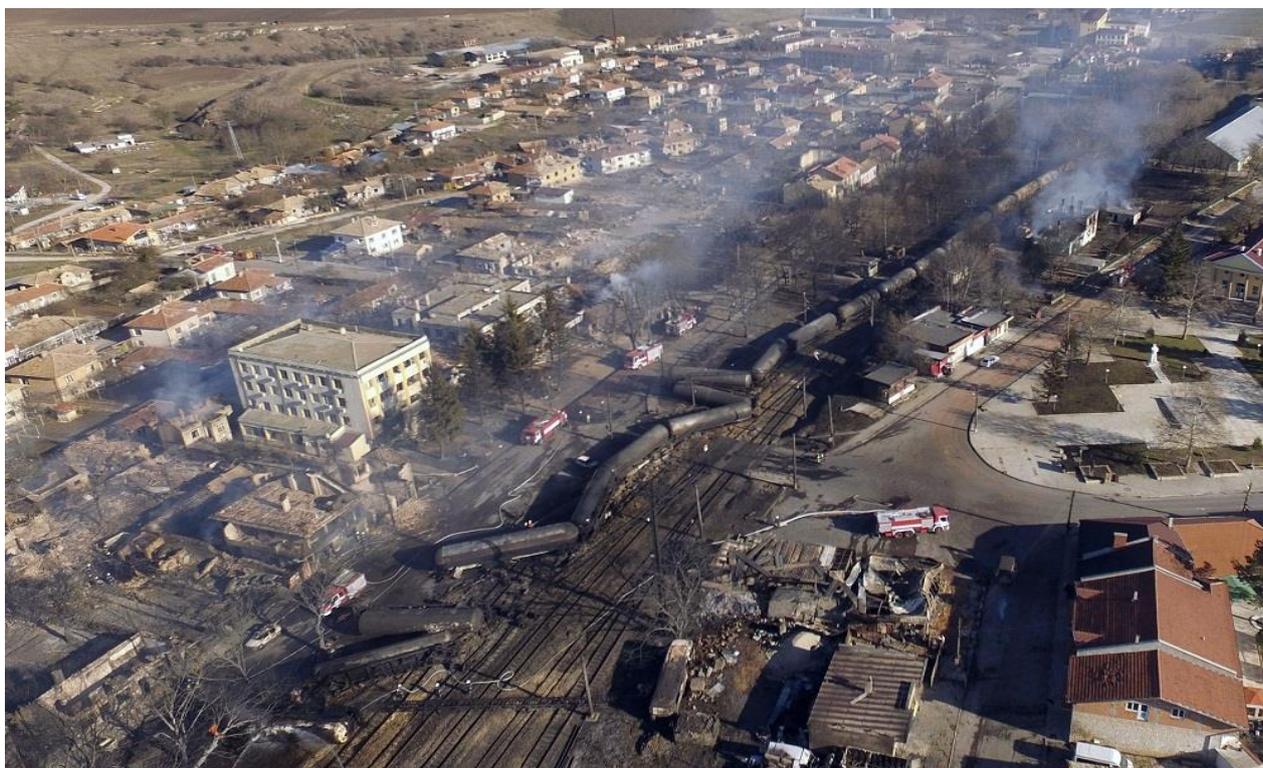
Figure 1

The two electric locomotives and the first five wagons arrived at the station. One part of the train had derailed, and the other part had settled in the throttle place accommodating the points at Post Nr.2. The post switchman at Post Nr. 2 called the traffic controller on duty via the station telephone connection line to inform him that freight train Nr. 90570 had derailed. During the conversation the post switchman felt strong suffocating smell which was followed in a while by a powerful explosion, as a result of which an extensive fire burst out, covering a significant area of the station and the village of Hitrino (Figure 1).

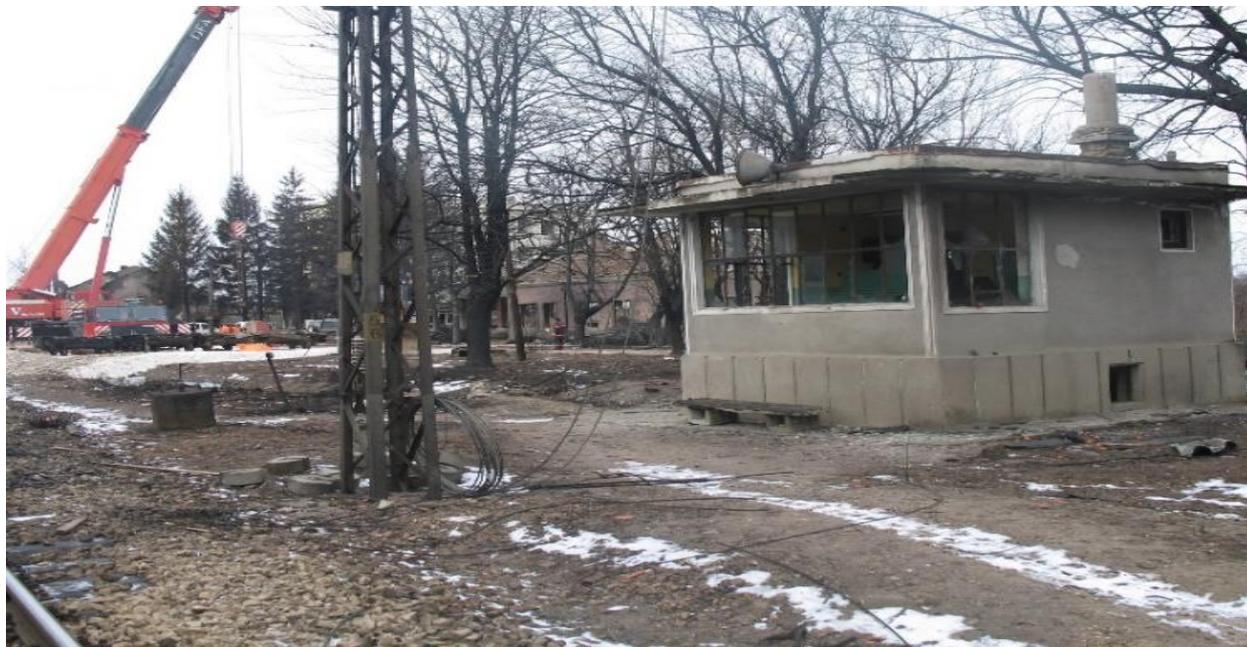
Figure 2

Destroyed are buildings and railway infrastructure in the area of Post Nr. 2 at Hitrino station (Figure 2). Many of the train's wagons are damaged.

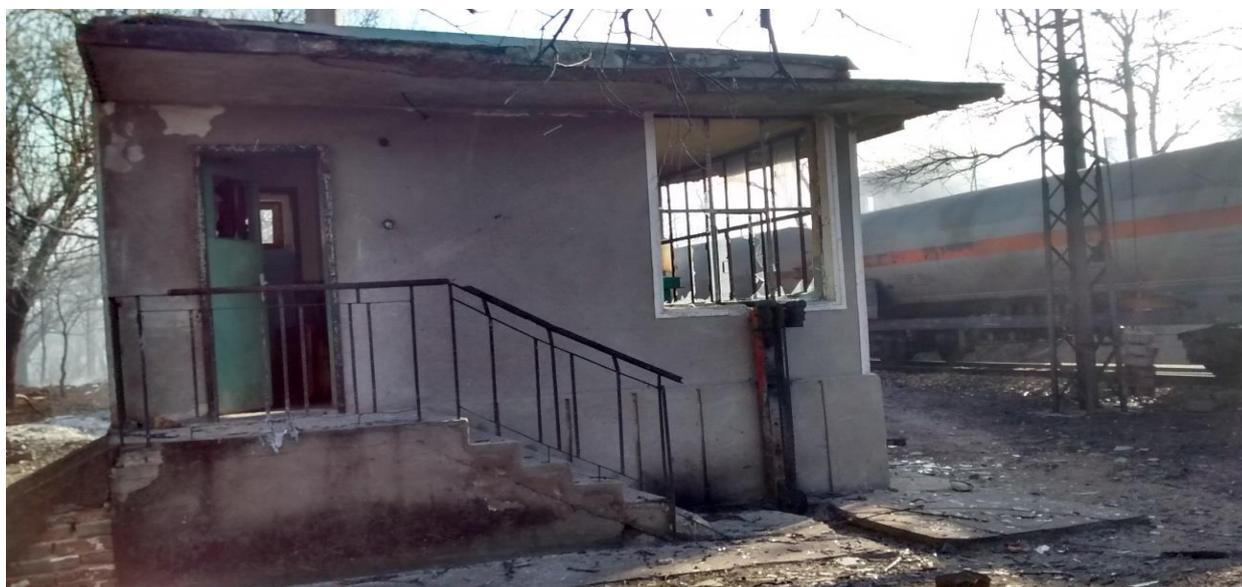
Figure 3

At 05:35 h. the traffic controller on duty went in front of the reception building of the station to meet the arriving train. After the train had entered the station and passed through the railway level crossing, found in the throttle place accommodating the points at km 110⁺⁴⁶⁰, the traffic controller on duty saw sparkles emitted from the wheels of the train. A few seconds later the lighting at the level crossing switched off, the catenary swung, and only a part of the train continued trafficking towards the reception building. The wagons, from the 6th to the 17th one, derailed, the remaining 9 wagons from the train did not derail and stopped in front of point Nr.1 at Post Nr.2 (Figure 3).

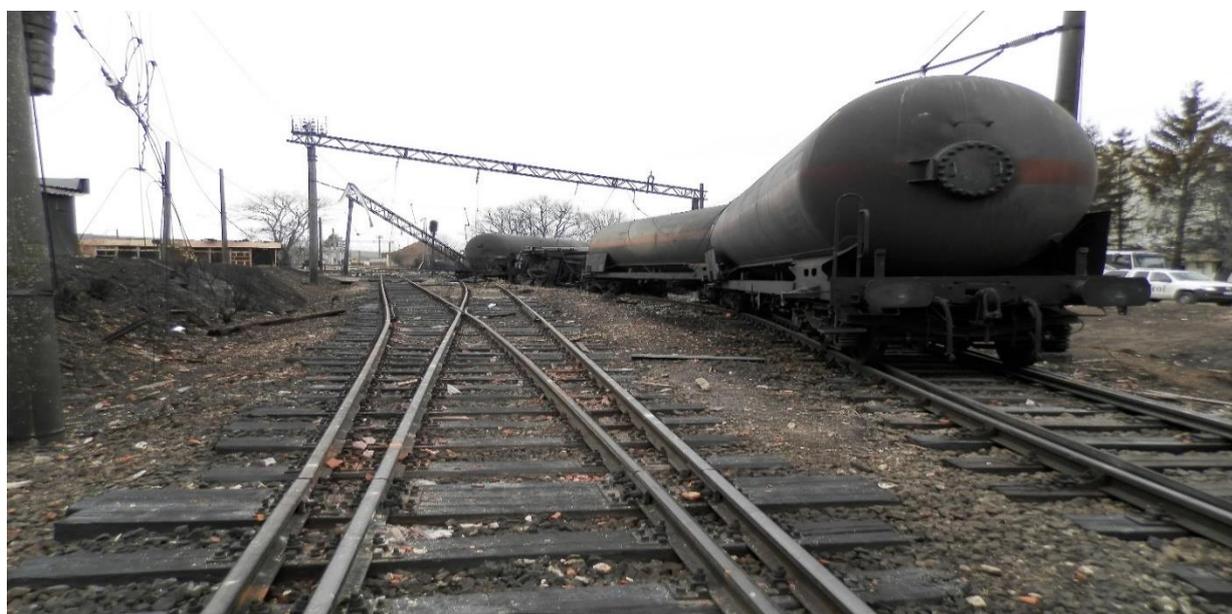
Figure 4

At the same time the post switchman at Post Nr.2 called by the station phone the traffic controller on duty to inform him that wagons from freight train Nr. 90570 had derailed in the throttle place of point Nr.5 and at the railway level crossing (Figure 4). During the call the post

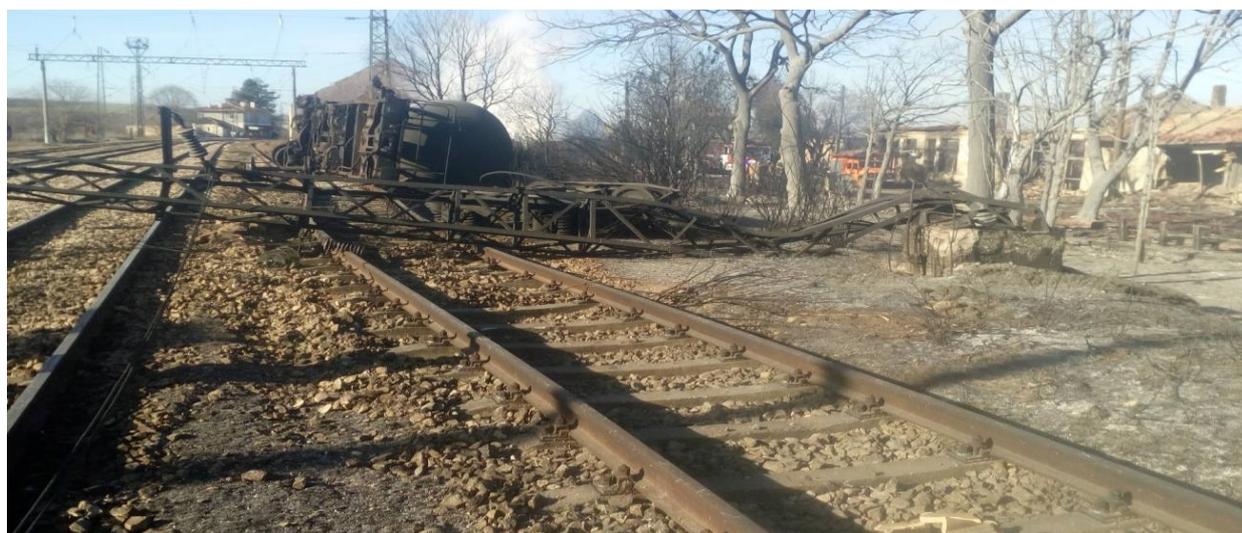
Figure 5

As a result from the derailing of the 6th wagon with one of its carts, the train was torn apart between its 6th and 7th wagons after the railway level crossing. The two locomotives, together with the 6 wagon-cisterns attached to them, continued their trafficking, as the 6th wagon moved with its first cart on the Third platform and the second cart moved on the Fourth platform. After 114 m the 6th wagon with its back side hit a pole of the catenary, broke apart from the 5th

wagon and laid aside on the Fourth platform (Figure 5). The other 5 wagons with the two locomotives continued their trafficking and stopped 340 m after the reception building of the

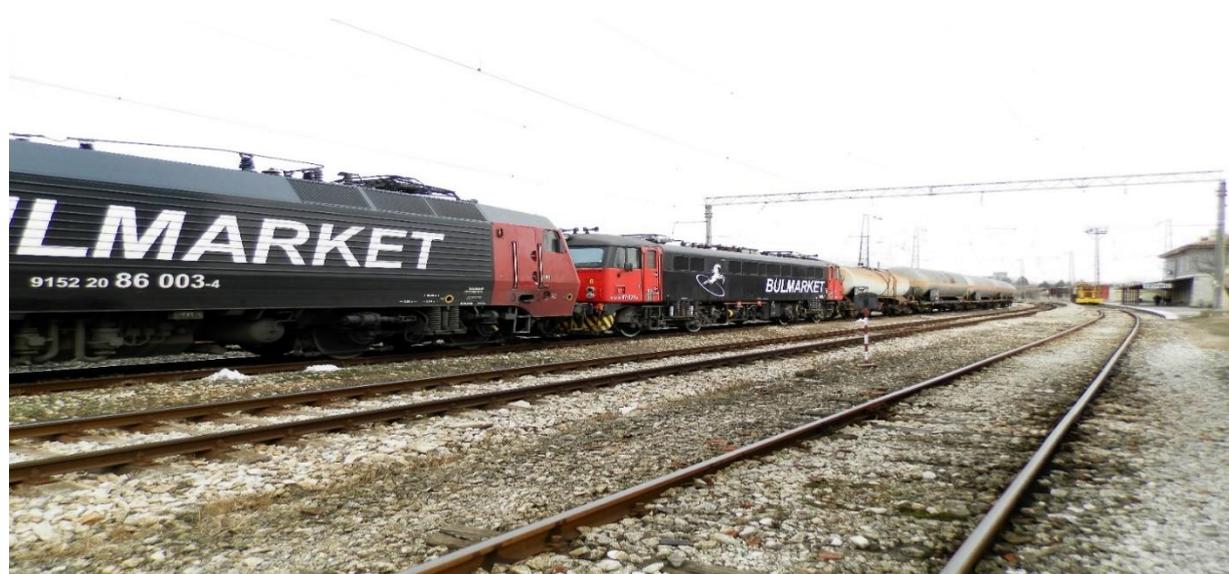
Figure 6

station (Figure 6).

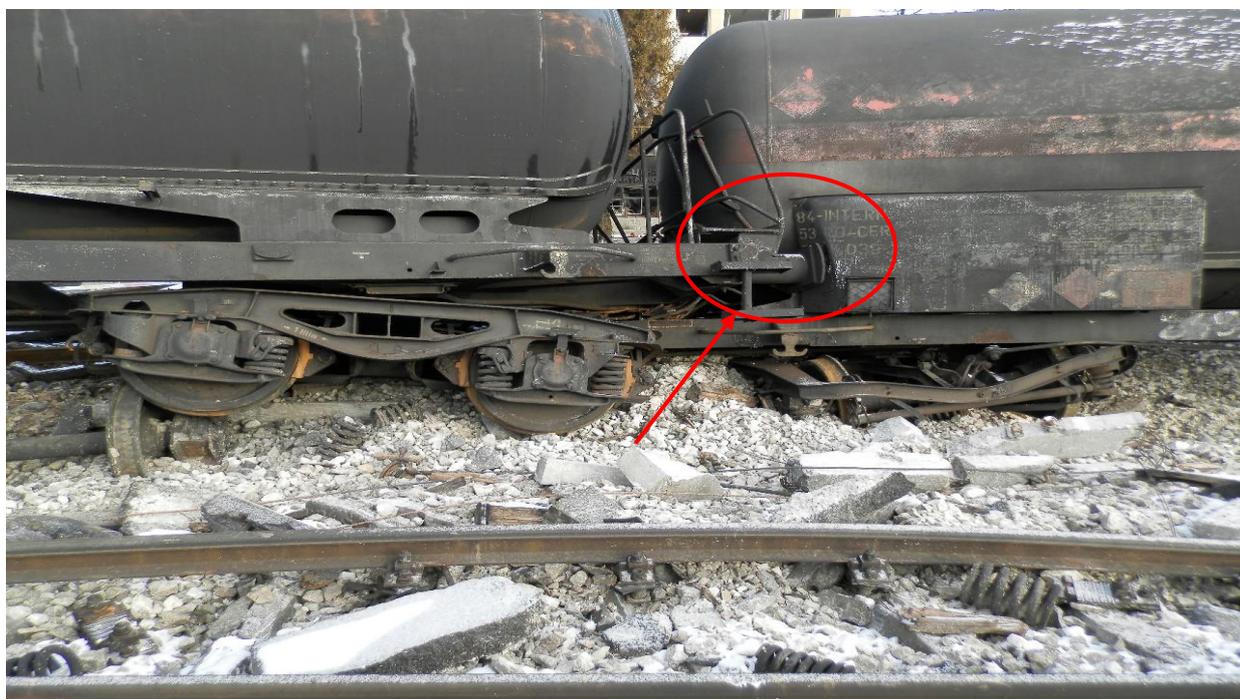
Figure 7

The next wagon-cisterns, from the 7th to the 17th one included, derailed and continued their movement uncontrolled, aside from the railway line. The pulling devices of some of the wagons got free from their catches, others got torn apart, which lead to the occurrence of crashes between the wagons, including in the area of the reservoirs (Figure 7). As a result from such

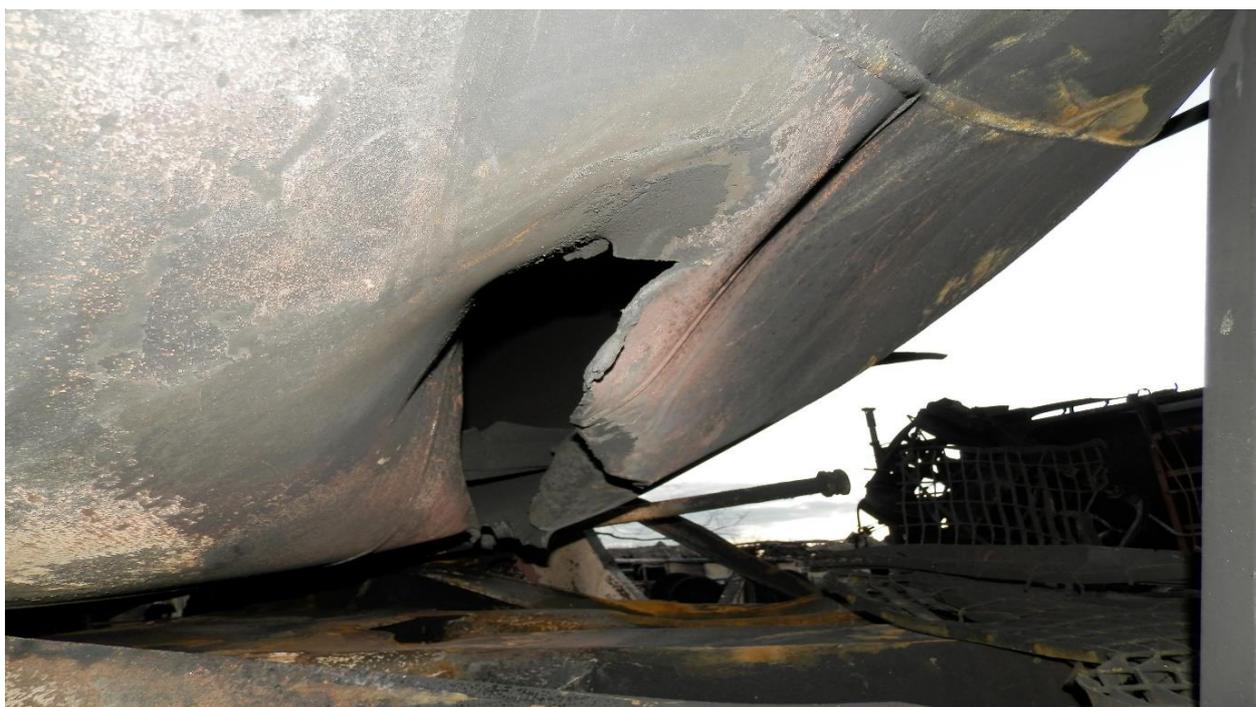
Figure 8

crashes and the uncontrolled movements, the frame of the 10th wagon-cistern got torn apart from the reservoir, bending on the left towards the frame of the 9th wagon-cistern, which climbed over it. Upon catching together of the two cisterns, the taller of the left buffer of the 9th wagon hit and cut the reservoir in its lower part of the 10th cistern Nr. 33 87 791 5652-4. As a result of the rupture, there commenced intense leaking of the freight (propylene), transported in a compressed state (Figure 8).

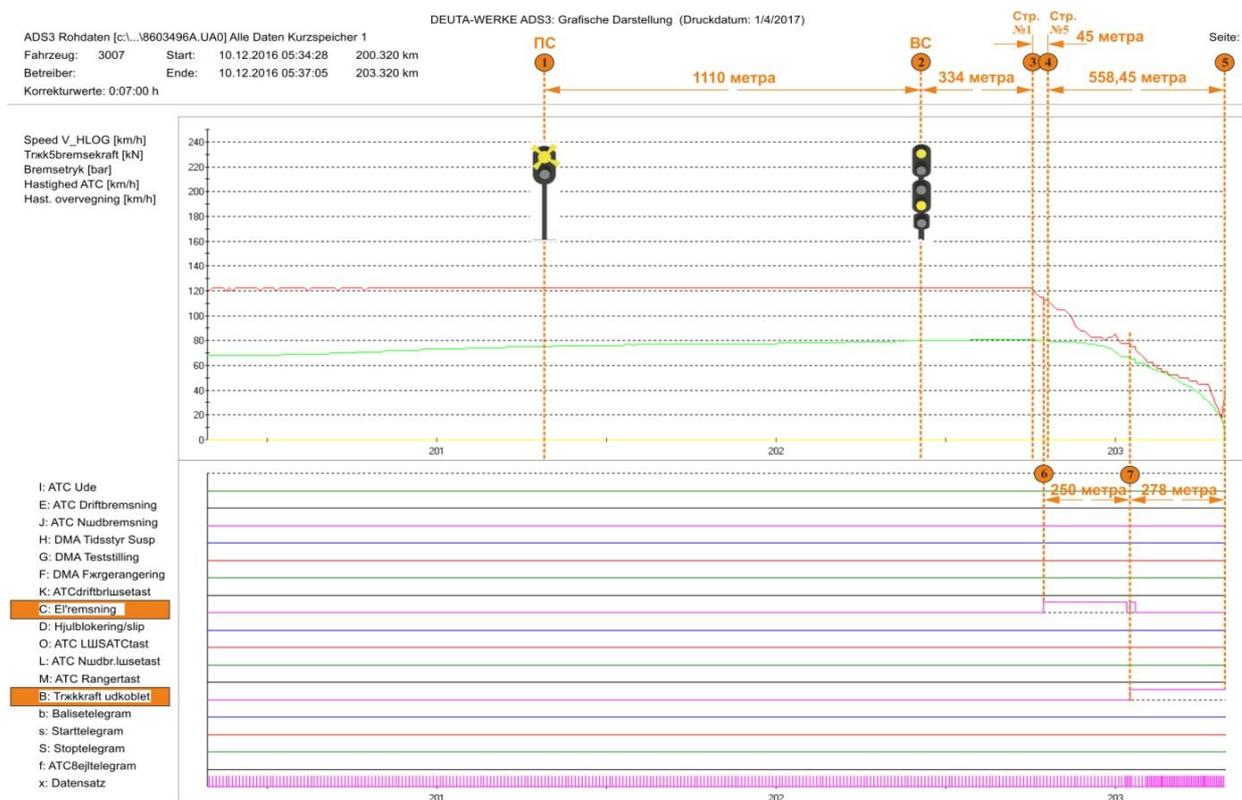
Figure 11

On Figure 11, on the image generated by the original software base markers are superimposed with numbering, designations and distances between them (in brown color). As exhibited by the diagram of speed as a function from the travelled road $V=V(S)$ (depicted in green color), till km 200,500 locomotive Nr. 86003.4 travelled with the permitted speed. After this moment the speed increased in an uncontrolled way and in violation of the trafficking

schedule it reached 81 km/h (marker ③ on Figure 11). At the warning traffic lights (marker ①) the train passed with the speed of 78 km/h, and at the entrance traffic lights (marker ②) – with 80 km/h.

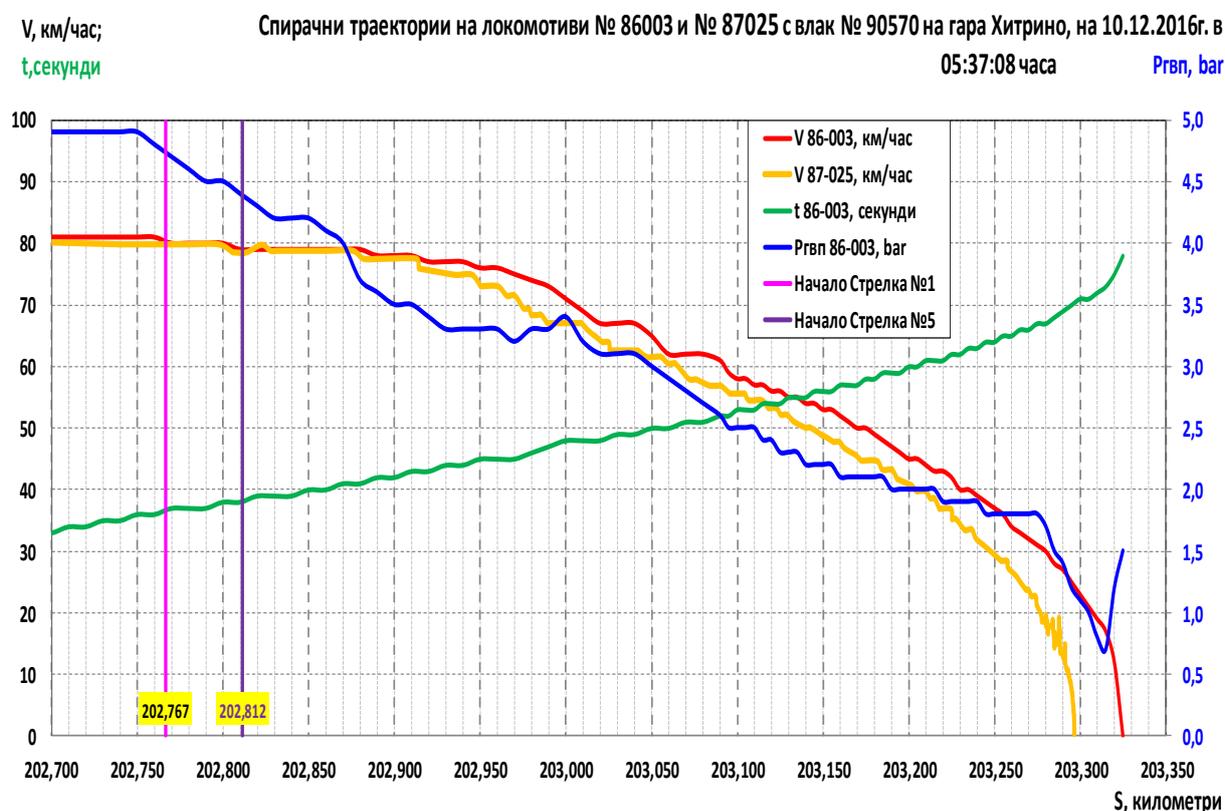
Figure 13

The coincidence of recorded data from the registering electronic systems of the two locomotives from km 202,700 to km 202,900 confirms the conclusion that train Nr. 90570 has passed through point Nr.1 with the speed of 81 km/h, and through point Nr.5 with the speed of 78 km/h.

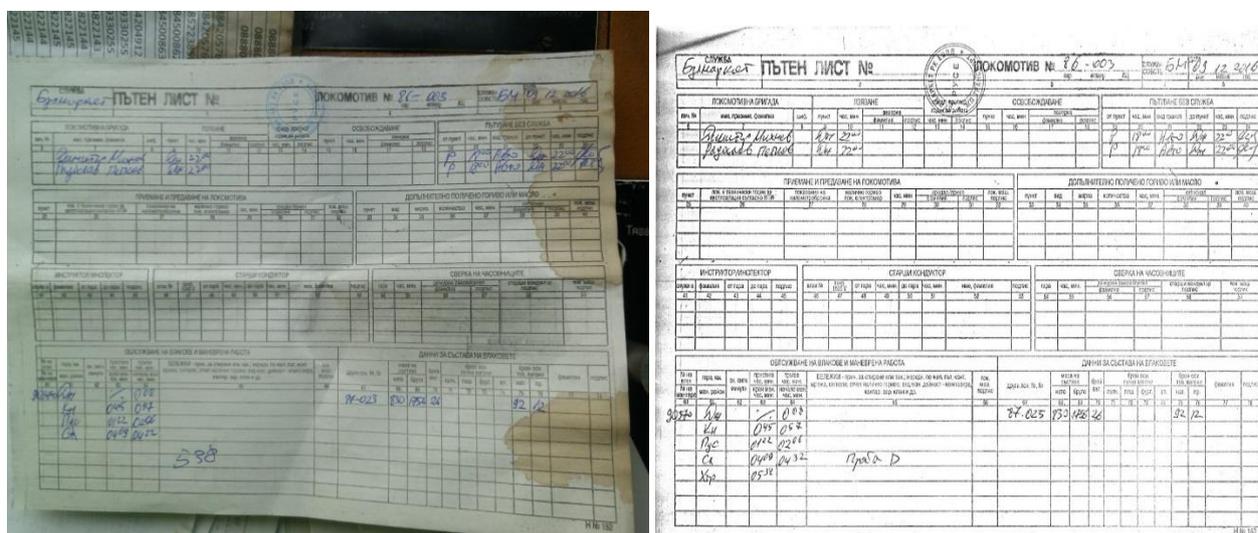
Фиг. 14

Upon their steeping in shift, the locomotive engine drivers who will service train Nr. 90570 appear in person at the office of the company carrier at Ruse-North station, where they are provided with a pass, an automobile for official use, which is driven by them in person to the station where the locomotive, which will be serviced by them, is parked. The pass, which the locomotive engine drivers receive upon their appearance at the office, has no number, verification or seal for capability of the staff members, affixed by the official issuing the pass, and this is a pre-condition for its replacement with another pass, which in reality was established in the process of investigation, namely: in the cabin of locomotive Nr. 86003.4 two passes were

found with different data filled in (Figure 14).

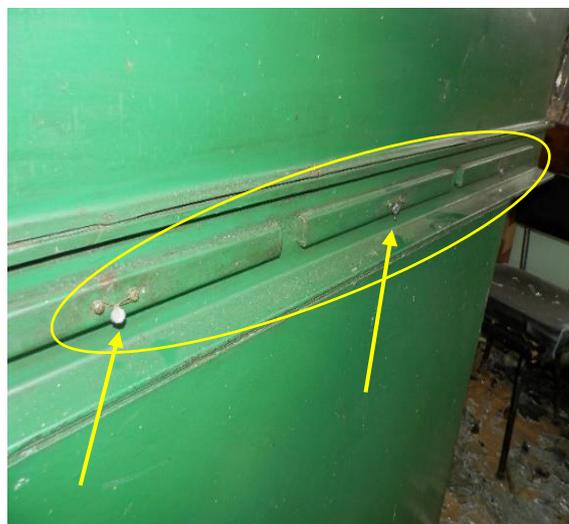
Figure 19

The seals of the Control unit and the Executive units were of a regular state (Figure 19).

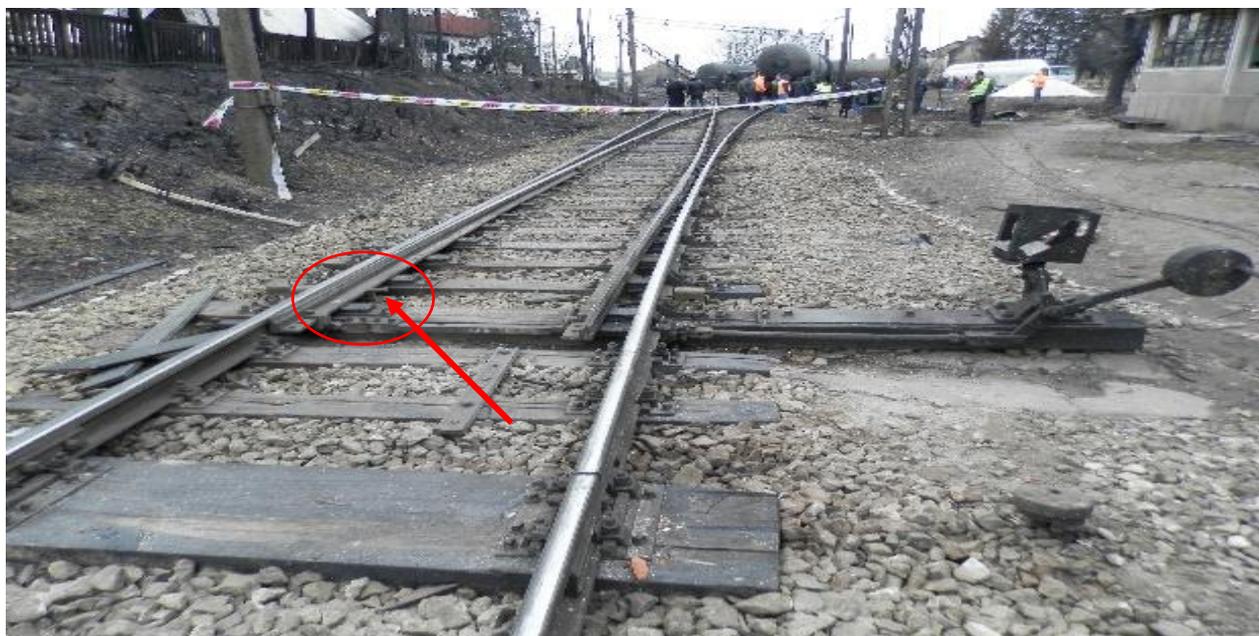
Figure 20

The manual point locks, “Kolben-Danek” type, have locked correctly the switch rails at point Nr. 1 in (+) position (on Figure 20) and point Nr. 5 in (+) position

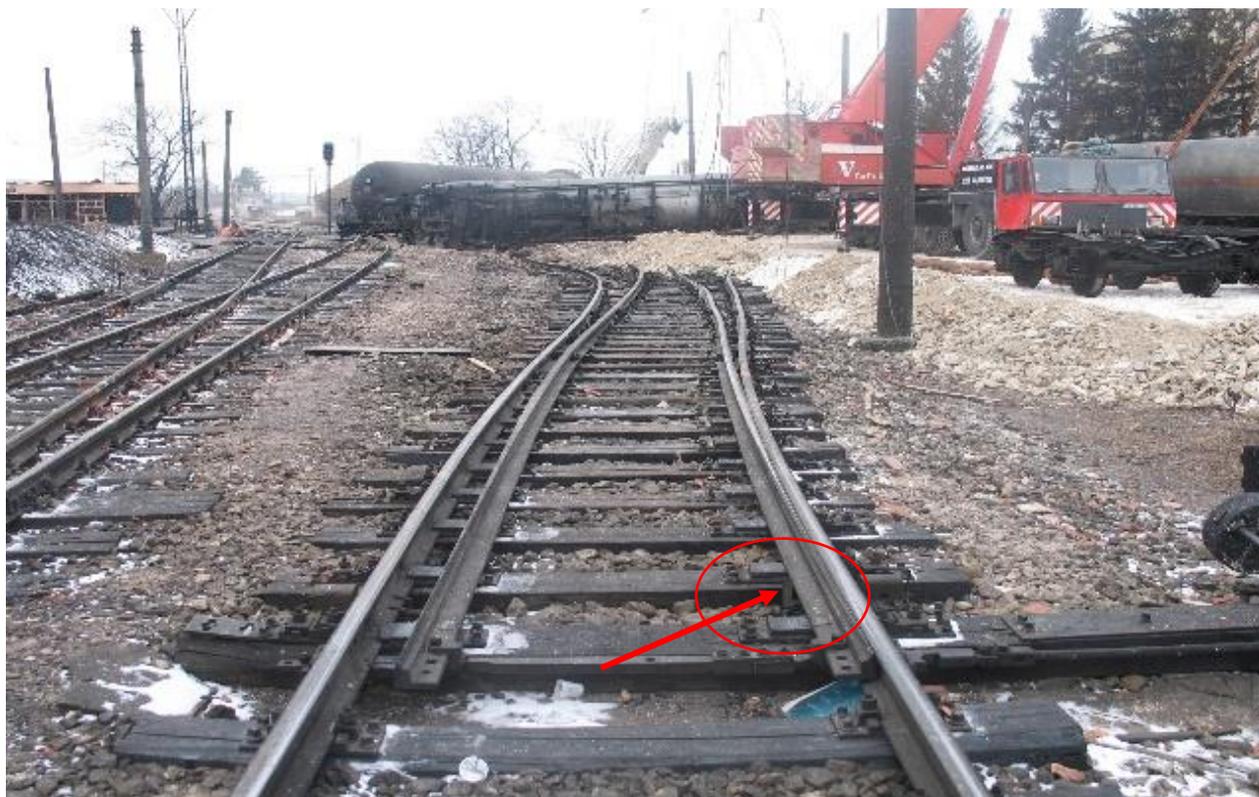
Figure. 21

(on Figure 21) for acceptance of the train on the Third platform. The keys from the manual point locks are placed in the sockets of the Executive unit at Post Nr. 2 for the prepared route, and the platform's lever is turned on correctly for entrance of the train on the Third platform.

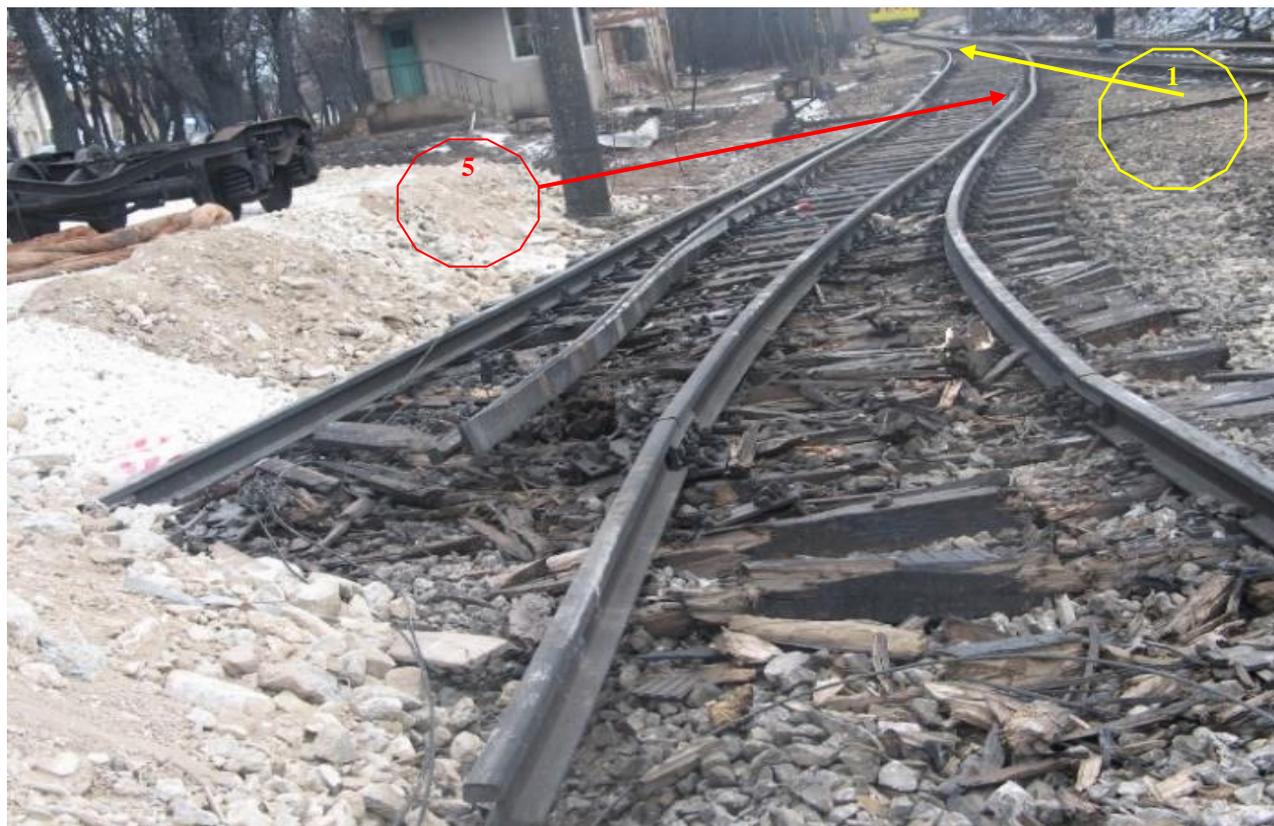
Figure 22

This was not the situation upon passing of the train through point Nr. 5 (Figure 22, the

point designated in red color). Because of the high speed of 78 km/h upon the entrance of the train in the point, the train changed its trajectory of movement depending on the position of the switch rails, and passed from right bent to left bend, as a result of which the horizontal crosswise forces had gained multiple increase. The locked right switch rail, densely affixed to the rail shoulder, and its strong fastening to the sleeper's grid, assisted the switch rail of the point to counteract at the forces generated from the wheels of the two locomotives and of the first five wagons.

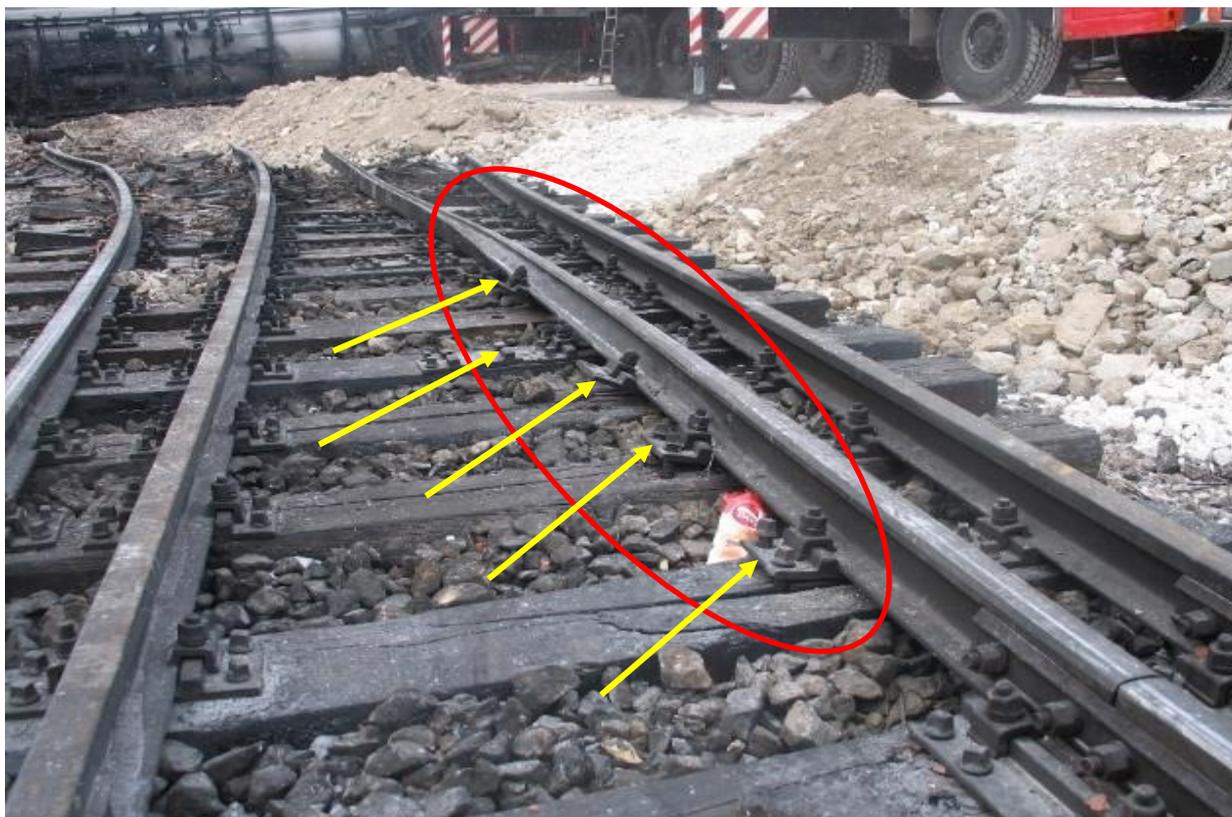
Figure 23

Because of the reliable locking of the right deviation switch rail to the rail shoulder and their joint counteraction against the big dynamic, vertical and horizontal forces, generated by the high speed, the two locomotives and the first five wagons were able to pass unobstructed through the point. This is not the situation with the intermediate right guide rail of point Nr. 5, there the largest shifting and changing of the design radius and the central line of the deviation platform occurred. On such causes, after the joint at the end of the switch rail there started pulling out of

the sleeper's screws, connecting the rib pads to the sleepers on the internal side of the rail. On the first sleeper after the double sleeper, the sleeper screws are pulled out with about 25 mm, and on the 2nd, 3rd and 5th sleepers (Figure 23) the sleeper screws are completely pulled out. On the 4th

sleeper, where there is a strengthened rib pad, the sleeper screws are not pulled out but the heel of the rail is pushed aside from the internal and external fastening sets. All this has contributed for twisting of the intermediate rail of point Nr. 5 along its longitudinal axis on the right. The crosshead of point Nr. 5 is totally destroyed. This occurred after passing of the two locomotives with the first five wagons and after the derailing of the second cart of the 6th wagon. Driven by the centrifugal force, the following eleven wagons jumped over the twisted intermediate rail on the right in the direction of trafficking and started derailing. Consequentially from the inert pressure generated from the remaining non-derailed part of the train, the 6th wagon was lifted and its buffers caught the buffers of the 6th wagon, in this moment the train got torn apart between the 6th and the 7th wagon. The 6th wagon, affixed to the 5th wagon, continued together with the first part of the train to move on the Third platform. The second derailed cart of the 6th wagon managed in the area of the right counter rail and the core of point Nr. 5 to climb on the railway line and continued its movement on the Fourth platform. With the train's first part moving on the Third platform, after 150 m the back side of the 6th wagon hit a pole of the catenary and pushed it down, the pole being located on the right on the Fourth platform. Upon meeting the resistance from the hit, the wagon disconnected its catch to the 5th wagon and after tearing apart the traction device, flew on the right over the Fourth platform and laid aside on the balloon (cylindrical part) of its reservoir. The two locomotives, together with the five wagons, continued to move and stopped a little after the reception building of the station. After the derailing of the 6th wagon and upon an already interrupted railway line, there followed the derailing of other eleven full wagon-cisterns, as the 17th wagon-cistern derailed only with its first cart at point Nr. 5. The second non-derailed cart of the wagon-cistern stopped in the switch rail part of the point. After the 17th wagon, there stopped the remaining non-derailed nine wagon-cisterns from the train's composition.

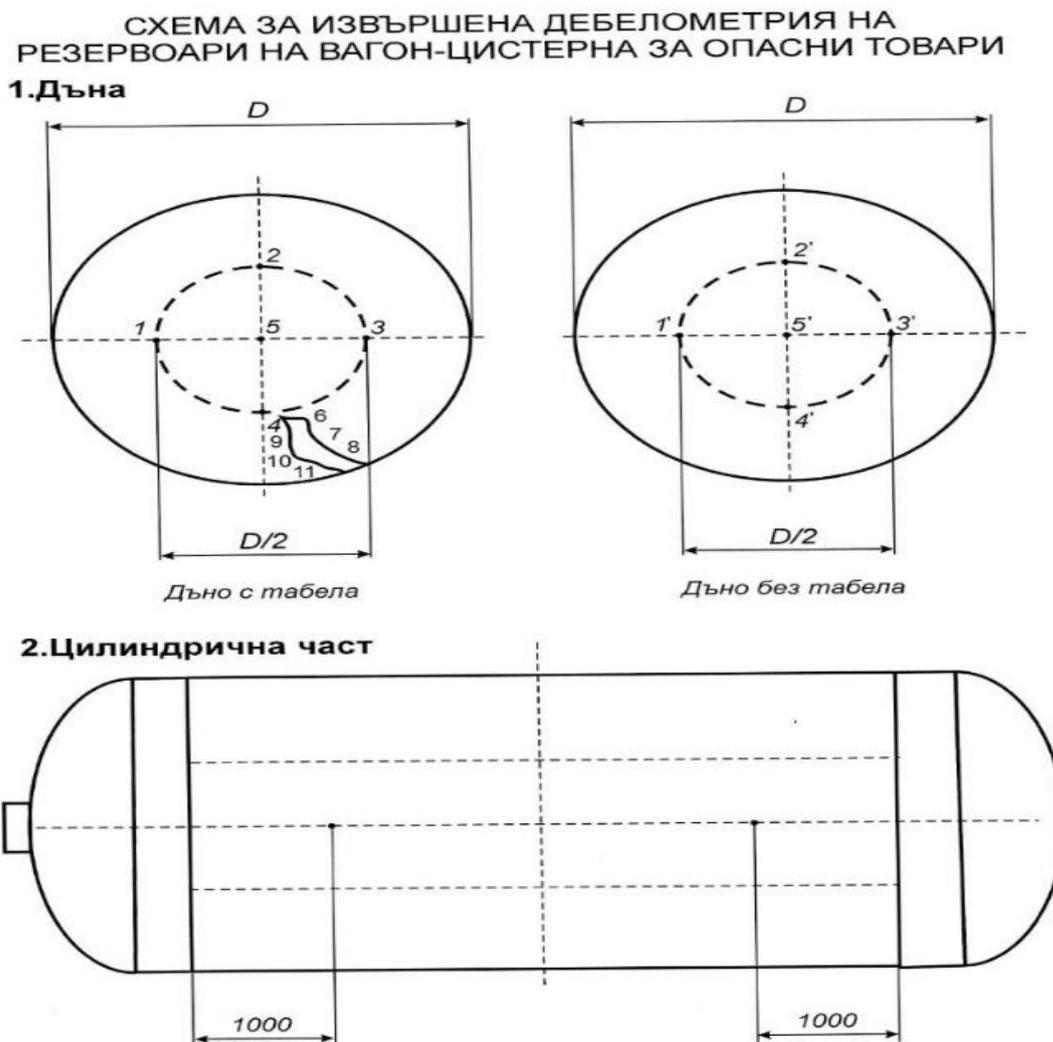
Figure 24

14.7. Measuring the thickness of reservoir Nr. 4418, volume 112440 l, mounted on wagon-cistern Nr. 33 87 791 5652-4 (Figure 24).

- measured values of the bottom thickness with a board – measurements are carried out at eleven points in total, from which the lowest measured value is at p. 8 of 7,8 mm, and the highest measured value is at p. 4 of 9,2 mm;

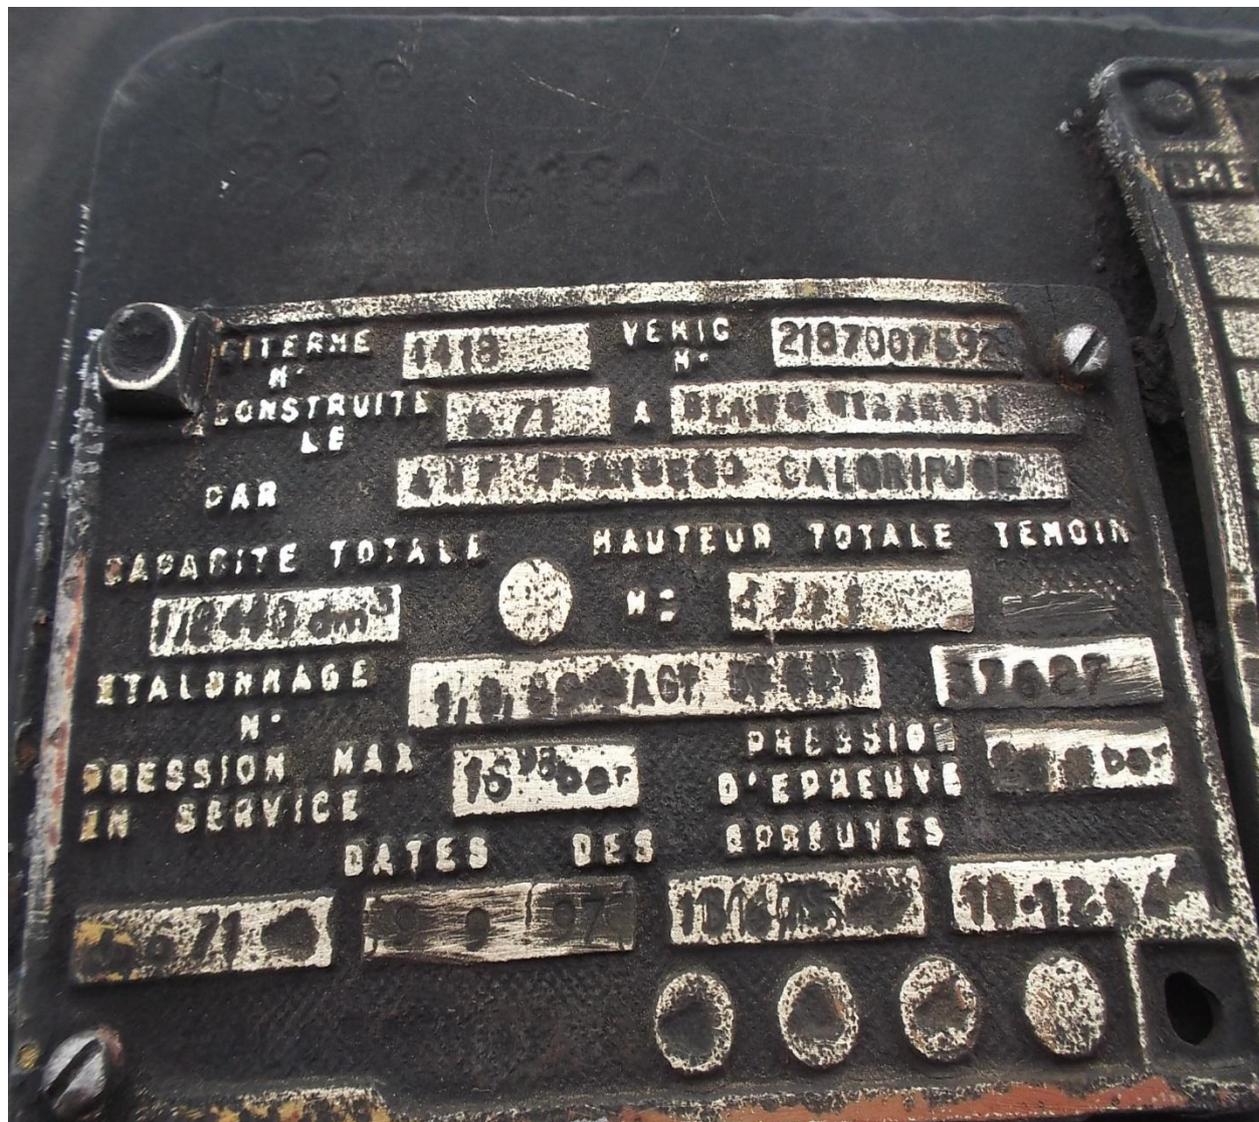
Figure 25

The performance of this test must be reflected not only in the certificate, but on the information plate at the bottom of the reservoir, which anyway was not done (Figure 25).

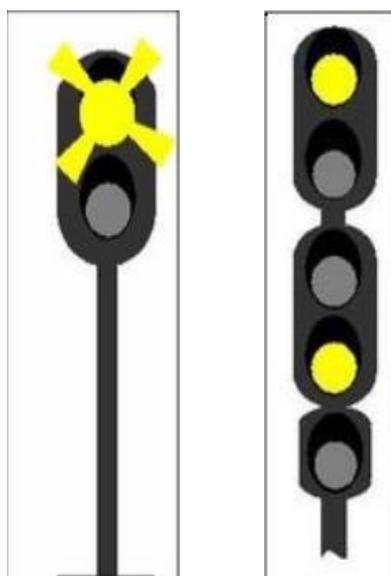
Figure 26

Upon the entrance of the train at Hitrino station, not fulfilled are the permission indications of the warning and the entrance traffic lights, limiting the speed of trafficking up to 40 km/h in accordance with Art. 317, item 3 and Art. 324, par. 2 and par. 3, item 5 of Ordinance Nr. 58 (Figure 26).

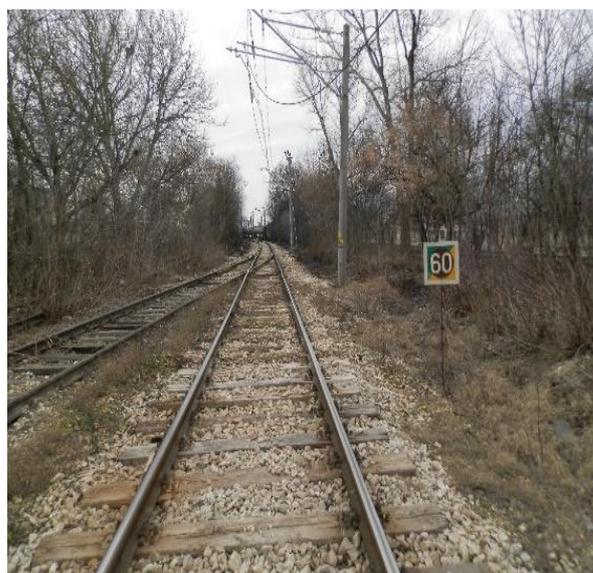
Figure 27

Not fulfilled is also the signal for limiting of the speed up to 60 km/h through the entrance points for entering on the Main platform, necessitated by the type of locking of the points at Hitrino station in accordance with Art. 384, par. 1 and par. 2 of Ordinance Nr. 58
