**Aircraft, Maritime and Railway Accident Investigation Directorate
Maritime Accident Investigation Unit**

FINAL REPORT

**Investigation of very serious marine casualty –
DEATH OF A CREW MEMBER OF M/V “INDRA II” IN THE
TERRITORIAL SEA OF THE REPUBLIC OF BULGARIA ON
09.11.2015**

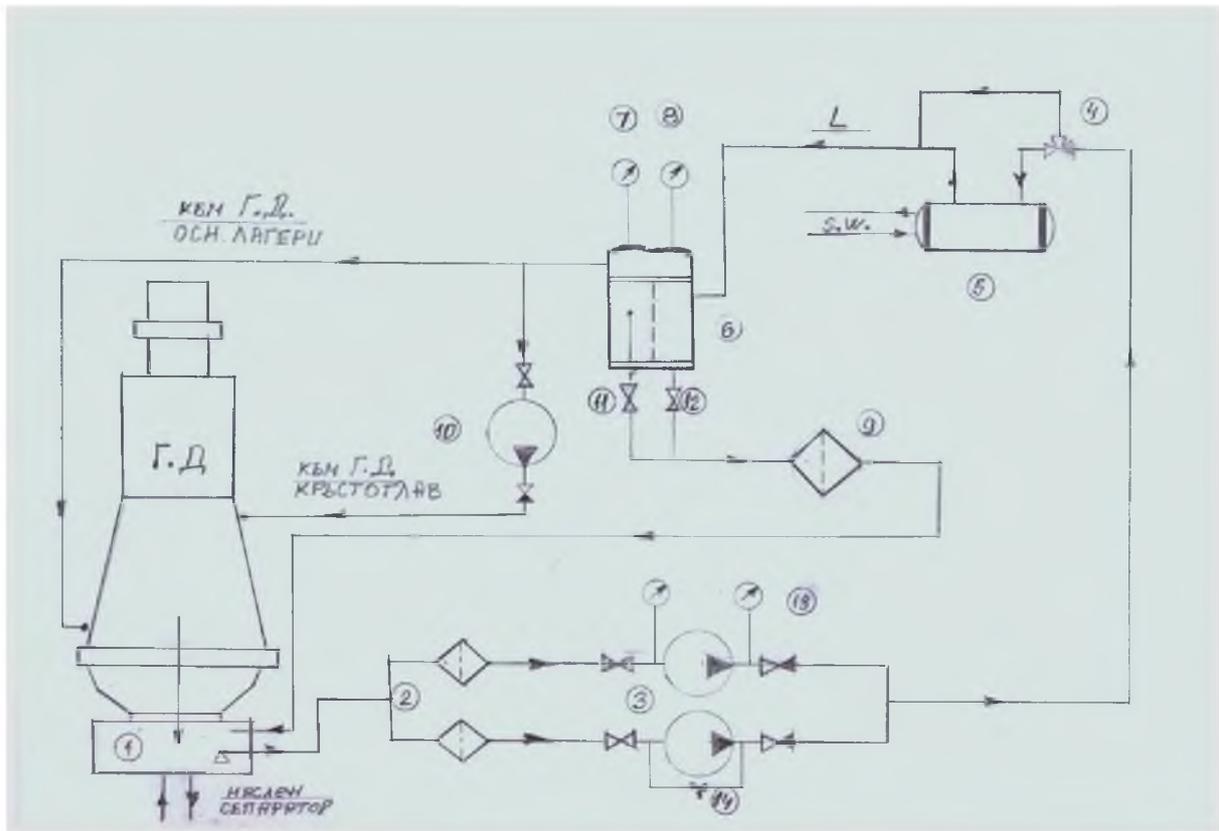
Fig. 2. Scheme of a part of the luboil system (main engine).

This is a prerequisite for easy clogging of the oil filters and lowering the oil pressure in the oil system, which causes the main engine emergency signaling.

They switched off the luboil pump, removed the suction filters **2** and cleaned them(**Fig.2**). Then switched on the pump again, but the oil pressure at the outlet of the MAX filter remained 0 kg/cm² according to gauge readings **7** (**Fig. 2**), whereas the arrow indicator **8** (**Fig. 2**) was in the red section indicating that the problem was in the main luboil filter.

the red zone, indicating that there was residual pressure in the oil system, between the non-return valve of the pump and the filter elements, there was a residual pressure (in the subsequent cleaning of the system after the accident it was found that the drain valve *12* was completely clogged). This fact had not been taken into account by the engine room members and they proceeded to open the left section of the main oil filter, without waiting for the draining of the oil and the pressure drop in the system. The third engineer and the motorman, working on the cover dismantling, were warned by the chief engineer to watch out for a new oil spill.

filter box had not been deaerated by the intended air vent valve. But the residual air, remaining in the right section, was gradually captivated and retained in the left section of the paired oil filter and the inlet of the oil pipeline L (**Fig. 2**) where, by forming an air cushion, it was compressed to the working pressure of the oil system, about 4 kg/cm². In an attempt to open the left section, the crew did not wait for a full drainage of the oil and pressure drop, which was further hampered by the drain valve plugging and the completely clogged left filter element. Namely this increased pressure of the present air in the filter body tried to push the filter element upwards with the cover, if it was released by the retaining nuts.

- The case was discussed at the Onboard Safety Committee Meeting.
- Notes on the oil system were rectified. The oil from sump tank **1 (Fig. 2)** was transferred to another tank, after which the tank was opened and cleaned by the crew. The oil cooler **5 (Fig. 2)** was cleaned using a reagent chemical. The oil separator was repaired. Mechanical cleaning of MAX-filter **6 (Fig. 2)** was performed and the drainage valve **12** was unclogged (**Fig. 2**).

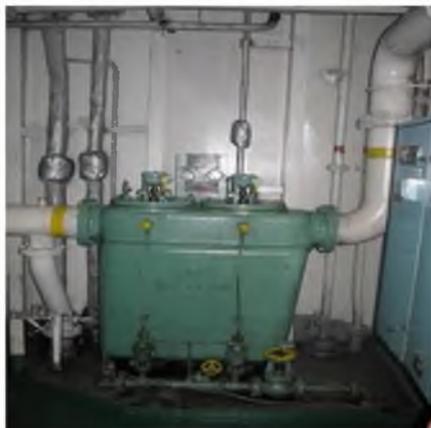
Fig. 3 Main luboil filter

The main oil filter (MAX-FILTER) (Fig.3) is a two-sectioned one, made by Niikura Kogyo Co Ltd, model MF-LSM. Represents a cast iron metal box with dimensions: height of 1.20 m, a width of 1.0 m and a depth of 0.50 m. It contains two separated

sections with a height of 1.0 m and cylindrical openings in the upper part with a diameter of 0.35 m, in which the cylindrical filter elements are mounted. It is possible to clean the filter elements without their extraction, using the "backwashing" system, with rotating the cylindrical filter elements manually by means of devices mounted on both filter covers (Fig.4) and opening the drain valve 12 (Fig.2) for drainage of removed impurity. It is this device, when disposing the cover upwards, had become the cause of the severe injuries to the third engineer. The oil enters the MAX-filter from the oil cooler 5 (Fig. 2) through a 4-meter

An additional contributing cause of the accident was related to the design of the main oil filter. The filter was mounted under a pipeline system and its relatively big height calls into question the rapid and safe opening and removal of the filter elements for cleaning purposes. There was no other way to quickly lift and remove the items except by hand and by stepping on the filter housing.

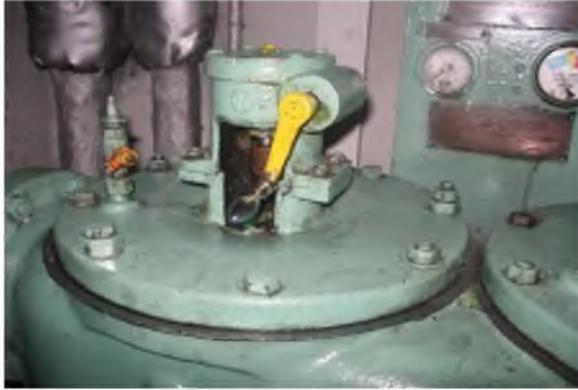
Fig. 4.
Filter left section cover with the manual cleaning system.

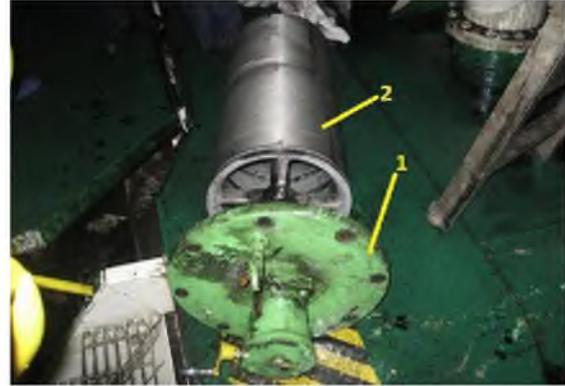
Fig. 5.
Dismantled filter cover (1) and a filter element (2).

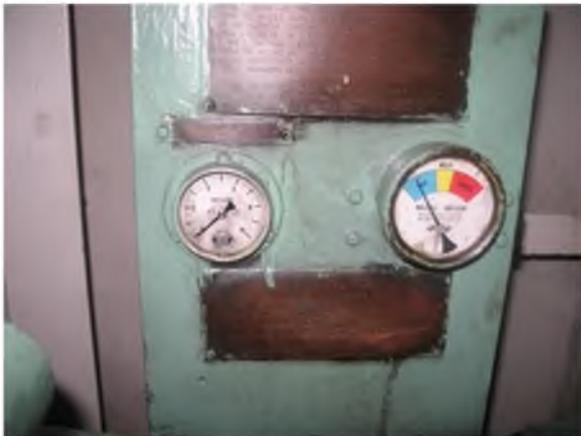
Fig. 6. Max filter gauges

The oil pressure before and after the filter is monitored by two pressure gauges (**Fig. 6**) mounted on the top part of the filter. The left pressure gauge reads the oil pressure after the filter.

The right manometer/differential type/ indicates the degree of contamination of the filter elements, taking into account the oil pressure difference before and after the filter. The manometer scale is divided into three sectors - blue, yellow and red. The arrows in the blue (safe) are an indication of the normal operation of the filter, in the yellow (wash) - cleaning is required, and in the red (danger)- warning of a complete blockage.

The main cause of the very serious casualty was the failure to comply with the safety measures when handling equipment working under pressure, due to nervousness and the desire to solve the breakdown more quickly. No attention had been paid to the differential oil pressure gauge indications of the MAX filter. No account had been taken to the chief engineer's warning that workers should move away from the filter. The elementary safety precautions for the removal of the filter cover were not met - preliminarily partial unscrewing of the nuts holding the cover.

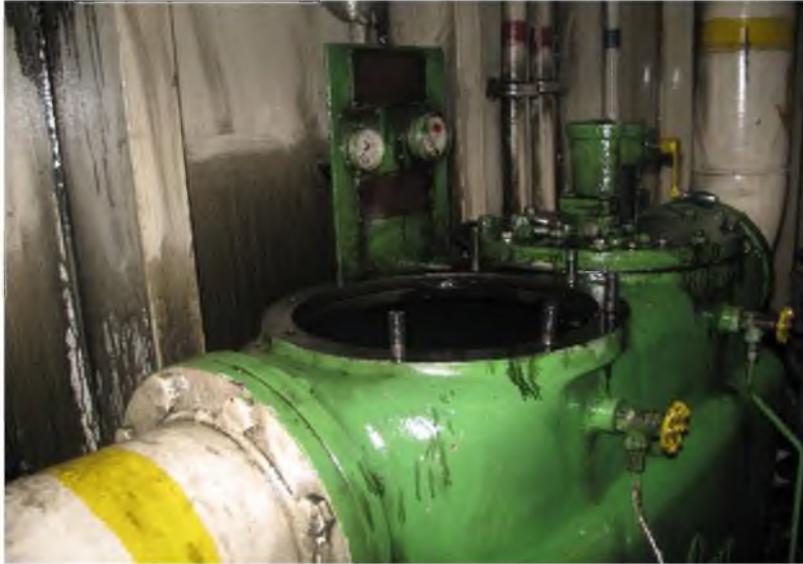
The eight nuts securing the cover of the section were unscrewed and put apart, but the cover was not detached from the housing - due to the sticking of its gasket and the fact, that part of the studs were distorted (**Fig. 8**). This made it difficult for the cover to move freely and even with the nuts unscrewed, it was likely that it to be held in place by the studs. The several attempts to remove the cover were unsuccessful.

Fig. 8. Throat of the left section with curved studs.

The retaining of the cover to the filter body was due to the sticking of the gasket and the curvature of a part of the studs.

- deformed studs holding the MAX-filter left section cover.

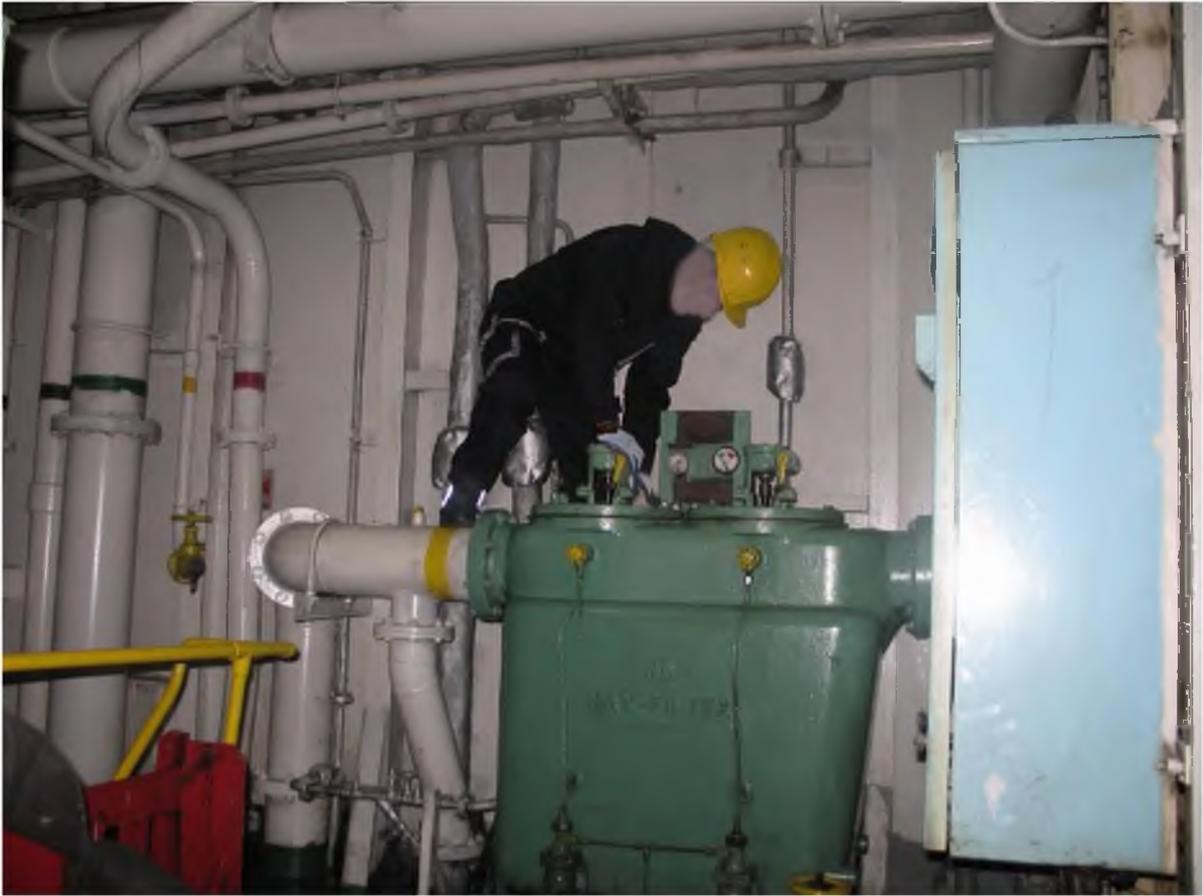
At 2305, the third engineer, without being specifically instructed, stepped on the filter housing and leaned over the cover of the section tried to release it by a hammer. Suddenly, the cover, together with the filter element, was thrown upward, hitting the third engineer in the chest area and pressing him against the engine compartment ceiling piping. From the open section of the filter, oil was spilled in all directions under pressure, sousing in the room and the people working in it.

Fig. 9 Position of 3rd engineer during filter opening/restoration/.

above, did not solve the problem and removing the left filter element of the main oil filter, as the last possible barrier to the free circulation of the oil, was undertaken. After cleaning, the oil system should work normally. According to the crew, in any of the previous filter extractions and cleanings, given the longer period for these operations, no residual pressure in the oil system or spillage of oil had been observed. This, in all likelihood, had blunted the attention to the safe working of the engine room personnel, and combined with the nervousness generated by the emergency situation and the desire to quickly restart the main engine, the third engineer was deprived of self-preservation in his pursuit to successfully complete the solving of the problem. No attention was paid to the differential pressure gauge, the arrow of which had stood in the red sector, a sign that there was a high residual pressure in the filter. The good maritime practice implies that covers of the vessels under pressure are released completely after a minimum unscrewing of the threaded connections to check for residual pressure. Instead of this, all eight nuts holding the cover of the left filter section were unscrewed and removed. The fact that the cover remained in place once again misled the staff to a lack of pressure in the oil system. The third engineer's decision to climb the filter casing and to bend over it for to make it easier to open and remove the filter element was fatal.

6.2. The ship-owner and manager of *m/v "INDRA II"*, BULCOM LTD to organize additional briefings on compliance with crews' personal safety regulations in accordance with the instructions for a proper and safe operation of all ship's machines and mechanisms and systems. To focus attention to informal implementation of occupational safety briefings prior to commencing a work or a repair, especially when dealing in extreme situations.
