Maritime Accident Investigation Unit

FINAL REPORT

Investigation of serious marine casualty – a collision of motor vessel „Lady Gul” with motor vessel „St. Catrien”, occurred on 07.03.2013 in Black Sea, in the territorial waters of Republic of Bulgaria

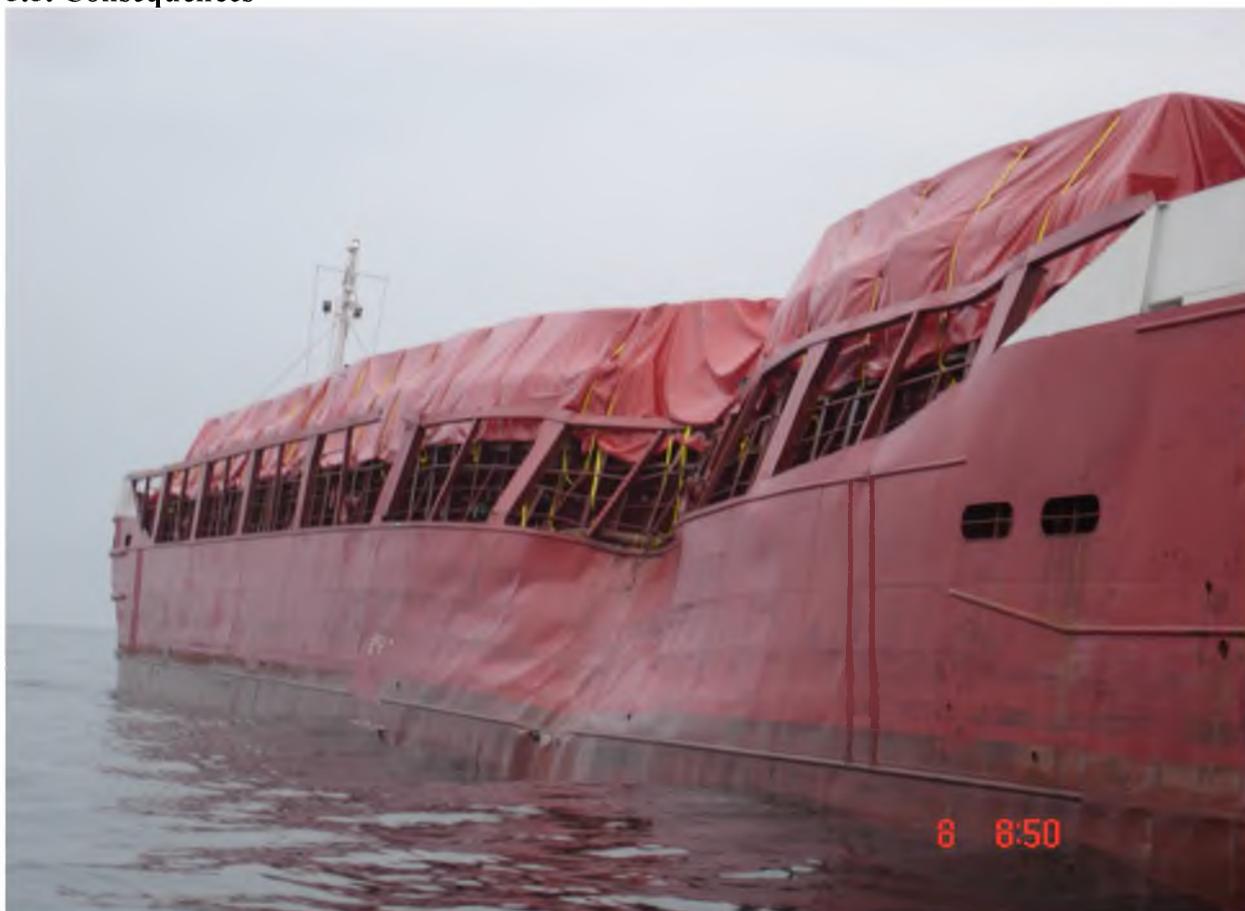
M/v „St. Catrien” after the collision on 07.03.2013. Anchorage berth No. 1 –Varna.

The *m/v "St. Catrien"* sustained severe structural damage. The hull was heavily bent inwards for about 19 m from the 82nd to the 30th stiffener at a height of about 3 - 3.5 meters. The main deck port was severely bent from 75th to 30th stiffener. The main deck starboard was heavily bent from 71st to 31st stiffener. The hatch cover was damaged, disturbed and unsealed. The longitudinal vertical sheets of the cargo room were deformed and cracked, etc. The vessel gets about 3° heel to the right. The vessel was detained for state inspection on port by the "Maritime Administration" - Varna until the restoration of seaworthiness.

After unloading the cargo of baled straw in Port Varna on 21.03.2013 the vessel was taken in tow by the tug "*Multratug 25*" to Bourgas for repair in Bourgas Shipyards PLC where she arrived on 22.03.2013.

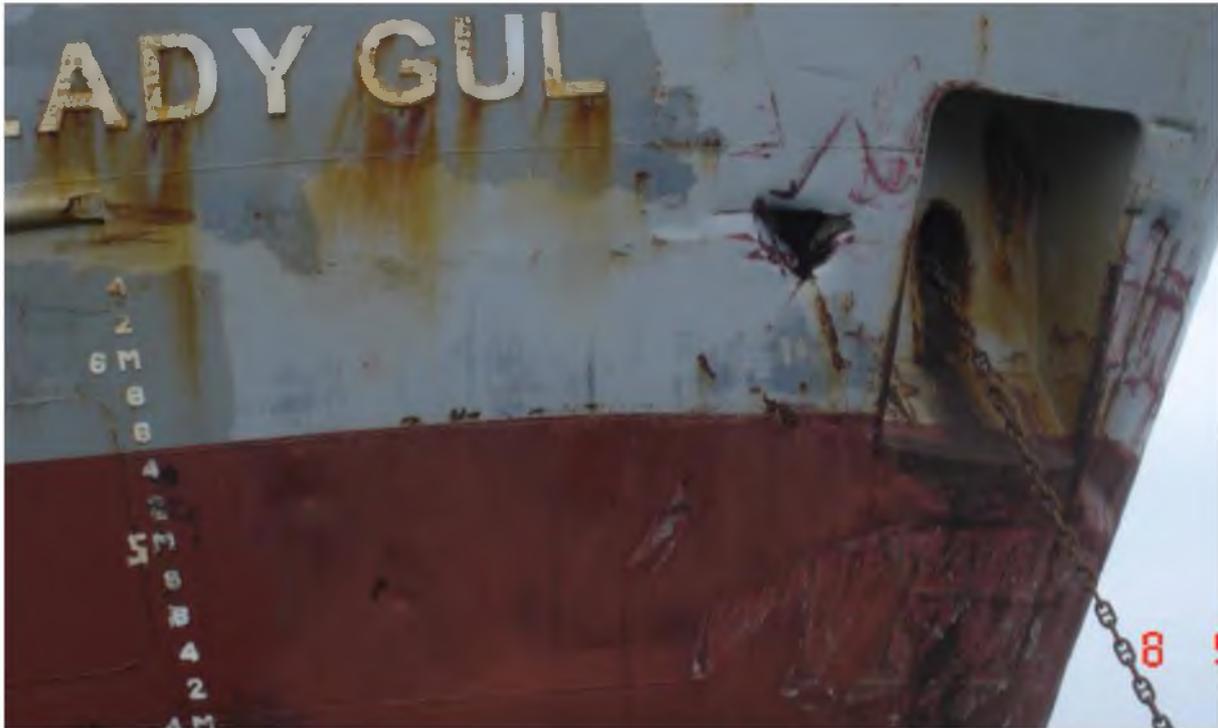
The *m/v "Lady Gul"* got a triangular hole on the right side of the bow at the height of the hawse pipes (possibly by the broken safety life line of the *m/v "St. Catrien"* as a result of the collision). The vessel was detained after the state inspection on port by the "Maritime Administration"–Varna until the restoration of seaworthiness and the audit by the flag administration of the safe management of the vessel before its departure with regard to violation of the International Safety Management Code (ISM Code). The vessel was berthed on a pier for repair in the Lake Varna and after restoring the integrity of the hull she sailed from Varna on 12.03.2013. The time out of service of the vessel was five days.

M/v "Lady Gul" – the hole after the collision on 07.03.2013 berth No. 1 - Varna.

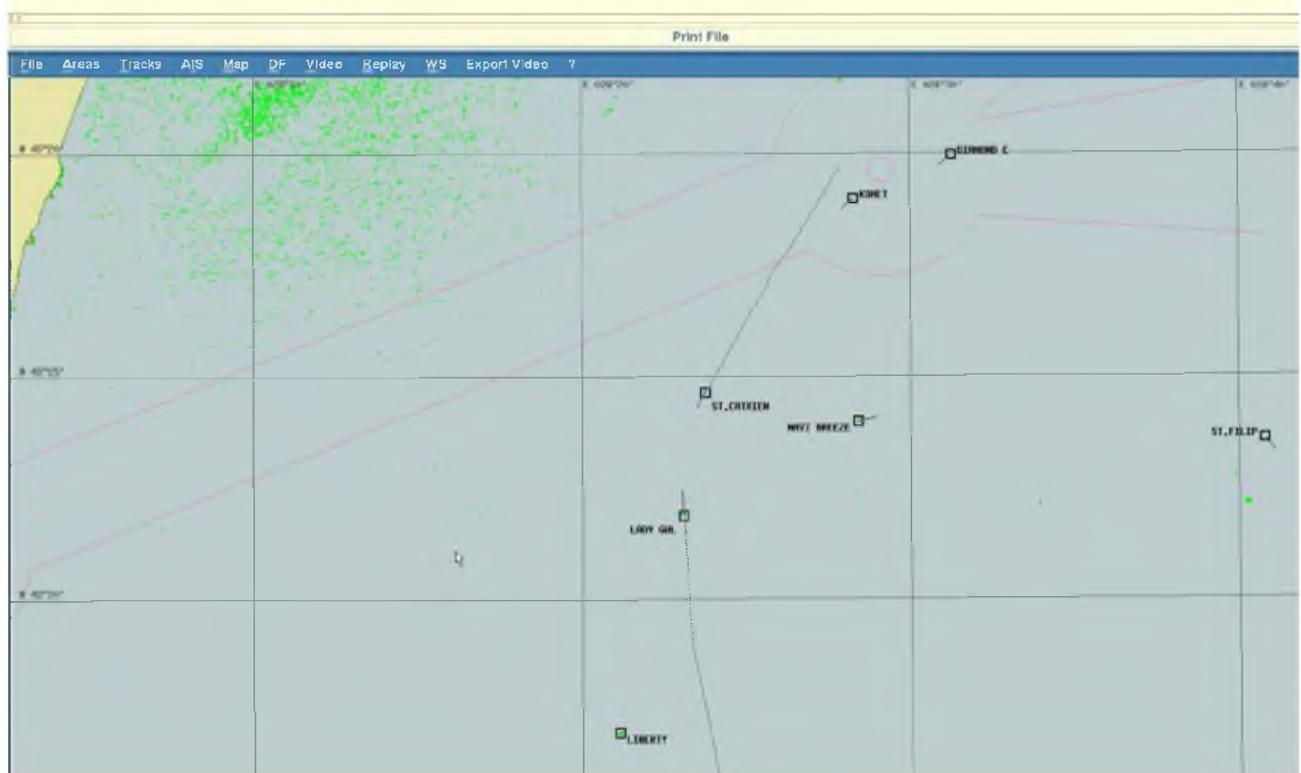
This means that within the past 12 minutes only the distance decreased from 64 to 28 cables. No change was observed in the bearings of each of the two vessels. *M/v "Lady Gul"* and *m/v "St. Catrien"* went surely on collision! This was a psychological moment.

17:12:07 on 07.03.2013 m/v,,Lady Gul" - bearing to m/v,,St. Catrien" = 010°; D = 28 cables.
m/v,,St. Catrien" - bearing to m/v,,Lady Gul" = 190°; D = 28 cables.

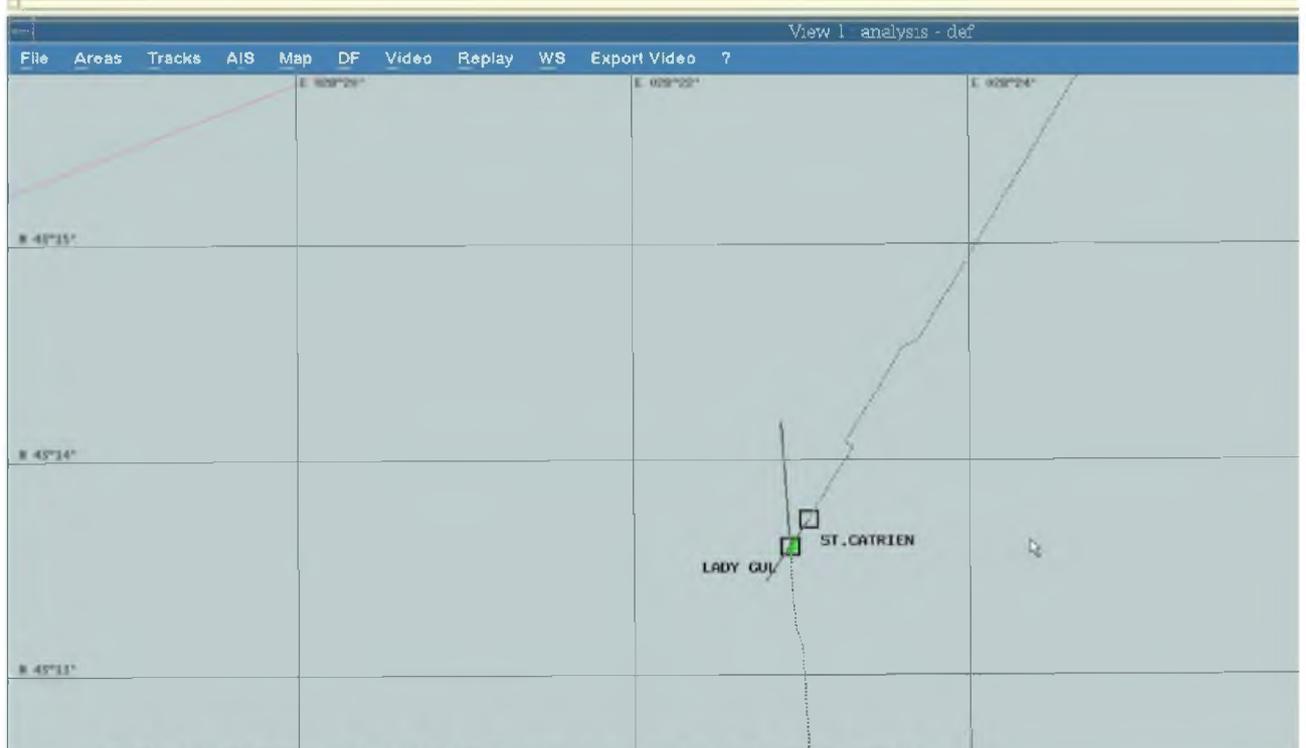
17:20:56 on 07.03.2013 *m/v „Lady Gul”* - bearing to *m/v „St. Cathrien”* = 33°; D = 210 m.
m/v „St. Cathrien” - bearing to *m/v „Lady Gul”* = 213°; D = 210 m.

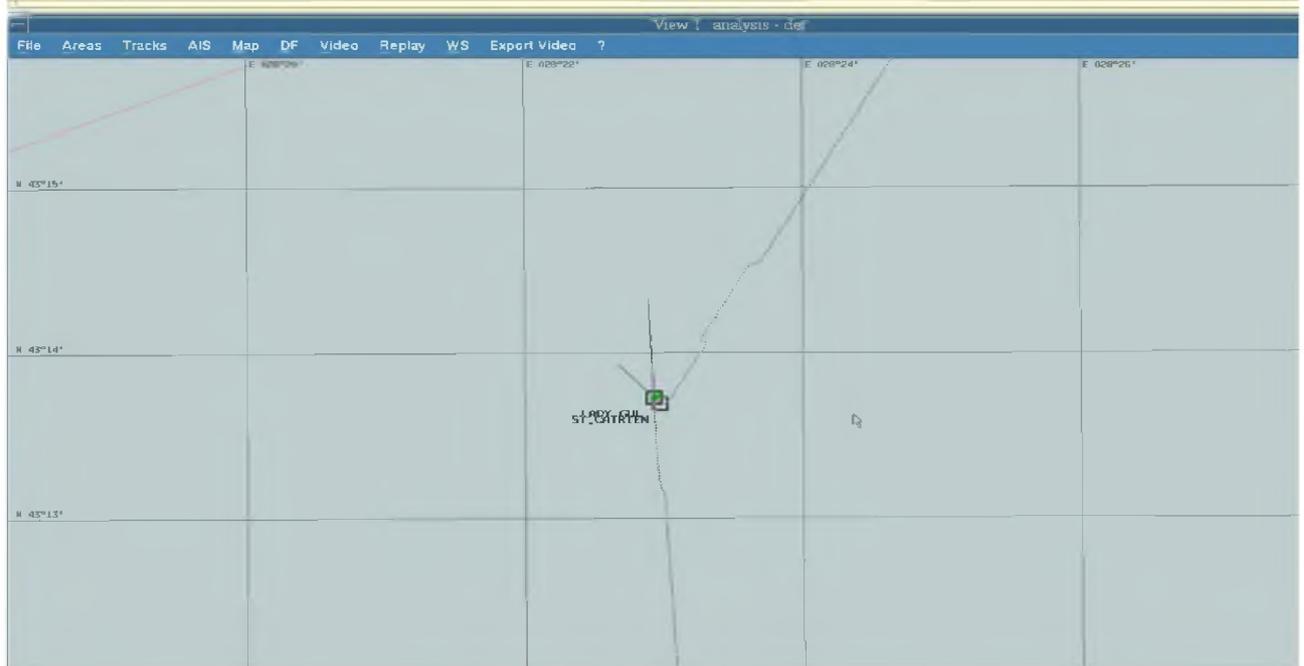
17:21:31 on 07.03.2013: m/v „Lady Gul” and m/v „St. Catrien”. The first moment of the collision. The angle between centre lines of both vessel is about 40°. „Lady Gul” COG is 358° and „St. Catrien” COG is 316°. VTMS – Varna

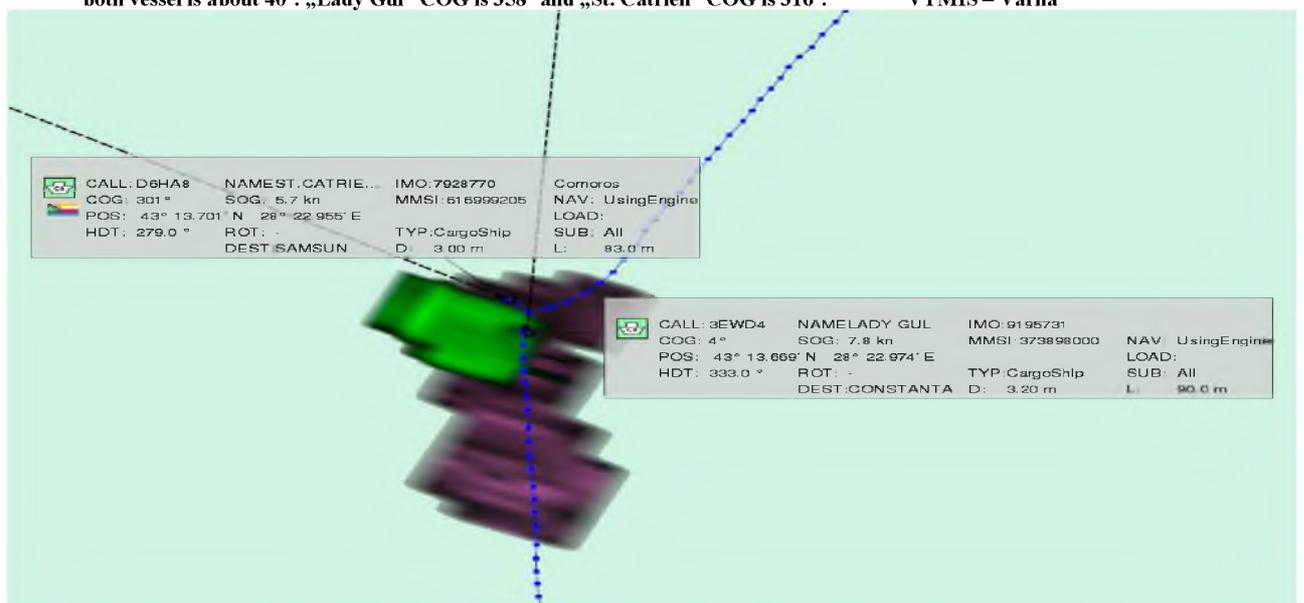
17:21:41 on 07.03.2013. A moment of the collision. M/v „Lady Gul” COG=004°, V=7,8 kt M/v „St. Catrien” COG=301°, V=5,7 kt
 Radar image. CD Border Police

M/v"*Lady Gul*" struck *m/v*"*St. Catrien*" and the speed was killed at 7,8 kt at 17:21:41, 10 seconds after the initial contact. The bow starboard of "*Lady Gul*" slid forward on the port side of "*St. Catrien*" which got a hole behind the right hawse pipe by the broken reinforced safety life line of "*St. Catrien*", then the speed of "*Lady Gul*" was finally killed to 1-2 knots. The vessel lagged and passed astern of the "*St. Catrien*" around 17:23:30.

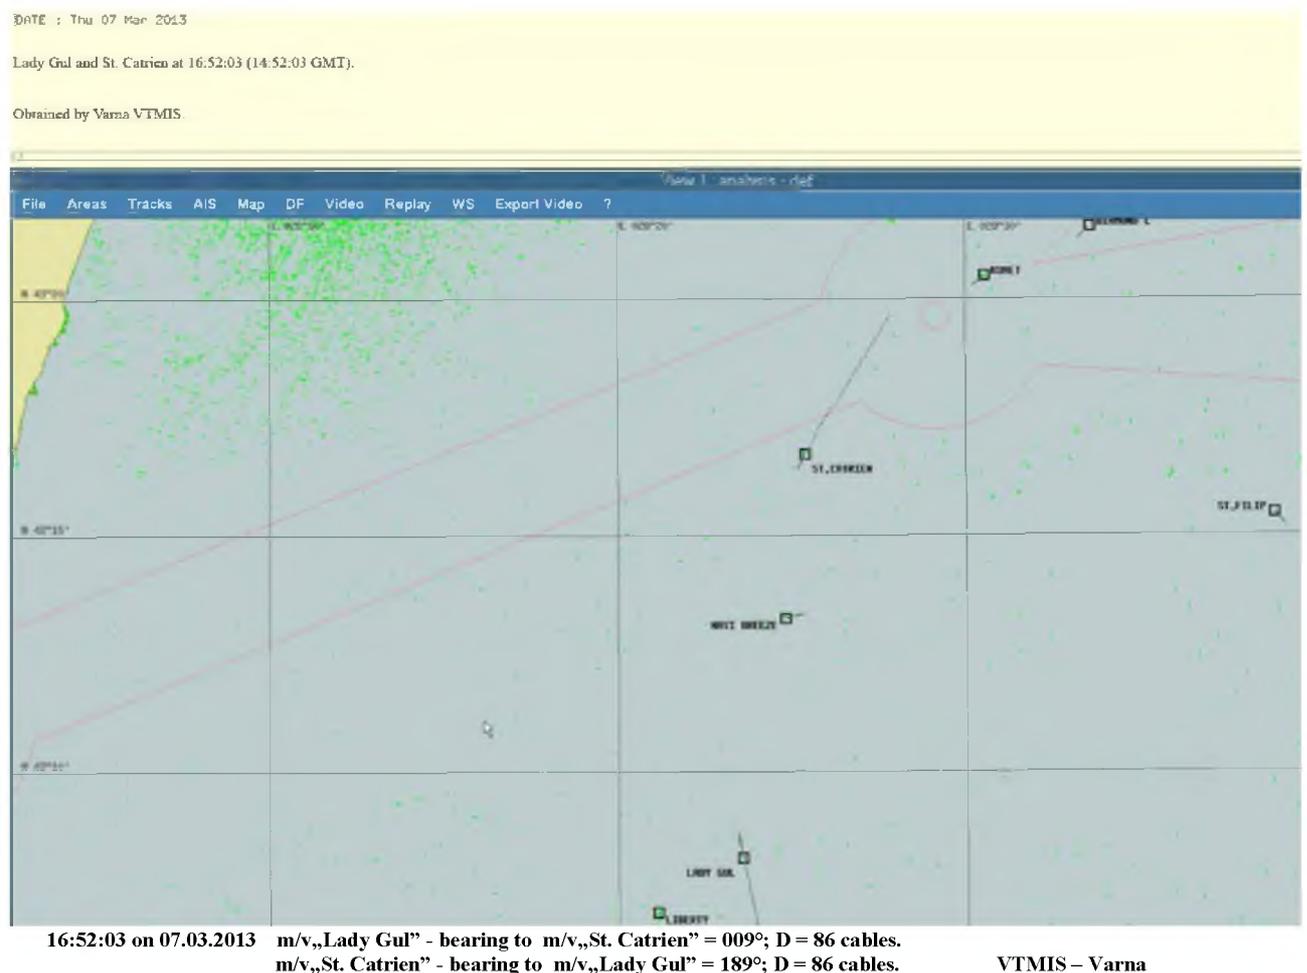
Fig.1

Figure 1 shows the mutual disposition of the vessels at 16:52 when the chief mate of the *m/v "Lady Gul"* saw the *m/v "St. Cathrien"* on the starboard bow.

The distance was 8.6 miles. It was evident that the courses of the two vessels cross. Both vessel should use the technical means for navigation and to assess the dangerous situation. At this point, this was done by the chief mate of the *m/v "Lady Gul"*. According to the Regulations for Preventing Collisions at Sea the *m/v "Lady Gul"* was obliged to give way to the *m/v "St. Cathrien"* as a left-hand vessel with a large deviation from the maintained so far course so that the manoeuvre to be substantial and to avoid a dangerous approach.

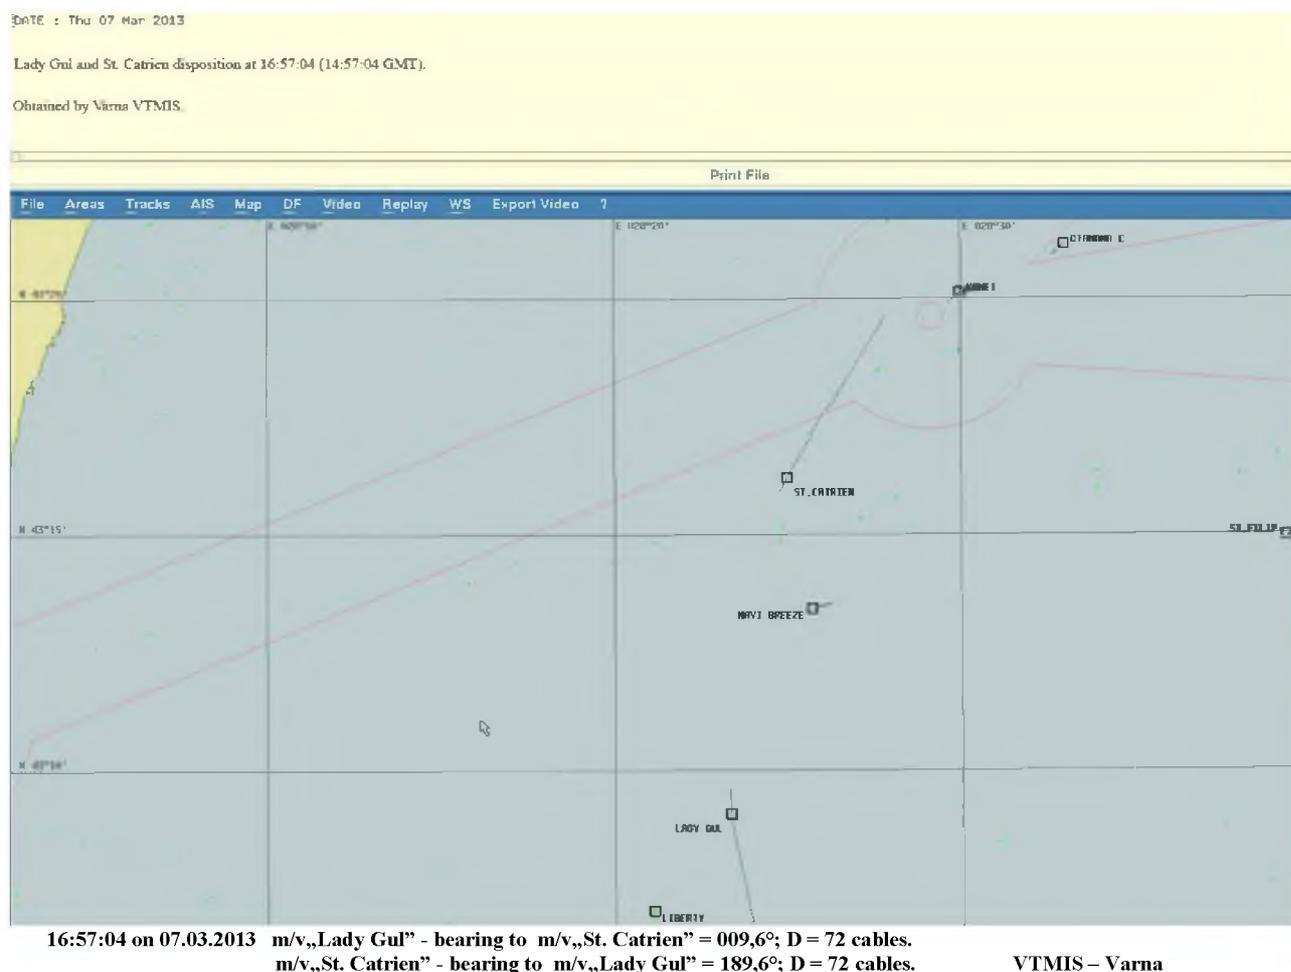
Fig.2

bearing to the target virtually remains the same, which was a clear indication that the two vessels are going on collision or in the best case on a dangerous convergence as shown on Fig.2.

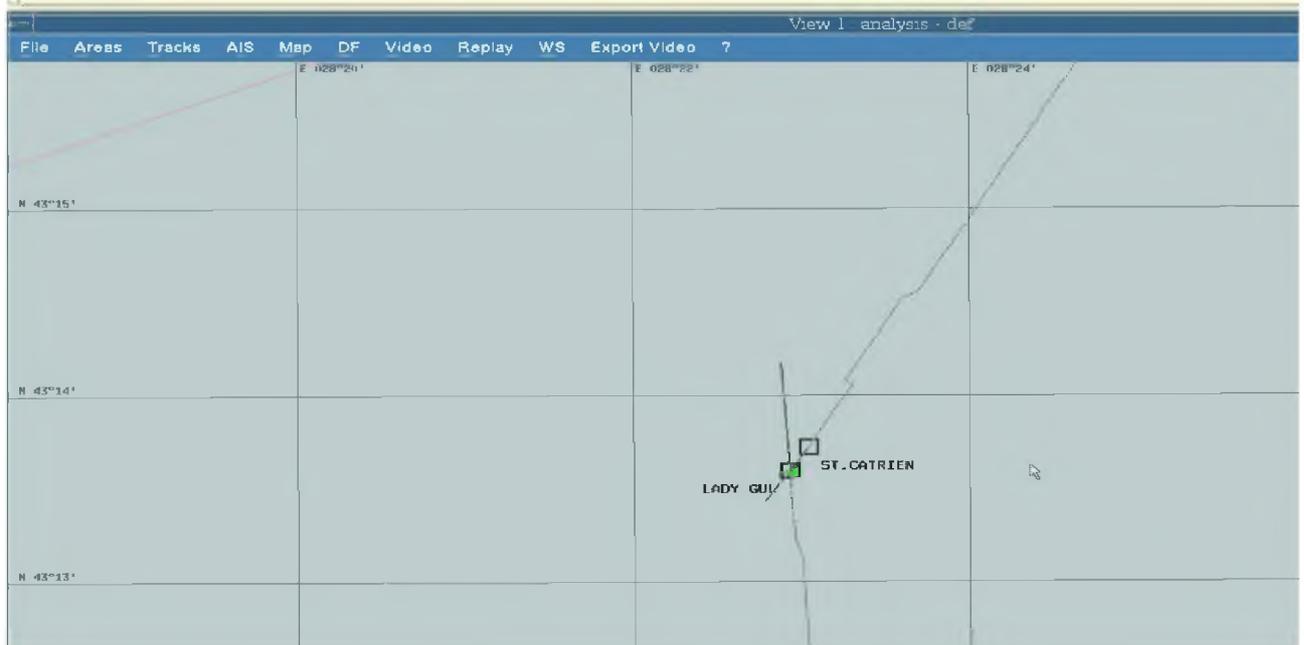
Not seeking the minimum time interval which would be necessary before 17:22 to avoid the collision using the manoeuvre of the *m/v "St. Catrien"*, it should be noted that at 17:20:56 *"Lady Gul"* was on starboard bow of *"St. Catrien"* at a distance of 210 meters. The probability of passing

17:20:56 on 07.03.2013 m/v, "Lady Gul" - bearing to m/v, "St. Cathrien" = 33°; D = 210 metres.
 m/v, "St. Cathrien" - bearing to m/v, "Lady Gul" = 213°; D = 210 metres.
