# FINAL REPORT

The investigation of a serious incident occurred on June 30, 2017 related to a bird strike of AIRBUS A321-211 aircraft, registration marks D-AIAC, in the controlled air space of the Republic of Bulgaria.

2018

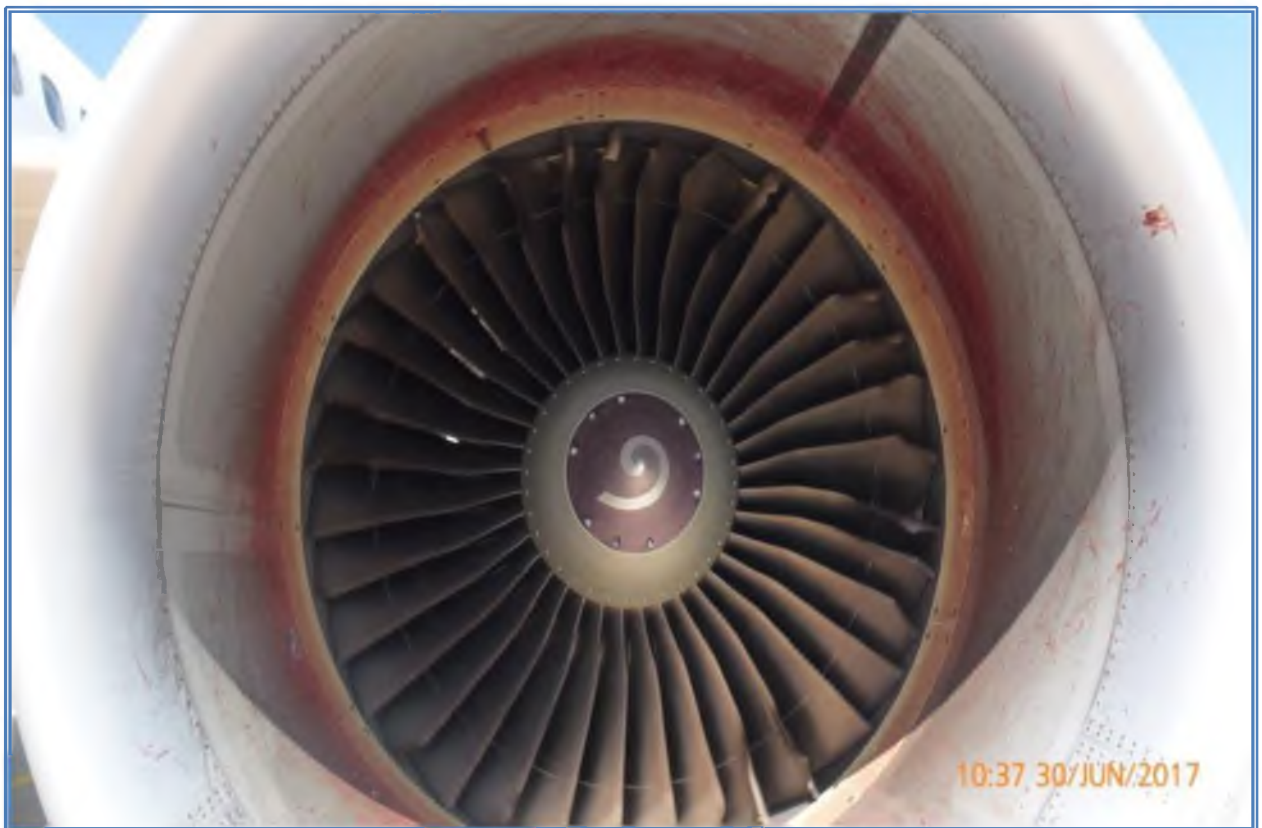
Fig. 3

During the inspection carried out, it was found that all damages were localized in the area of the inlet and the fan of the left engine.

Within the engine No 1 inlet, along the entire circle, there were found traces of blood, possibly resulting from a large bird strike (see Figure 3). In some places, there were spots on the abradable liner and breaking of acoustic panels. There are visible deformations and tears of 26 (twenty-six) fan blades.

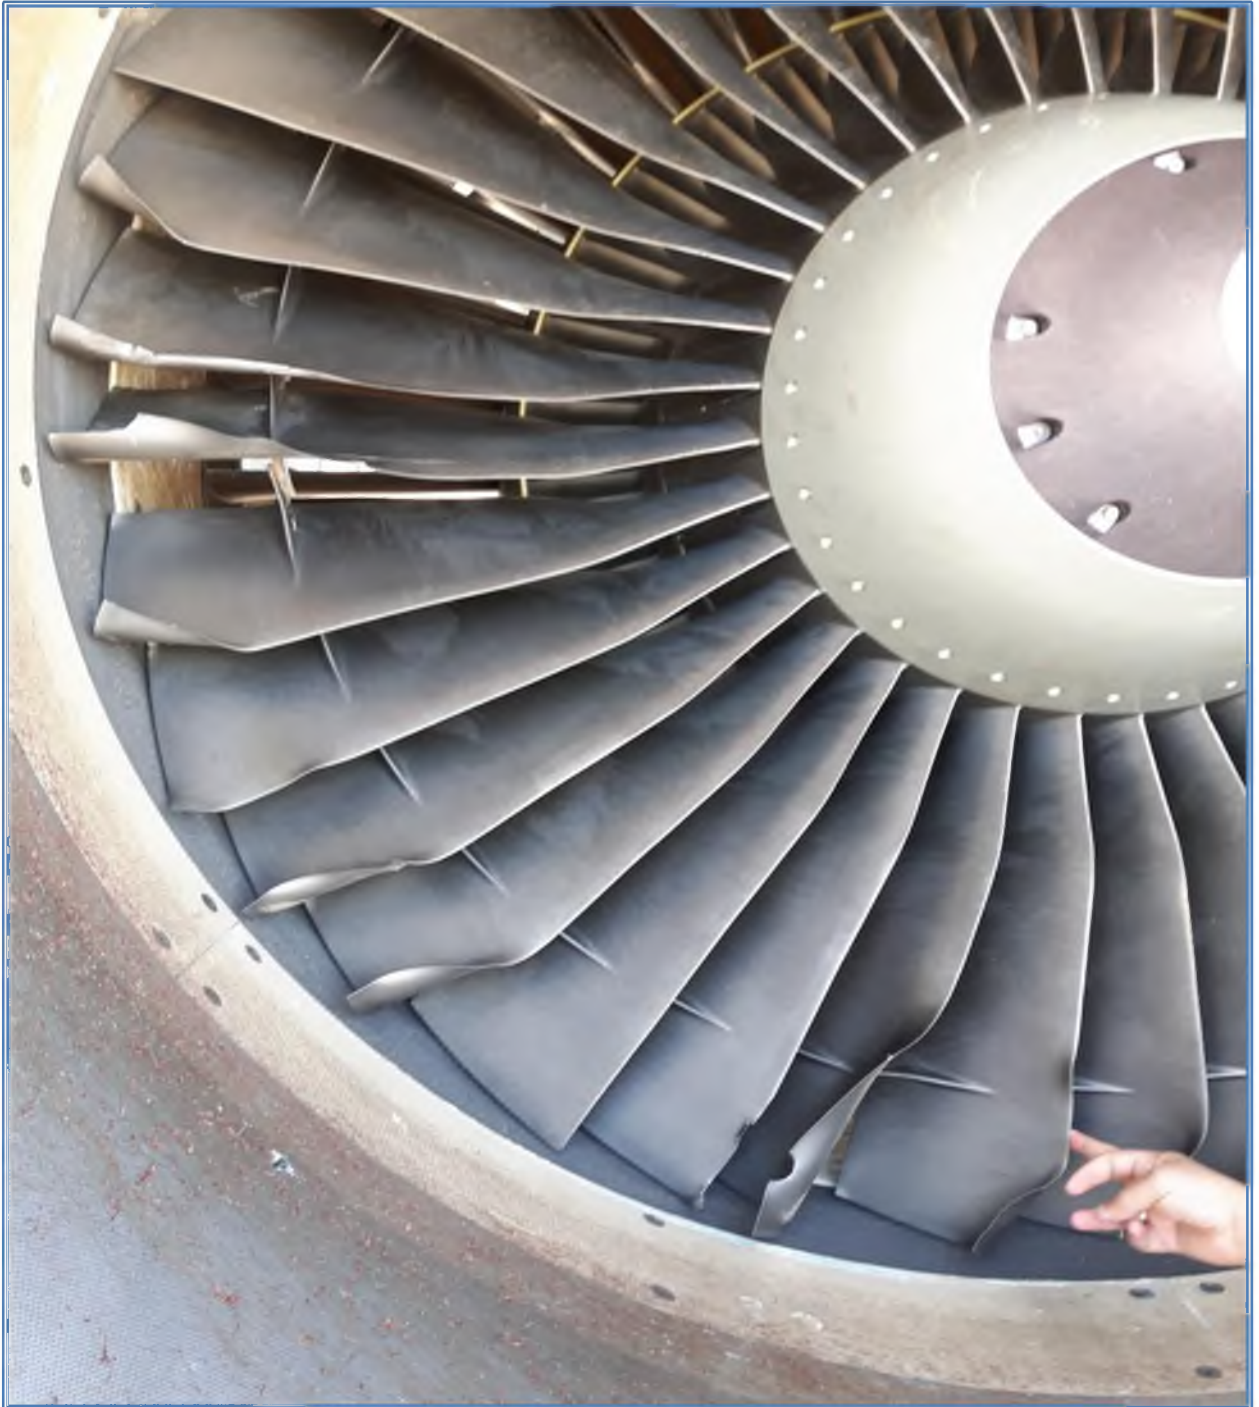
Fig. 4

The main part of these deformations and tears were located along the tips of the blades (Fig. 4). There were damages to the coating of the fan abradable shroud. No damages and deformations were observed on other surface of the nacell and the pylon. There were no faults and deformations at the engine exhaust (primary and secondary). There were found damaged blades of the stator vanes of the secondary path. Due to difficult access, it was difficult to determine the number of damaged blades. The fan rotor rotates freely not only by hand but also by the wind. No damages found of the low pressure turbine.

The ingestion of a large bird, most probably a Short-toed Eagle, into the left engine during initial climb, causing mechanical damage to the inlet and to the fan rotor, which led to a loss of the left engine thrust.

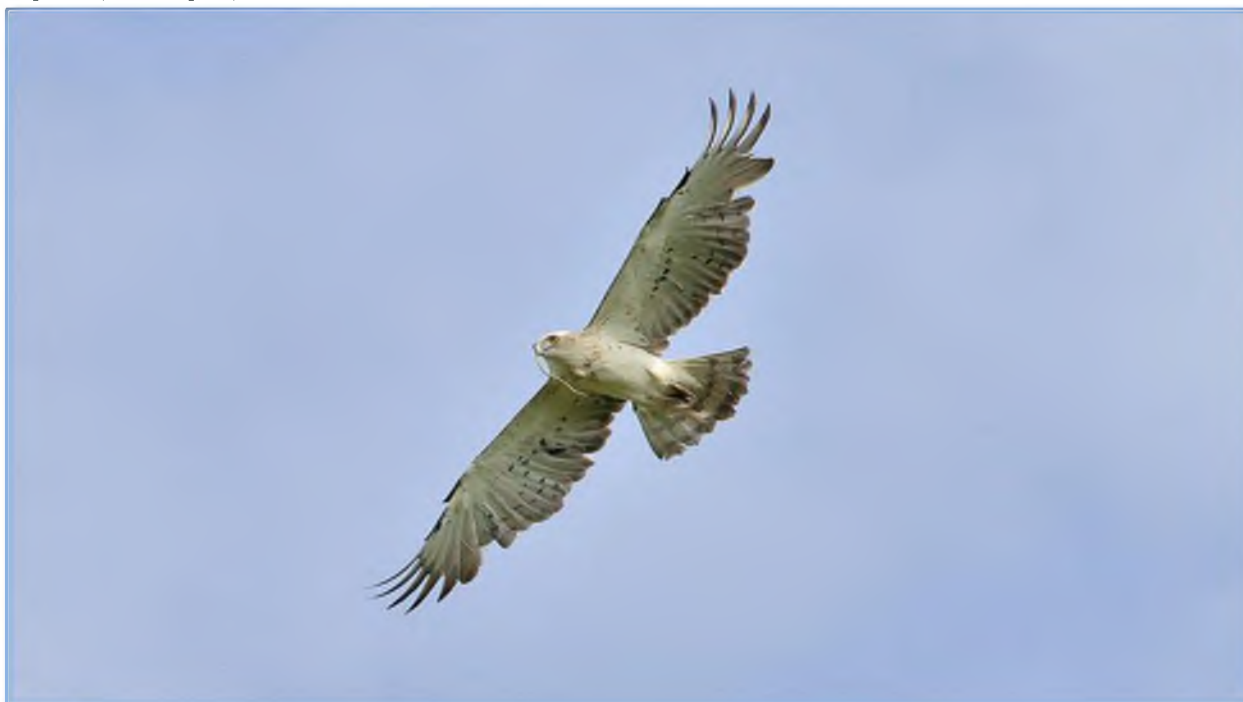
Fig.7

1. Short-toed Eagle/*Circaetus gallicus* is a large bird, 0,62 – 0,69 m long with a 1,8– 1,9 m wingspan and weigh of 1,5–2 kg . They can be recognised in the field by their predominantly white underside, the upper parts being greyish brown. The chin, throat and upper breast are a pale, earthy brown. Only one nest in the southern slopes of the Aitos Mountain is known from the Bourgas region (See Fig. 7) or
