FINAL REPORT

Investigation of a serious incident, realized on 09.09.2017 with A320-231 aircraft, registration marks LZ-LAD, operated by Bulgarian Air Charter AO Jsc, in a ferry flight from Bratislava airport to Sofia airport.

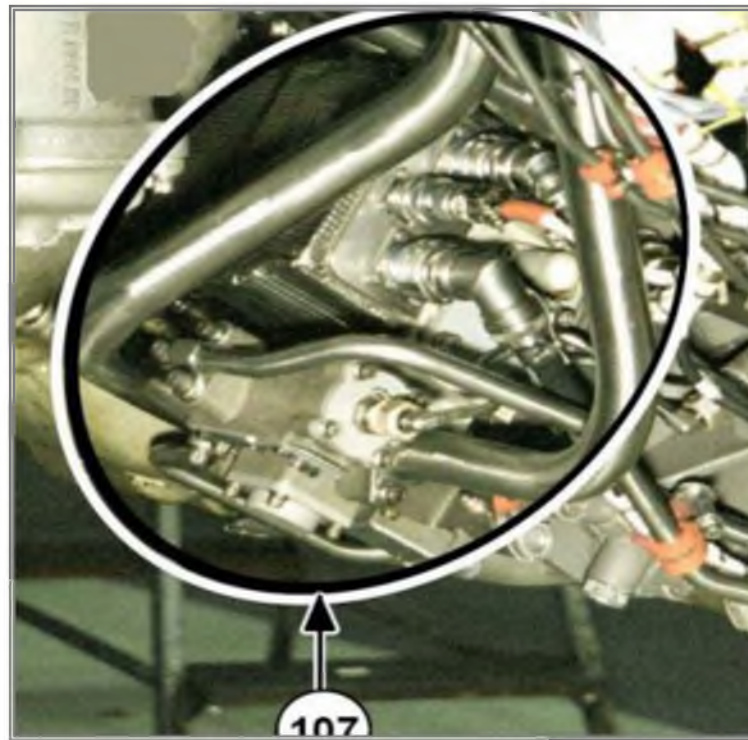
On the Fig. 4 the position 107 was shown, with the three electrical connectors.
