# FINAL REPORT

the investigation on a serious incident, realized on 21.08.2017 on Balchic Airfield, District of Varna, by Cessna 172RG airplane, registration marks LZ-SPD, operated by Air Operator Avio Detachment - Varna Ltd.

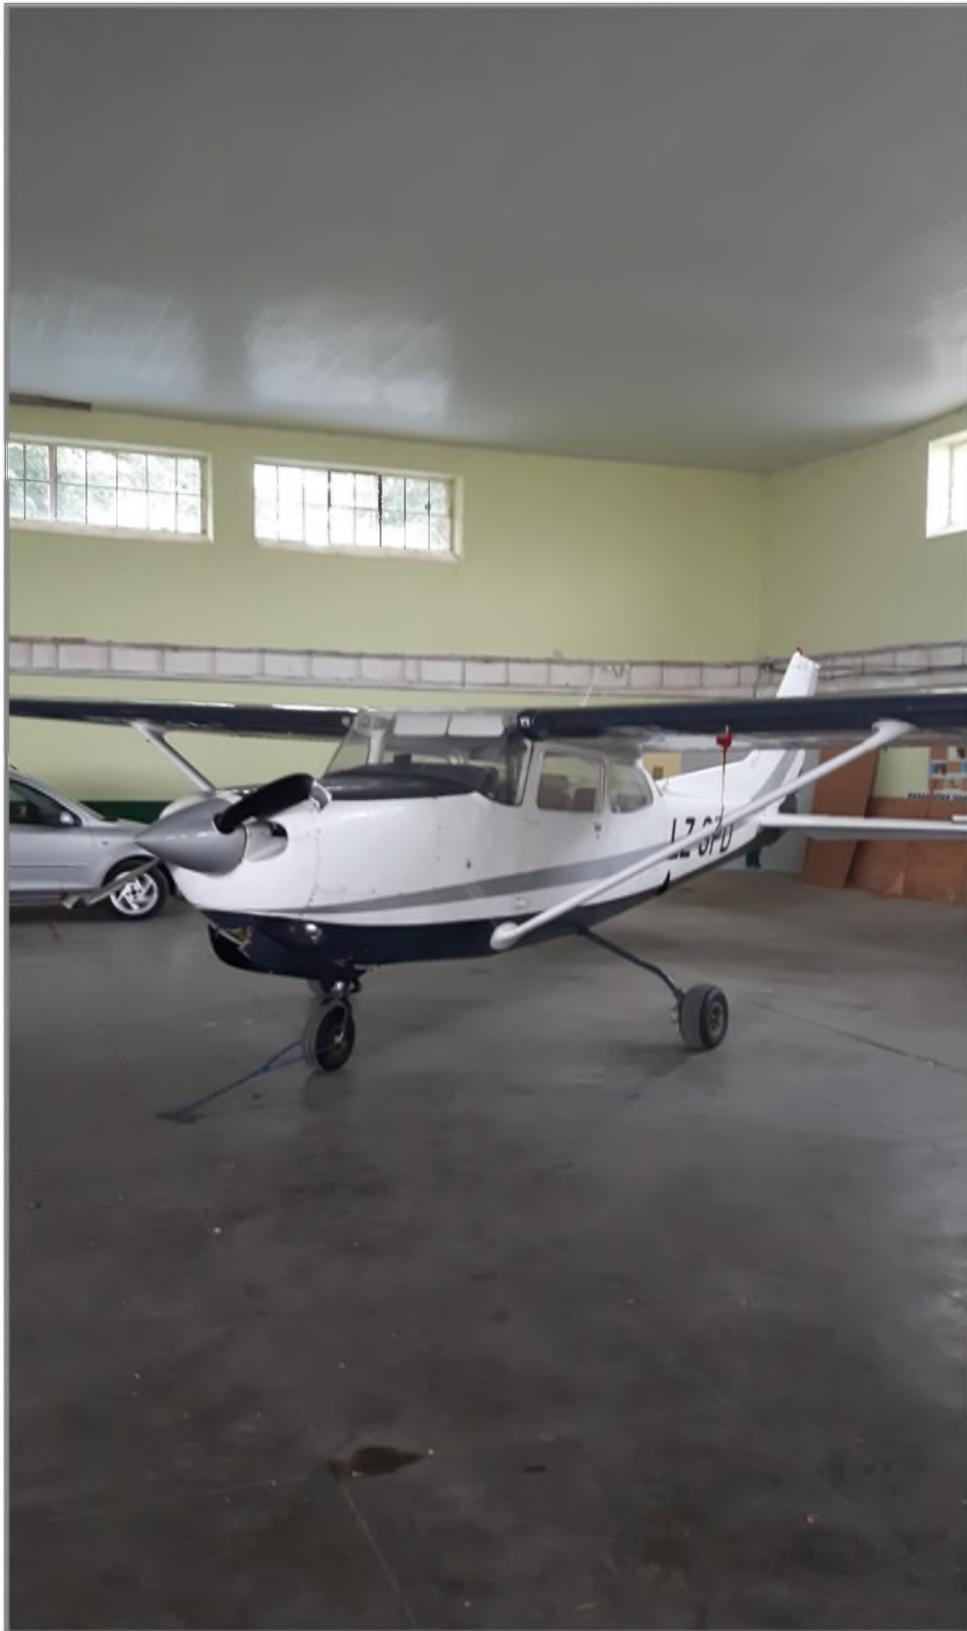
- Bent blades of the propeller, Fig. 1 & 2 of Enclosure 1;
- Abrasion of the nose landing gear doors and damages to drainage pipes on the left side of the bow, after the nose landing gear doors, Fig. 3 of Enclosure 1;
- Abrasion on the lower surface of the fuselage and light deformation, Fig. 4 of Enclosure 1;
- Rubbing of antenna cover on the radio compass, Fig. 5 of Enclosure 1;
- Rasping of part of the material of the rear suspension hook, Fig. 6 of Enclosure 1;
- Cut off the transponder antenna from the fuselage, Fig. 13 of Enclosure 1.

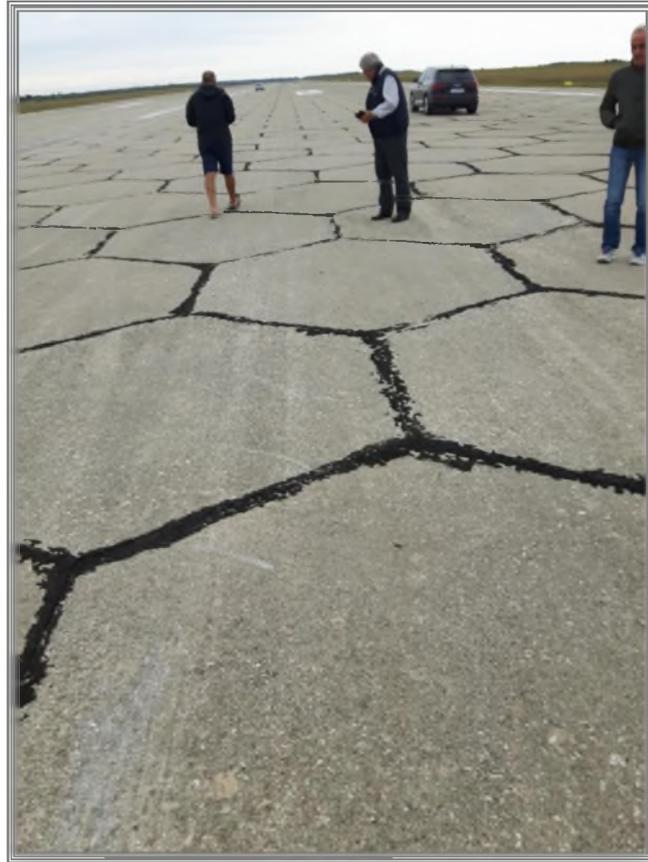
Fig. 12

The place of the A/C contact with the ground is shown in the picture in Fig. 12, where the traces of the propeller's contact with the RWY surface are visible. It is also visible where the aircraft fuselage rubbed the concrete surface. The touchdown was at 500 m from the threshold of RWY 34. From the point of touchdown to the final stop of the aircraft 17.80m were measured. The touchdown was smooth, without impact, by sliding on the surface of the runway. The aircraft retained its structural integrity, with only one piece detected on the runway, the transponder antenna shown on the picture, Fig. 13 of Annex 1. After the aircraft's full stop on the runway, the airfield crew arrived and measured, captured and documented the occurrence, and then the plane was moved by a crane to the air operator's hangar. The damages to the aircraft are described in paragraph 2.3.
