FINAL REPORT

Investigation of a serious incident related to a loss of separation, realized on September 8, 2016 with involved Airbus by A321-211 aircraft, registration marks TC-ATF, and Boeing B737-8F2 aircraft, registration marks TC-JVS in the controlled air space of the Republic of Bulgaria.

2017

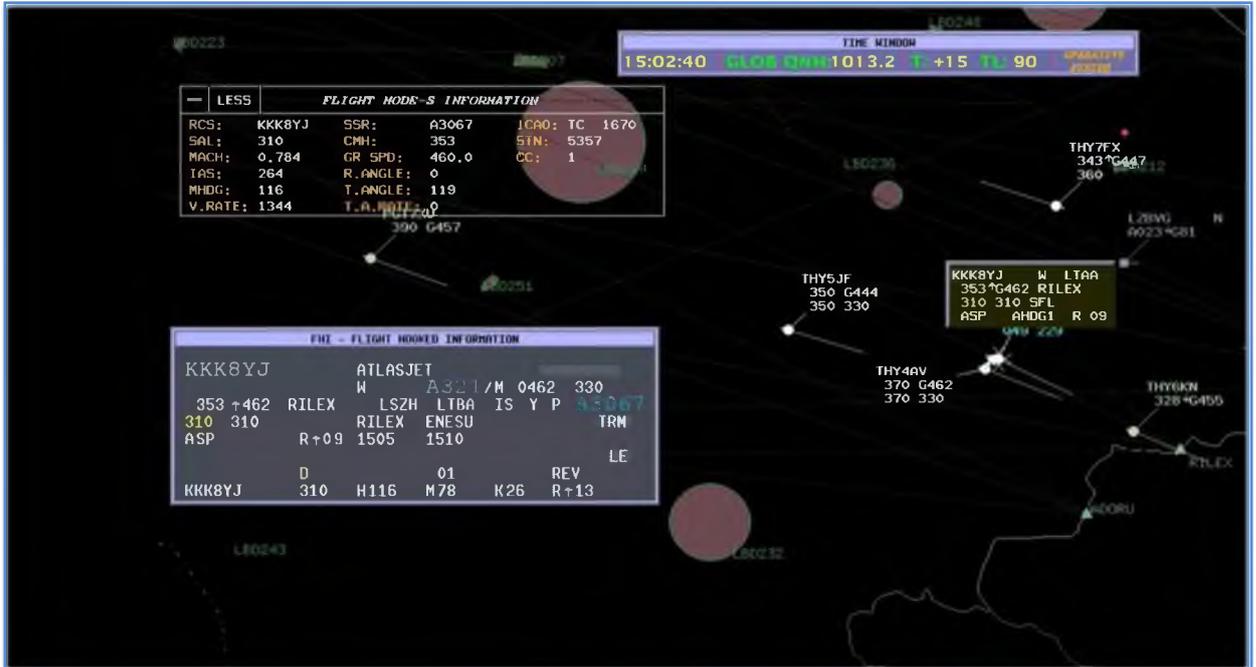
Fig. 1

According the radar information it is visible, that at 15:02:29 A321-211 aircraft KKK8JY started climbing instead of implementing a descent to FL310 as instructed. The distance between KKK8JY and THY4AV at that moment was 1,9 NM, and the vertical separation was 1900 ft. (See Fig. 1)

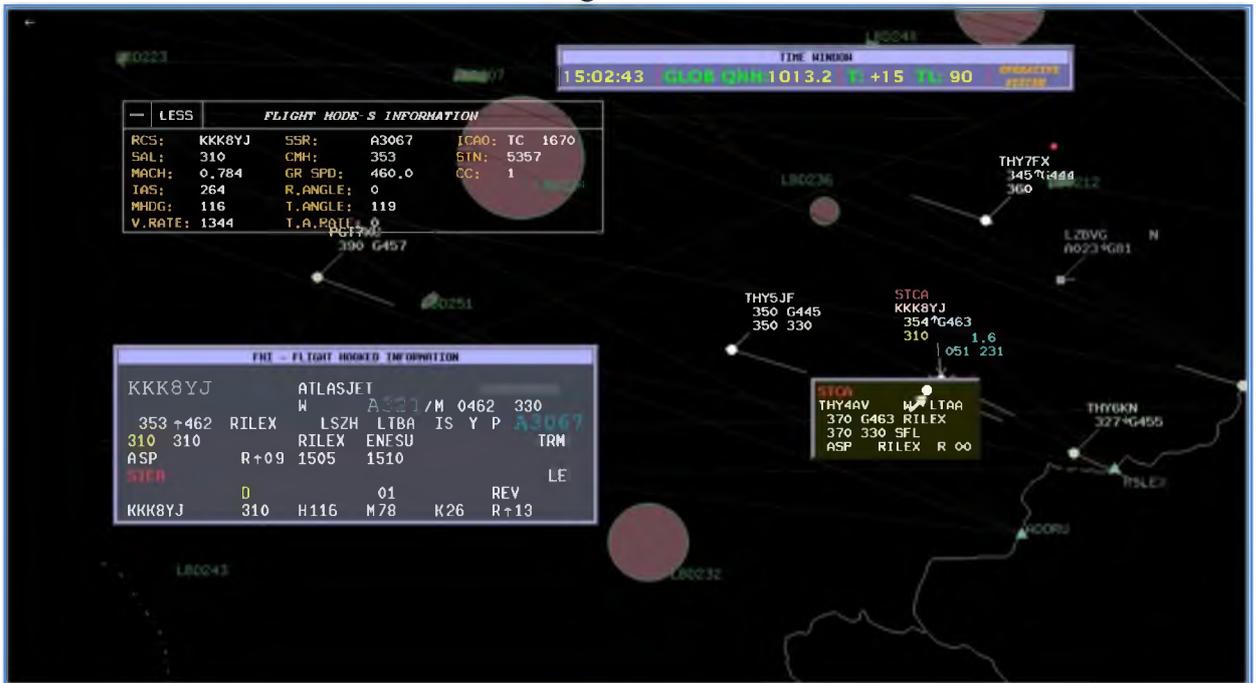
Fig. 2

At 15:02:43, SELEX ATCAS generated an alarm for a short-term conflict (STCA) between THY4AV and KKK8JY, which was displayed on the work position of SBL family sector. At this moment, the EXE ATCO instructed THY4AV to descend from FL370 to FL350. The crew did not confirm the clearance issued and the EXE ATCO instructed the crew to continue descending

to FL330, specifying a V/S of - 1000 ft/min or less. Again, there was no confirmation from the crew of THY4AV. At this point KKK8JY was already crossing FL357 in climb to unknown flight level with a V/S of +1500 ft/min, the distance between both aircraft was 1,5 NM and the vertical separation was 1247 ft. (See Fig. 2)

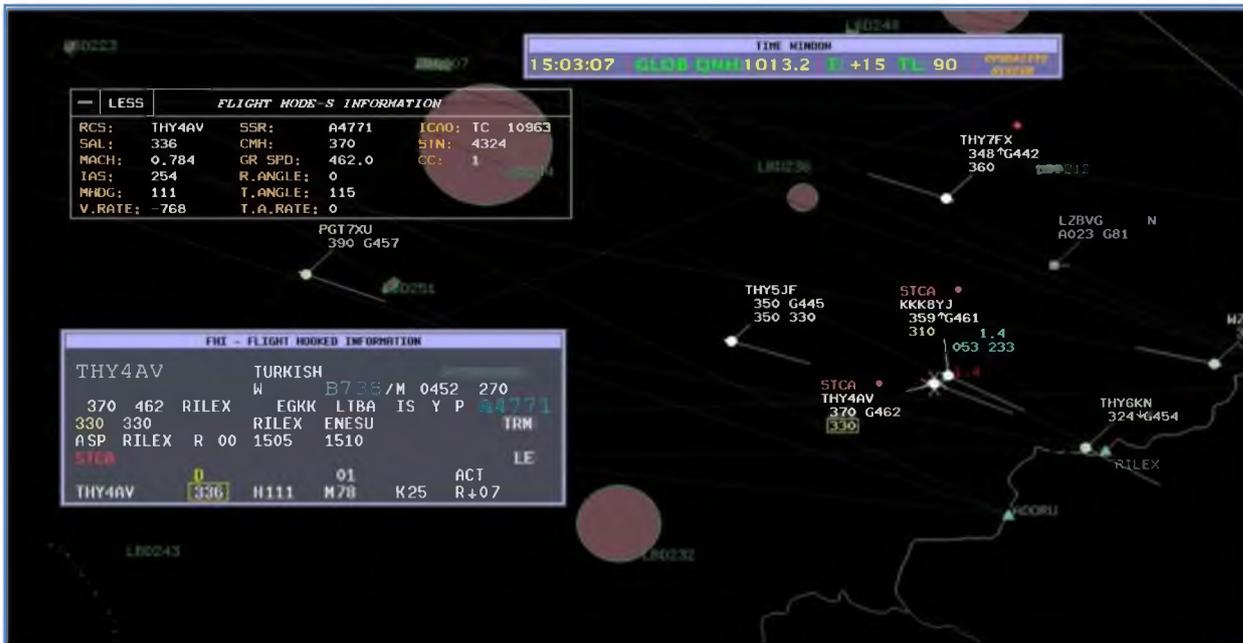
Fig. 3

At 15:03:07, the standard for minimum radar separation was infringed. THY4AV was descending and crossing FL368 with a V/S of -1300 ft/min, and KKK8JY was crossing FL360 in climb with V/S of +1500 ft/min. The distance between both aircraft was 1,5 NM and the vertical separation was 852ft. (See Fig. 3)

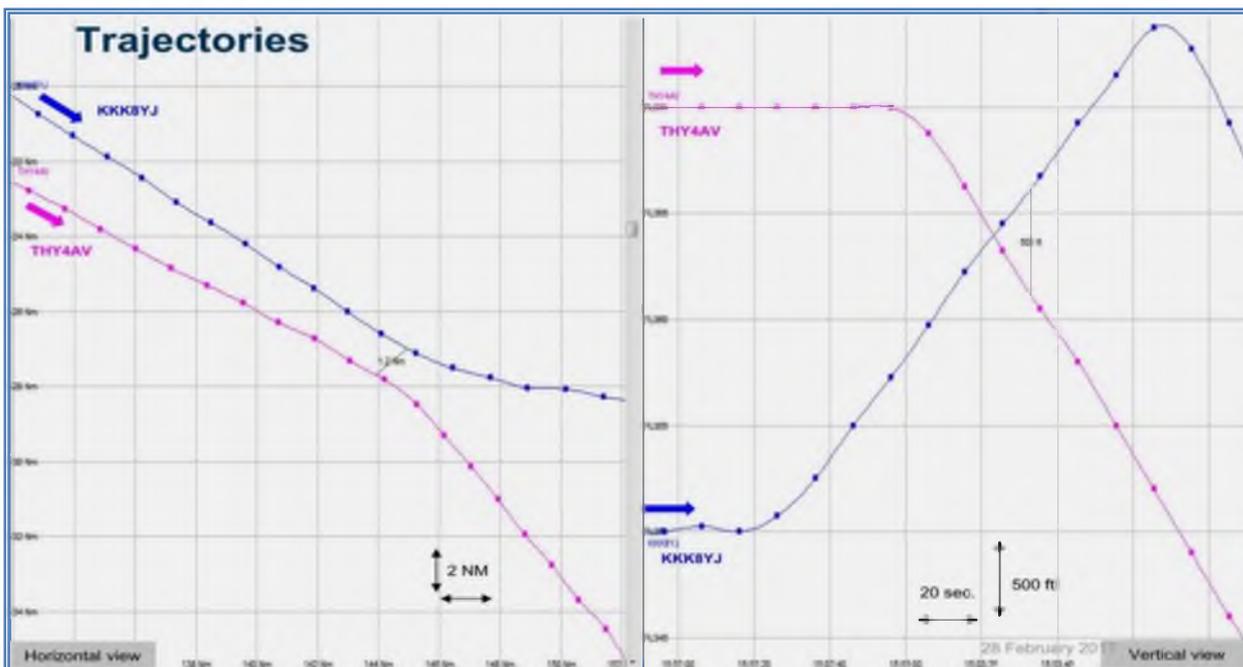
Fig. 4

At 15:03:24 h KKK8JY was climbing with a V/S of +1300ft/min and crossed vertically the heading of THY4AV, which was descending with a V/S of -1700ft/min. The distance between both aircraft was 1,3 NM and the vertical separation was 46ft.

According to the simulation performed (Annex 2), the closest point of approximation occurred at 15:03:33 h. The horizontal distance between both the aircraft was 1.24 NM and the vertical was 500 ft. (See Fig. 4)

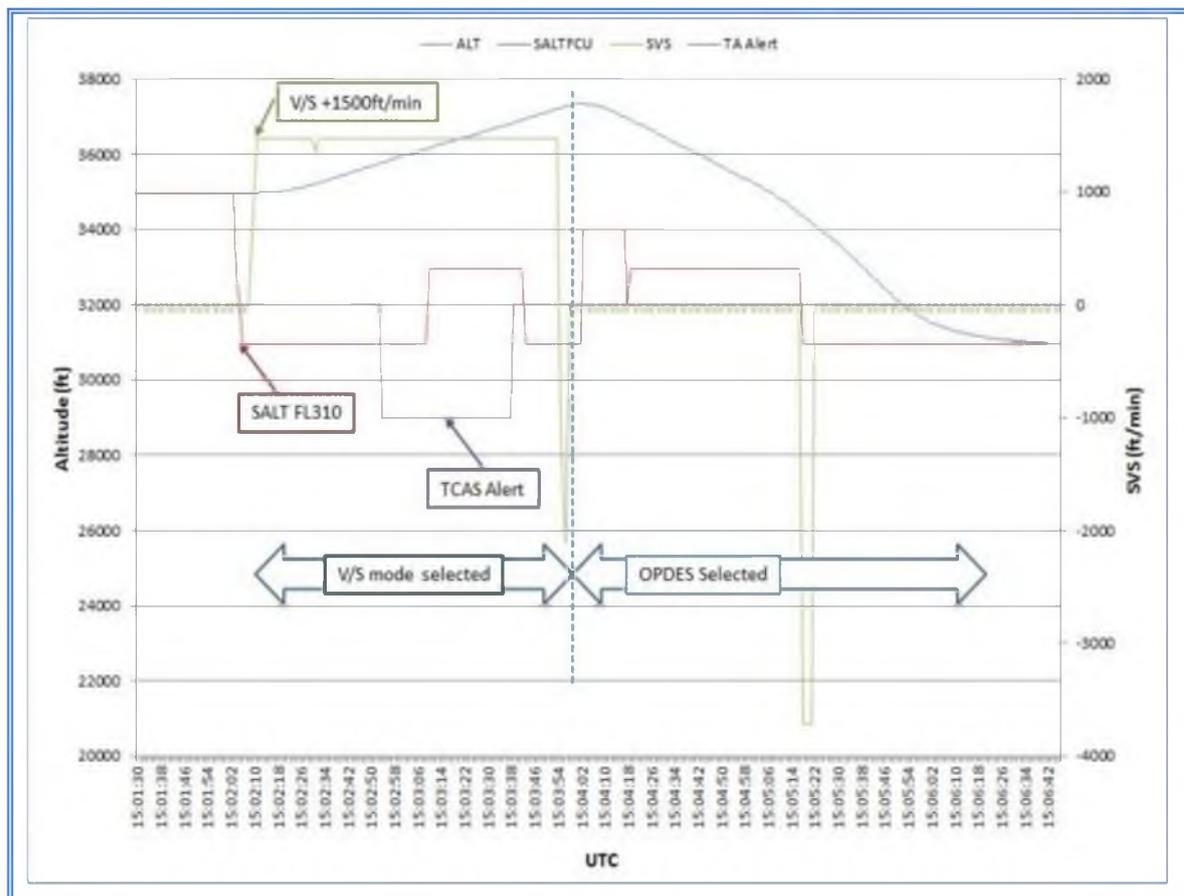
At 15:03:57 h at FL373, the crew of KKK8JY changed the SVS on FCU to - 2100 ft/min and after 4 s the AP switched to OPDES mode (ALT knob pulled). As a result, engine power reduced to idle, the pitch angle started to decrease from 4,2° and the altitude also started to decrease. SALT was changed from FL310 to FL340, 15s later to FL330 and 1min later - again to FL310.

At 15:05:17 h the descent mode of KKK8JY was changed again - the aircraft crossed FL344 with a pitch angle of -3,2° in a V/S mode, the SVS was selected on -3700 ft/min, and 4s later the AP was switched to OPDES mode.

On the Fig. 5 a diagram with the parameters of descent of KKK8JY with TC-ATF registration marks is shown as it was presented in the report of Airbus (Reference GSI 420.1037/17) following DFDR flight analysis:

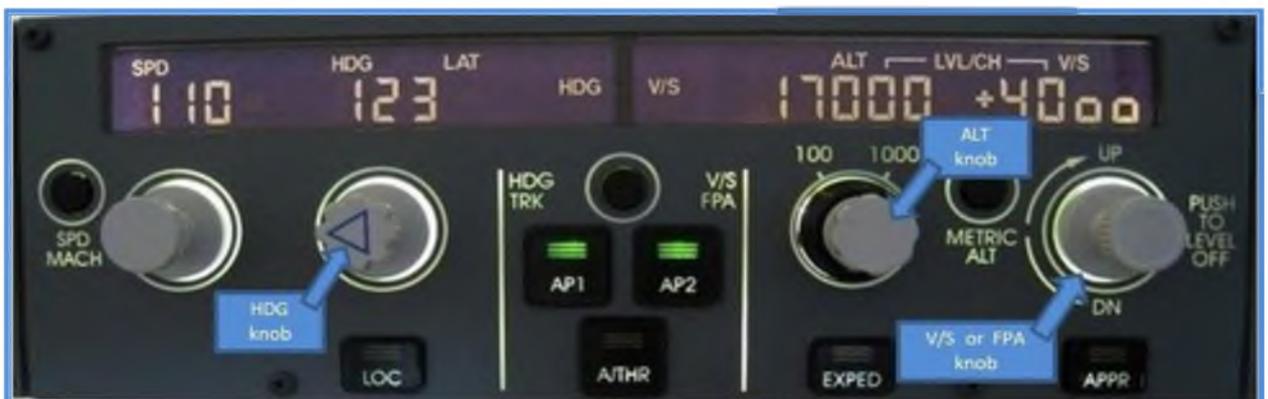
At 15:02:03 the flight crew of KKK8JY entered changes to the settings of the FCU: the SALT (Selected Altitude) was changed to FL310, OPDES (Open Descend) was selected for a second and after that the SVS (Selected V/S) was engaged to +1500ft/min and the pitch increased from 1.4° up to 4.2°. The aircraft started to climb because of the positive V/S set.

At 15:03:10 h A321-211 aircraft KKK8JY crosses FL362 in climb, the crew changes FCU SALT (selected altitude) from FL310 to FL330 for 28 s and after that return it to FL310. The crew did not make any changes to the descent mode selected or rate of V/S. Therefore, the positive rate selected remained engaged.

On Fig. 6 is shown the FCU panel on board of A321 aircraft.
