FINAL REPORT

the investigation to a serious incident occurred on September 17, 2017 with involved a MXP140, registration marks YU-A019, at landing at Slivnitsa airfield.

2018

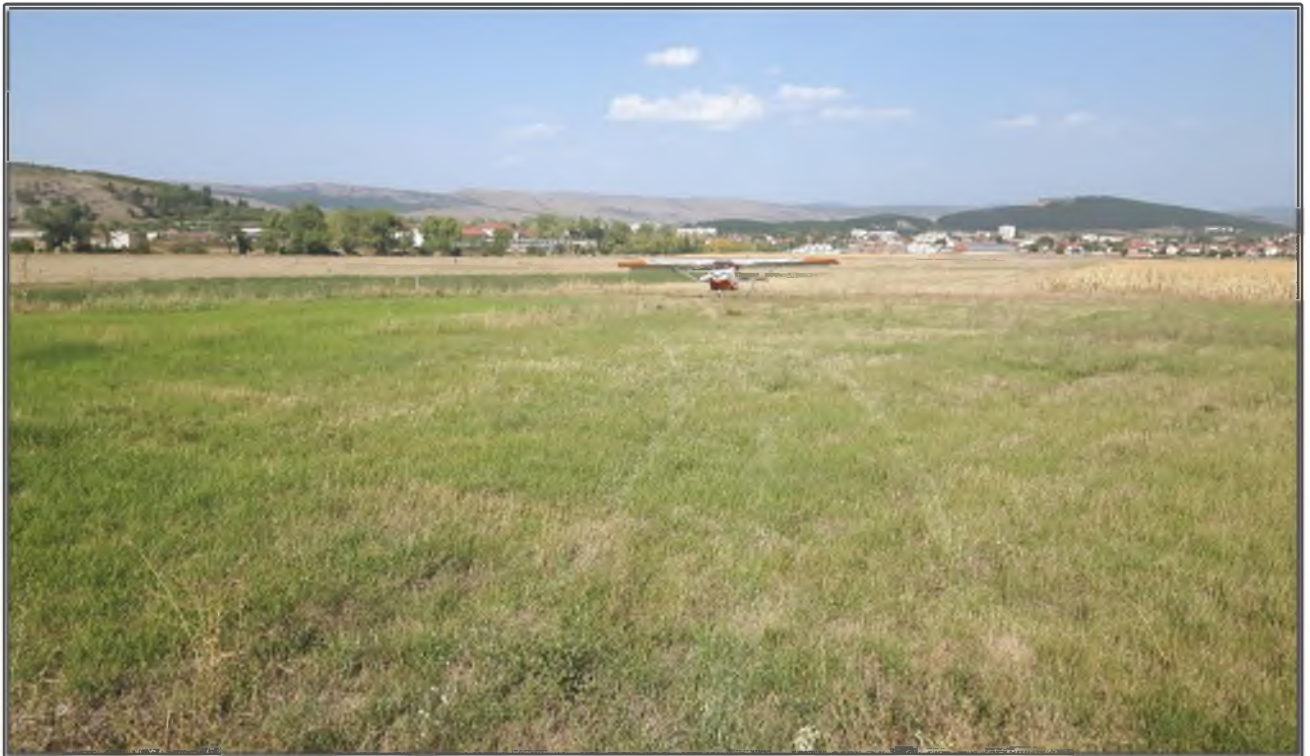
Fig. 1.

In the pictures in Fig. 1 and 2 of Appendix 1, the airplane is shown at its final position, turned 180°. Breaking tracks of a 39 m length ending at 49 m from the end of RWY 08 have been found during the asphalt coating inspection. At the end of the stopping track, it was found a trace of a working fluid spillage (possibly braking fluid) of 5 m length. On the airplane's trajectory, 5 m before the end of RWY 08 there is a second trace of working fluid spilling with a length of 5 m as well.

The peripheral fence of airfield was in a condition that makes it difficult to carry out its main function of preventing intrusion into the territory of the airfield. It is shown in Fig. 1, 5, 6, 7 & 16 of Appendix 1.

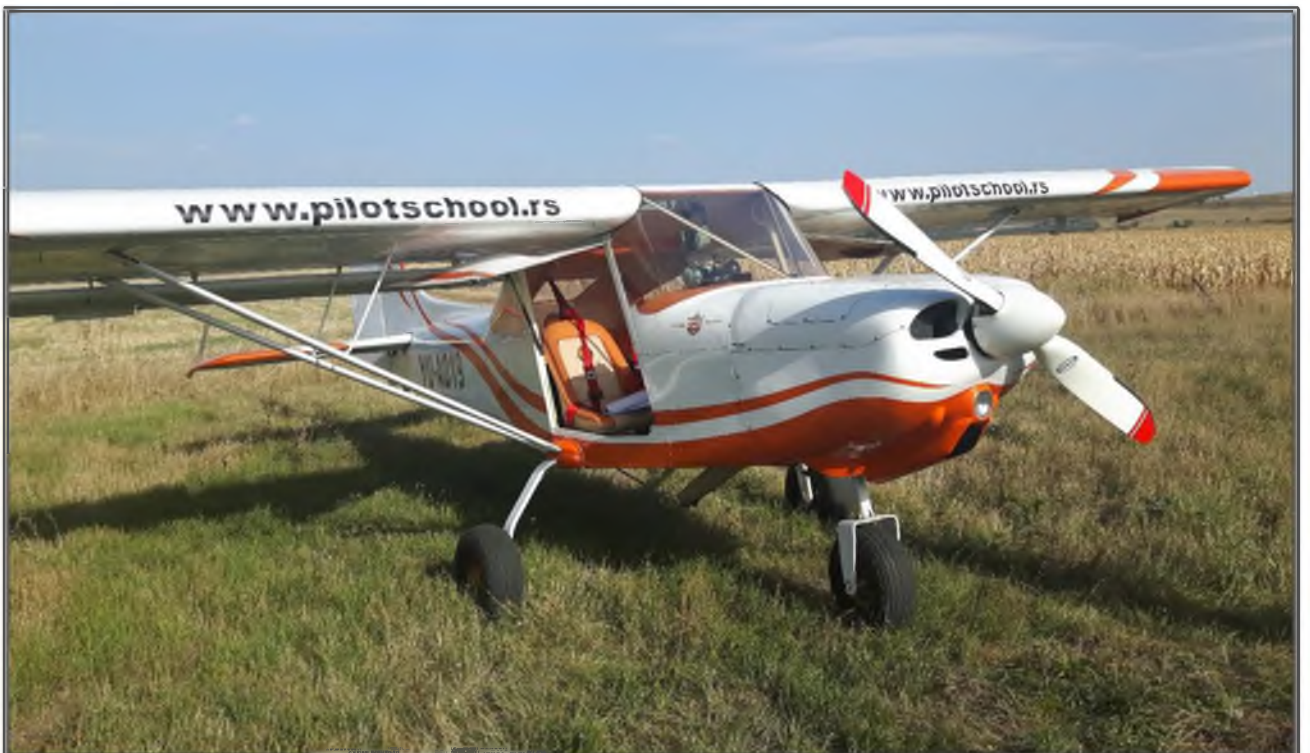
Fig. 2.

- Damaged leading edge of the propeller periphery part, as about 2 cm of one of the two blades were broken off (Fig. 3, Appendix 1);
- Bruises and warping on the right-hand side of the engine cowling (Fig. 2, Appendix 1);
- Damage to the lacquer coating and scratches on the upper bonnet of the engine (Figures 3 and 5 of Appendix 1).
- Deformed wheel frame of the nose landing gear; (Fig. 12 of Appendix 1).
- Deformation in the controlling fork of the nasal wheel.
- Scratches and cracks on the windscreen of the cockpit (Fig. 4 and 5 of Appendix 1).
- Leakage of brake fluid from the brake packing of the right-hand main gear (Fig. 14 and 15 of Appendix 1).
- Deformations of the left-hand wing bracing strut; (Fig. 6 of Appendix 1);
- Bruises on leading edge of leading edge slat of the left-hand half-wing; (Fig. 4 and 7 of Appendix 1).

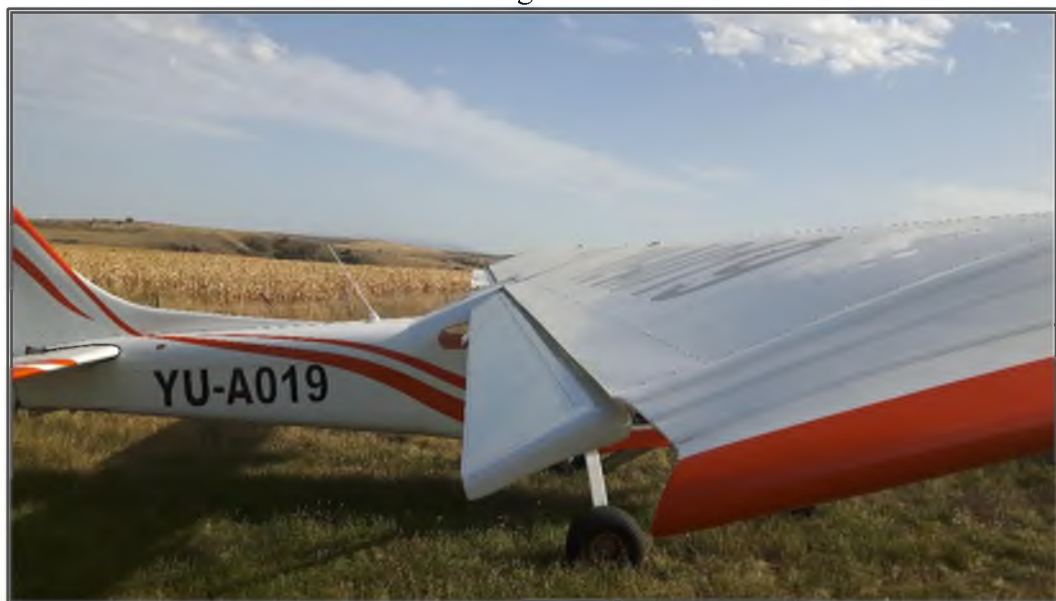
Fig. 8.

The inspection conducted by the safety investigation commission revealed that the aircraft had suffered minor damages as shown in Figures 2 through 15 in Appendix 1. These damages include:

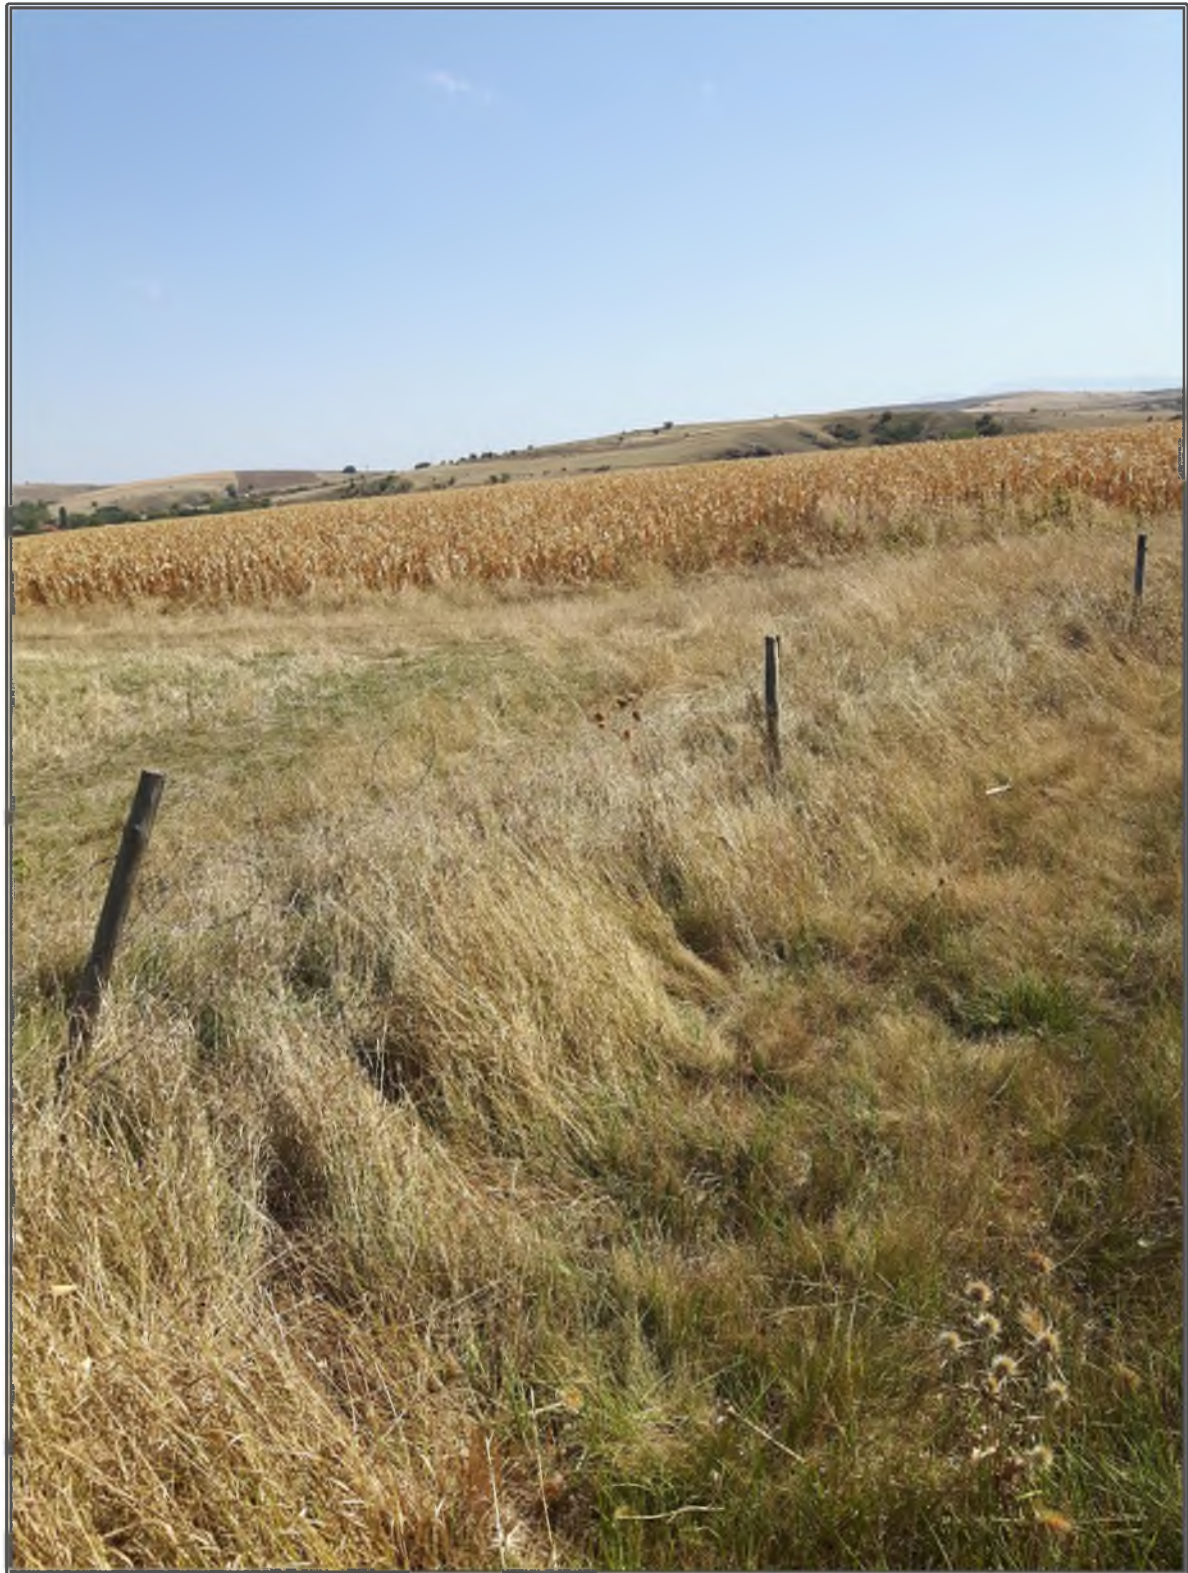
Fig. 16.

The end of RWY08 is located 60 m from the perimeter fence of the flight site. Fig. 16 shows a photo of the fence at the airplane stop.
