# FINAL REPORT

**On the investigation of a serious accident on July 16<sup>th</sup>, 2018, by McDonnell Douglas MD-82 aircraft, registration LZ-LDM, upon approach for landing on the Tarbes–Lourdes–Pyrénées Airport, France**

**Aircraft Accidents Investigation Unit AAUI  
Republic of Bulgaria**

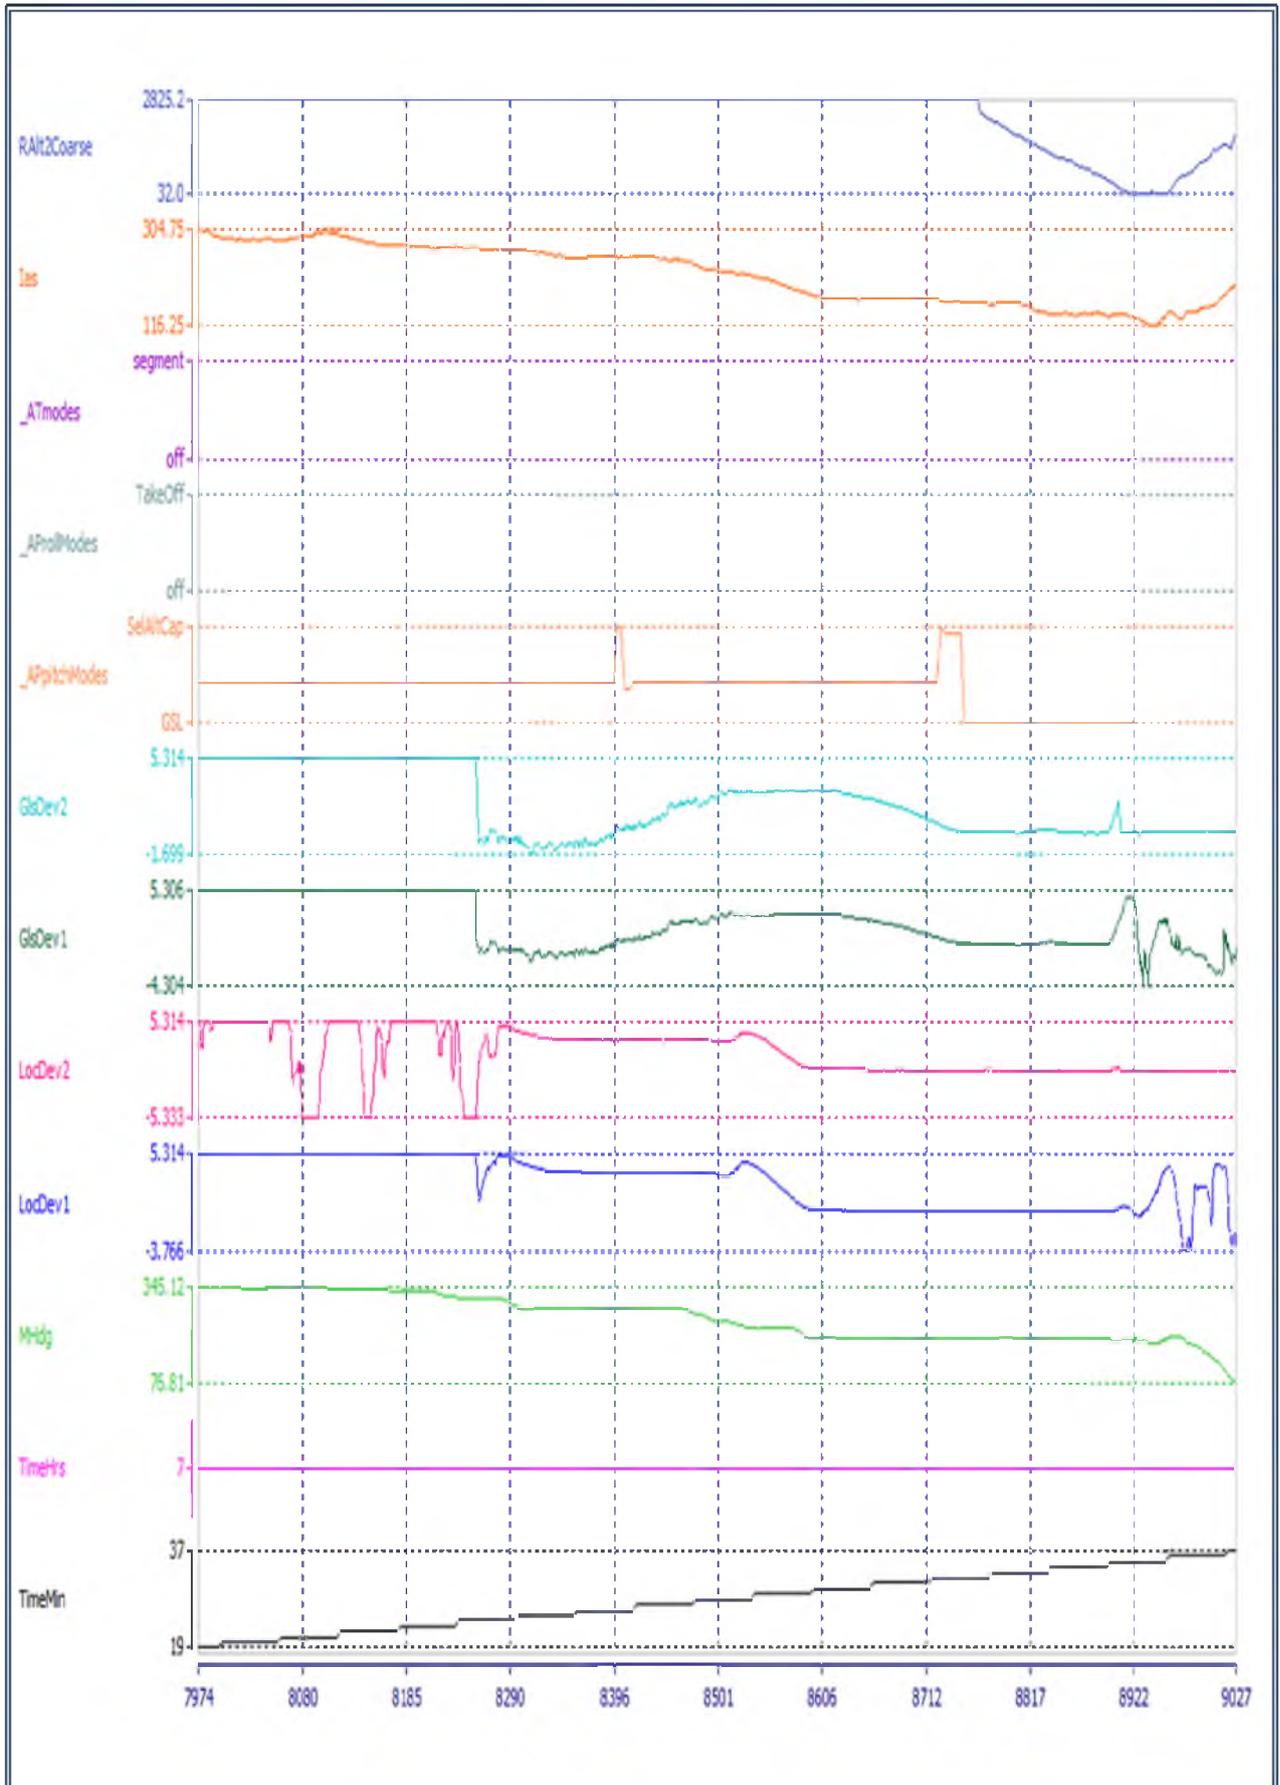
Figure 1a

At 07:33:56 AM, according to the FDR: at altitude 2200ft and speed CAS 140kts, the A/C was fully configured, on the course and glide slope of ILS RW 20 with AP and ATHR ON. All stabilized approach criteria were covered.

At 07:34:57 AM, FDR data show that the autopilot was ON (AP engaged) and the auto-thrust control is engaged in a "SPEED" mode (A/T Mode "Speed"). Both they working perfect, regardless of whether difficulties and the A/C was in a perfect position in space towards the airport at full interception along ILS RW20. ALTbar 1450ft and ALTradC1/// 469.844ft, Head 200.556°, CAS 136.75kts, deviation from glide GldDev1/// 0, and deviation from course LocDev1/// -0.018. Right then, the co-pilot switched off the active autopilot No.2 and started manually to control the plane, while the auto throttle remained in the "Speed" mode at a set speed of 140kts. Immediately after the manual control, the plane was exposed to strong wind gusts and heavy rain. The co-pilot failed to hold the plane on course and glide. The plane began to deviate to the left of the course, as well as from the glide with aircraft sinking under the glide.

The approach was totally out of the standards and the required parameters for the stabilized approach, significantly under the glide, but the PIC did not command a "Go-around".

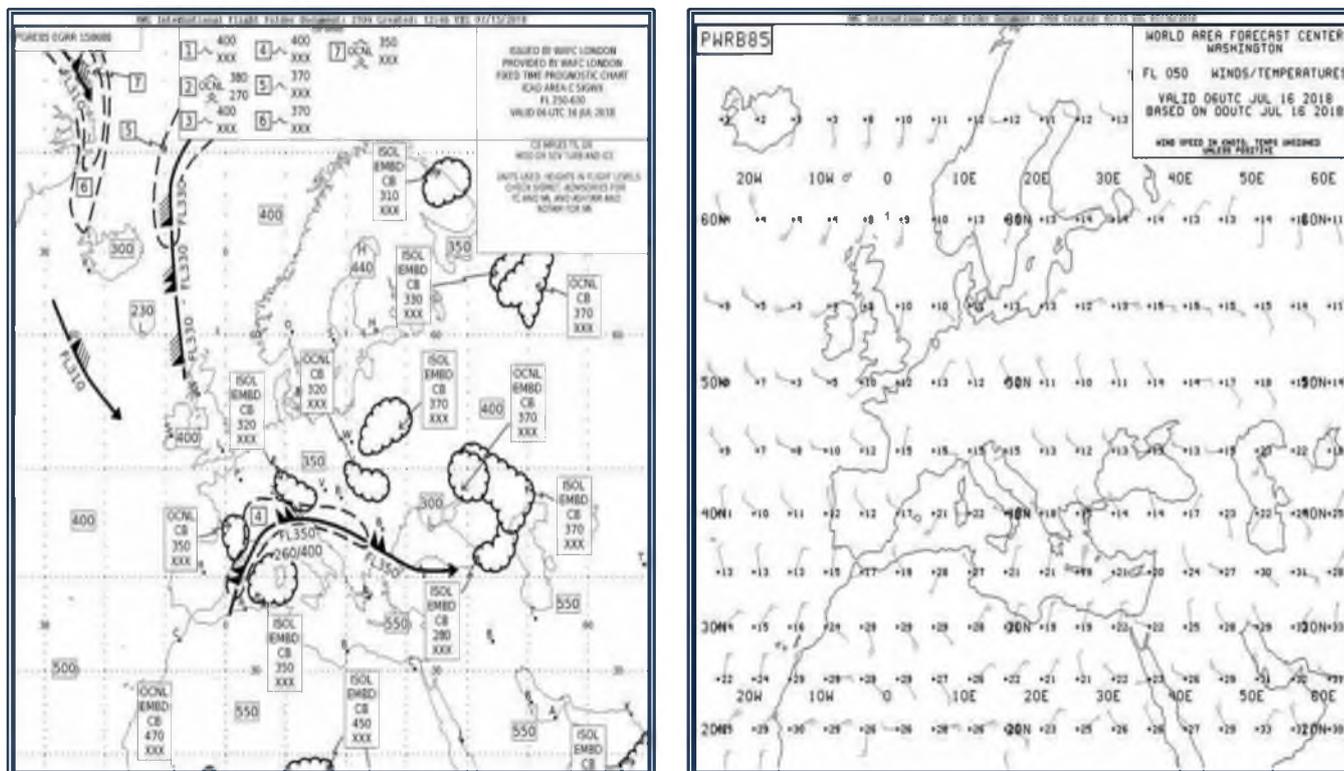
Figure 3

The information, given by the airport shows that the weather during the aviation event was significantly complicated:

Precipitation is intensifying in the Southern part of the country. There have been reports of thunderstorms in the Tarbes area with peak values at flight level FL350. The wind power at FL50 flight level is heading North at a speed of about 5kts. It should be noted that account is not taken of the possible gusts of wind in the information.

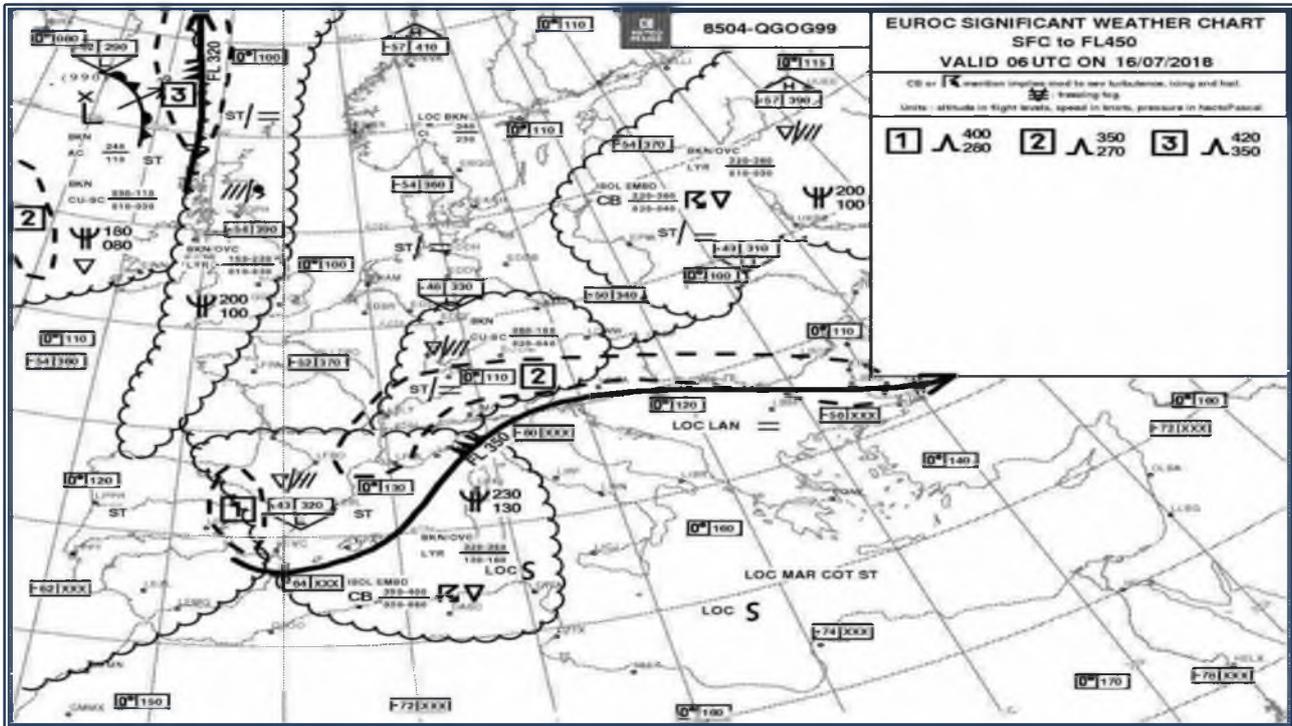
Figure 4

The map shows thunderstorms in the Southern part of LFBB, LFMS and part of the flight information area in the Mediterranean region. The expected maximum values are between FL350 and FL400, which implies more advanced and intense storms.

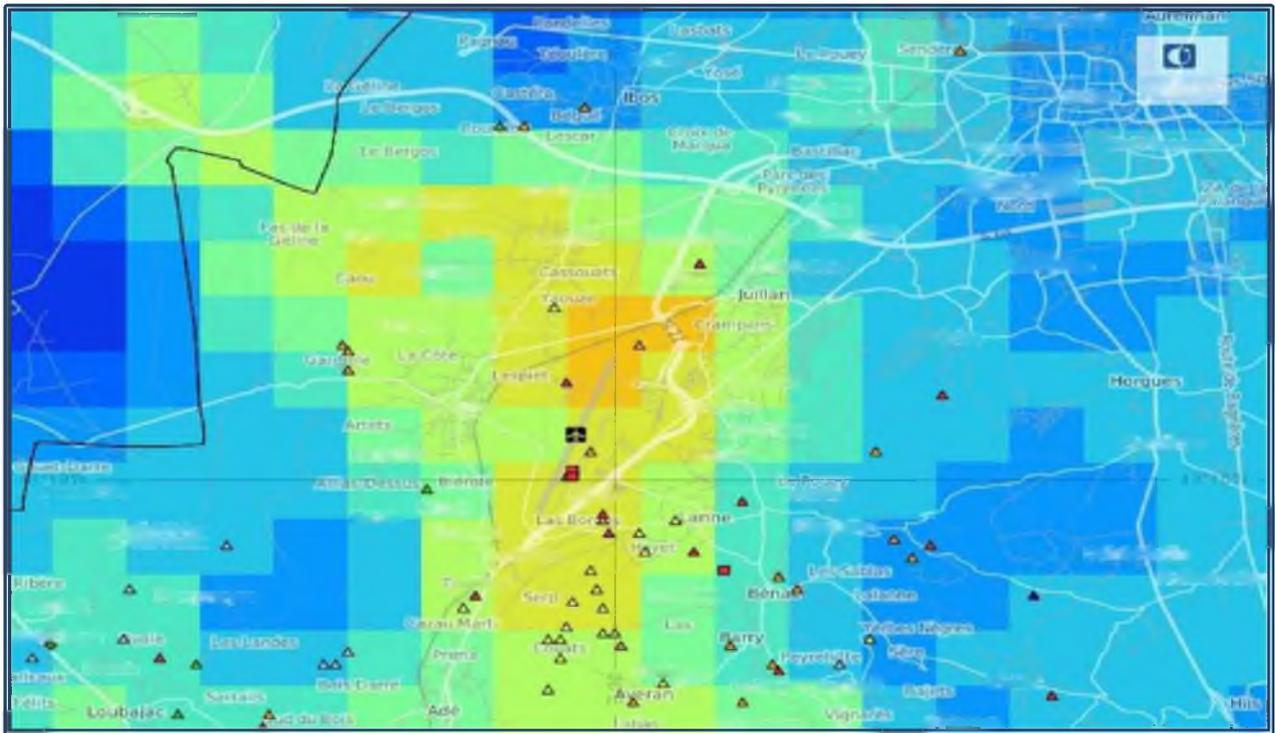
Figure 7

The picture shows the radar mosaic of conditions (in color reflection) with the lightning spots (orange-red symbol) at 07:30 UTC.

When zooming the picture around the airport area, we see a significant intensity of conditions in the Northern area of the airport.
