FINAL REPORT

the Commission for Investigation concerning the serious incident (Airprox) involving the Boeing B737-800 aircraft, registration marks D-ASXP, operated by SunExpress Deutschland GmbH and the Boeing B737-800 aircraft, registration marks OM-GTF, operated by Go2Sky, spol. s r. o., on 12 August 2018 in the controlled air space of the Republic of Bulgaria.

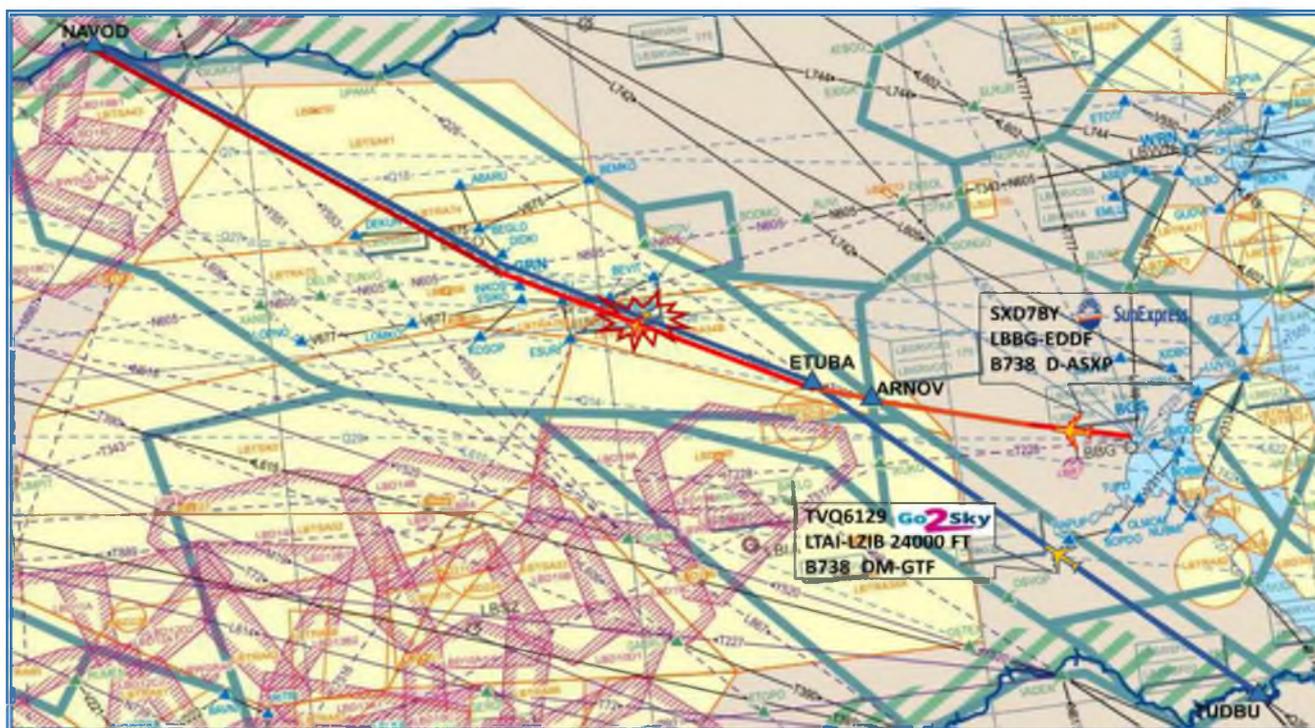
Fig. 1

On 12 August 2018, the Boeing B737-800, aircraft with flight number 6D6129 and call sign TVQ6129 was performing a charter flight on the route Antalya (LTAI) - Bratislava (LZIB). According the flight plan, the aircraft will enter SOFIA FIR through TUDBU TCP at FL240, to fly one-way ATS route Q26 to point ETUBA, then one-way ATS route T226 and leave SOFIA FIR via NAVOD TCP at FL240.

The Boeing B737-800, aircraft with flight number XG3208 and call sign SXD7BY, was performing a flight on the route Burgas (LBBG) – Frankfurt (EDDF). According the flight plan, the aircraft takes off from Burgas (LBBG) to point ARNOV, after that flies the T226 one-way ATS route and leaves SOFIA FIR via NAVOD TCP planning cruising level - FL380.

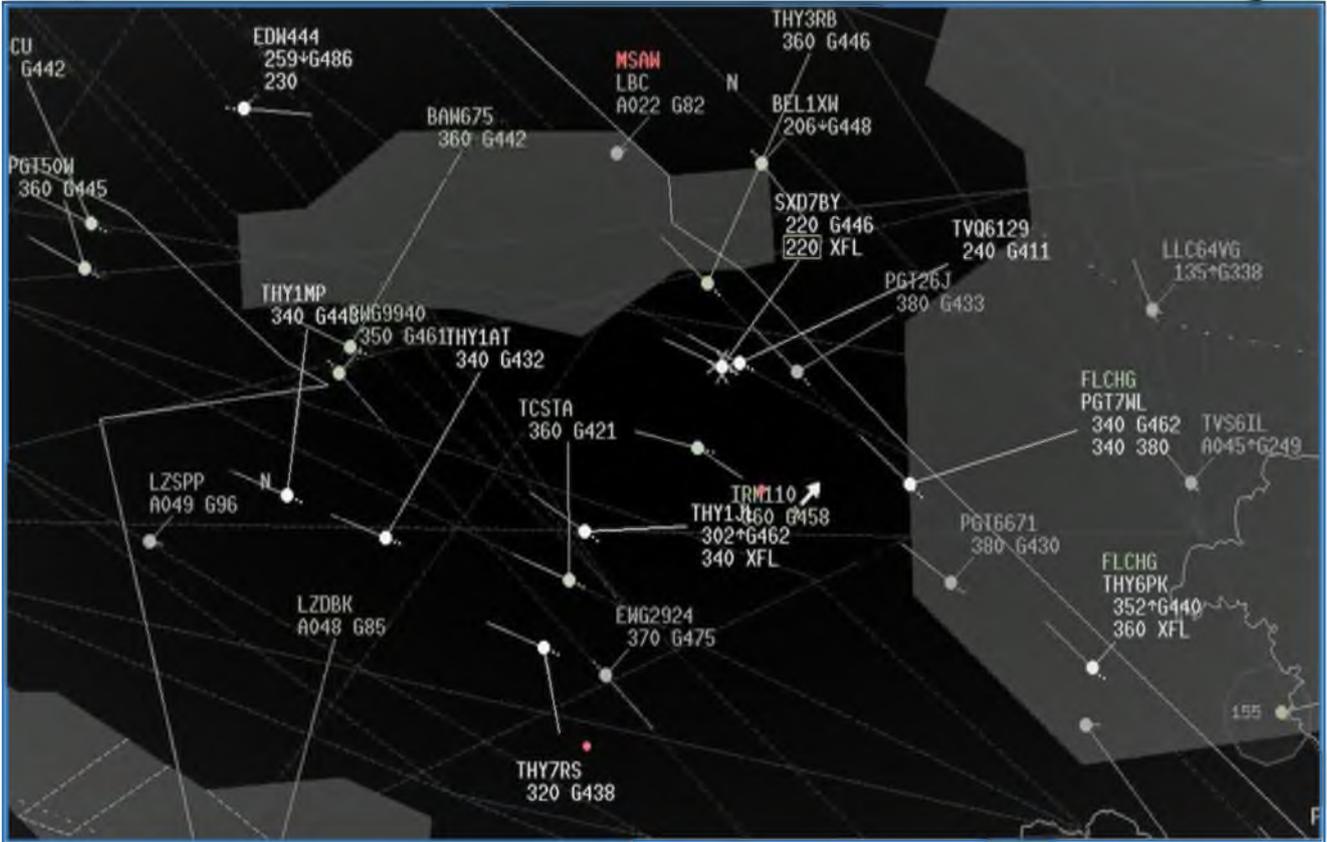
Fig.2

At 06:41:59, a deviation message was presented in the track label of SXD7BY (yellow frame visualized around the 220 FL, warning the ATCO for an existing difference between the CFL, introduced by him and the SAL FL270 by the flight crew, which was displayed on the Controller Working Position of family sector SBL. (Fig.2)

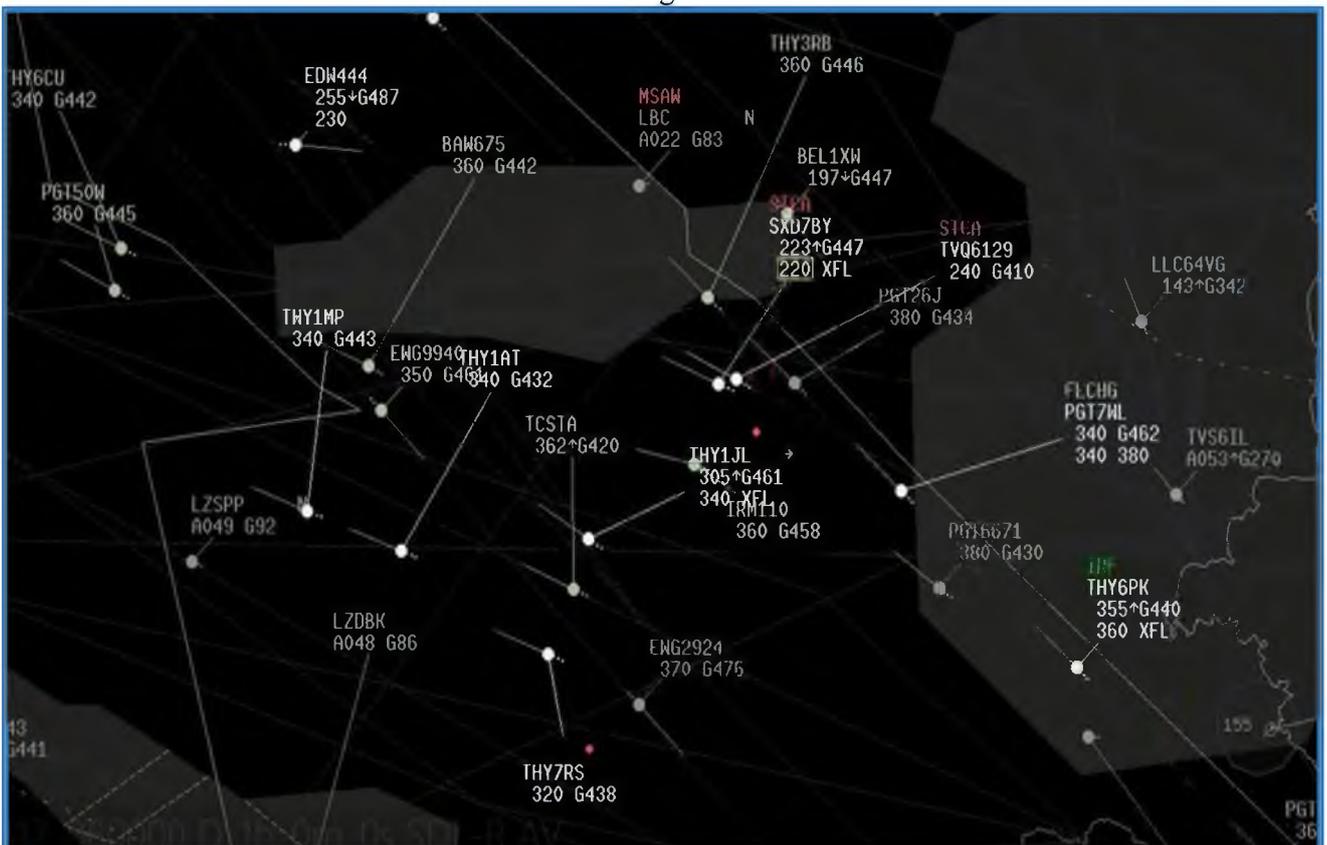
Fig.3

At 06:42:20, SATCAS generated visual indication in bright red colour with sound alarm for a short-term conflict (STCA) between SXD7BY and TVQ6129, which was displayed on the work position of SBL family sector. At this moment, SXD7BY crossed FL223 in climb. (Fig.3)

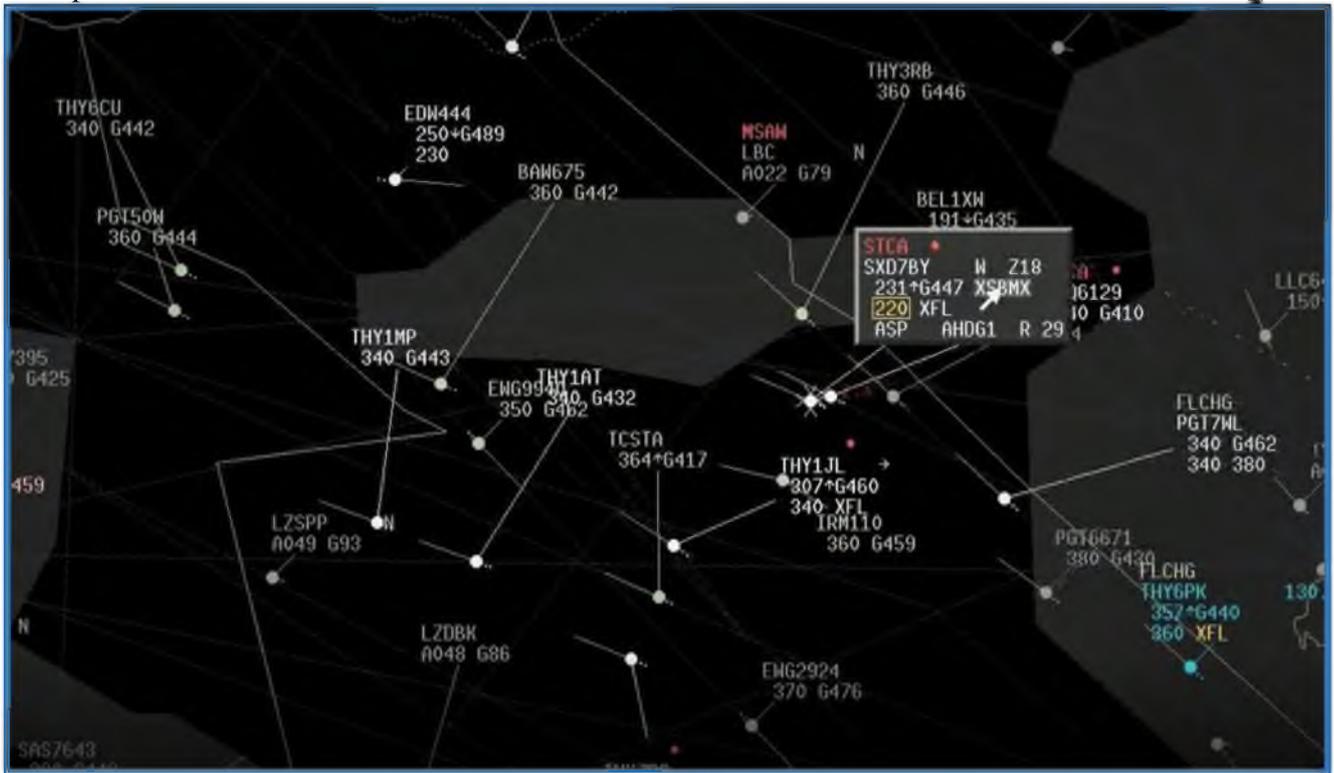
Fig.4

At 06:42:33, the standard for minimum radar separation was infringed between SXD7BY and TVQ6129. (Fig. 4)

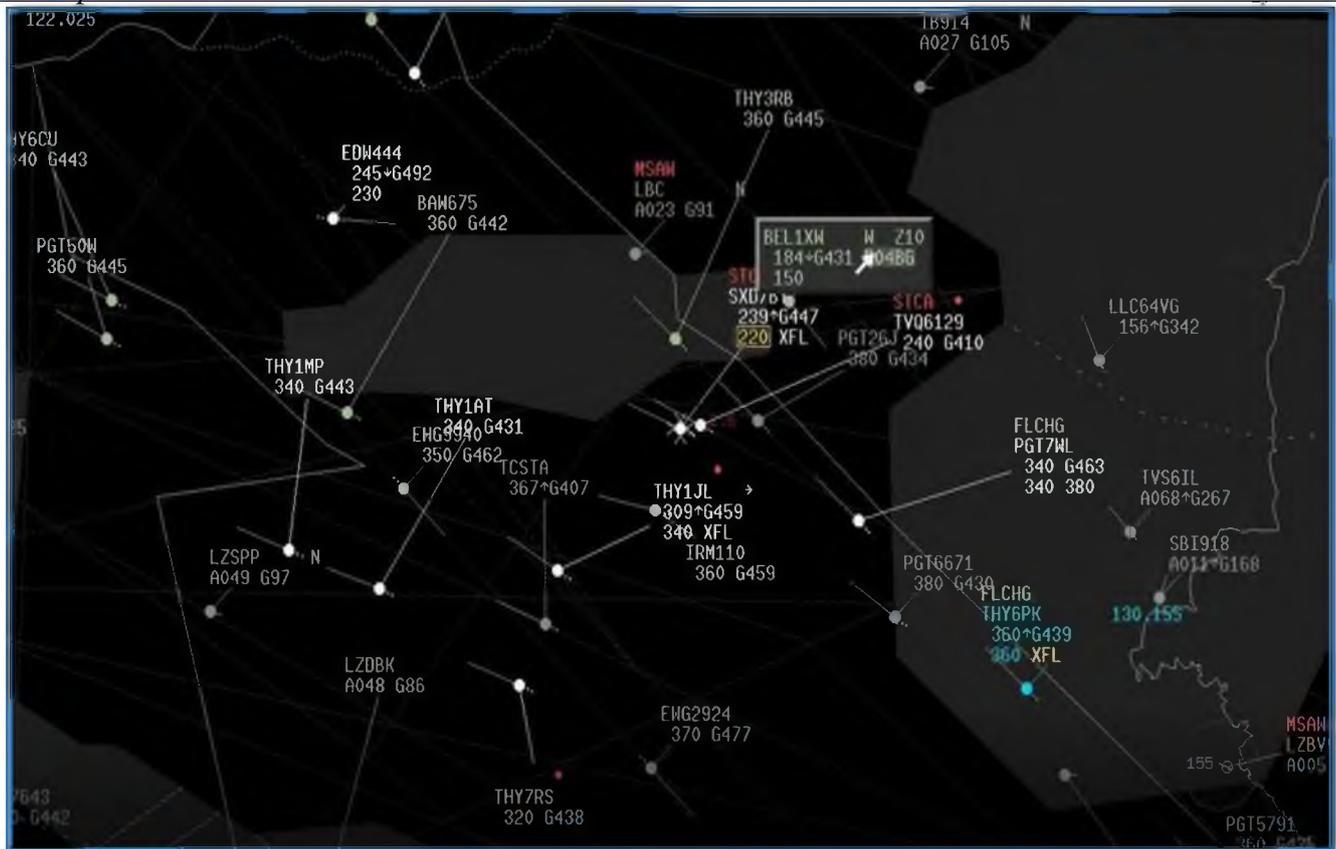
Fig.5

At 06:43:26, the flight crew of TVQ6129 informed EXE ATCO “We have a traffic very close to us, now 5 miles, I suppose. This was well below the minimum”

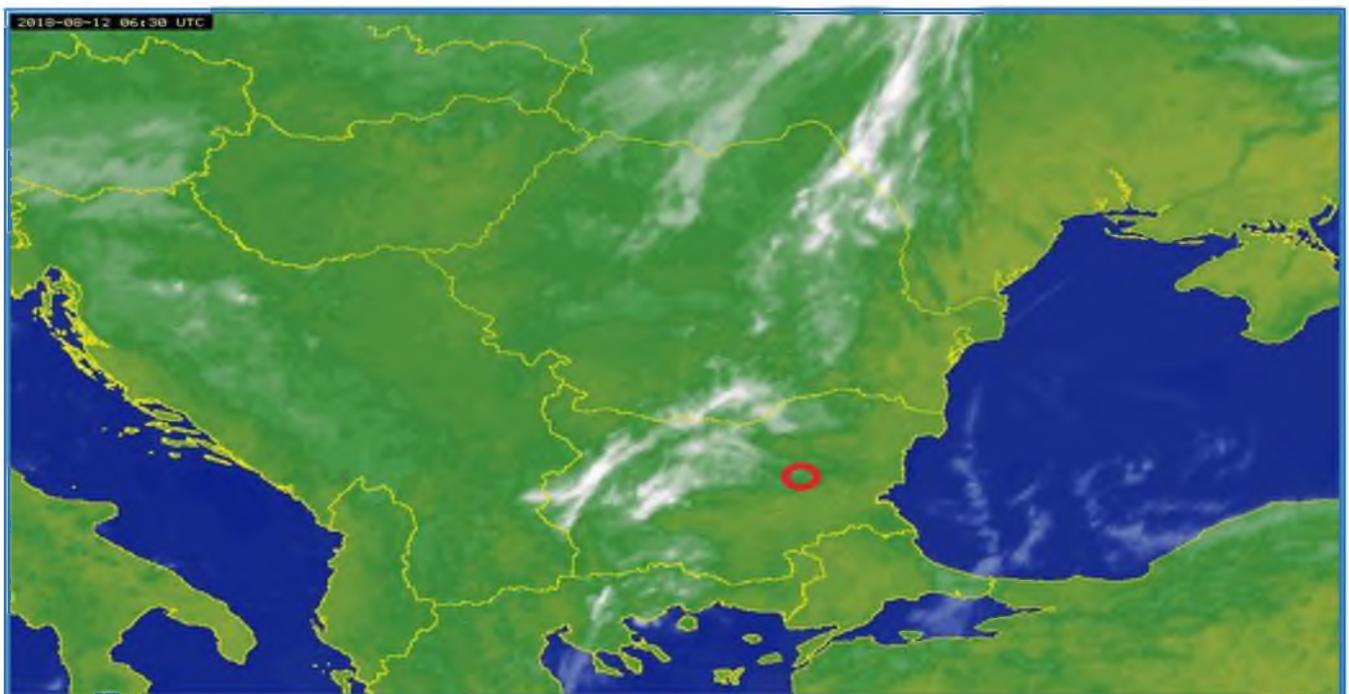
Fig.6

Anticyclone pressure field with stable air mass and no dangerous phenomena were observed. There are no issued SIGMETs for FIR Sofia for that period and no lightning activity was detected. From the

satellite images, high and middle layer clouds were observed over Western and central Bulgaria, and a few middle layer clouds were observed in the area of ARNOV. The wind at FL180 was from North-west / 10kt, at FL240 – North-west / 15kt and at FL300 from West-northwest / 20kts. There was no Jetstream in the area of interest and the wind field should not cause moderate or severe turbulence.

The meteorological conditions at the time of the air occurrence were of no effect to the serious incident.
