FINAL REPORT

Investigation of a serious incident, occurred on July 25, 2018 at Burgas Airport, Bulgaria, involving the McDonnell Douglas MD-82 aircraft, registration marks LZ-LDW, operated by „Bulgarian Air Charter Ltd“, during passenger embarkation

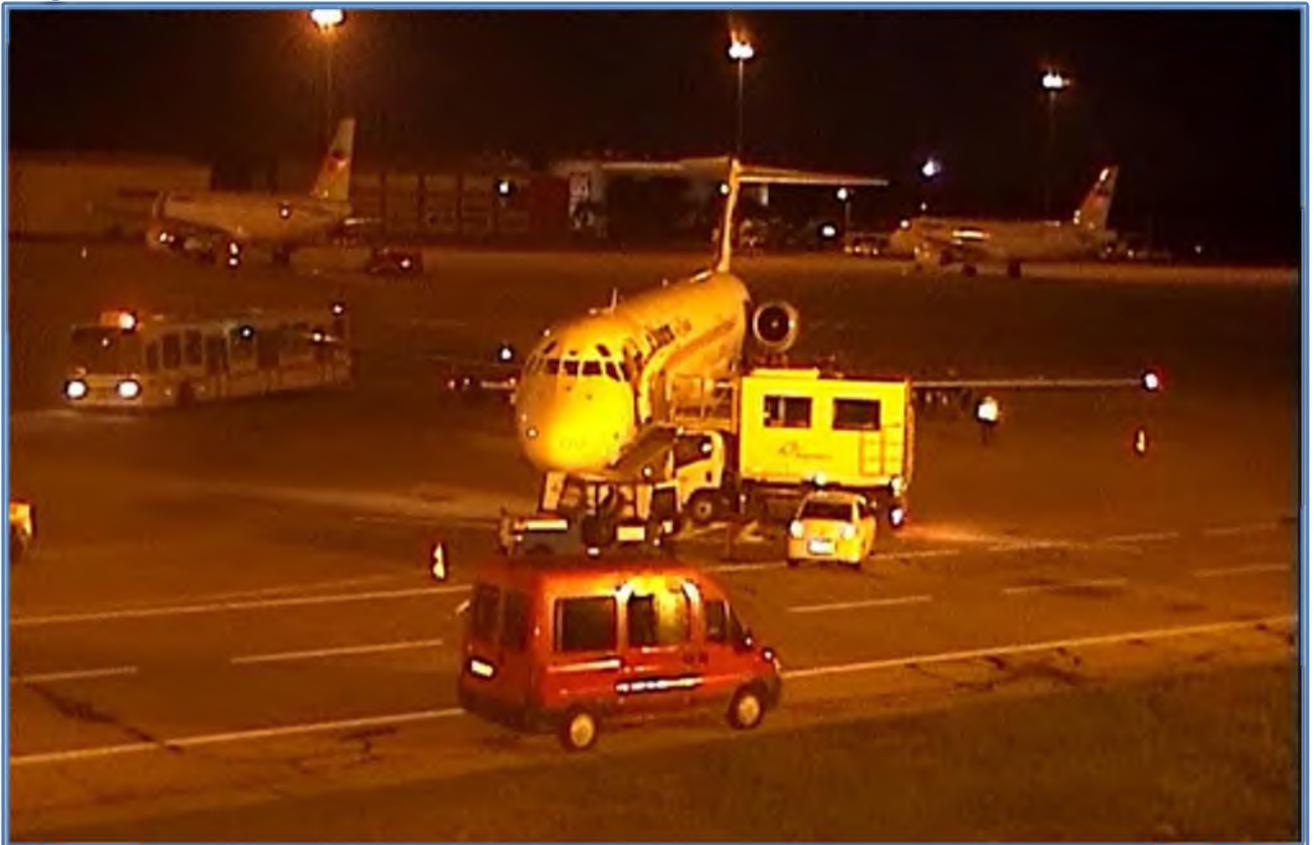
Fig.1

stand 14, the driver of an apron bus started for leaving from the aircraft stand. After leaving, the aircraft stand the apron bus while manoeuvring around the aircraft, hit the wingtip of the aircraft right wing.

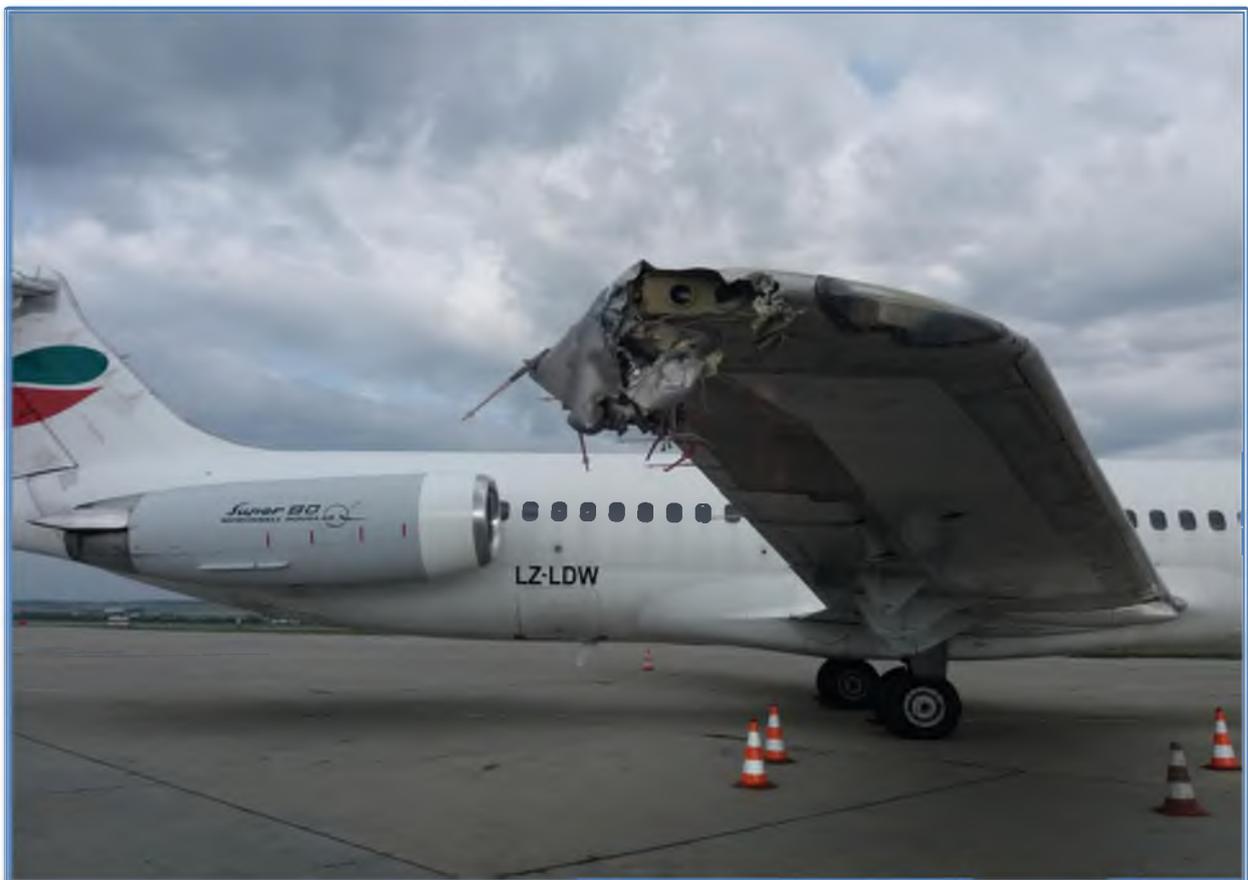
Fig.3

During the inspection of the aircraft at the aircraft stand No 14 at Burgas airport, the following damage were found:

- Damage of the wingtip of the right wing;
- Deformation of the end web of the right wing;
- Broken louver and lamp of the right wing;
- Broken strobe forward light of the right wing;
- Broken wing landing light of the right wing;
- Broken lens of forward position light and strobe light of the right wing;
- Broken fairing logo light of the right wing.

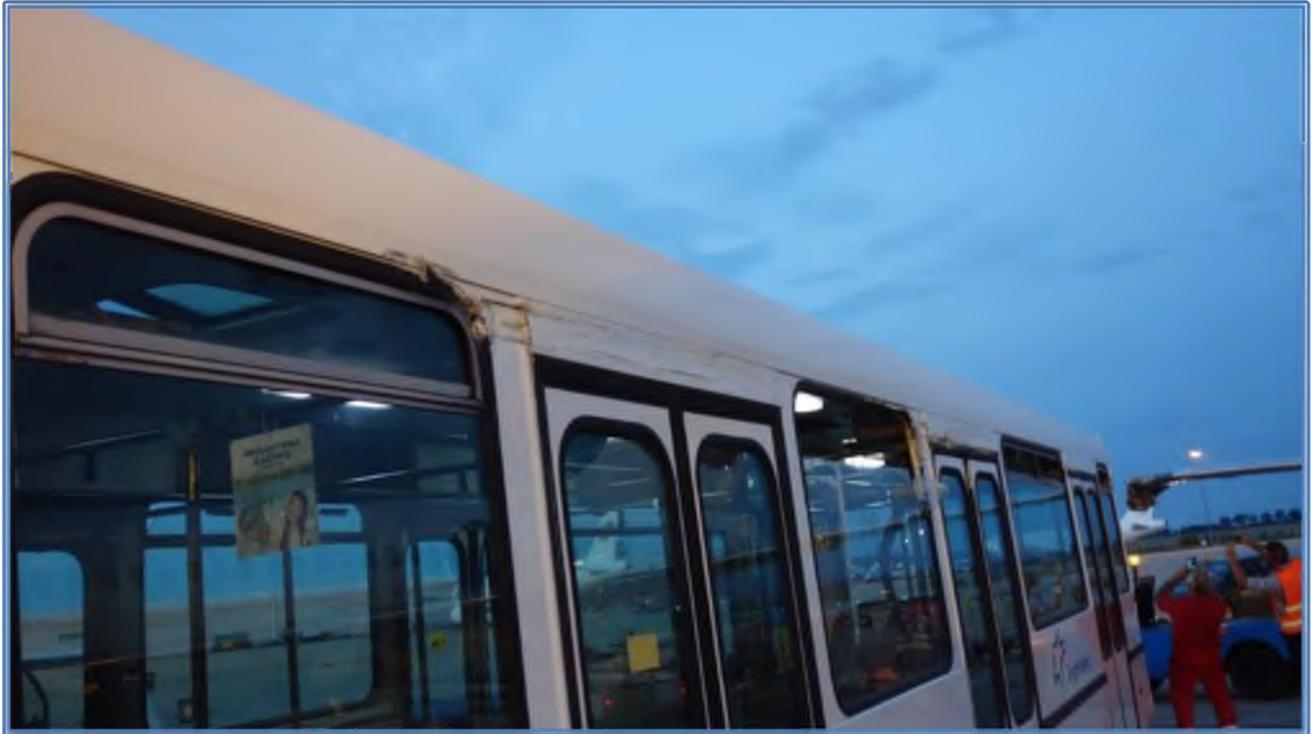
Fig. 4

The apron bus performing passenger transport received the following damage:

1. Deformation of beam and frame of the first left door of the bus;
2. Deformation of frame and broken window between the first and second left door of the bus;
3. Deformation of beam and frame of the third left door of the bus;
