# **FINAL REPORT**

**investigation of an accident, realized on 09.05.2020 with a JA 600 aircraft (SKYLEADER 600), registration marks LZ-ACS, operated by a pilot owner, during landing on the Lesnovo Airfield**

**2020**

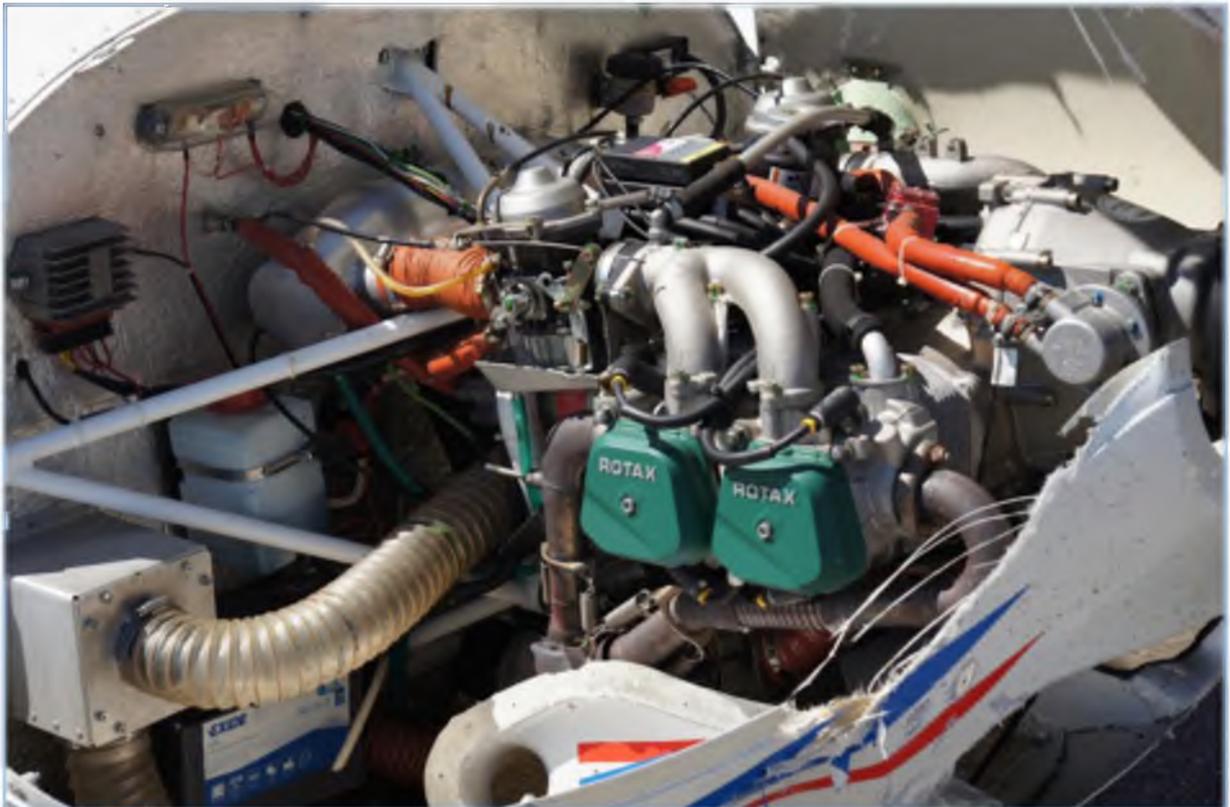
Fig. 8.

The cover of the engine cowling was removed after the contact with the ground in order to break the battery circuit and not fitted thereafter. The aircraft suffered significant damages to the nose part including destruction of the propeller blades, bending of the nose wheel landing gear, partial loss of stability of the engine mounting frame, and deformation of the firewall to which the frame was attached. No ruptures of pipelines was noticed in the engine compartment and at the time of the inspection there were no leaks. Displacement has been found as a result of the impact on of pipelines

of the gas exhaust system and burn-out of a drainage pipe of the drain fuel cuvette of the right-hand carburetor. The above can be seen in Fig. 8, 16, 17, 18.20 & 23 of Enclosure 1. The engine serial number 6784233 is written on the Rotax ULS 412 engine identification plate.

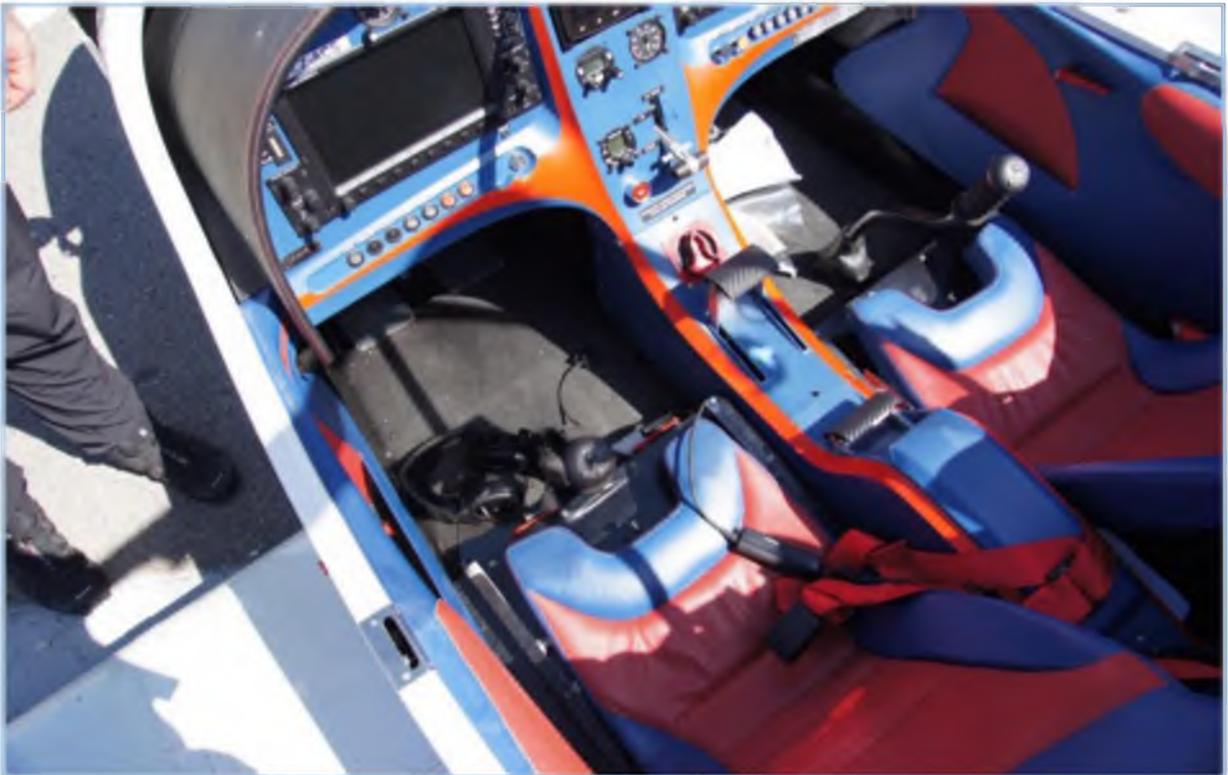
Fig. 10.

The engine is controlled by a throttle control lever in the cockpit. In the picture Fig. 10 of Enclosure 1, made immediately after the landing of the aircraft, this lever was in the extreme forward position corresponding to the maximum engine mode. The lever is connected by a steel wire to the two carburetors. The movement of the carburetor throttle levers follows the movement of the engine control lever and when it is in the extreme forward position, the levers are in position of fully opened throttle valve. No problems were found with the operation of the choke. The control wires are in good condition, when the lever is released, a spring returns the choke to its initial position. The left- and right-hand carburetors are shown in the pictures in Fig. 17 and Fig. 20. In the pictures in Fig. 22 it is visible, that the carburetor heating control button is in closed position. In the pictures in Fig. 9 it can be seen that the switches of the two magnets are in the on position, the electric fuel pump is also on. The engine is controlled from the cock pit properly and responds to impacts.

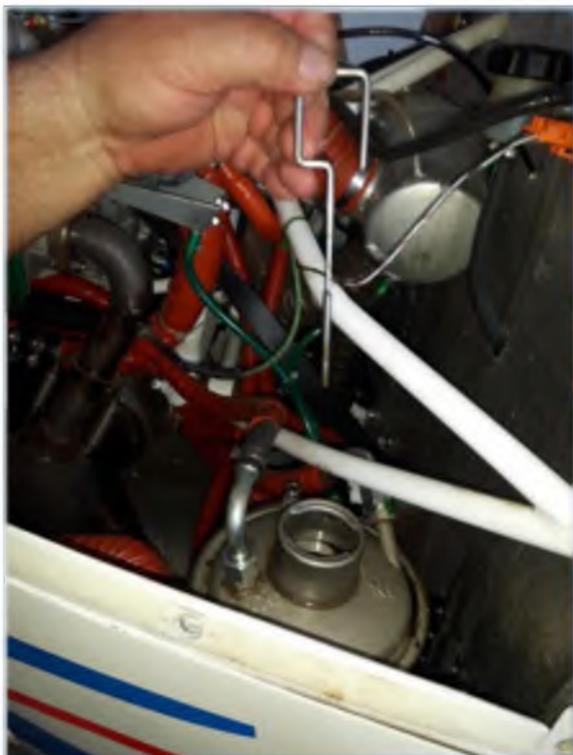
Fig. 16.

On the Fig. 16 of Enclosure 1 shows a picture of the oil tank and the dipstick, which shows the presence of oil in the tank. There is no oil leak in the engine compartment, and when rotating the rotor, it rotates without feeling any seizure. 1 liter of oil was drained for testing. There are no shavings or other mechanical impurities in the oil.

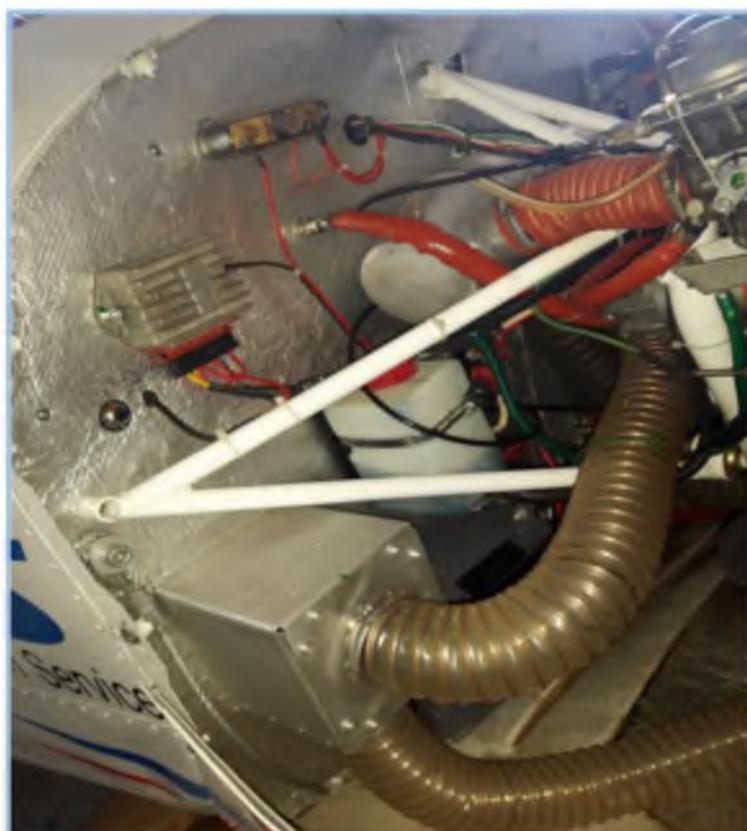
Fig. 18.

On the Fig. 18 of Enclosure 1 shows a picture of the cooling system tank. No coolant leak was observed.

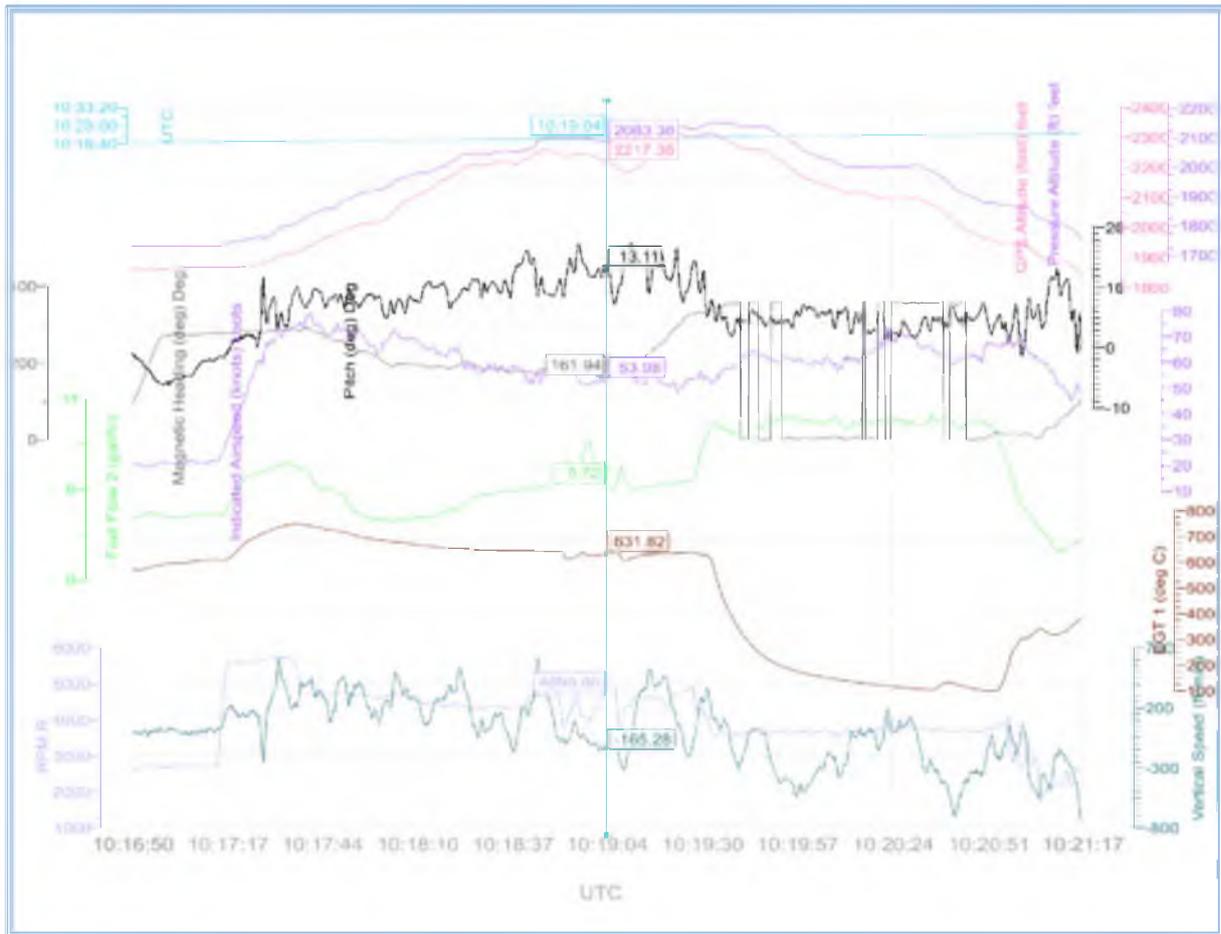
### UTC 10:19:32

At Pressure Altitude 2149 ft, indicated Airspeed 54 kt the engine parameters EGT 1, 2 and RPM L, R start to decrease. Fuel Flow 1, 2 increase.
