FINAL REPORT

Investigation of a serious incident, realized on 14.08.2019 by Cessna 172N airplane, registration marks LZ-SPB, operated by Air Operator Avio Detachment Varna Ltd on Lesново Airfield, District of Sofia

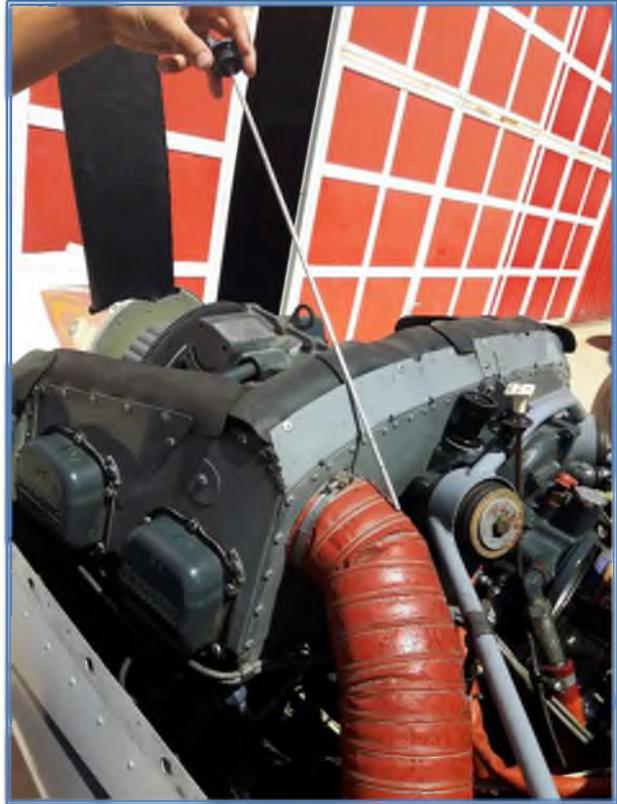
Fig. 9.

There are no signs of fire during the oil leakage. The measuring line is shown on Fig. 9 of Annex 1 indicates for complete leakage of the oil.

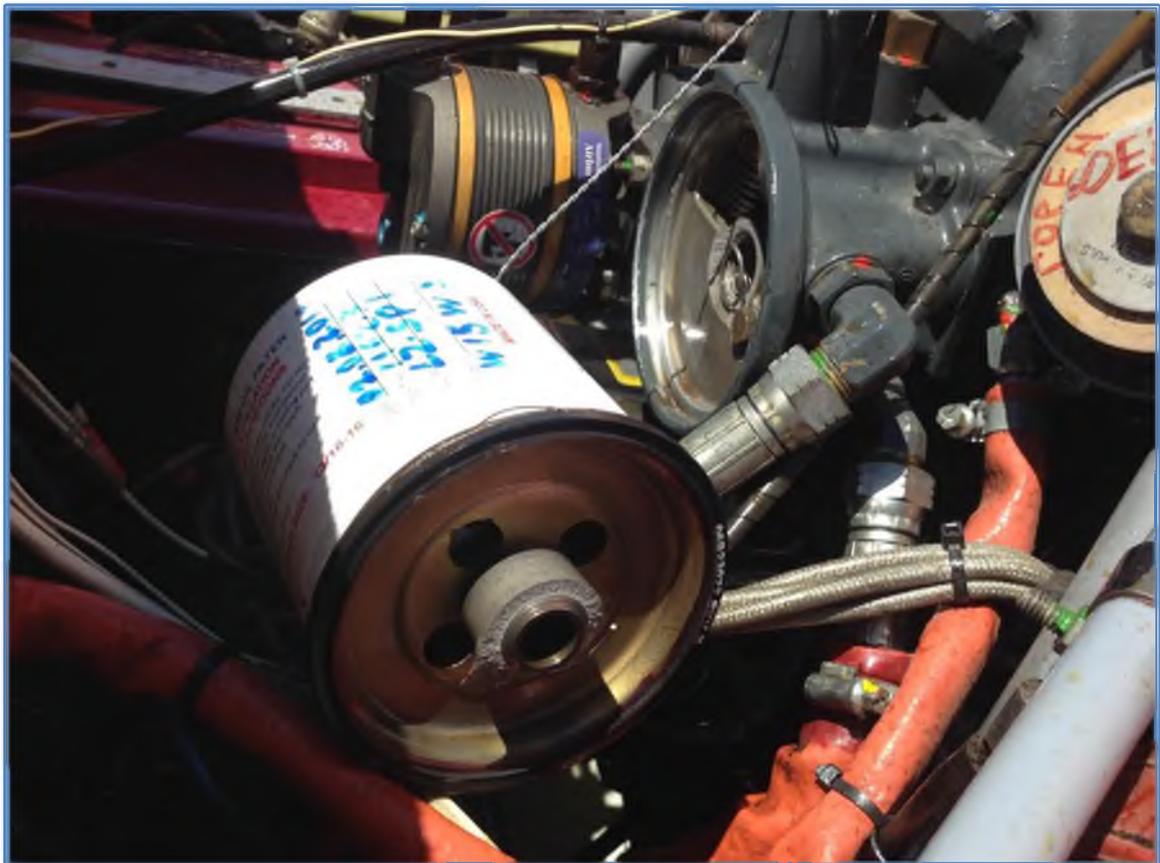
Fig. 10.

- There were traces of oil leakage under the airplane and all over the lower surface of the airframe;
- The oil filter was torn from the adapter plate and attached by the locking wire only, as shown on Fig. 10 of Annex 1;
- Destruction of mounting assembly of the adapter plate at the crankcase, Fig. 11 and 12 of Annex 1;
- Demolition of the valve lifter housing of the outlet valve of fourth cylinder, shown on Fig.13 of Annex 1;
- The mark on the dipstick for controlling the actual amount of oil shown in Fig. 9 of Appendix 1, evidenced of complete leakage of oil, and 200 ml of oil were drained from the crankcase.

After the cabin inspection, the engine compartment was inspected. During the inspection, it was established that the oil filter was torn from the adapter plate and attached to the engine by the locking wire only, as shown on Fig. 10 of Annex 1. There were traces of oil leakage, Fig. 8 and 11 of Annex 1. The location of the oil filter tearing off from the engine housing, the adapter plate to the housing, is shown in Fig. 12 of Annex 1. The inspection of the engine housing also revealed the demolition of the exhaust valve lifter housing of the fourth cylinder, shown in Fig. 13 of Annex 1.

The fractographic analysis has shown that the destruction of the filter was likely to have started as a plastic fracture in the cross section of the adapter sleeve about 50% and the final breakage was a brittle fragile. On the Fig. 10, 11, 12, 14, 15, 18 и 23 are shown pictures of this destruction. Para2.12 states the findings after disassembling of the detached filter assembly. When considering the outcome of the fractographic analysis and the findings made during disassembly, several possible scenarios related to the destruction of the assembly might be identified. For each of them there is a certain effect of reducing to some extent the area of the bearing cross section of the sleeve, associated with the insertion of the helical spring to form the inner thread of the sleeve. As it was indicated in para2.12, such a spring may be fitted during the engine overhaul.

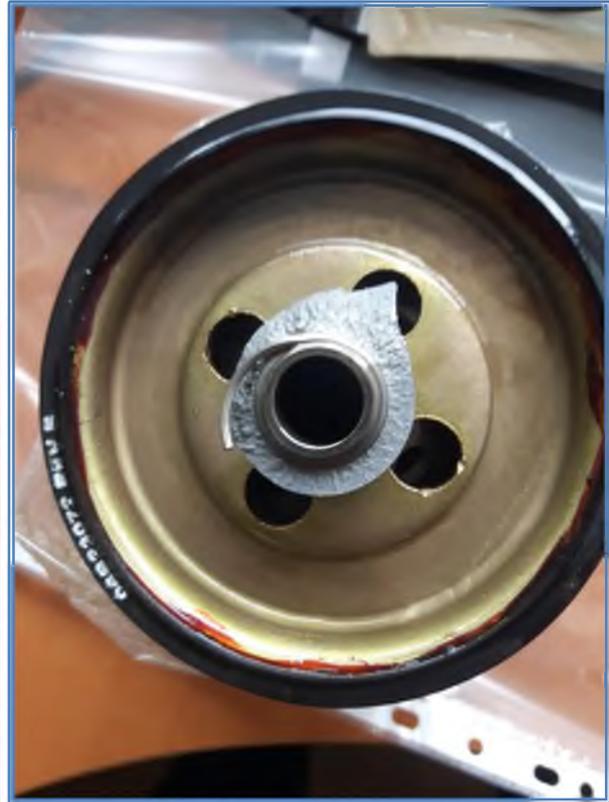
Fig. 14.

Upon inspection of the detached filter assembly from the engine, it was found that the adapter sleeve of the filter adapter plate to the adapter housing was broken, Fig. 14 and 15 of Appendix 1.

1. Traces of spreading over the adapter plate seal holder with some screed for fixing when securing it or for improving the seal due to possible leakage, Fig. 14 and 15 of Annex 1;
2. Significant residual deformation (flatten) on the adapter plate, Fig. 15 and 18 of Annex 1.
3. Traces of impacts with a solid metal, notches, on both surfaces of the adapter plate at the locations of the oil passage openings, Fig. 18, 29 and 22 of Annex 1.
4. Traces of corrosion of the material on the sleeve, in which helical spring is mounted.
5. Unscrewing the adapter plate from the filter was made by attaching it in a vice and using a device for unscrewing, made of a tooth chain; considerable force was applied, but it was not measured due to the absence of a torque measuring device.
6. Considerable force was also applied to unscrew the stud from the adapter plate.

In the findings made when disassembling the assembly of the detached filter, it was stated that traces of spreading of some kind of paste on the bed of the adapter plate seal have been found, Fig. 14, 15, 18 and 21 of Annex 1. Such kind of spreading might be made in order to fix the seal at installation or to improve the sealing in case of leakage. In the first case it is not related to the load on the assembly, but in the second one it may be related to the additional tension of the sleeve in order to stop leakage. It is more likely, that this was done during the overhaul when the gasket was replaced, but the possibility that it was made in operating conditions should not be excluded; however, there are no entries for this in the technical documentation kept by the operator. Under all conditions, tightening of the sleeve or filter may cause plastic deformation observed in the fractography of the fracture. It is also possible to have a complex effect of tightening, combined with a reduced cross section from the threaded spring installation. Further fracture, brittle one, can be caused also by vibrations.

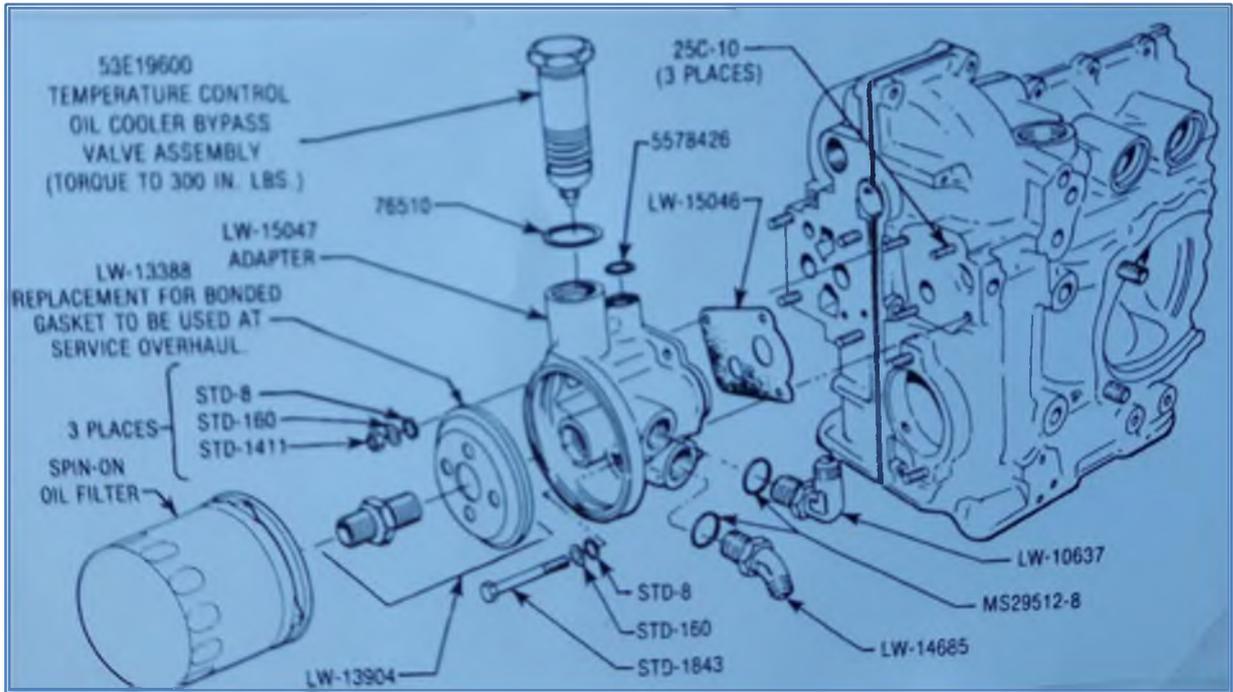
Fig. 16.

In the scheme on Fig. 16 taken from SSP-885-1 ENGINE MOUNTED OIL FILTER KITS AND REPLACEMENT FILTERS OF TEXTRON LYCOMING, dated from April 1986., it is shown, that the seal of adapter plate shall be replaced at major overhaul. In the same diagram, the steel helical spring is not shown as an element of the adapter arrangement.

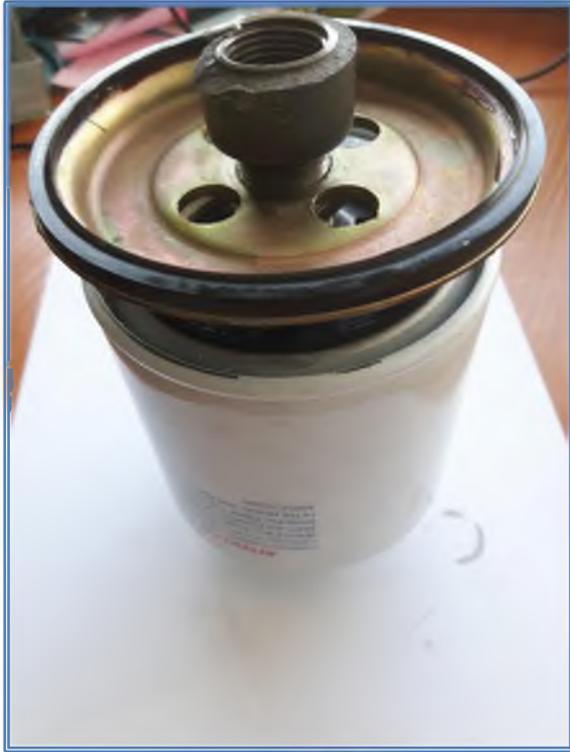
Fig. 18.

The Commission failed to explain the reason for traces made by a solid metal, described in para 2.12 on the both surfaces of the adapter plate at the locations of the technological opening for oil passage, fig. 18, 21 and 22 of Annex 1.

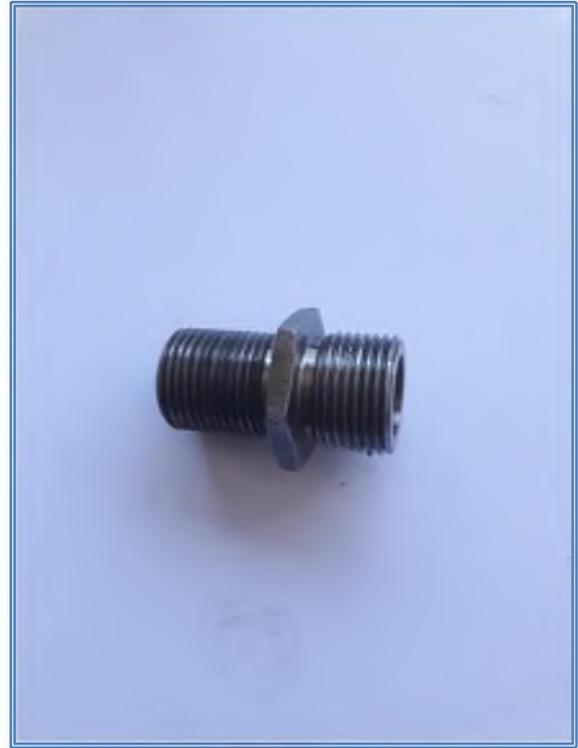
Fig. 19.

The sleeve is mainly loaded by the tightening force of the stud, shown in Fig. 19 of Appendix 1, by the force caused by tightening of the filter on the stud, by vibrations of engine running and the vibrations of the aircraft when moving on runway.
