FINAL REPORT

Investigation of a serious incident, occurred on January 26, 2019 at Sofia Airport, Bulgaria, involving the AIRBUS 320-232 aircraft, registration marks G-EUUL, operated by “BRITISH AIRWAYS PLC”

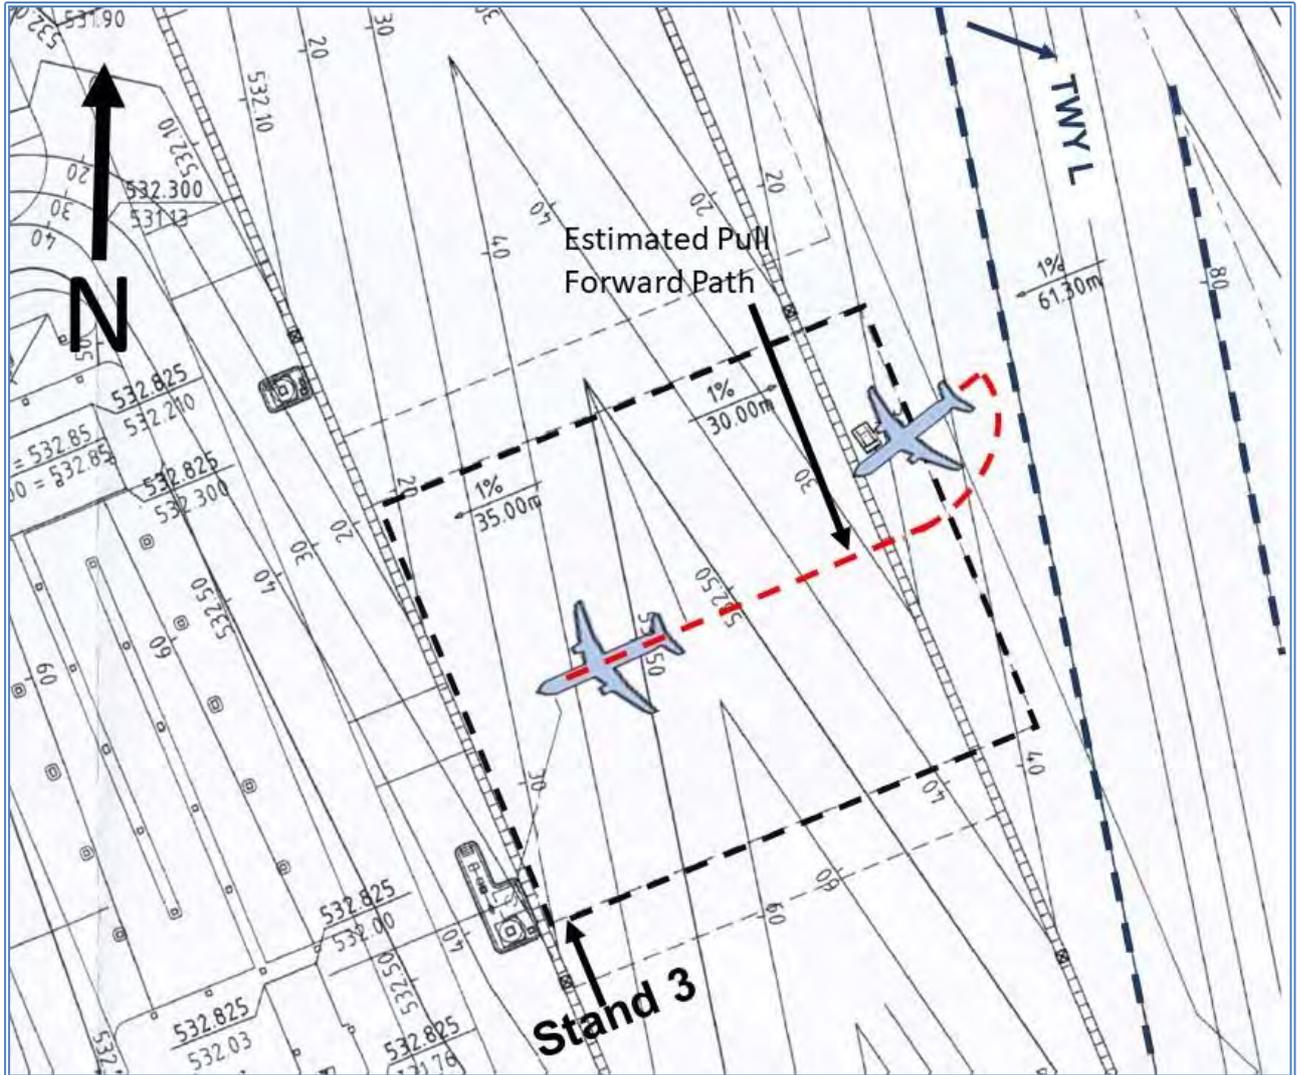
Fig.1 Path of the aircraft during the push from stand No 3 to TWY “L”

While the aircraft was being pushed in a straight axis towards the rear end (red borderline in Fig. 1), the flight crew started the starboard engine No2 on the aircraft stand. After crossing the borderline with TWY L, the main landing gear of the aircraft began to climb up the slope to centreline of the taxiway.

At this point, the driver of the tug began a manoeuvre to turn the nose of the aircraft along the yellow line of the southern arc, to the centreline of the taxiway TWY L, pointing the aircraft's nose to the south. When the tires of the main landing gear of the aircraft were at the highest point of the slope taxiway, the crew started the left engine No1 of the aircraft.

At this time, the tug entered an icy surface pavement area where it began to slip in place, while the aircraft stopped moving backwards. The tug failed to continue pushing and even began to slide backwards, pushed by the force of the forward-moving aircraft.

The tug driver attempted to stop the tractor and the aircraft by pressing the brakes. The tractor stopped, but the aircraft continued to move forward. Since the tug had stopped and the rear end of the towbar was attached to it, the front end rotated the nose landing gear 90° degrees to the direction of movement of the aircraft.

However, the aircraft continued to slide forward along the icy surface, breaking two of the tear bolts (pins) of the towbar, which started diverting backwards. The plane continued its forward movement, passing the tug, which remained on the side of its starboard side until the attacking edge of the inlet cowl of the starboard engine collided into the left side of the tractor. Then the aircraft stopped moving.

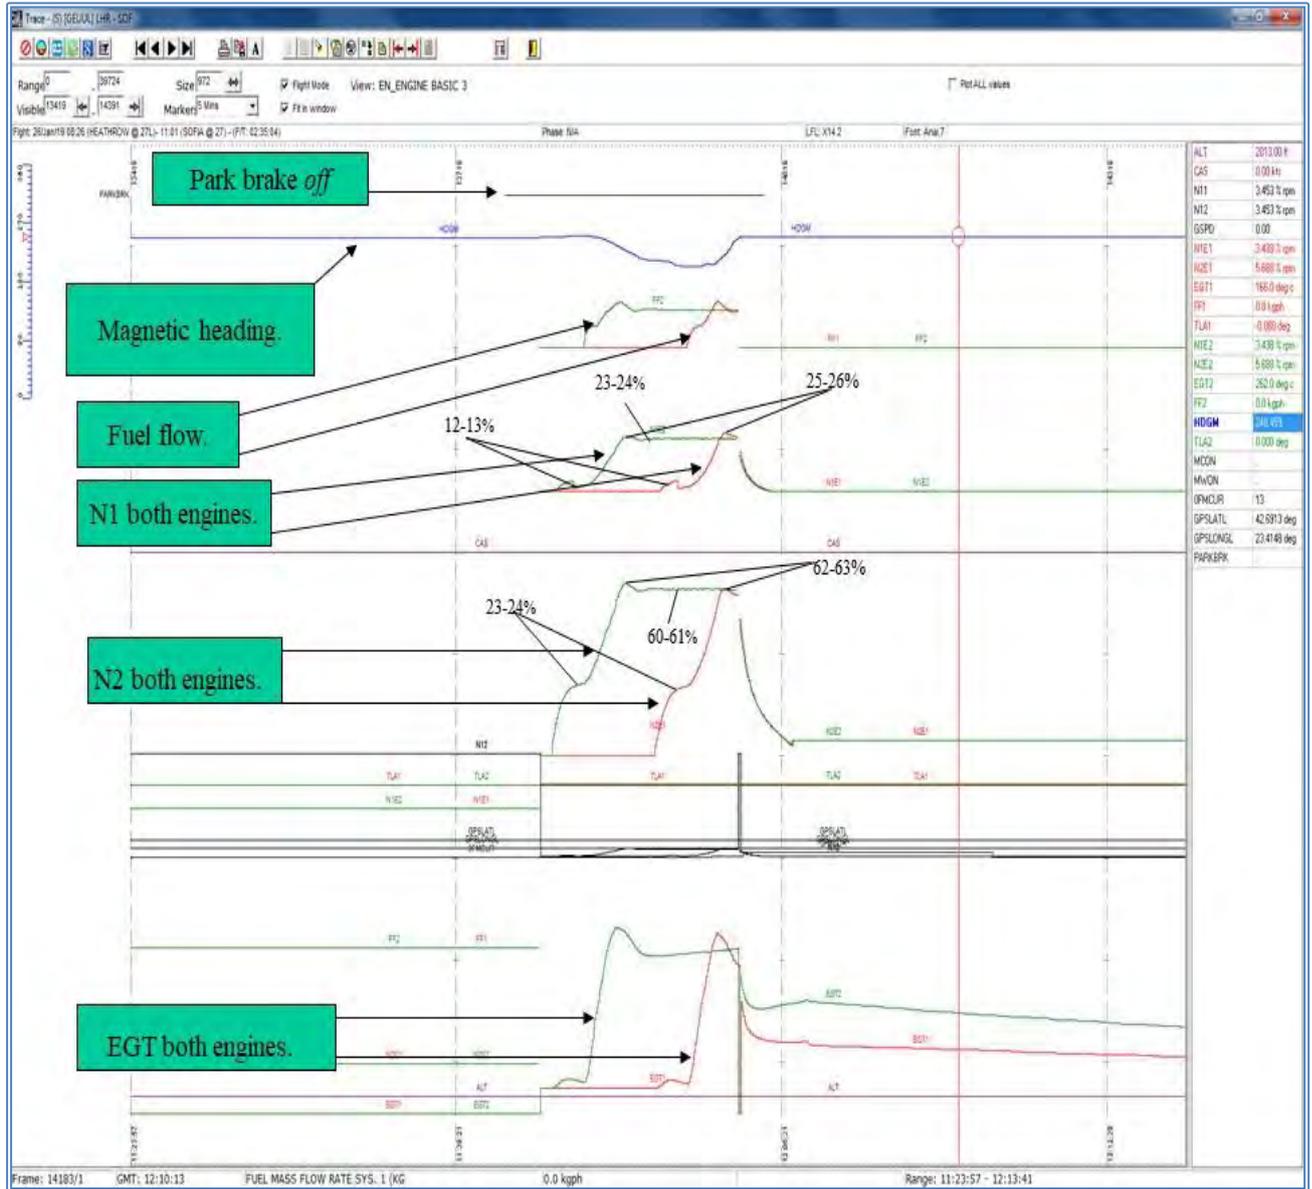
Fig.3

This data indicated that the starboard engine was being started during the pull forward manoeuvre.

The maximum engine rotation speeds reached during the start procedure were recorded as 62% N2 and 25% N1. After 1:35 min when the tires of the main landing gear of the aircraft are at the highest point of the slope of the taxiway TWY L, the flight crew was started the engine No 1 of the aircraft, with the maximum rotation speed was reaching approximately 62% N2 and 25% N1.

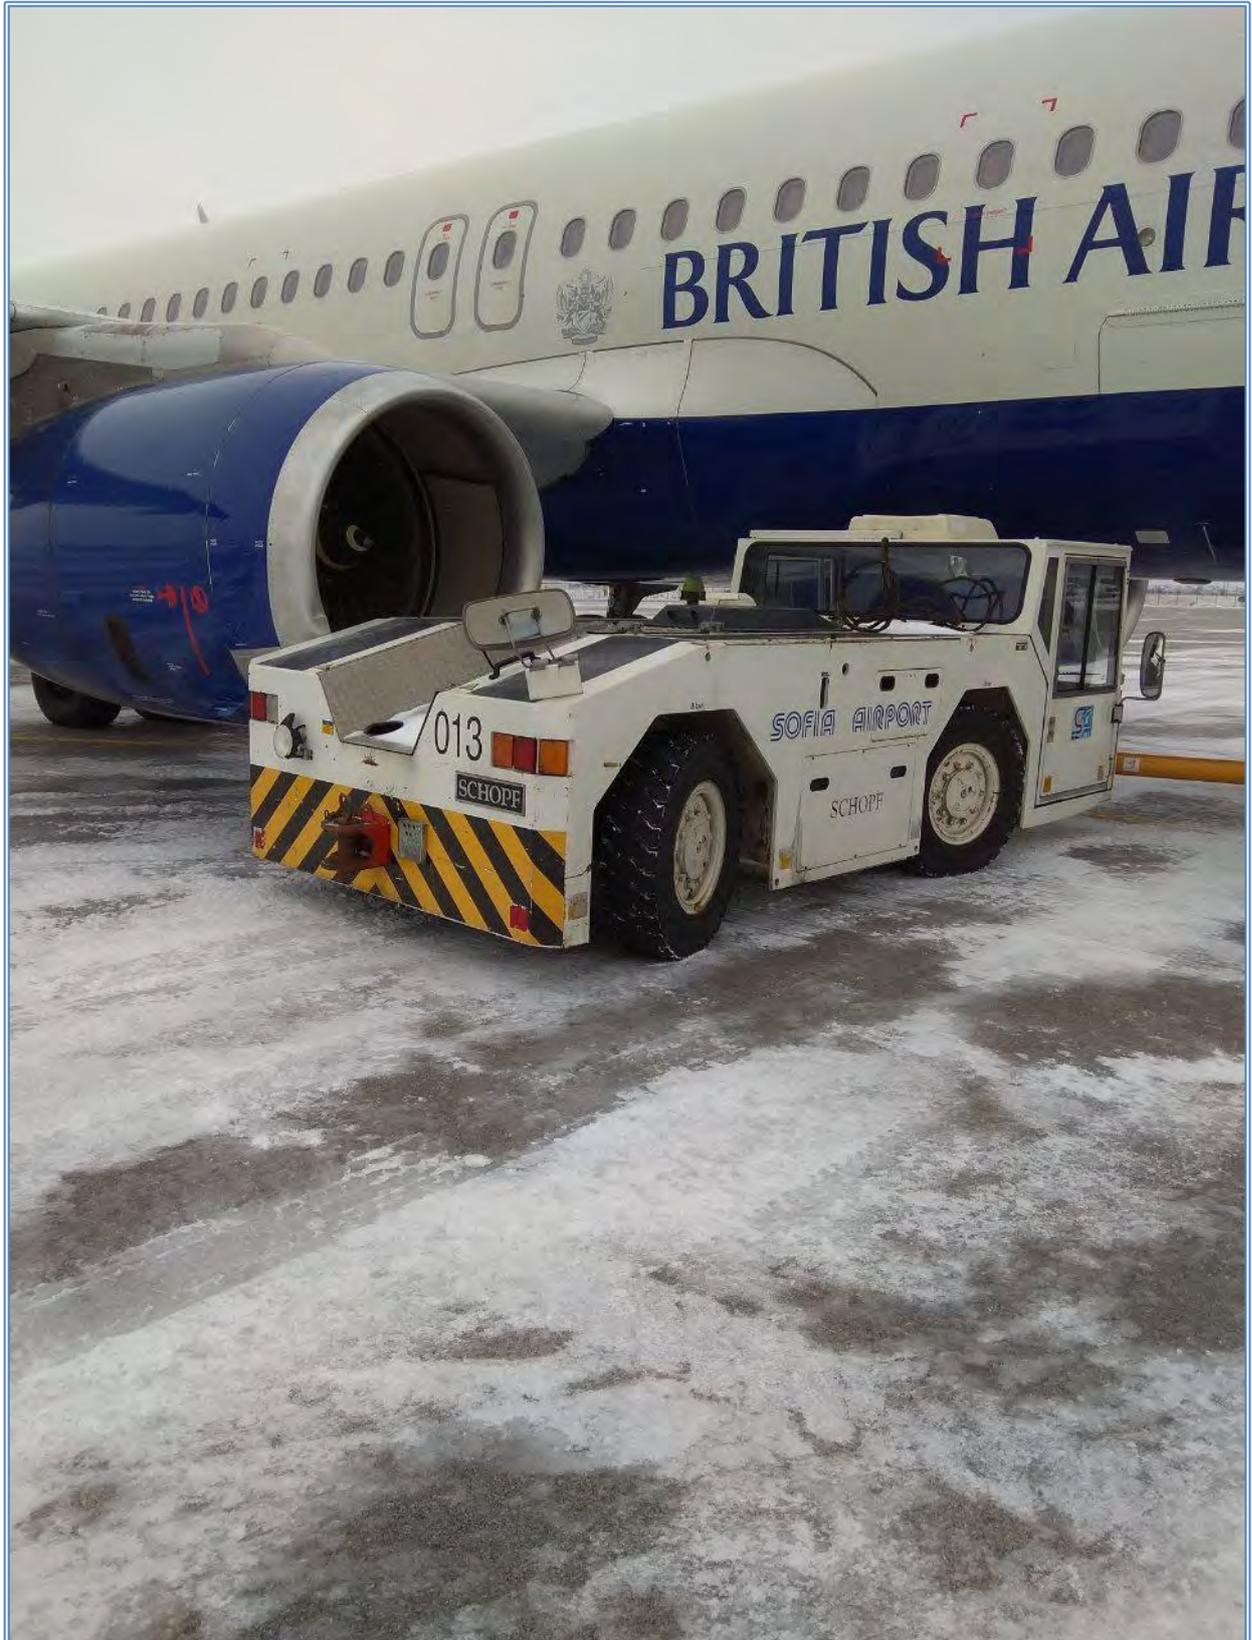
Fig. 1.

- The lower part of the nose wheel is rotated at an angle greater than 90° and remains in this position. This can be seen in fig. 9 of Appendix 1.
- Dent on inlet cowl of Engine No 2 nacelle. Fig. 1, fig. 3 and fig. 4 of Appendix 1.
