AIR, MARITIME AND RAILWAY ACCIDENT
INVESTIGATION NATIONAL BOARD
9, Dyakon Ignatiy Street, 1000 Sofia, Bulgaria

Ref.:
AAIU-2021-02

**SERIOUS INCIDENT, OCCURRED ON MAY 22, 2021,
INVOLVING A320-214 AIRCRAFT, REGISTRATION
MARKS LZ-FBC, OPERATED BY „BULGARIA AIR“,
PERFORMING FLIGHT FROM SOFIA TO SHARM EL-
SHEIKH**

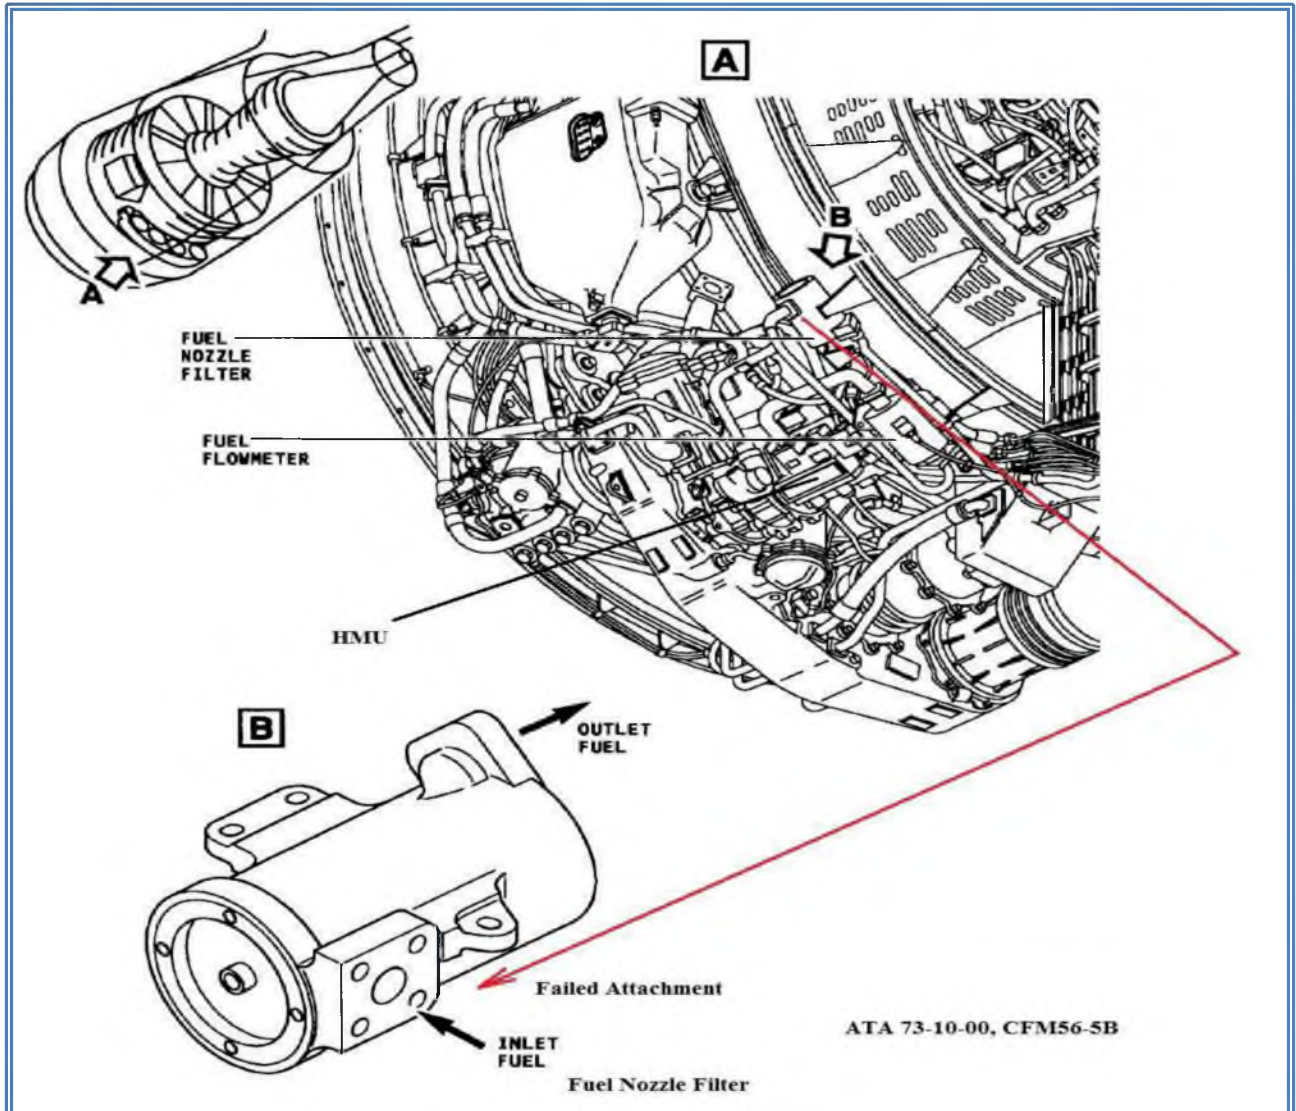
Fig.1

During the inspection performed after landing, a fuel leakage was found from gasket between fuel hose tube and fuel filter.

After the detection of the leak is established, that bolts connecting fuel hose/tube to fuel filter were not tightened properly. No fuel leakage is observed through the loose connection flange when the engine is operating mode "Idle" on ground. During the take-off phase, along with higher engine vibrations, increased fuel pressure and mass flow have been able to overstrain and dislodge the partially loosen gasket, causing a massive fuel leak and loss right at the entrance of the Fuel Nozzle Filter, which leads to Engine No 1 failed and flamed out.

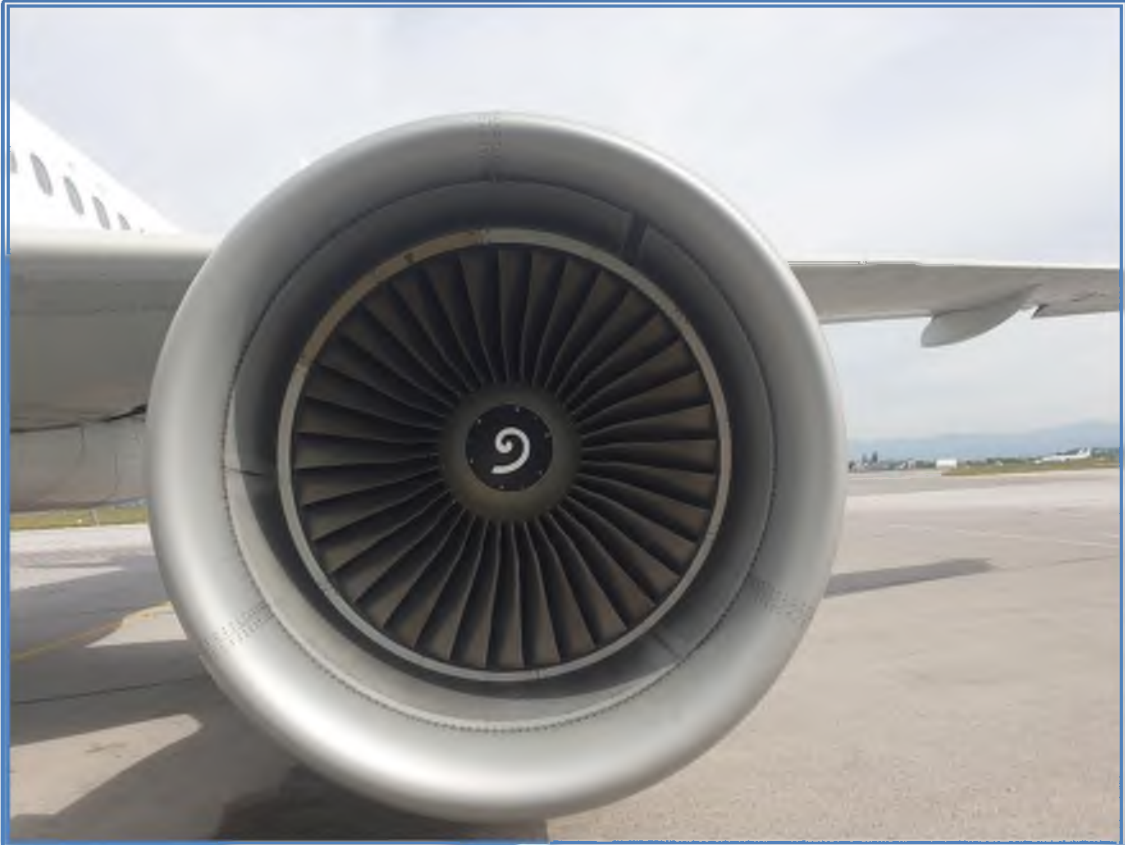
Fig. 1

No damage to the airframe was detected during the visual inspection performed after the completion of the flight, see Figures 1 and 2 of Annex 1.

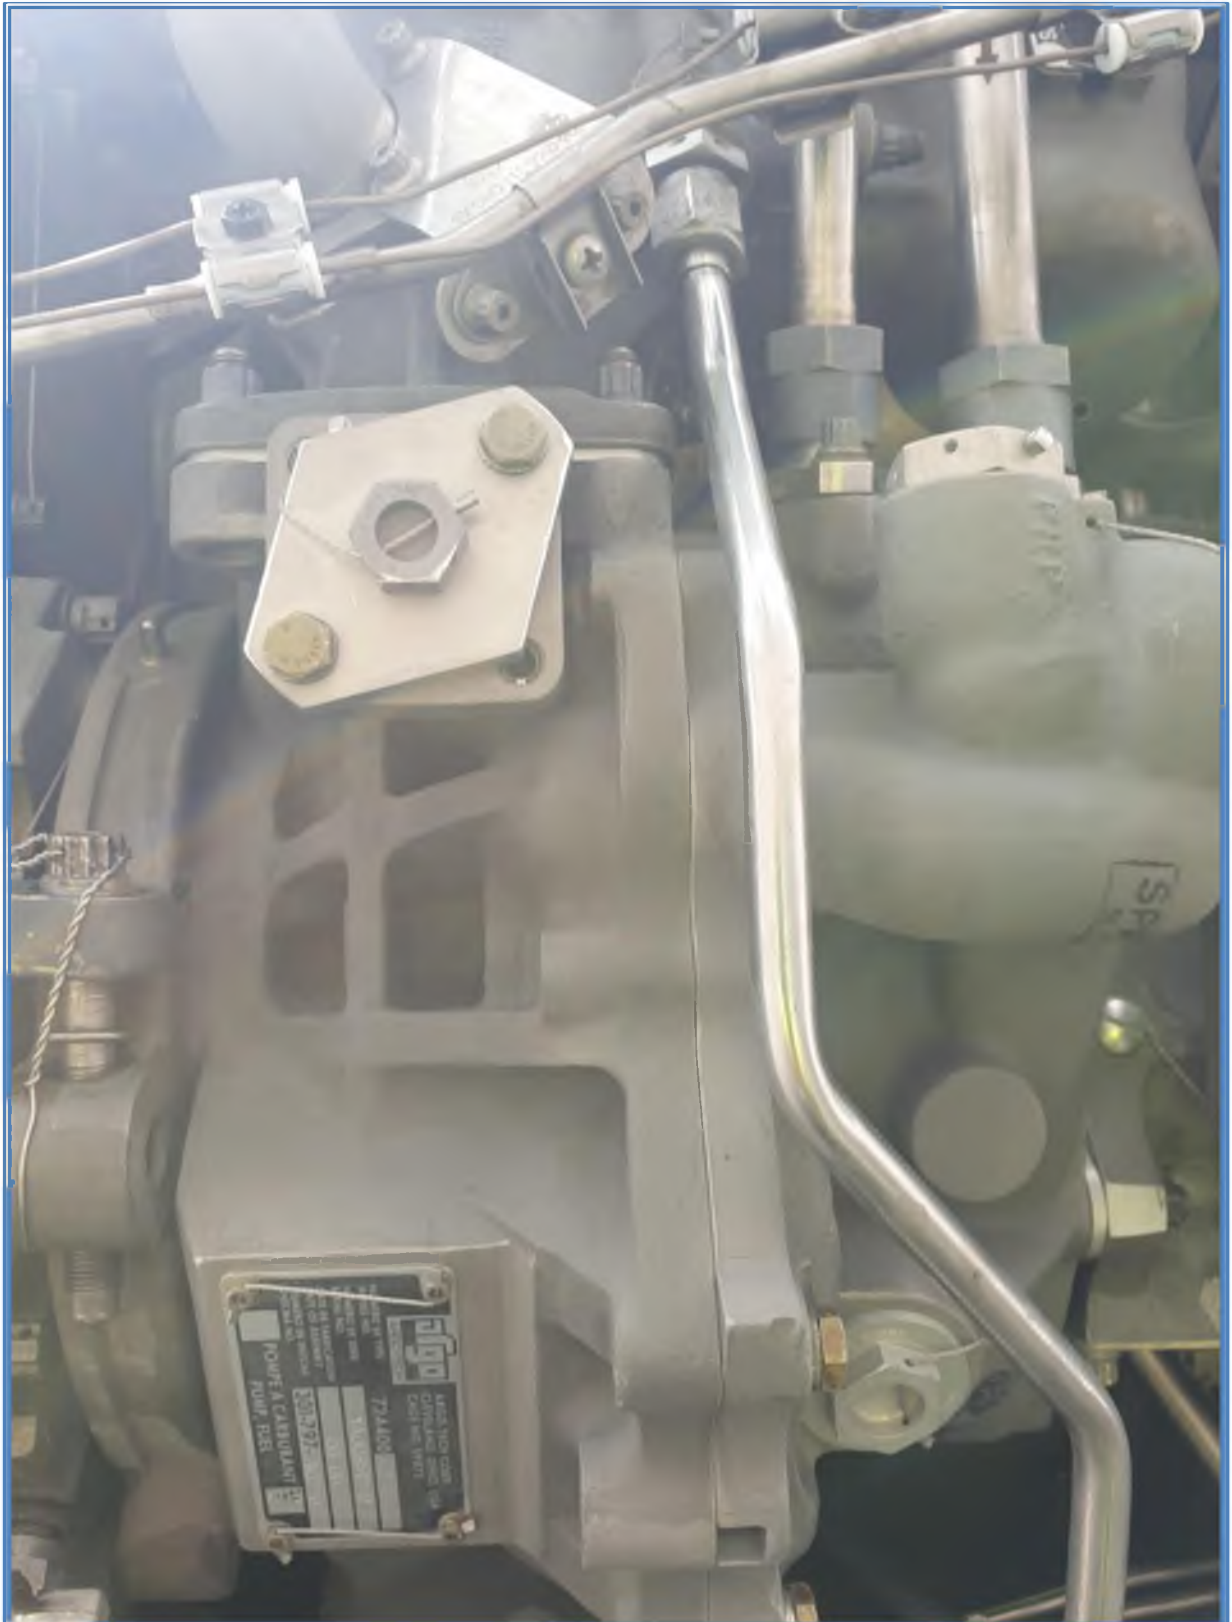
Fig. 3

Three bolts were found loose from the fuel line connection flange to the fuel manifold and fuel filter. The loose bolts and the resulting fuel leak can be seen in Figures 3 to 8 of Annex 1.

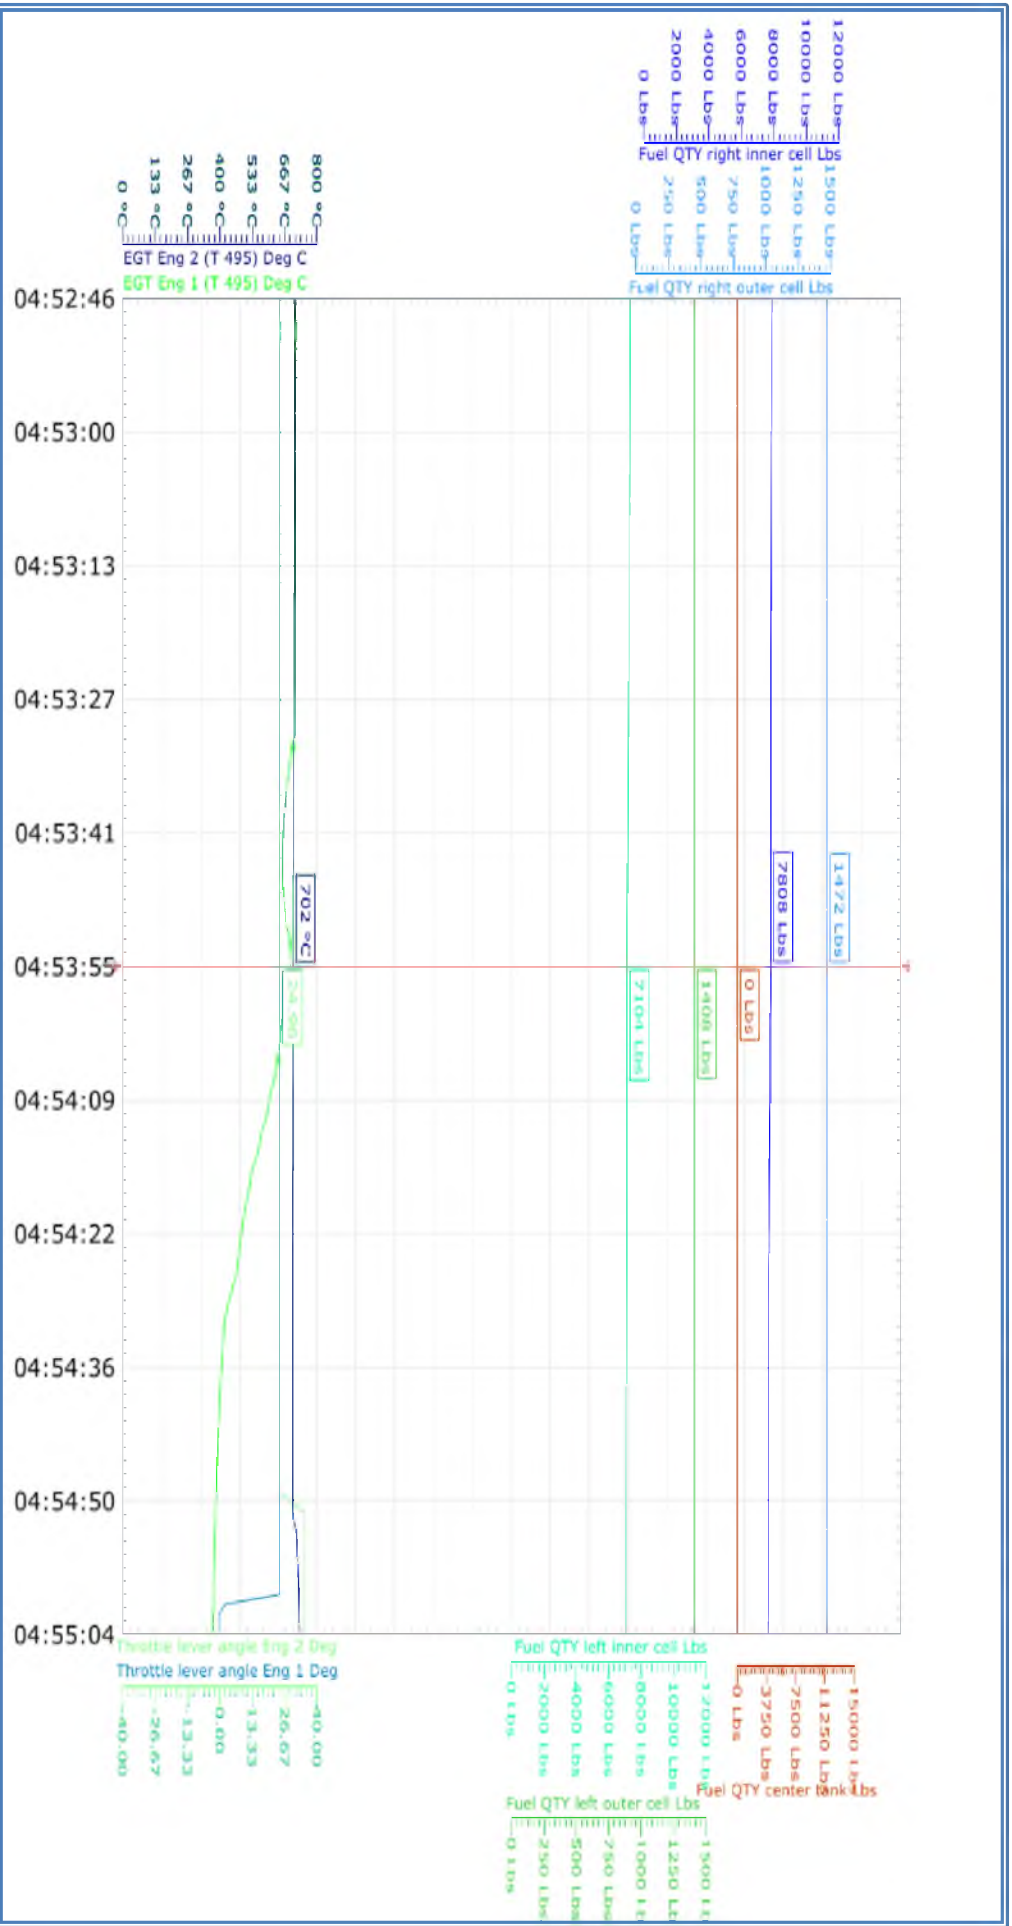
04:54:40 ENG 1 OIL LOW PRESSURE and Master Caution alarms
