FINAL REPORT

Investigation of a serious incident, occurred on February 26, 2018 at Sofia Airport, Bulgaria, involving the AIRBUS 321-231 aircraft, registration marks HA-LXP, HA-LXL and HA-LXD, operated by “Wizz Air”

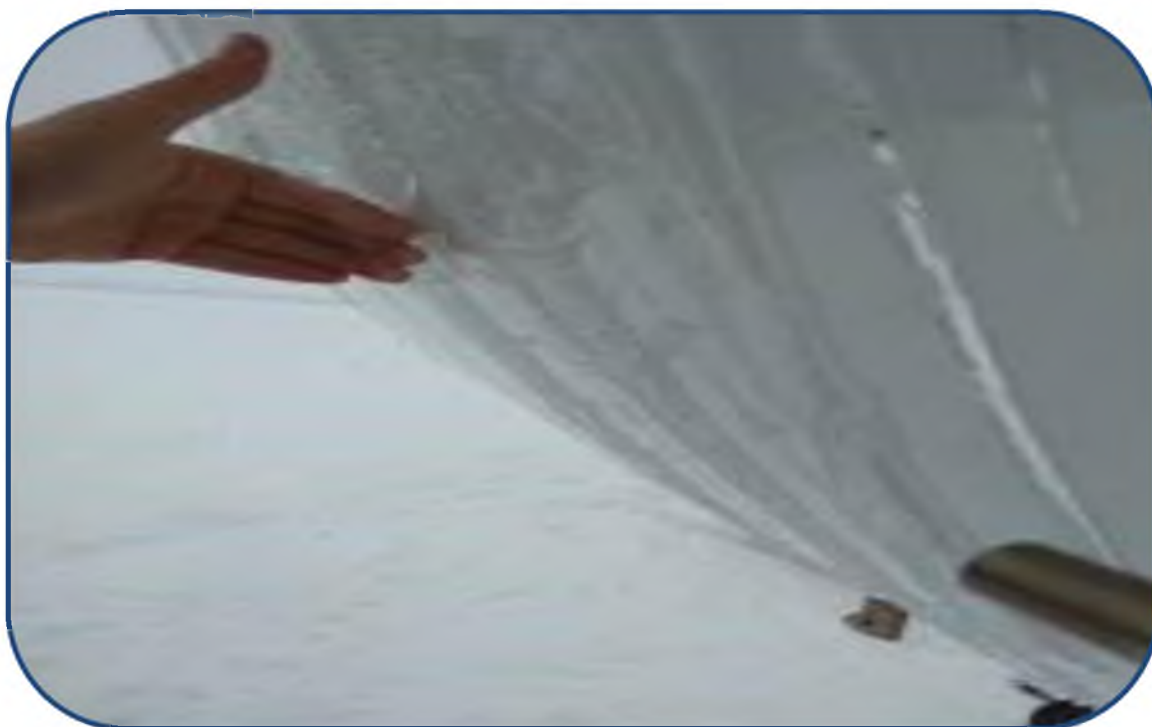
Fig. 1

As seen from the above photo, the flowing melted snow from the warmed shelter of the aircraft on the insufficiently heated side and bottom surface of the aircraft fuselage froze in the form of ice ridges on the lateral surface of the aircraft fuselage in front of the dynamic pressure sensors, which caused deviation in the readings between the different speedometers in the cockpit and a change in aerodynamic characteristics.

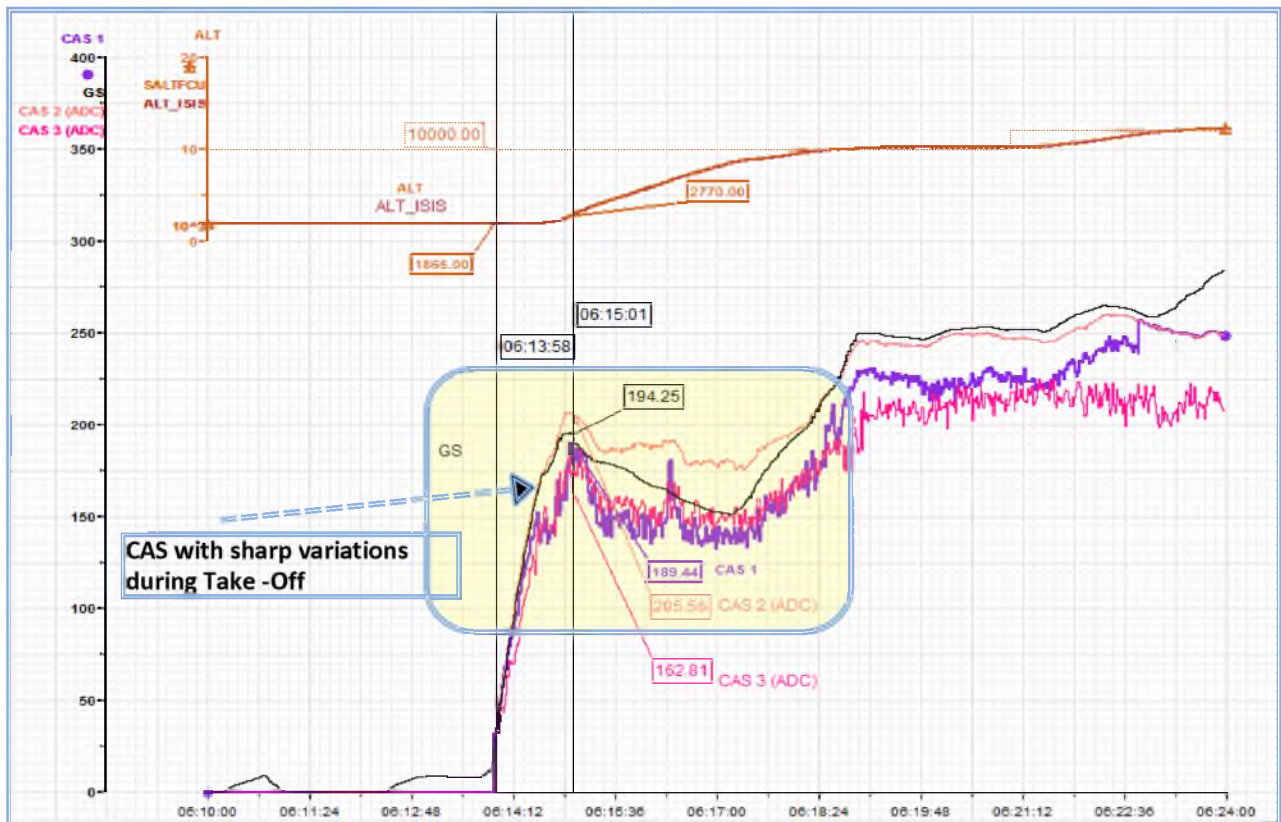
At 06:14:35 UTC, A/C took-off with GS=170kt
 - CAS1 reached 136kt, CAS2 was 171kt and CAS3 was 146kt
 - The three CAS were varying with sharp variations
 In the PFR at 06:14 UTC, the following failure messages were recorded:
 - “ADR2” [source EFCS] meaning that both ELAC or SEC (EFCS) incriminate ADR2
 - “SEC2 OR BUS2 FROM ADR1” meaning that EFCS (SEC2) has detected a difference between ADR 1&2
 - “SEC3 OR BUS2 FROM ADR3” meaning that EFCS (SEC3) has detected a difference between ADR 2&3

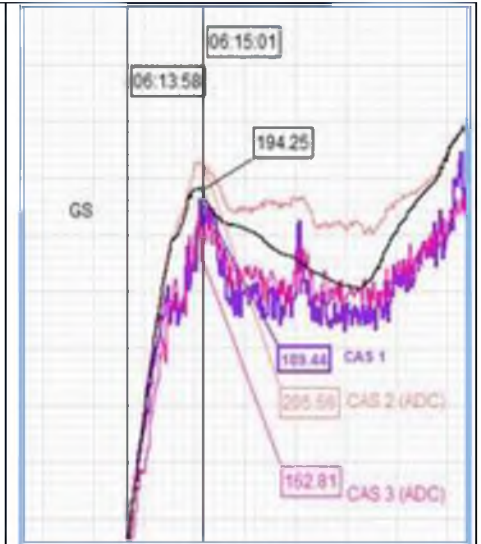
Most probably, the ADR2 was rejected by EFCS during the take-off roll due to CAS2 discrepancy with the 2 other CAS.

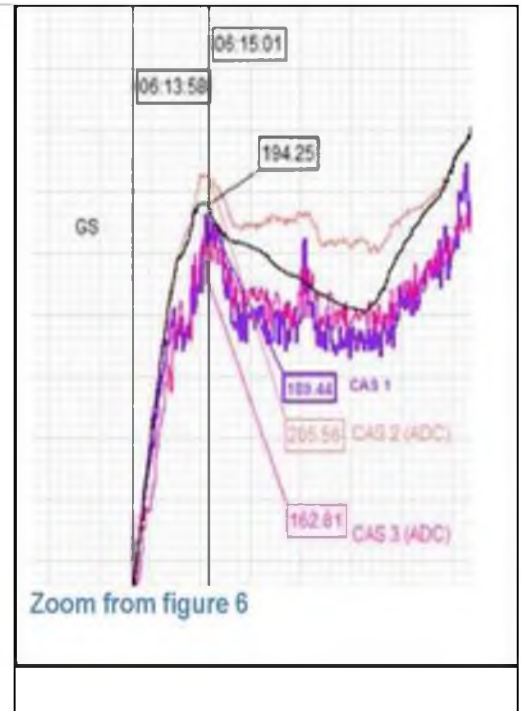
Then, during lift off, the CAS discrepancy has increased with a difference of more than 40kt between CAS1 and CAS3 (considering ADR2 already rejected).

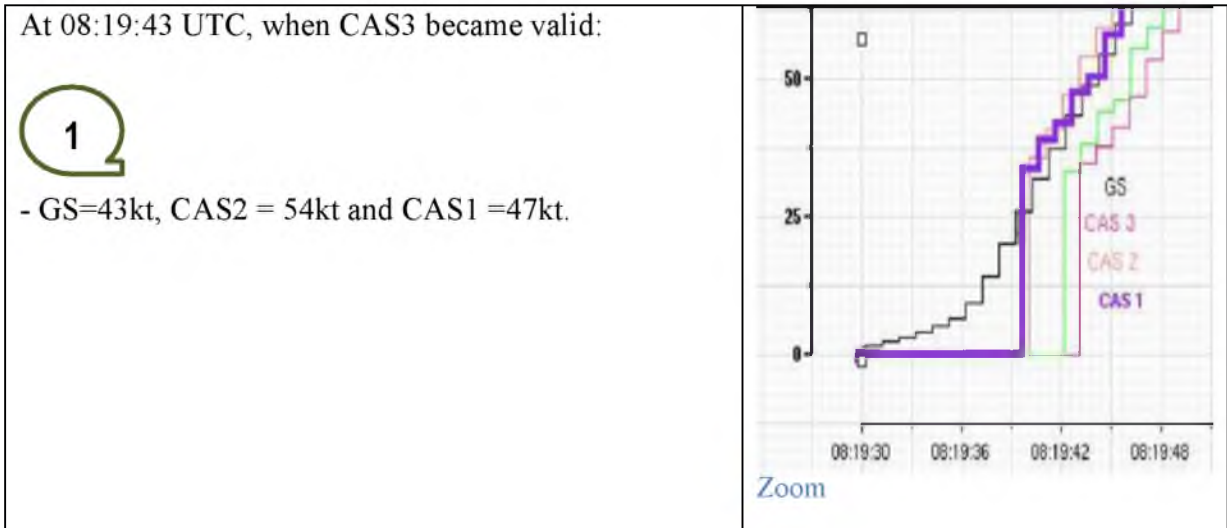
During take-off roll, CAS1 and CAS2 became valid first (i.e. increased above 30kt) then the CAS3 became valid 4s later meaning that CAS3 was not consistent with CAS1 and CAS2.

When CAS3 reached 30 kt, the following airspeed discrepancies were recorded:

- up to 20kt between CAS3 and CAS2
- more than 10kt between CAS1 and CAS3
- more than 10kt between CAS1 and CAS2

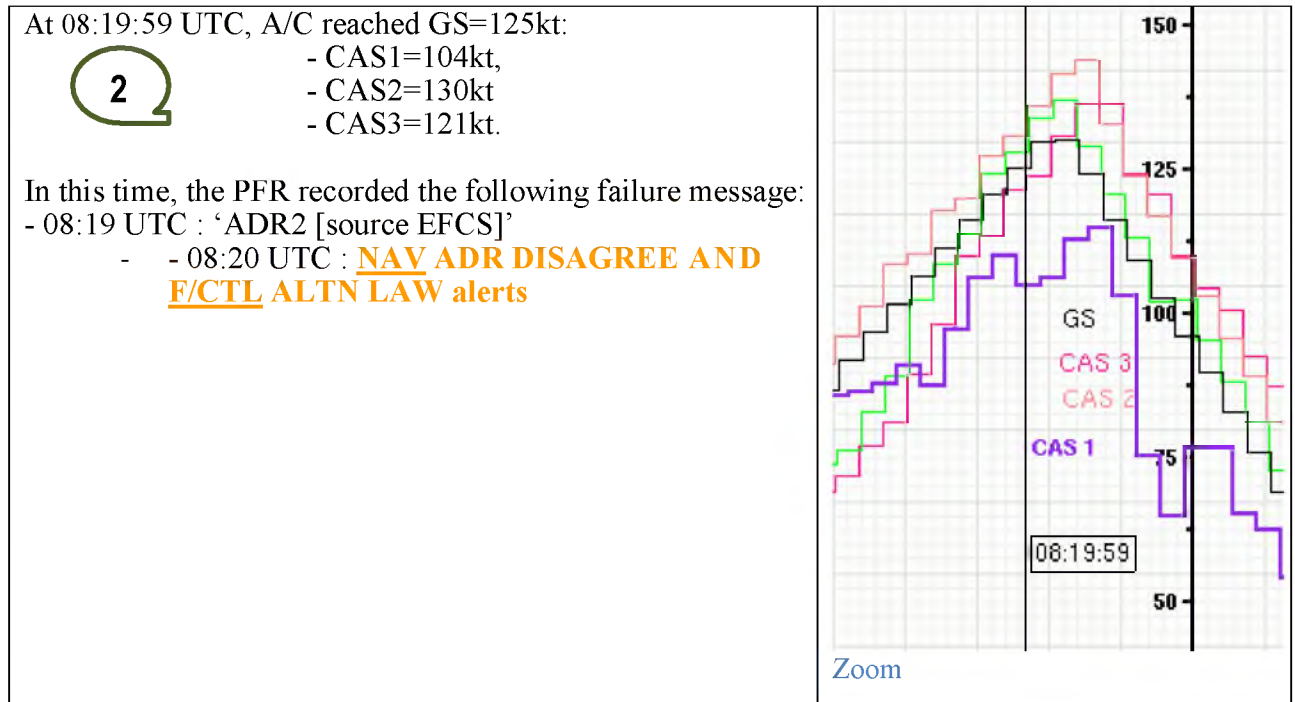
The message on ECAM and maintenance messages, the message **NAV ADR DISAGREE** was triggered most probably because ADR2 was already rejected by ELAC and whether another discrepancy was detected between the 2 remaining ADRs. As a result of at least two ADR rejected by EFCS, Flight control reverted to ALTERNATE LAW.

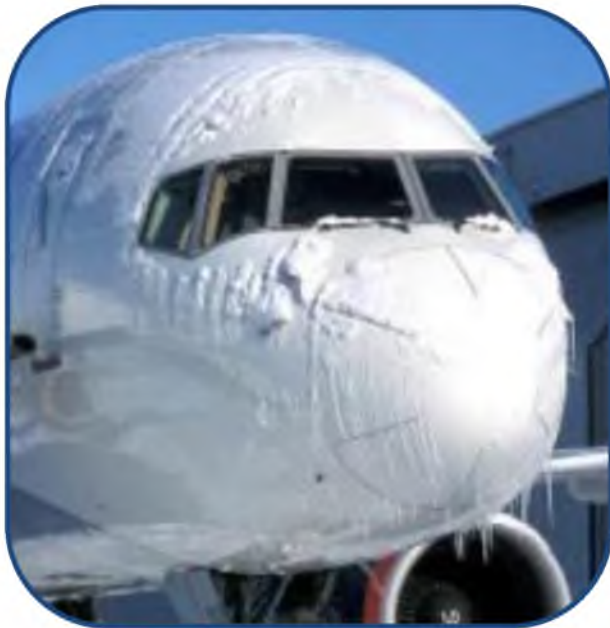
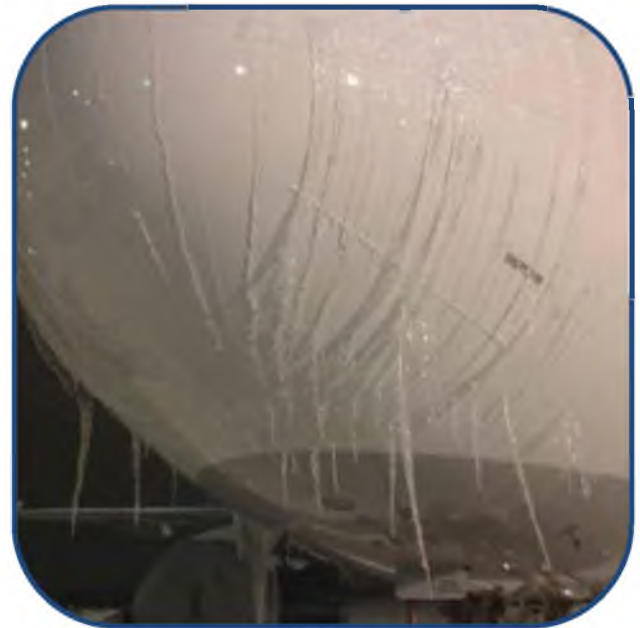
On ground, in cold weather conditions, water could freeze on the fuselage, generating ice accretion (“ice ridges”) on the lower part.

Several causes can lead to such ice ridges being present on the aircraft, even after de-icing:

- Lower (nose) fuselage not properly de-iced before departure
- After de-icing / anti-icing operation, snow melts on the heated windshield and runs down from windshield onto the nose fuselage, creating ice accretion (re-freezing)

Examples of Ice ridges

Even thin ice ridges on the lower nose fuselage may disrupt the airflow upstream to the pitot probes. AoA measurement can also be impacted by this phenomenon. Such discrepancies can disappear in flight or remain until A/C landing.

- Closely inspect nose fuselage in search of any trace of ice ridges.
- Perform de-icing procedure to remove any ice build-up trace, even thin it is, not only on windshield and probes surroundings but on the entire nose fuselage paying specific attention to lower nose fuselage.
- In case of any doubt request additional de-icing

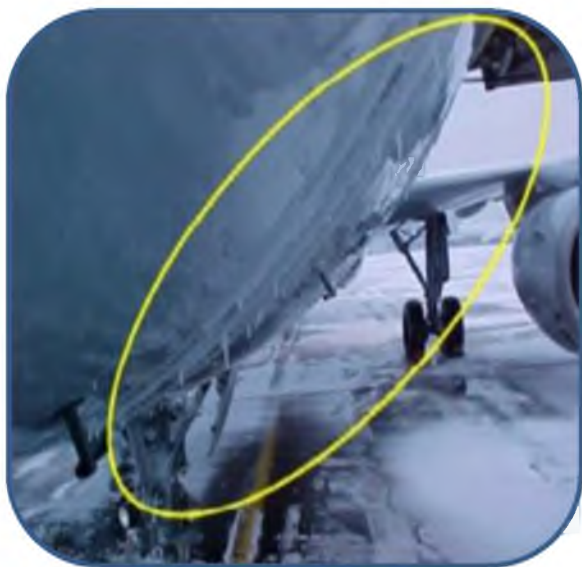
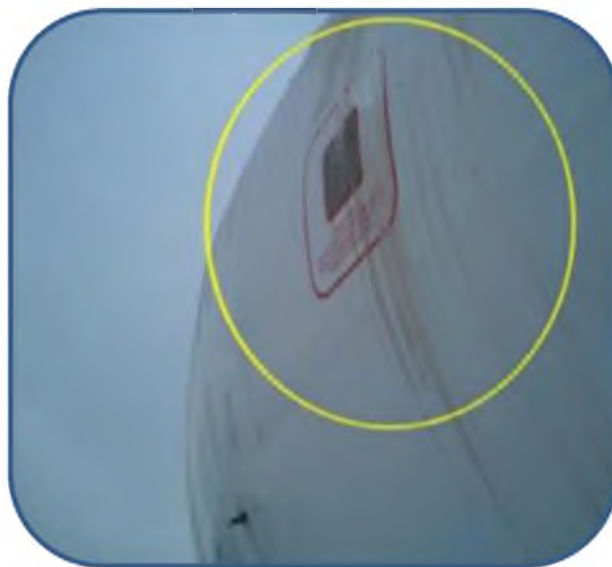
Ice build-up in front of air data probes can lead to erroneous air data measurement.

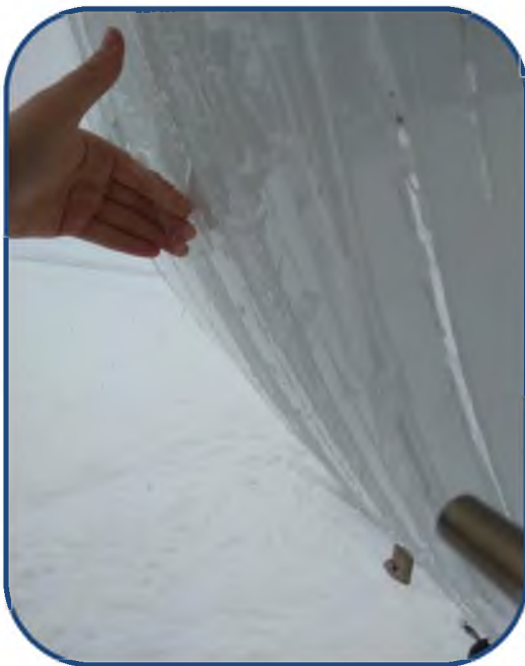
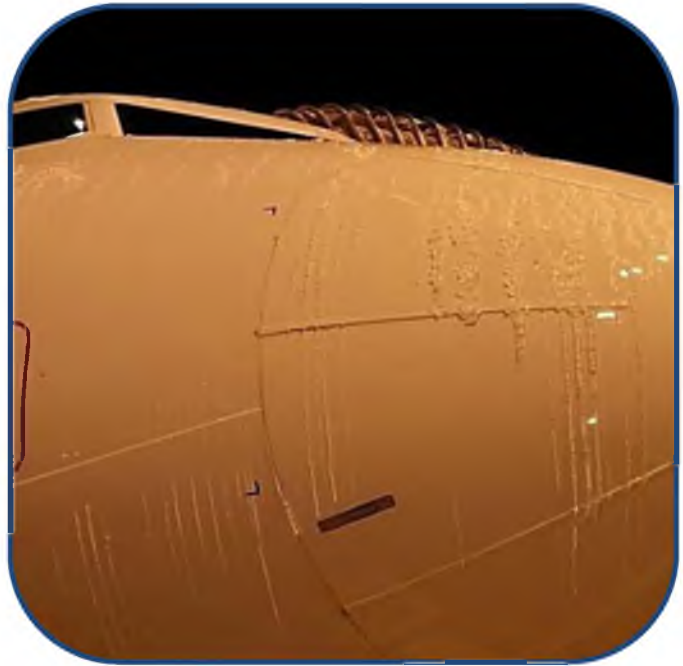
Zoom on Ice accretion on lower fuselage
