FINAL REPORT

Investigation of a serious incident, occurred on February 26, 2018 at Sofia Airport, Bulgaria, involving the AIRBUS 321-231 aircraft, registration marks HA-LXP, HA-LXL and HA-LXD, operated by “Wizz Air”

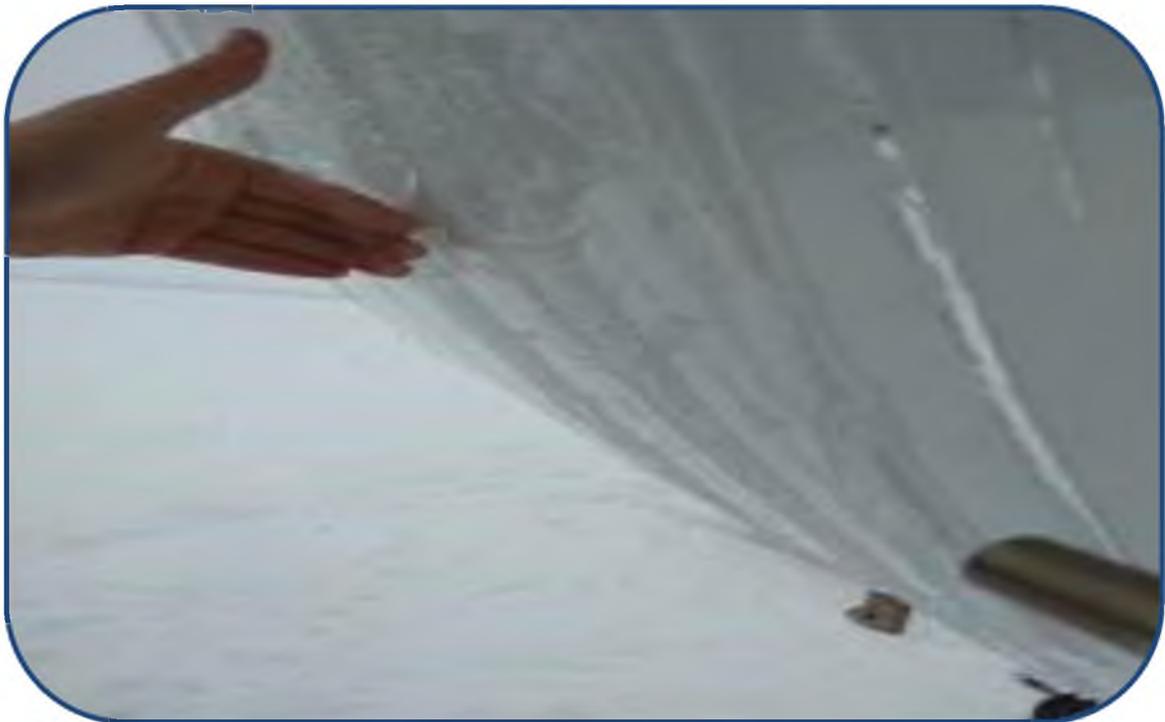
Fig. 1

As seen from the above photo, the flowing melted snow from the warmed shelter of the aircraft on the insufficiently heated side and bottom surface of the aircraft fuselage froze in the form of ice ridges on the lateral surface of the aircraft fuselage in front of the dynamic pressure sensors, which caused deviation in the readings between the different speedometers in the cockpit and a change in aerodynamic characteristics.

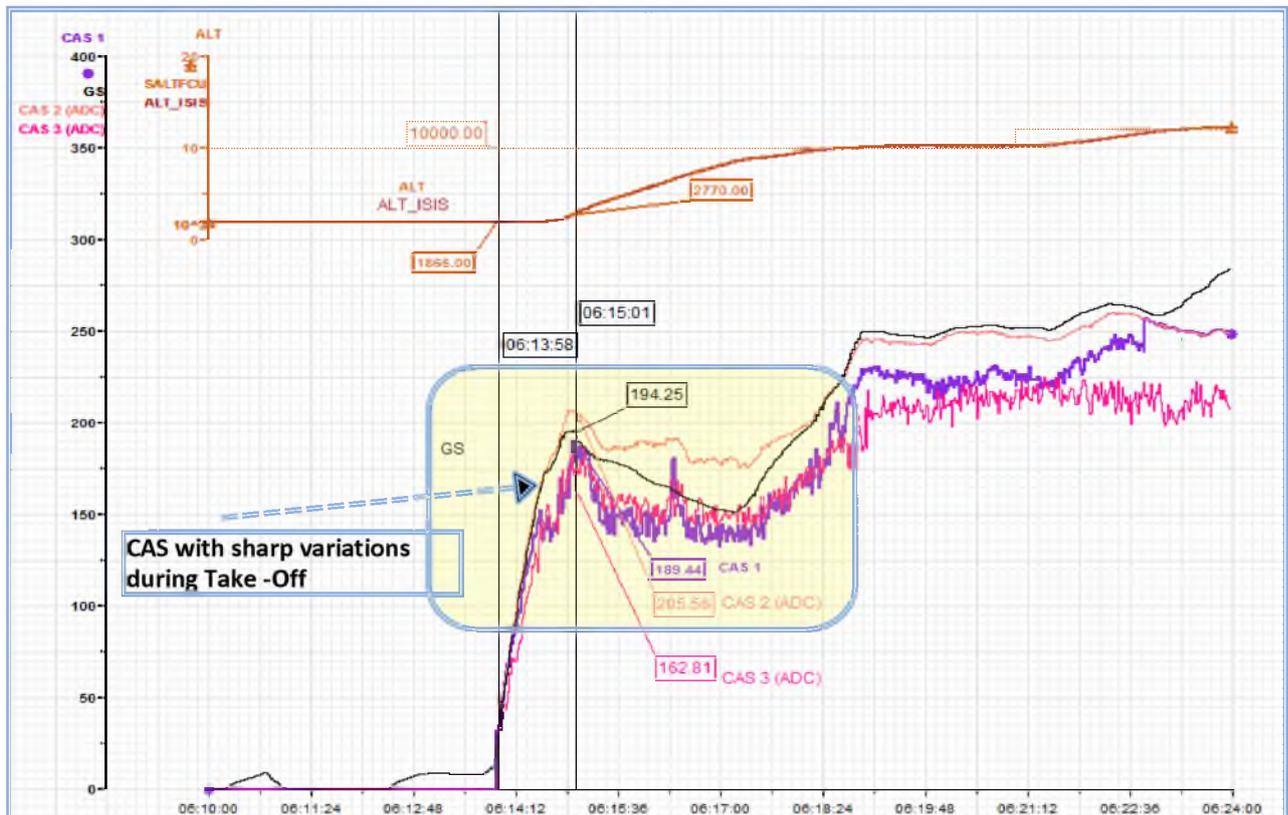
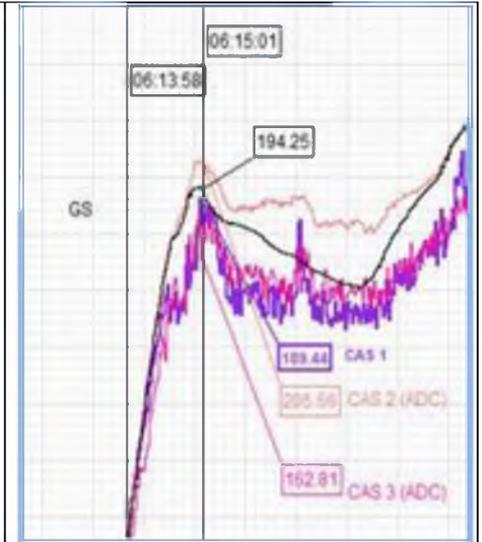
At 06:14:35 UTC, A/C took-off with GS=170kt
 - CAS1 reached 136kt, CAS2 was 171kt and CAS3 was 146kt
 - The three CAS were varying with sharp variations
 In the PFR at 06:14 UTC, the following failure messages were recorded:
 - “ADR2” [source EFCS] meaning that both ELAC or SEC (EFCS) incriminate ADR2
 - “SEC2 OR BUS2 FROM ADR1” meaning that EFCS (SEC2) has detected a difference between ADR 1&2
 - “SEC3 OR BUS2 FROM ADR3” meaning that EFCS (SEC3) has detected a difference between ADR 2&3

Most probably, the ADR2 was rejected by EFCS during the take-off roll due to CAS2 discrepancy with the 2 other CAS.

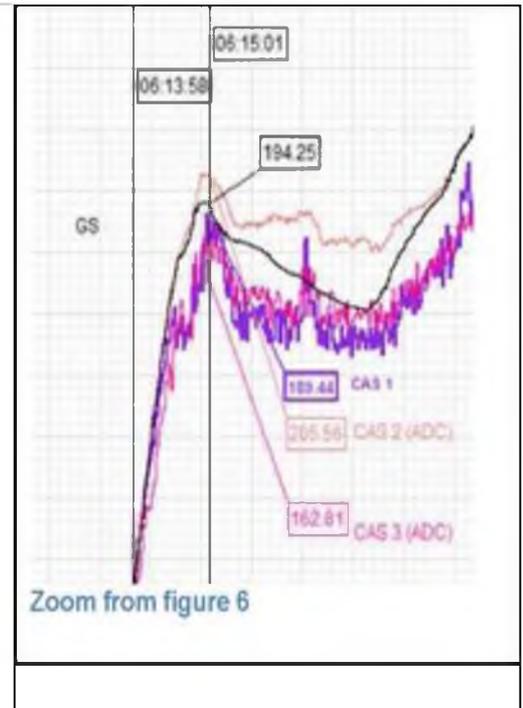
- **AUTO FLT A/THR OFF**
- **AUTO FLT RUD TRV LIM SYS**
- **F/CTL ALTN LAW**
- **NAV ADR DISAGREE**
- FAC(1CC1)/DMC2(1WT2) [source EIS2]

Then, during lift off, the CAS discrepancy has increased with a difference of more than 40kt between CAS1 and CAS3 (considering ADR2 already rejected).

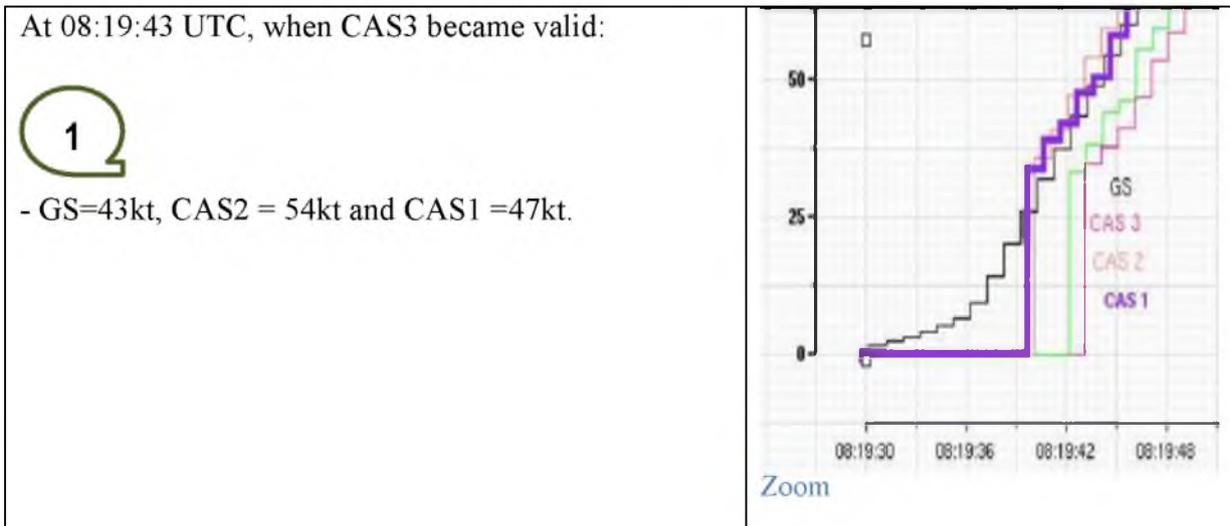
During take-off roll, CAS1 and CAS2 became valid first (i.e. increased above 30kt) then the CAS3 became valid 4s later meaning that CAS3 was not consistent with CAS1 and CAS2.

- up to 20kt between CAS3 and CAS2
- more than 10kt between CAS1 and CAS3
- more than 10kt between CAS1 and CAS2

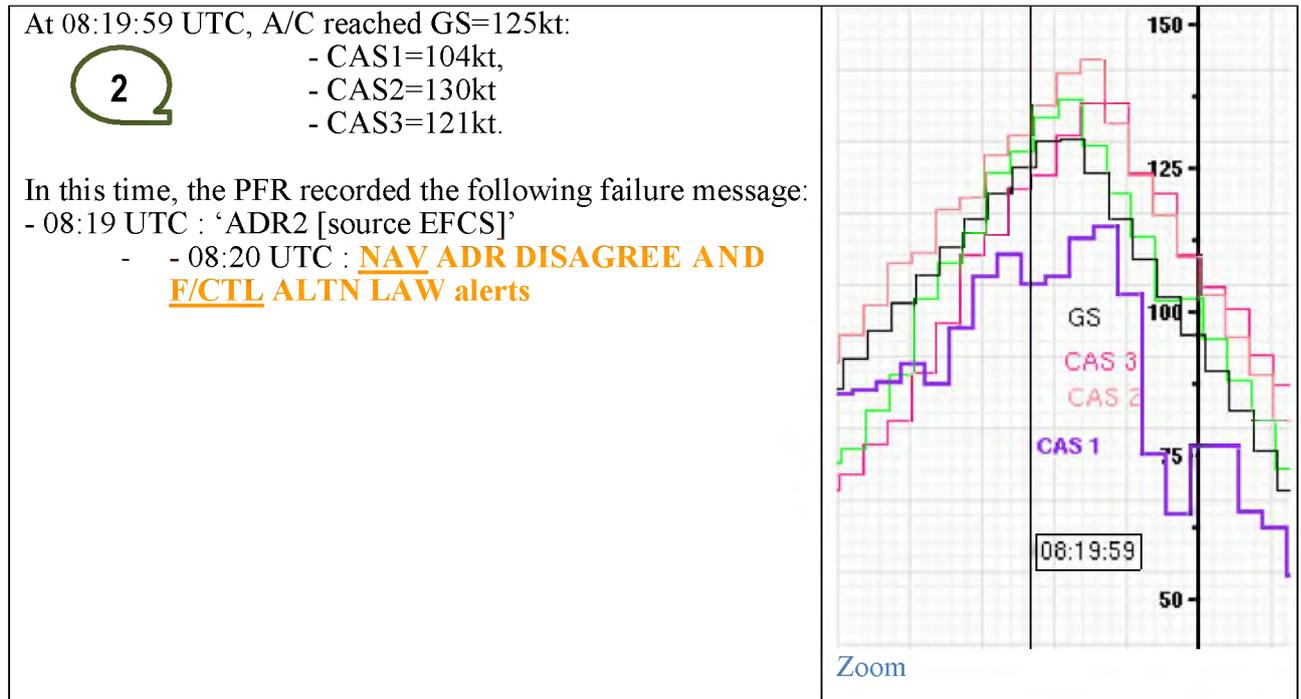
The message on ECAM and maintenance messages, the message **NAV ADR DISAGREE** was triggered most probably because ADR2 was already rejected by ELAC and whether another discrepancy was detected between the 2 remaining ADRs. As a result of at least two ADR rejected by EFCS, Flight control reverted to ALTERNATE LAW.

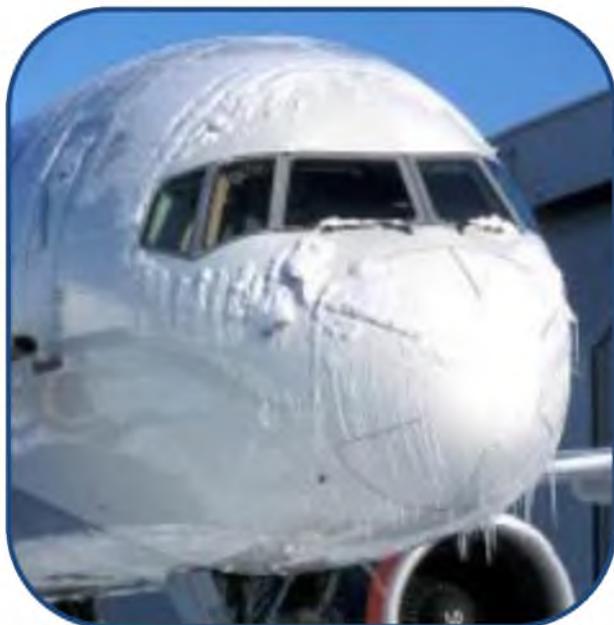
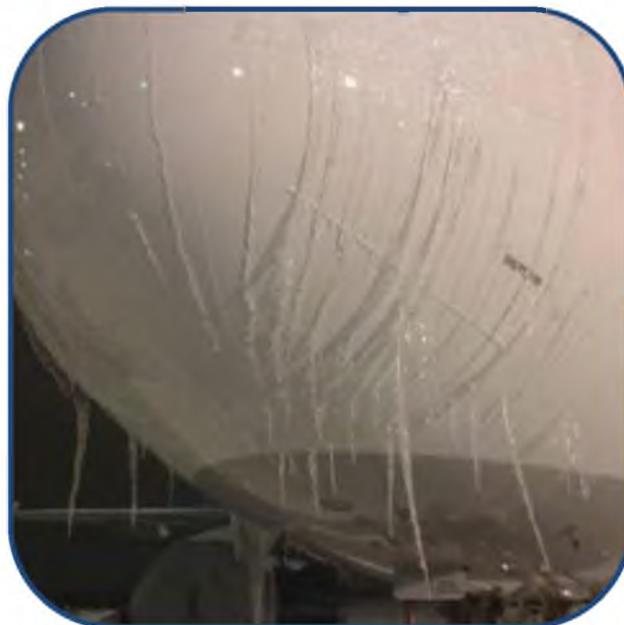
Examples of Ice ridges

On ground, in cold weather conditions, water could freeze on the fuselage, generating ice accretion (“ice ridges”) on the lower part.

Several causes can lead to such ice ridges being present on the aircraft, even after de-icing:

- Lower (nose) fuselage not properly de-iced before departure
- After de-icing / anti-icing operation, snow melts on the heated windshield and runs down from windshield onto the nose fuselage, creating ice accretion (re-freezing)

Even thin ice ridges on the lower nose fuselage may disrupt the airflow upstream to the pitot probes. AoA measurement can also be impacted by this phenomenon. Such discrepancies can disappear in flight or remain until A/C landing.

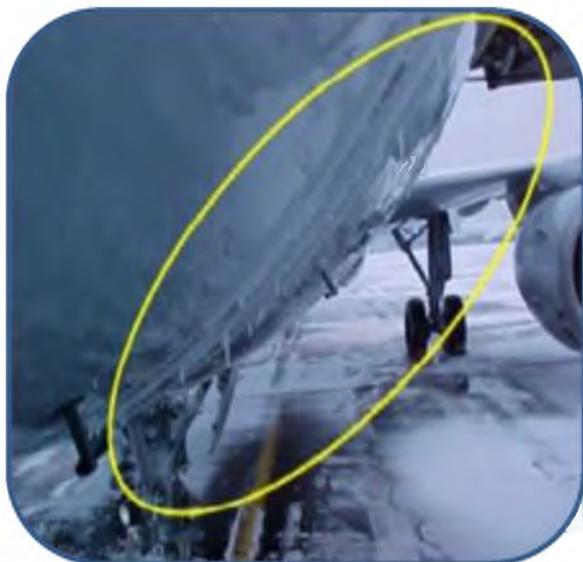
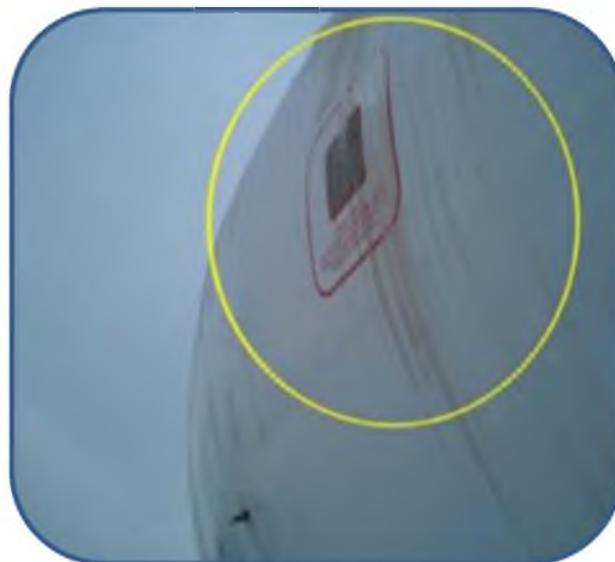
Ice build-up in front of air data probes can lead to erroneous air data measurement.
