Safety Investigation Report

Ref.:
AAIU-2020-04

**SERIOUS INCIDENT, OCCURRED ON AUGUST 5, 2020
AT SOFIA AIRPORT, BULGARIA, INVOLVING A320-
232 AIRCRAFT, REGISTRATION MARKS HA-LWH,
OPERATED BY „WIZZ AIR HUNGARY“ LTD.**

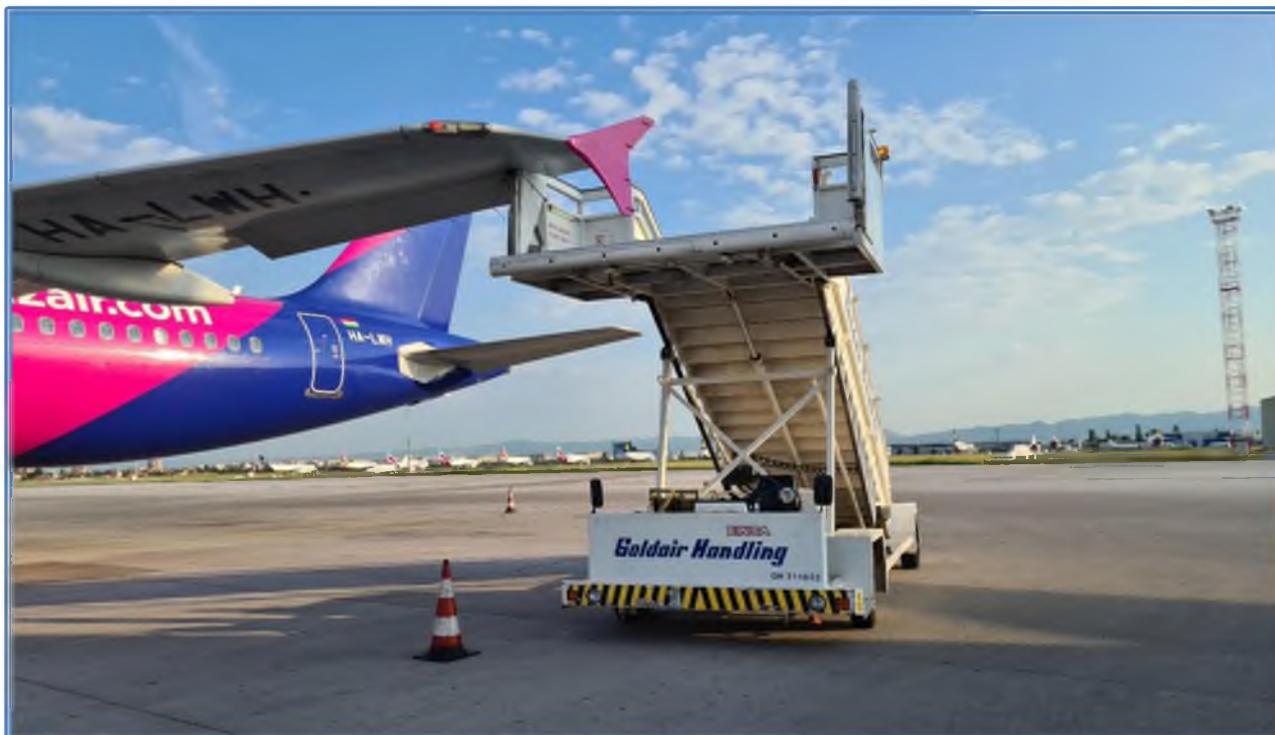
Fig. 1

During the inspection of the aircraft at the aircraft stand No 26 at Sofia airport, the following damage were found:

- Damage of the wingtip of the left wing;
- Deformation of the aileron of the left wing;

- Damage of upper and lower panels of the left wing;
- Damage at left wing side aft corner of panel with the following dimensions: span wise length 40mm and width 20mm.

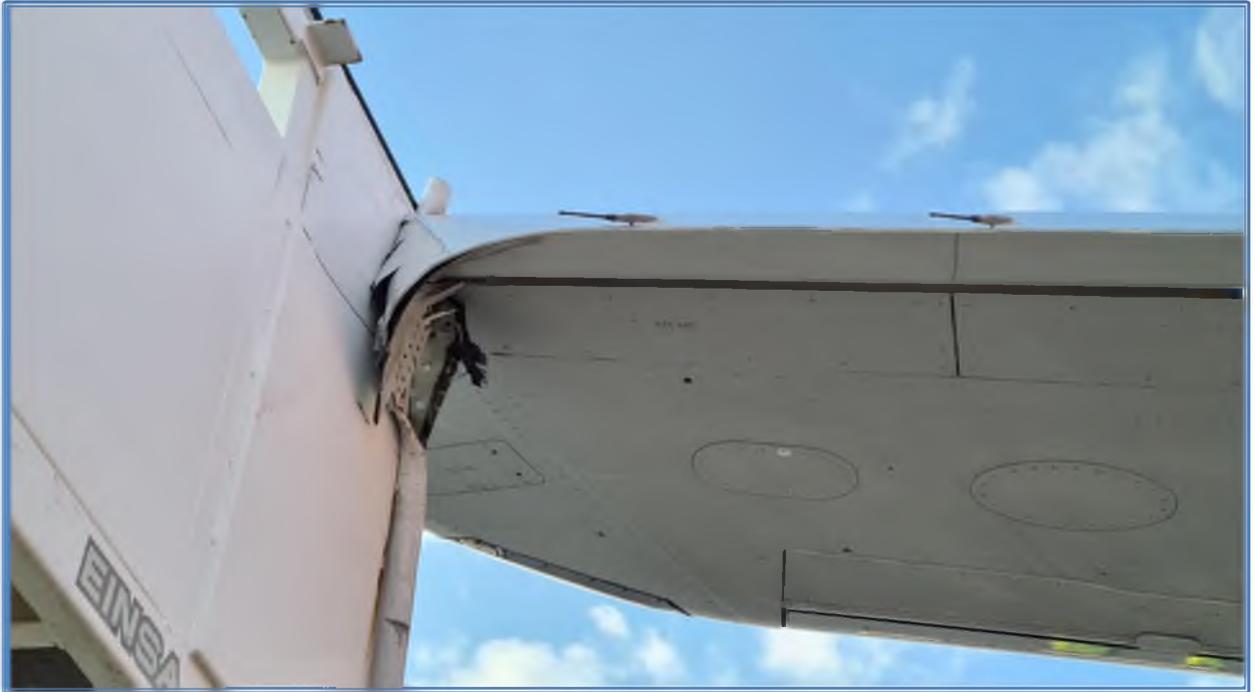
Fig. 3

The self-propelled passenger stairs received the following damage:

1. Torn rubber bumpers of the passenger stairs;
2. Torn retainer of a removable element at the front of the right railing of the passenger stairs.
