AIR, MARITIME AND RAILWAY ACCIDENT
INVESTIGATION NATIONAL BOARD
9, Dyakon Ignatiy Street, 1000 Sofia, Bulgaria

Safety Investigation Report

Ref.:
AAIU-2022-03

ACCIDENT, OCCURRED ON AUGUST 8, 2022 BY PARTENAVIA P.66C "CHARLIE" AIRCRAFT, REGISTRATION MARKS LZ-PTS, OPERATED BY THE PILOT OWNER AFTER TAKE-OFF FROM PRIMORSKO AIRFIELD, DISTRICT OF BOURGAS

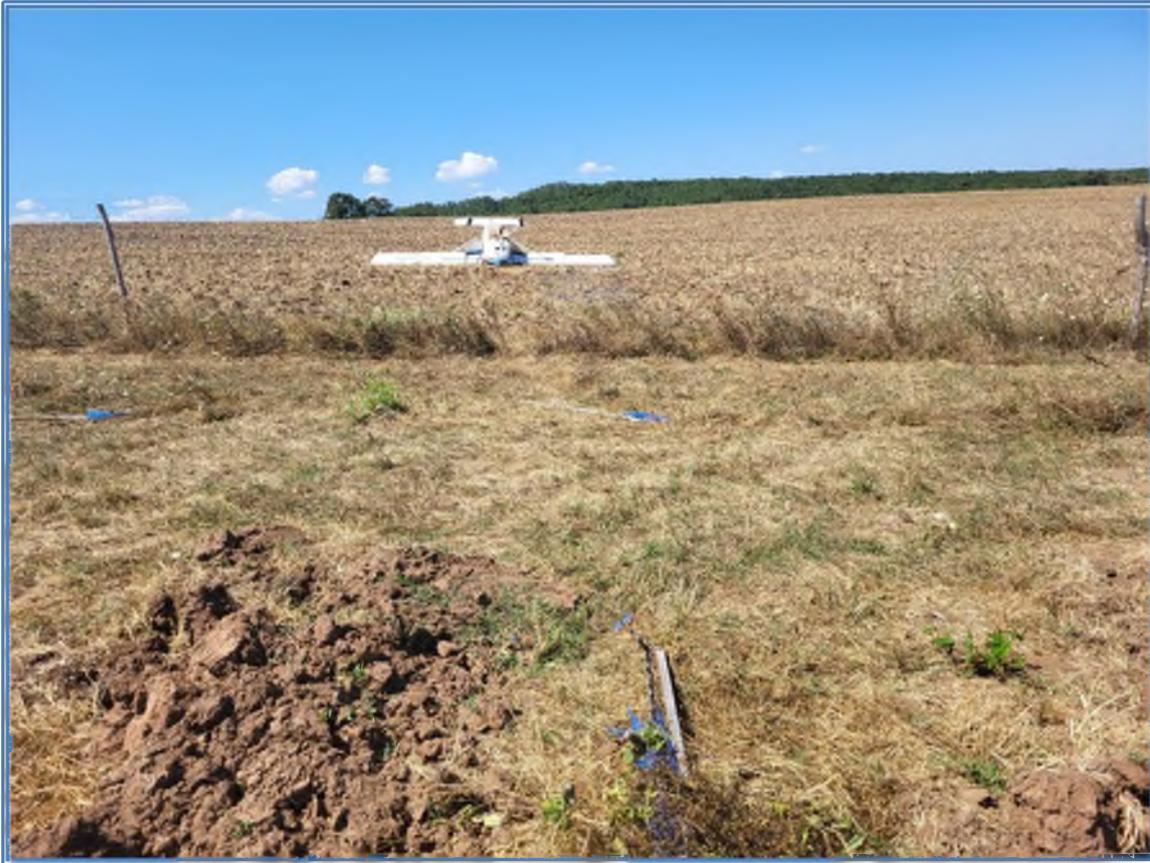
Fig. 1.

Five stakes and the wire on the fence of the field were knocked down and broken (Fig.1 of Enclosure 1).

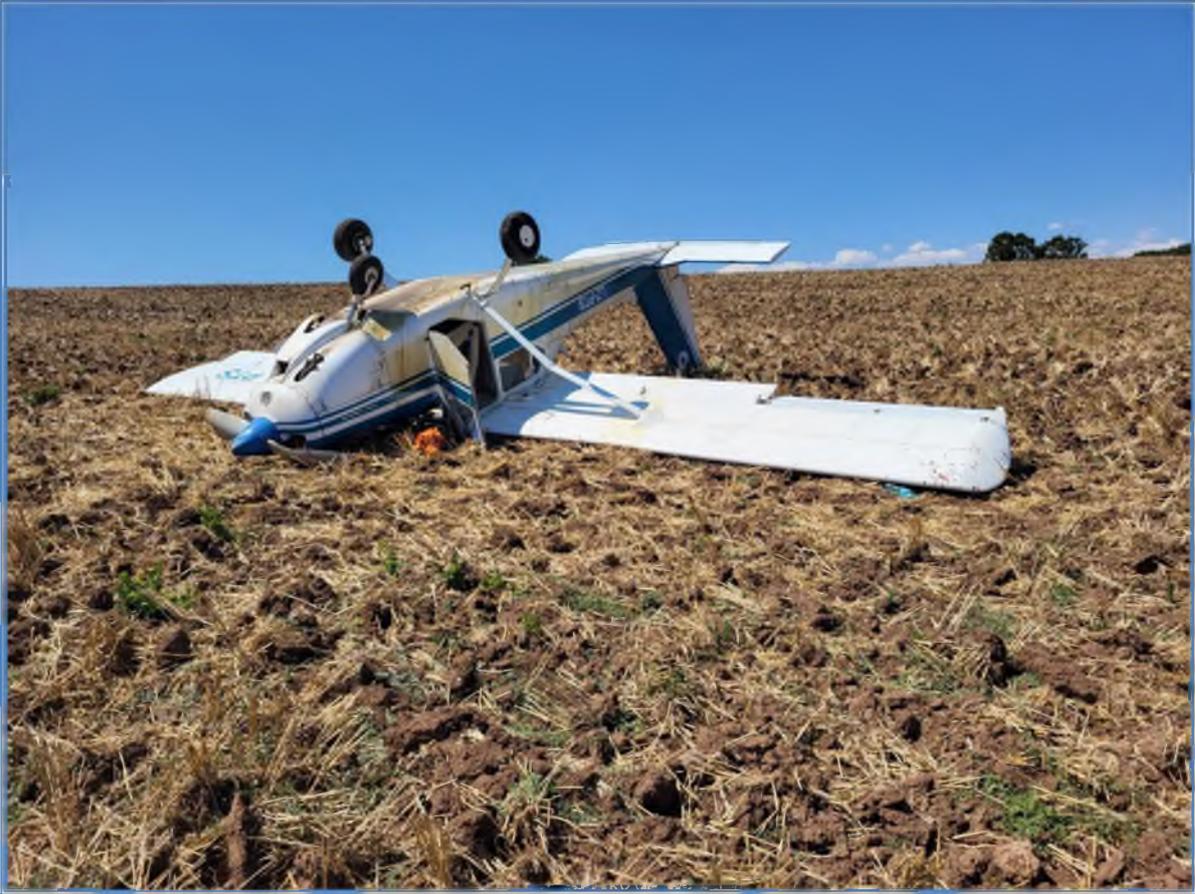
Fig. 3.

There were traces of oil leakage on the aircraft, on the entire right-hand airframe and on lower surface (Fig. 3 of Enclosure 1);

Destroyed nose wheel assembly (Fig.3 and 11 of Enclosure 1);

Bent wing bracing strut of the right-hand half-wing (Fig.3 of Enclosure 1);

There were traces of oil leakage on the aircraft, on the entire right-hand airframe and on lower surface (Fig. 3 of Enclosure 1); there were also traces of oil leakage on the fire wall (Fig. 14 of Enclosure 1). No signs of oil leakage from the oil filter connection assembly to the engine housing were found.

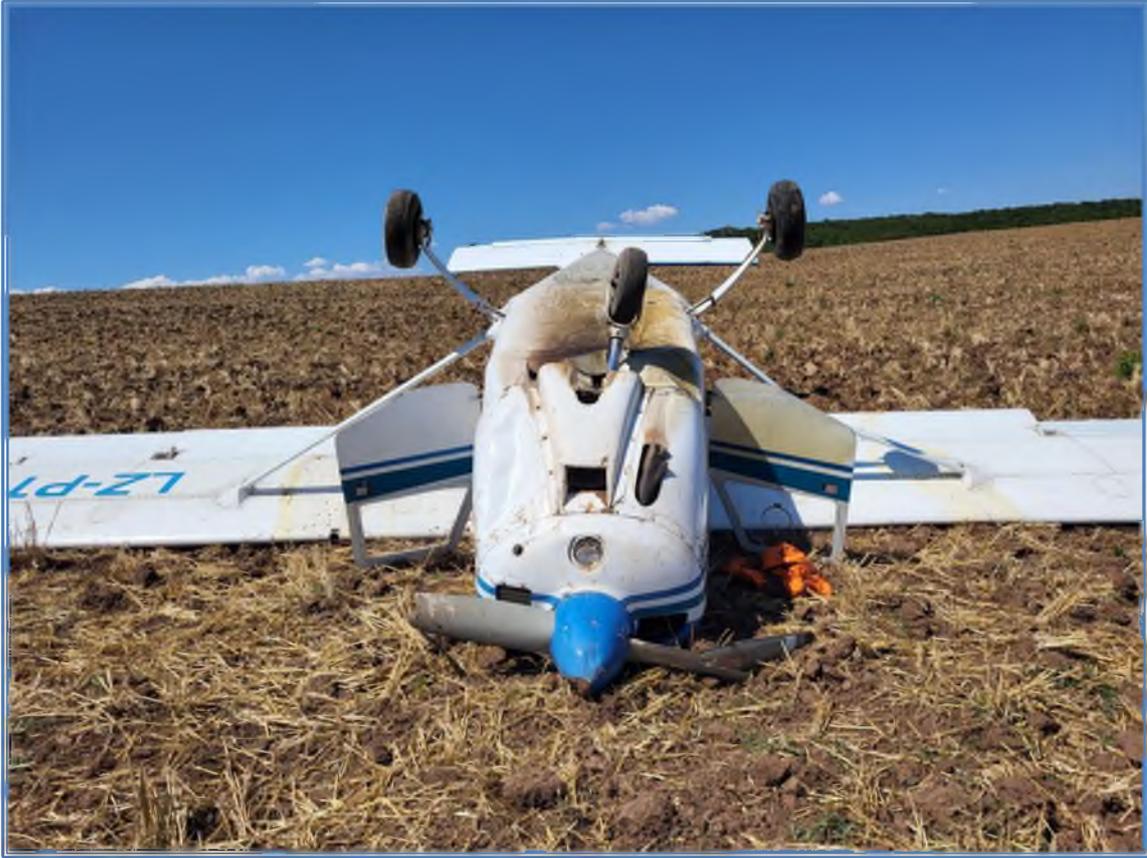
Fig.6.

Destroyed blades of the air propeller and bruised propeller spinner (Fig.6 and Fig.10 of Enclosure 1);

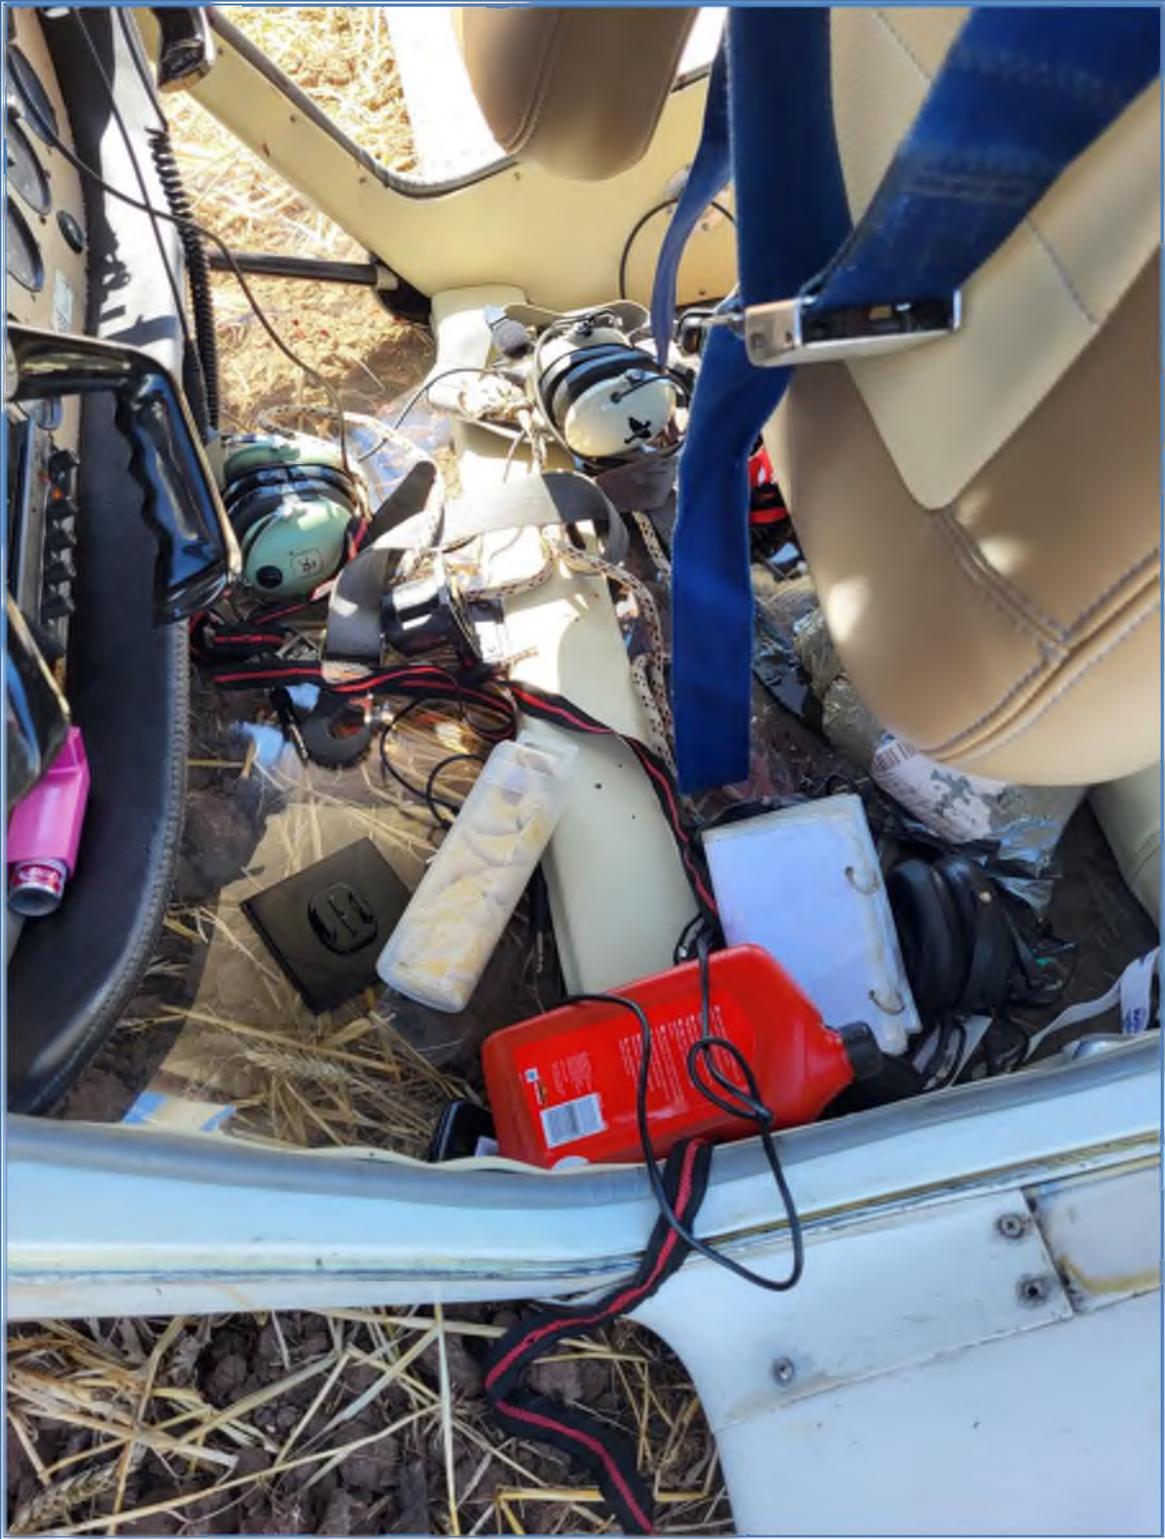
Fig. 9.

A mobile phone, a tablet with specialized navigation software and laminated maps for actions in normal and emergency situations in Italian (not approved by DG CAA) were found in the cockpit (Fig.9 of Enclosure 1).injury.

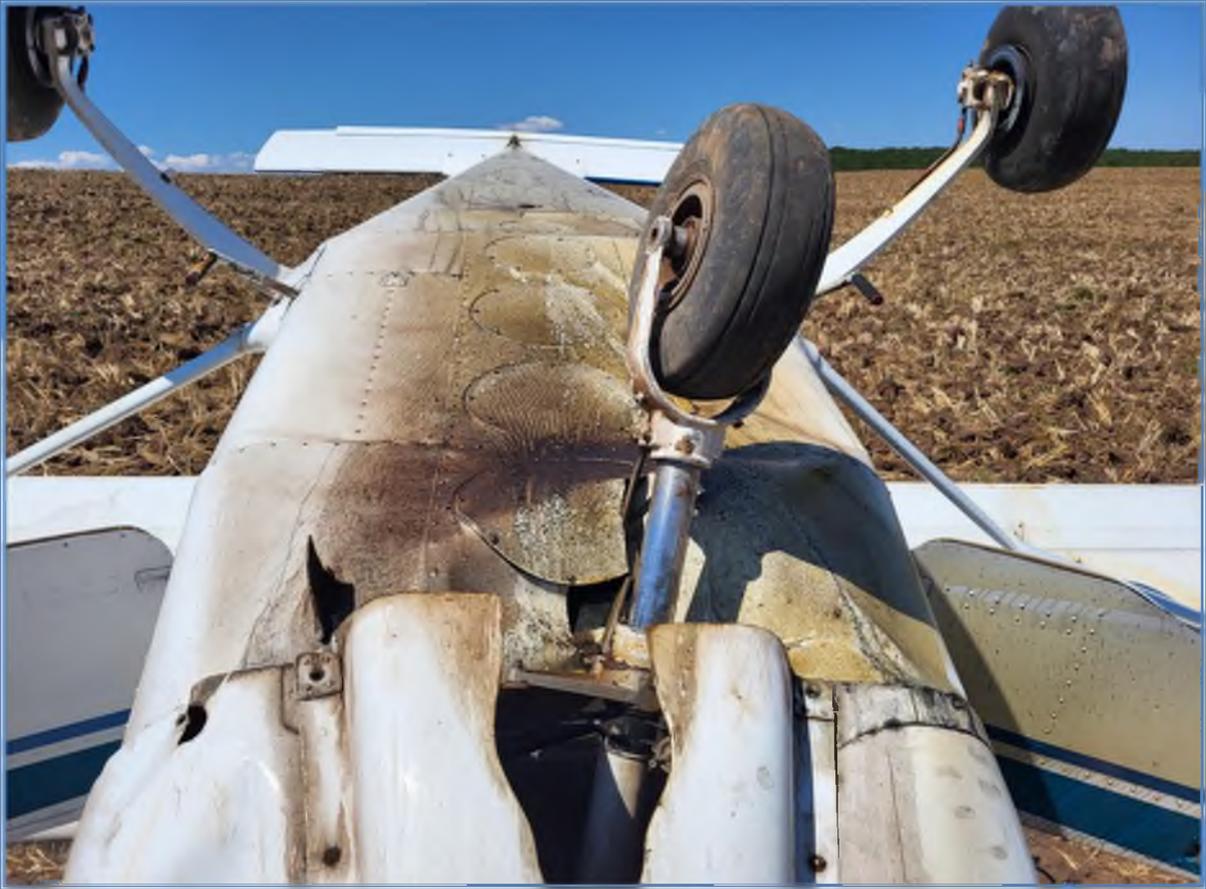
Fig. 11.

Abrasions and deformations on the lower surface of the aircraft body (Fig.11 of Enclosure 1);

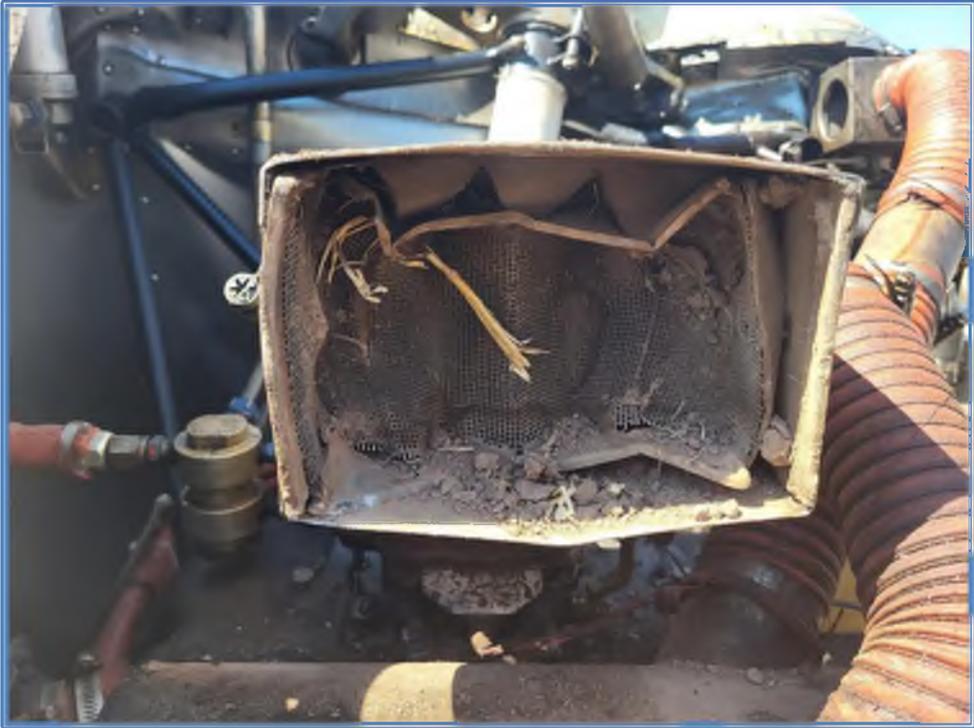
Fig. 12.

Destroyed engine intake air duct (Fig.12 of Enclosure 1);

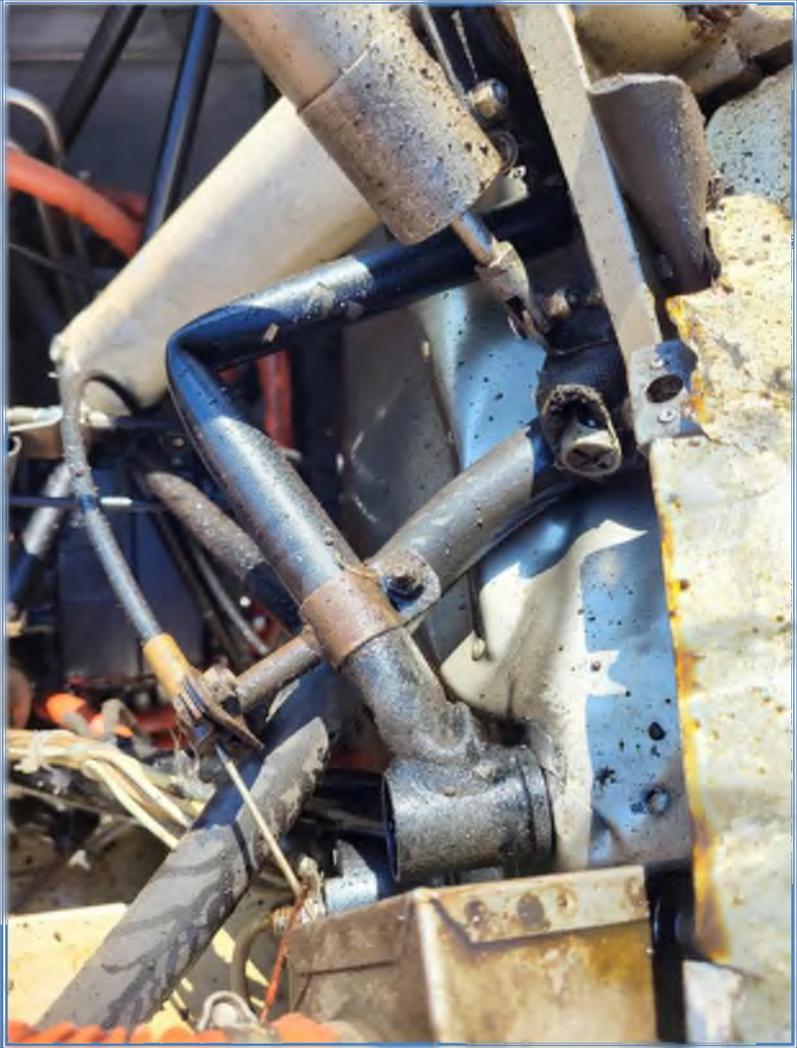
Fig. 13.

Deformed fire wall (Fig.13 and 14 of Enclosure 1);

Deformed engine mounting frame (Fig.13 and 14 of Enclosure 1);

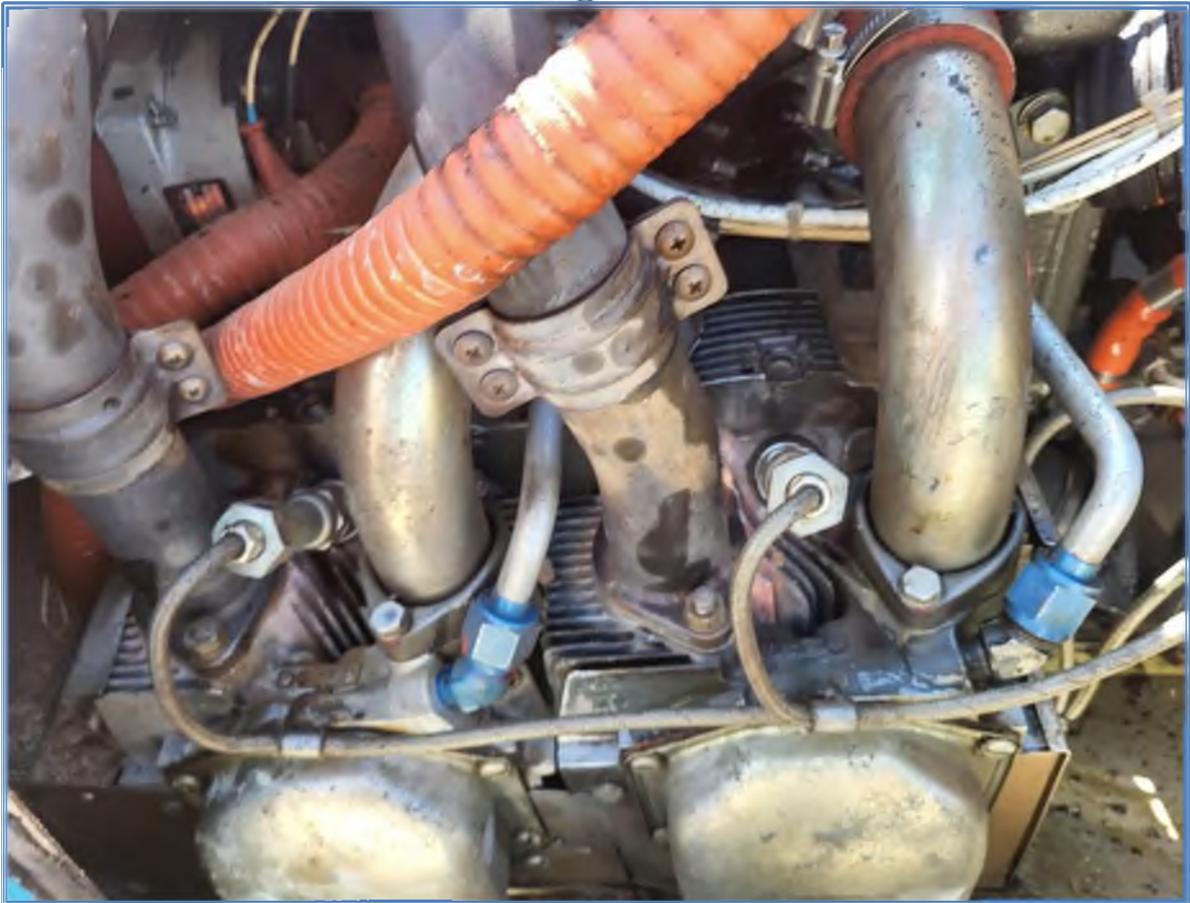
Fig. 15.

Traces of overheating on the cooling fins of the engine cylinders (Fig.15 of Enclosure 1);

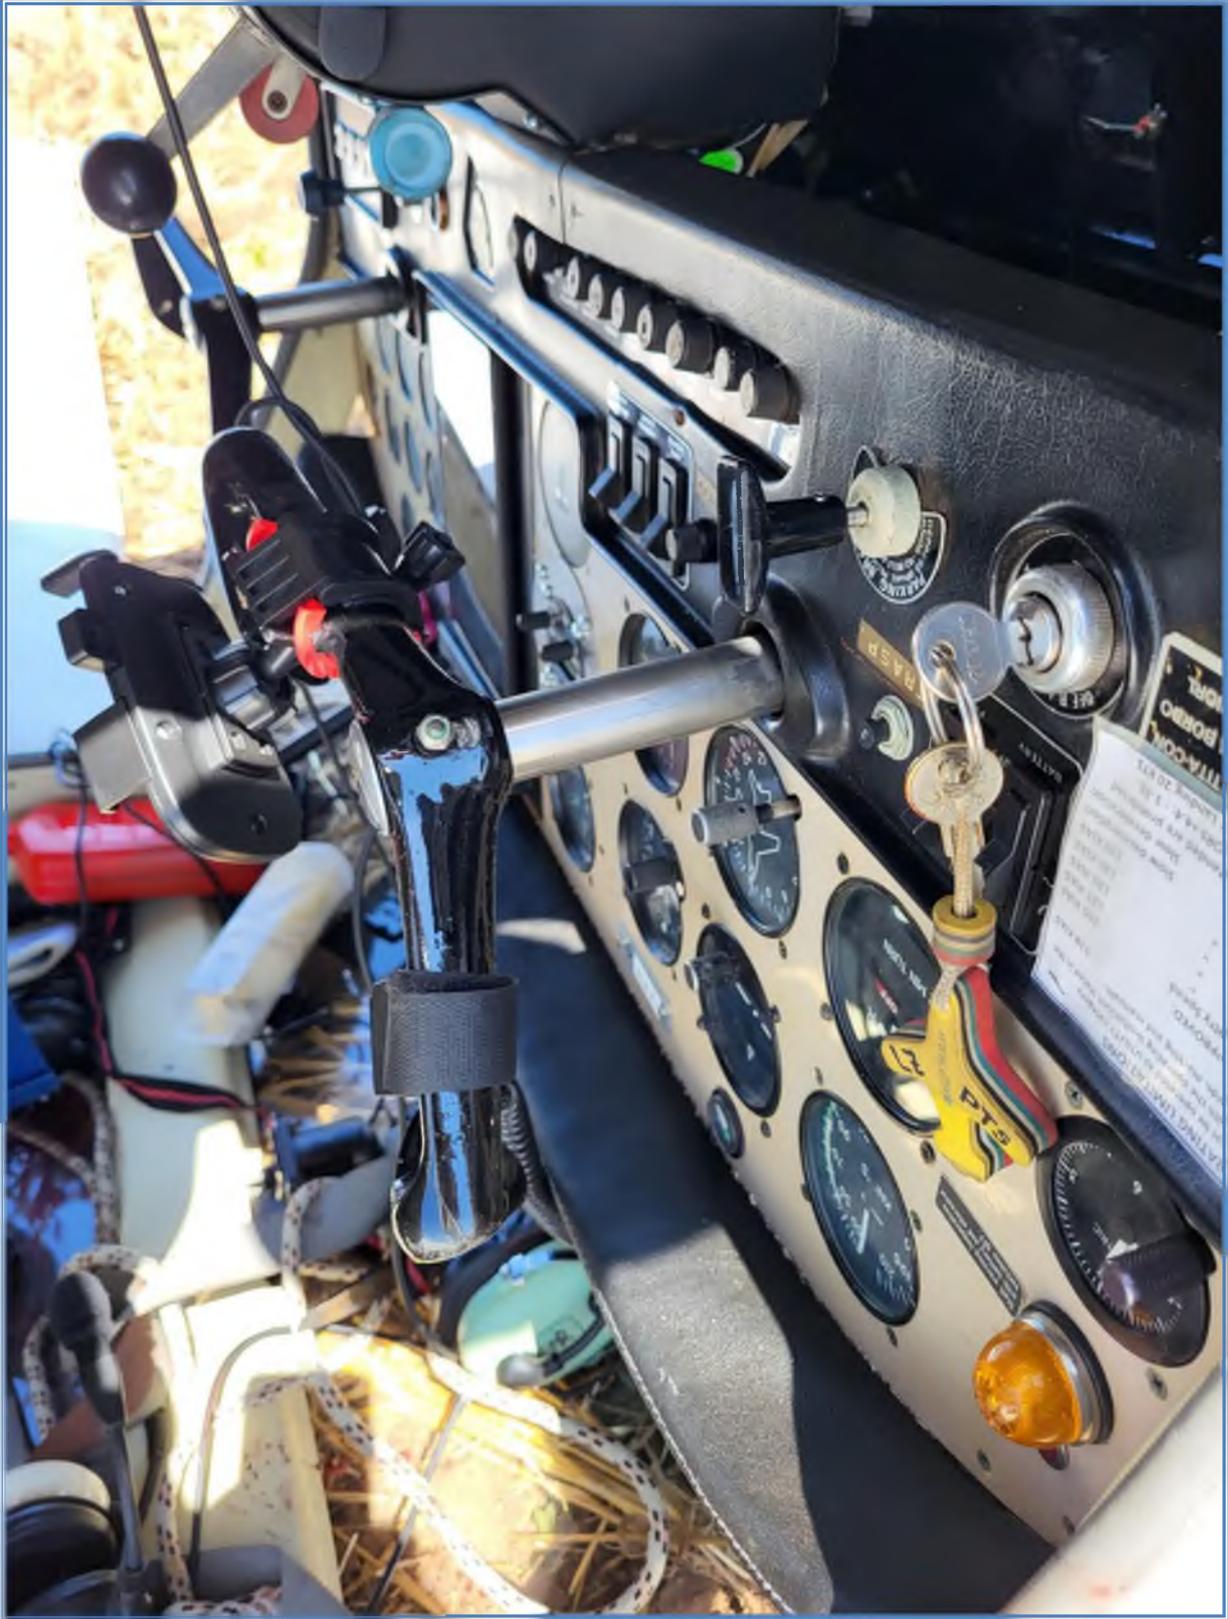
Fig.16.

During the inspection of the scene, it was also found that the main switch was in the off position (Fig. 16 of Enclosure 1). The engine control levers were in the following positions: the throttle lever at 2/3 from the stop for maximum, the mixture control lever at 1/2 of the stop for a rich mixture, the lever of the heating of the carburettor was at the front stop (Fig. 18 of Enclosure 1). From this figure it can be seen that the flap position pointer is at 10o position. The position of the arrows of the instruments in the cockpit is at technological zero, including the indicators of oil pressure and temperature. The altimeter arrows indicate an altitude of 750 ft. The running hour's indicator reading is 1378.1 hours. The fuel cock is in the position both tanks on (Fig. 20 of Enclosure 1).

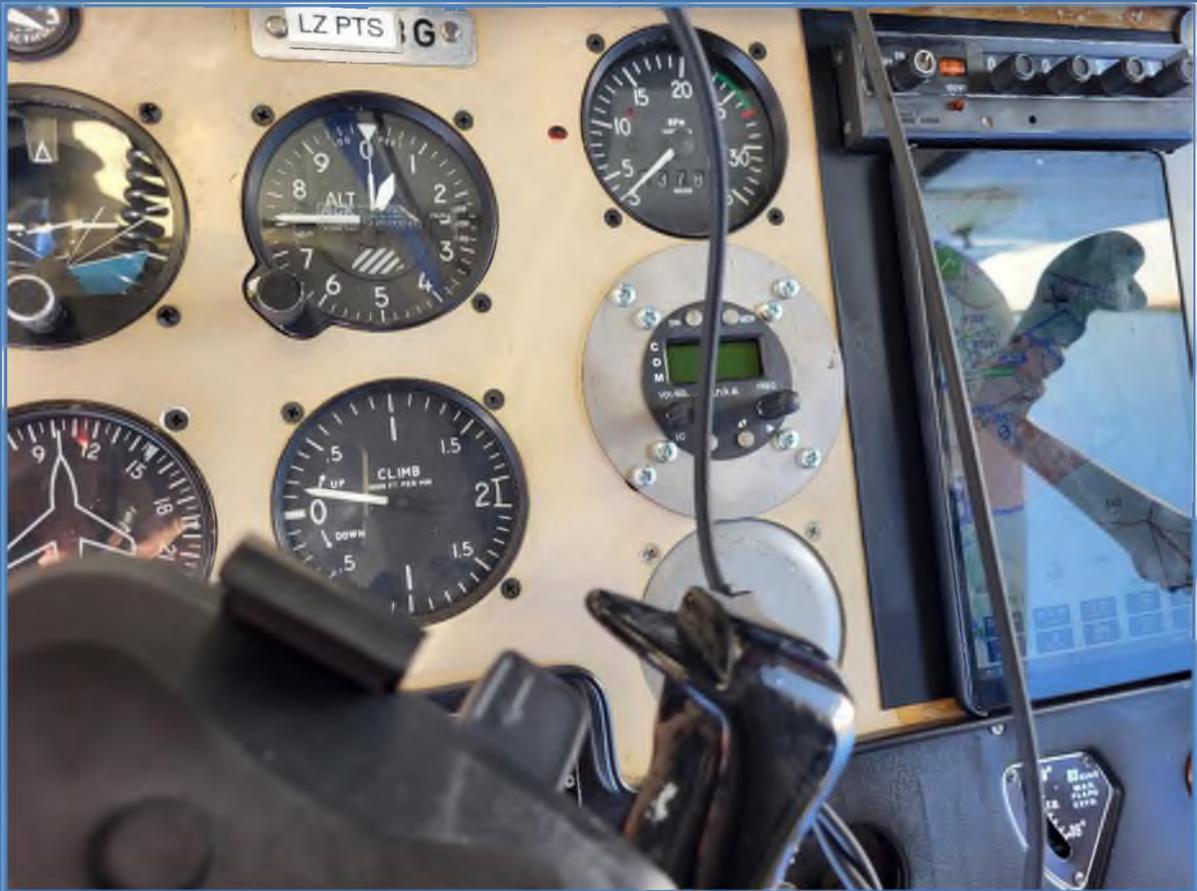
Fig. 19.

running hour indicator was 1,378:06 h (Fig.19 of Enclosure 1), with time between overhauls of 2000 flight hours or 12 years. The last engine overhaul was on 27.03.2006 and activities related with prolongation the time to overhaul according the calendar period were carried out. In the engine technical logbook when documenting the annual inspection carried out on 27.08.2021, a running hour indicator reading of 1394:42 h was recorded, which is 16:36 h more than the running hour's indicator reading at the occurrence. The difference between the running hour's indicator readings and the entry in the technical logbook was not noted in the inspection report after presentation of the aircraft for airworthiness review on 15.10.2021.

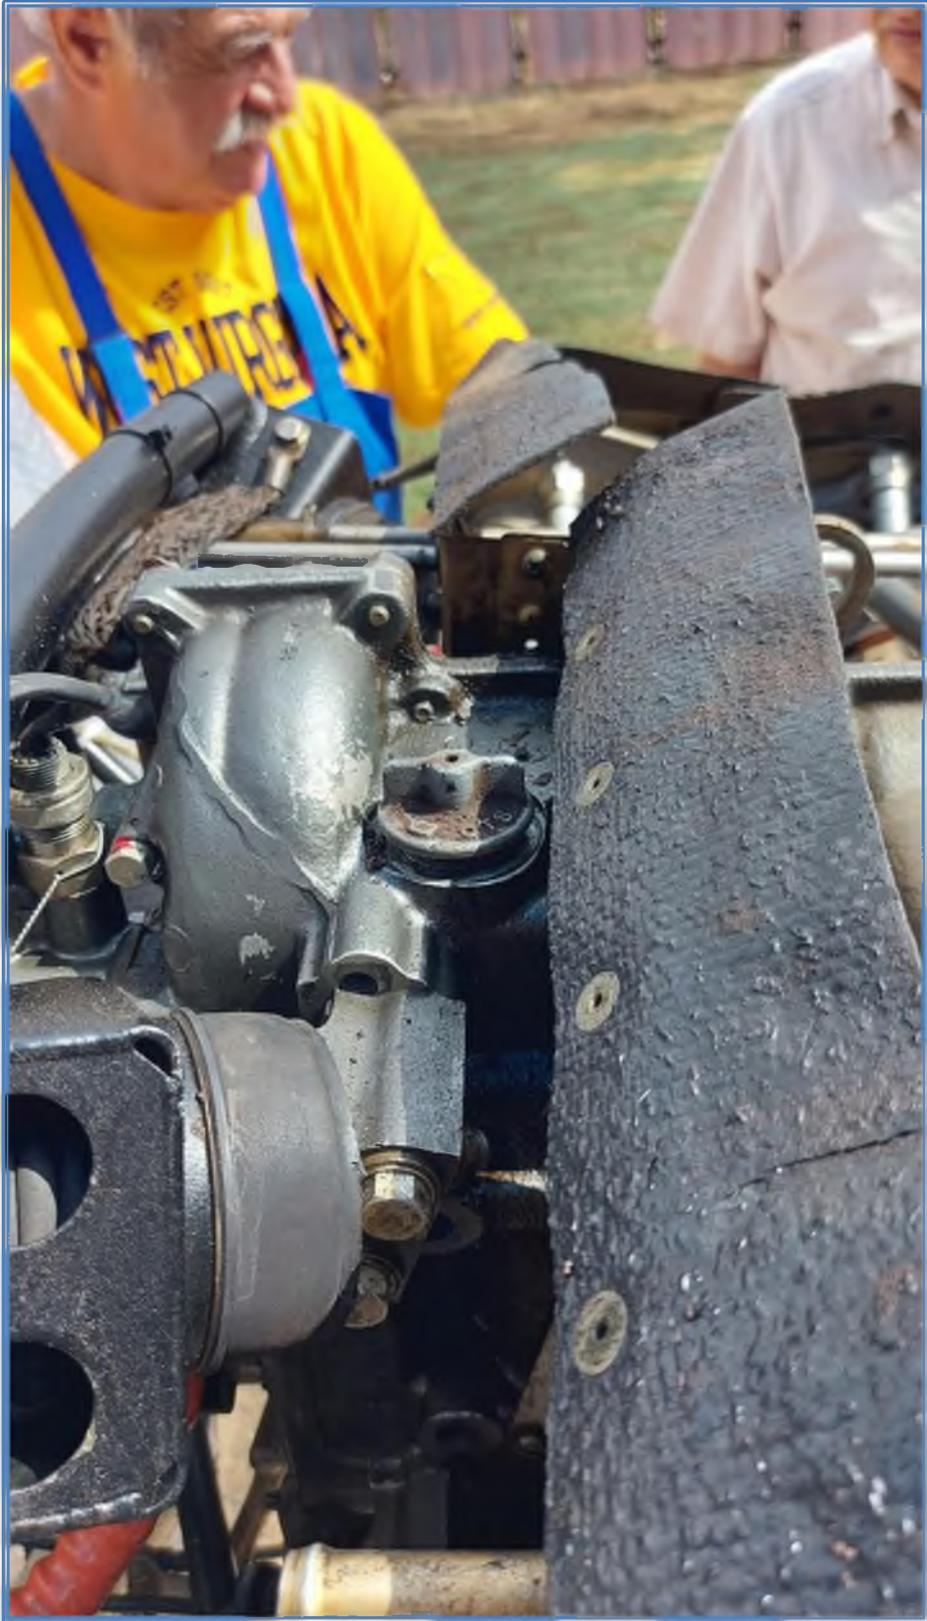
Fig. 21.

Engine oil filler cap not locked (Fig. 21 of Enclosure 1);

The statement in paragraph 2.1.2 shows that the cause of the attempted forced landing at an air-selected site, which turned into an emergency landing, was a drop in oil pressure in the engine oil system. The pressure drop was due to oil leakage, from the engine oil filler neck, as it was found during ground inspections. This neck should be closed by a cap, which must be tightly screwed and locked with a locking wire. According to the piloting pilot, before taking off he has performed a preflight inspection, checking the amount of oil. This check includes: Unlocking the cap (if it was locked at all), unscrewing the cap and checking the oil level by the oil level gauge and, if the level is satisfactory, then screwing and locking the cap. The subsequent oil leakage situation showed that the pilot after the check left the oil filler cap not properly closed, i.e. not screwed or not screwed all the

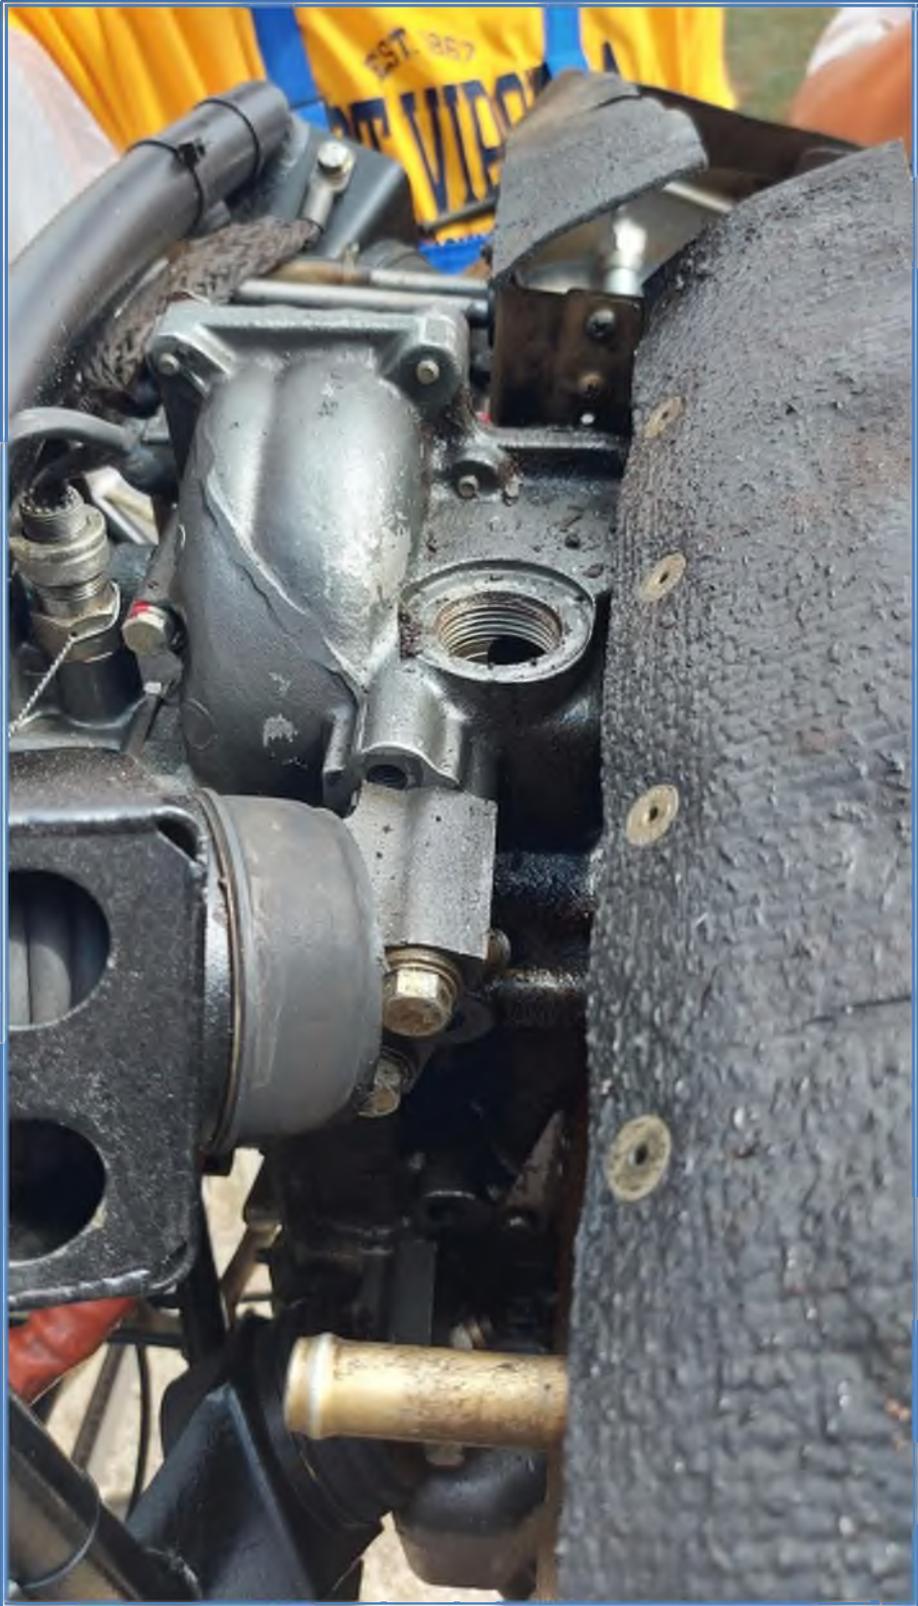
Fig. 22.

Dropped engine oil filler neck cap (Fig. 22 of Enclosure 1). The cap was found dropped at the place of final stop of the aircraft, when it was disassembled for transportation.

1. Falling off of the oil filler cap of the aircraft engine due to failure to close and lock it during the preflight inspection by the pilot-owner.
2. When landing at selected from the air site, the pilot-owner didn't identify the site fence.
