# FINAL REPORT

Investigation of a serious incident on 30.06.2015 with FALCON F900 aircraft, registration marks VP-CGD, and EMBRAER 170 aircraft, registration marks SP-LDK, started in the controlled air space of the Republic of Romania and realized in the controlled air space of the Republic of Bulgaria.

2016

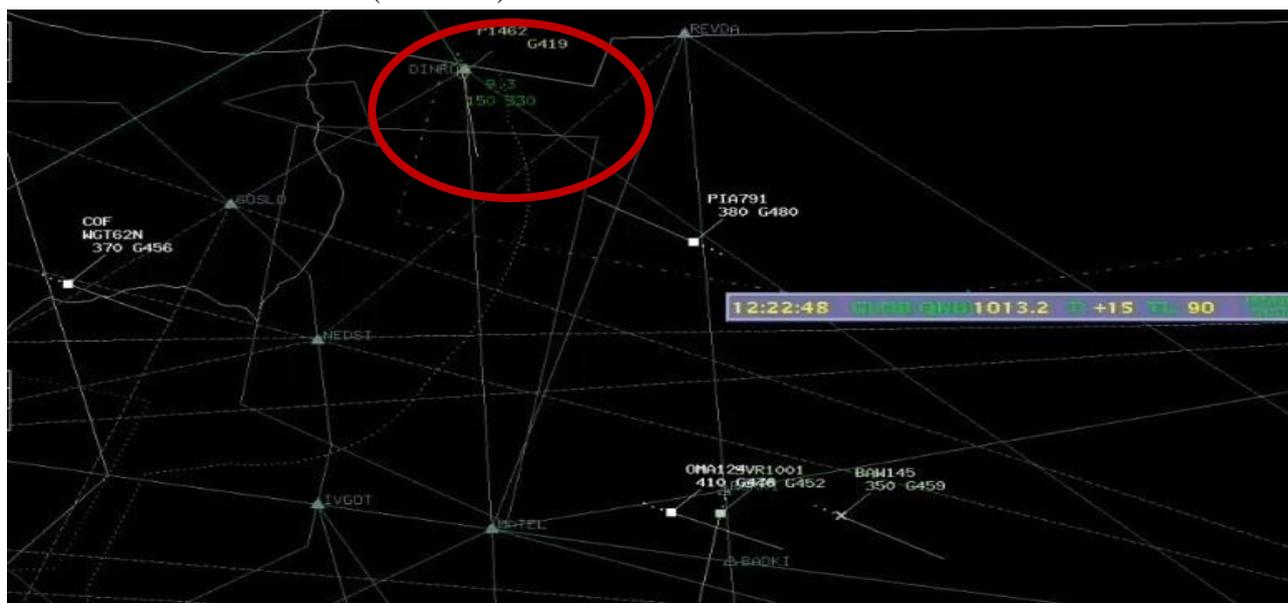
Fig. 1

At 12:21:35 UTC, multiple conversations about the direction of flight of the unidentified target between the EXE ATC and the PLN ATC from DINSI sector and the Air Traffic Controller-Supervisor of ACC Bucharest and on the frequency of DINSI sector between the EXE ATC from DINSI sector and NATO07 (AWACS) were held.

At 12:22:09 UTC the Air Traffic Controller – Supervisor from ACC Bucharest notified the military air forces that NATO07 have informed them about a target at FL 370, heading 170 and speed 170 kt. At 12:22:47 UTC the military air forces informed the PLN ATC from DINSI sector that the unidentified target is found exactly above DINRO point with variable FL.

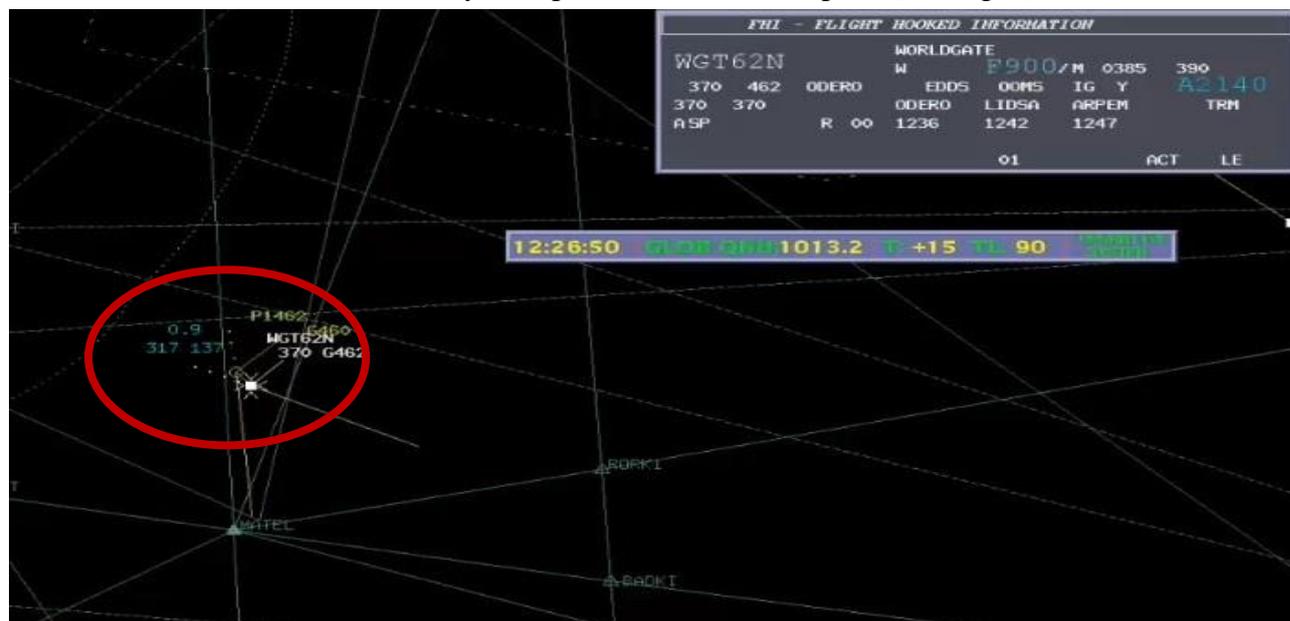
Fig. 2

At 12:26:50 UTC the horizontal distance between WGT62N and LOT7293 is 0,9 nm, at one and the same FL 370, determined by extrapolation of the radar plots (see Fig. 2).

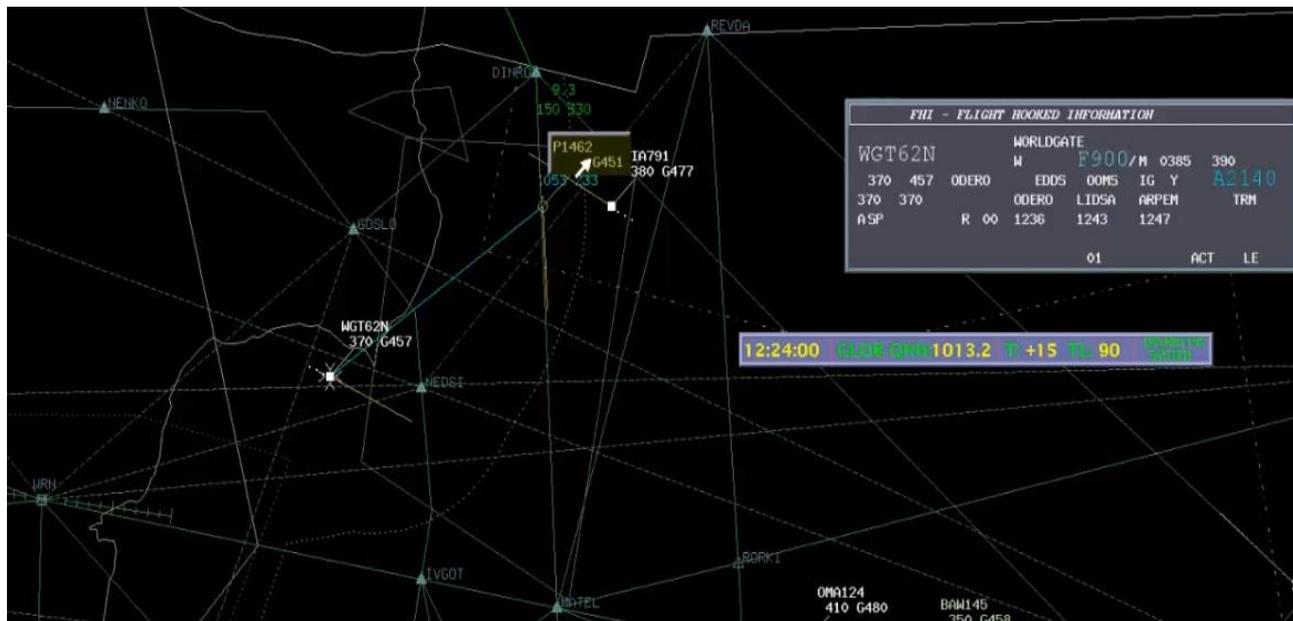
Fig. 3

At 12:24:00 UTC, ACC Bucharest requested confirmation of information about the unknown aircraft: “I want to ask you if you have on the primary radar over DINRO any traffic” (see Fig. 3).

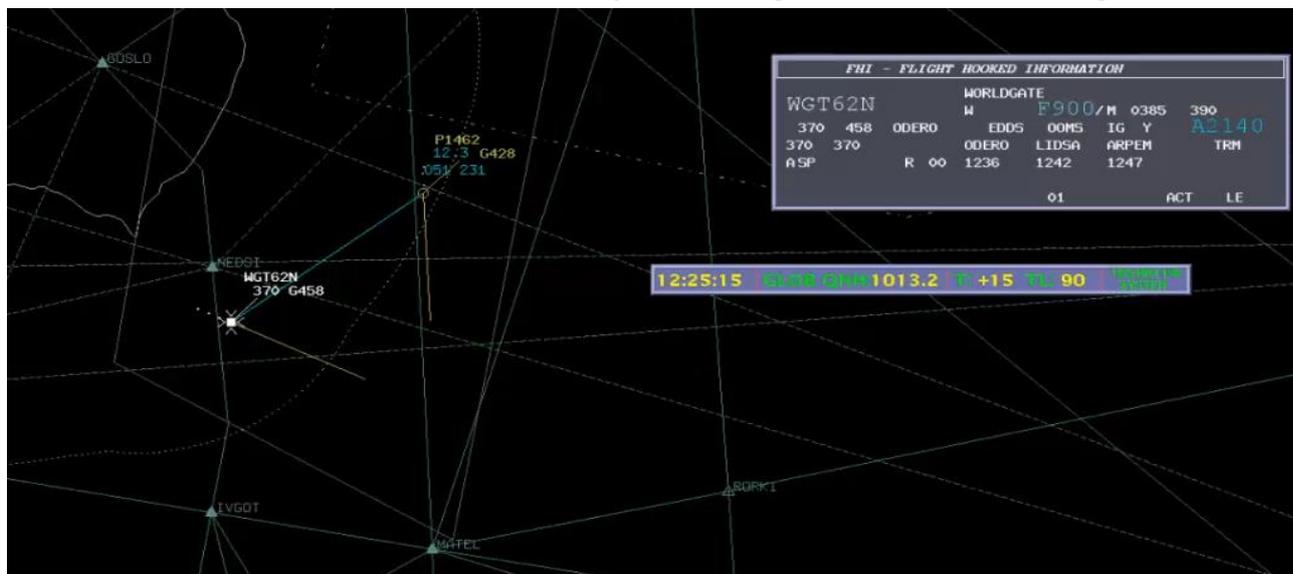
Fig. 4

At 12:25:15 UTC ACC Bucharest: “So you have target over DINRO” (see Fig. 4).

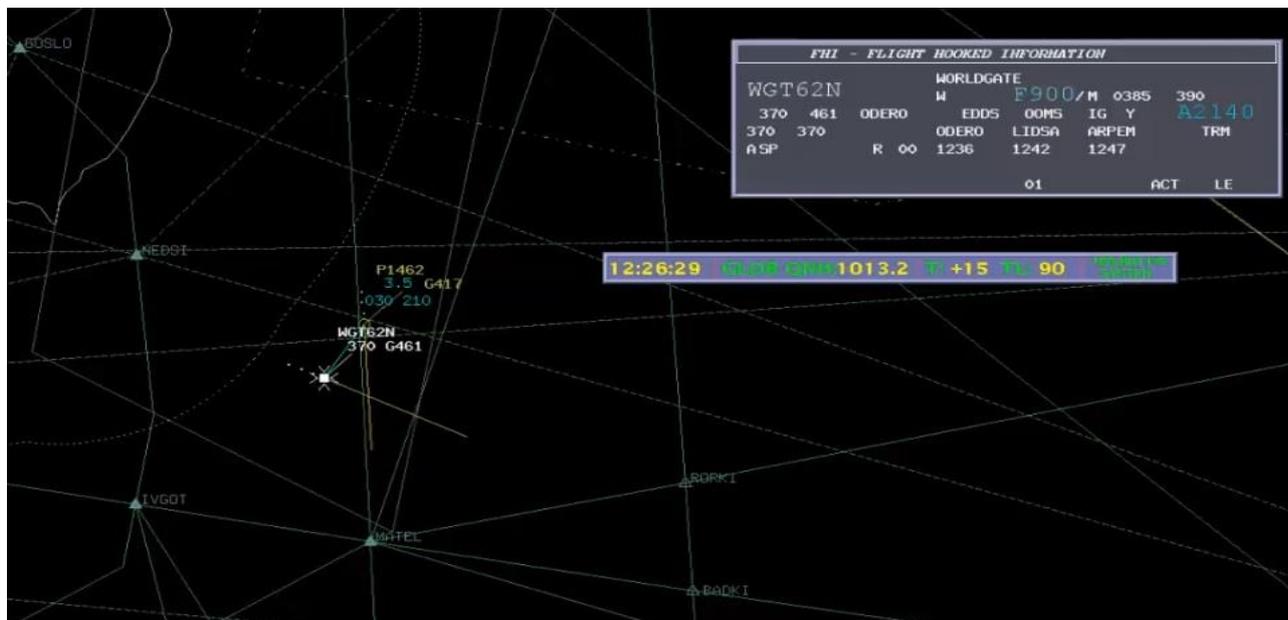
Fig. 5

At 12:26:29 UTC ACC Bucharest: “It might be LOT7293 It might have FL370, Yes, LOT7293 Flight Level 370 ok” (see Fig. 5).

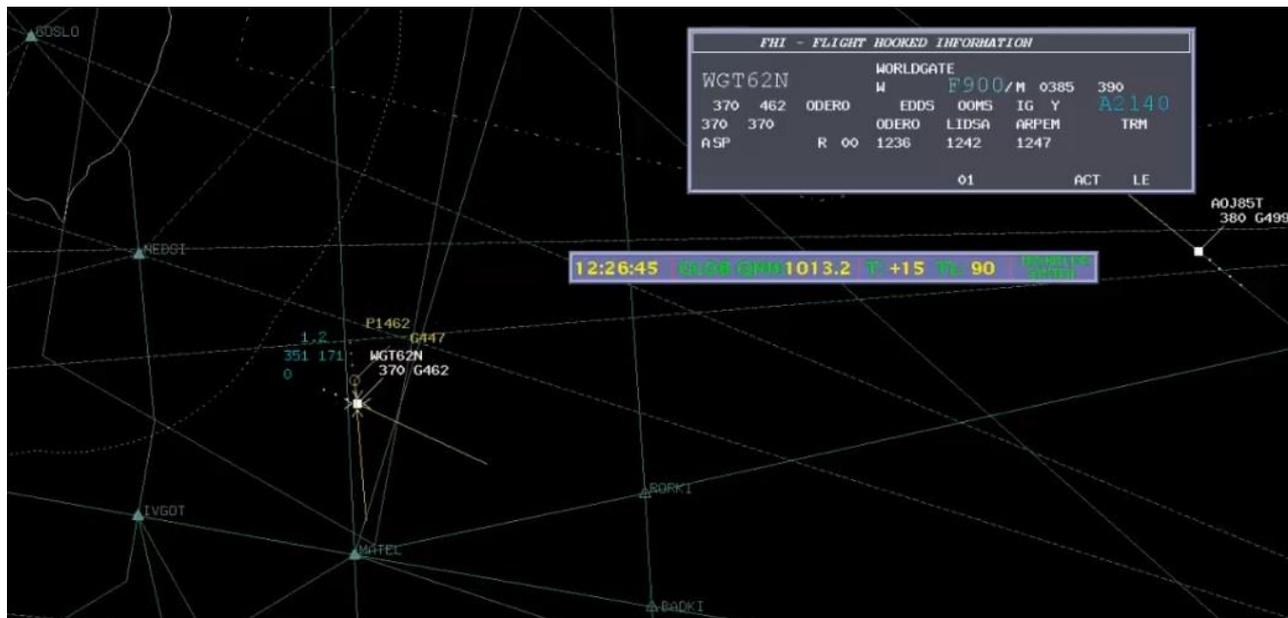
Fig. 6

At 12:26:45 UTC ACC Bucharest: “LOT7293 It might be flight level. Stand by”(see Fig. 6).

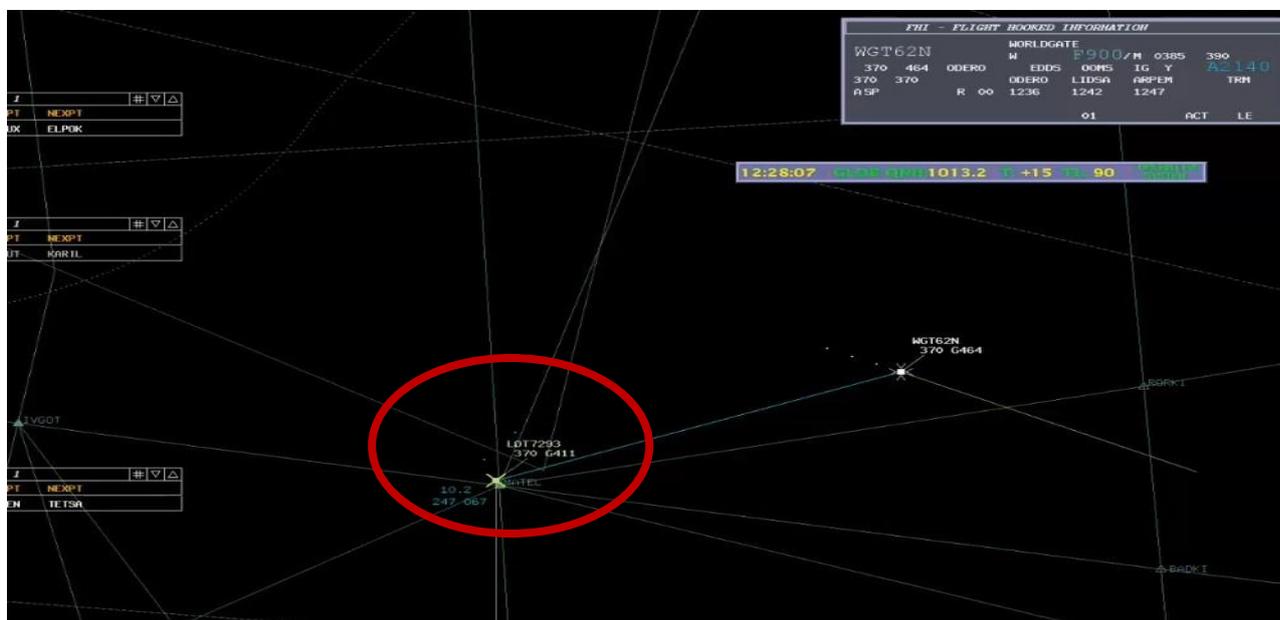
Fig. 7

At 12:28:10 UTC LOT 7293: “Thank you very much sir LOT 7293” (see Fig. 7).

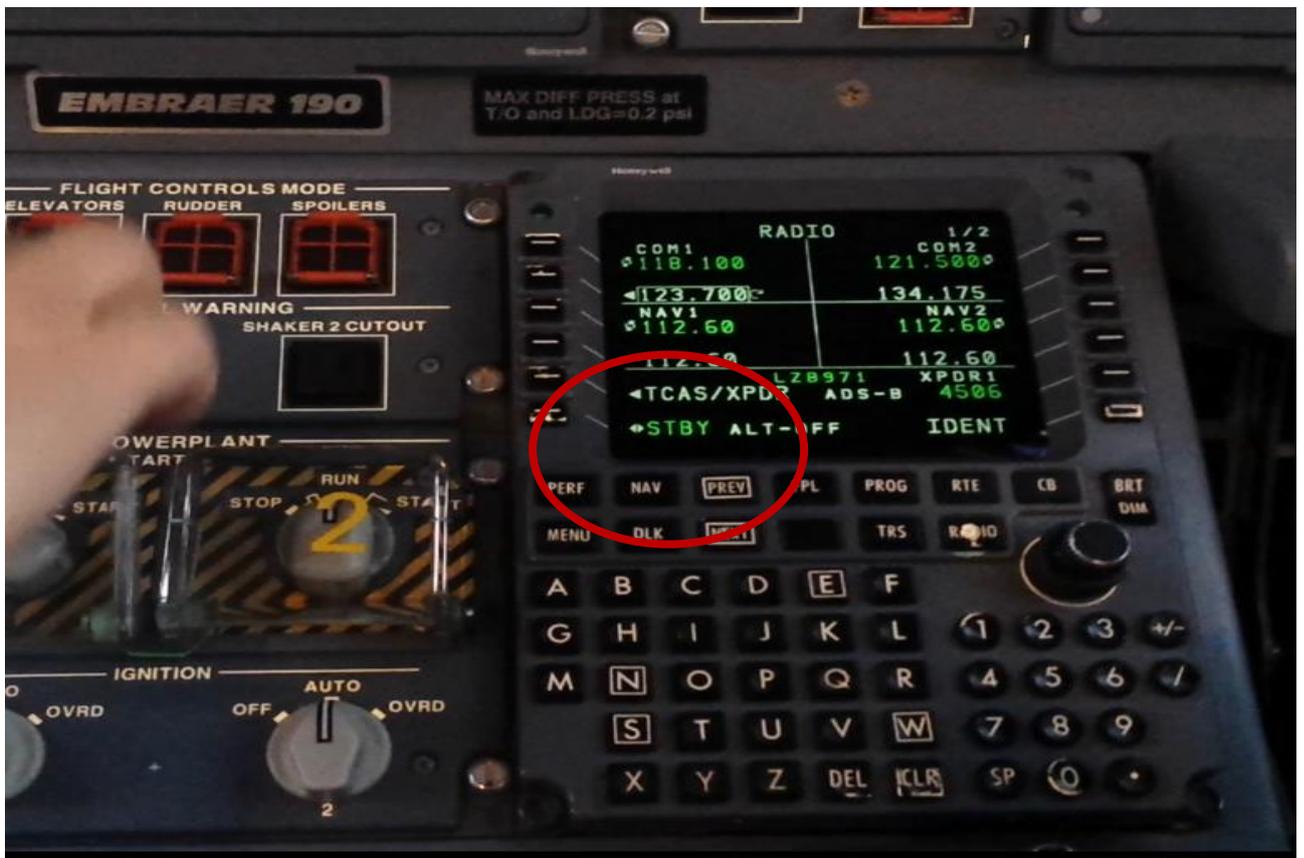
Fig. 10

Where the transponder is in STANDBY Mode, a “STANDBY” inscription is displayed in green on the MCDU (see Fig. 10).

- In result from the momentary failure, the transponder switched to STANDBY mode during the flight.

- The flight crew did not notice the current STANDBY mode of the transponder indication, as well as the inscription TCAS OFF on PFD and did not report about the improper operation of the XPDR/Transponder system to the Air Traffic Service authorities till ACC Sofia Control FS Varna West informed them about the non-operating transponder.

**BG.SIA-2015/03/06.** “LOT” AO shall perform in the shortest time simulator training for actions on detection, reporting and rectification of failure of the XPDR/Transponder system to be performed by the flight crews operating Embraer 170/175/190/195 aircraft.

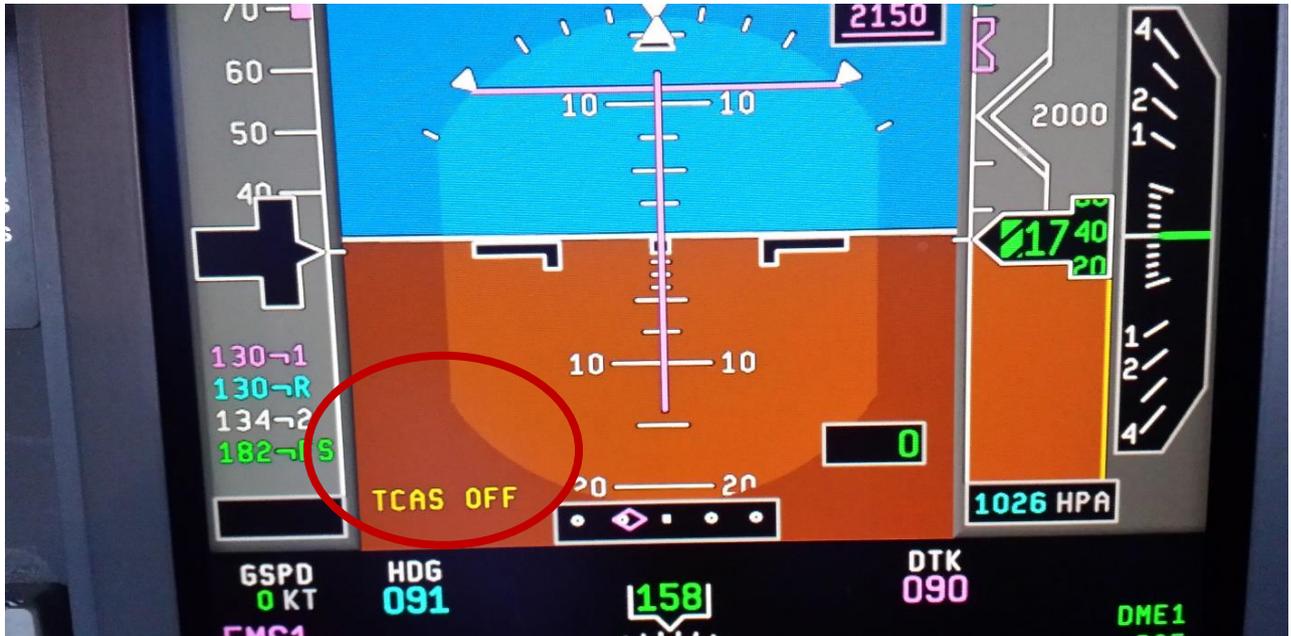
Fig. 11

and a “TCAS OFF” message is displayed on both Primary Flight Displays (see Fig. 11).

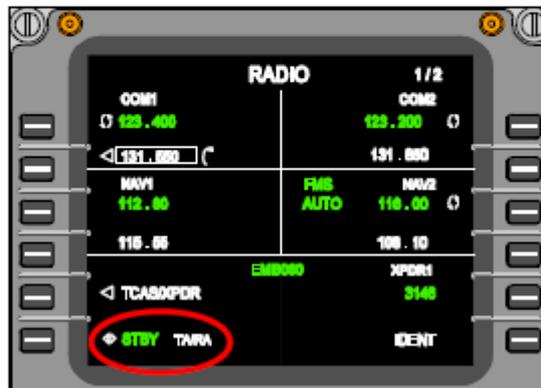
The MCDU Radio page annunciates that the transponder system is in STANDBY mode at the left bottom of Radio Page 1/2.

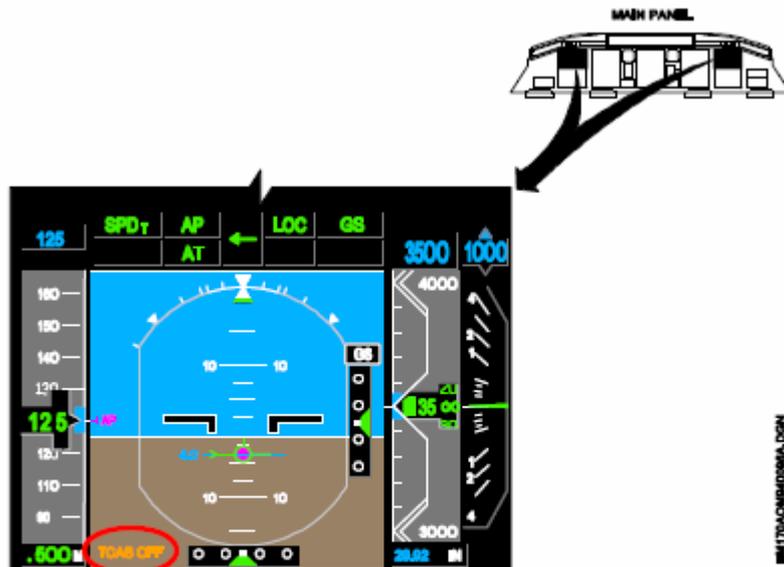
On the PFD the TCAS OFF annunciation is displayed promptly every time the TCAS is set to off.
