FINAL REPORT

investigation of a serious incident realized on 11.02.2015 with F2000 aircraft, registration nr. LZ-OOI, upon takeoff from Sofia Airport

2016

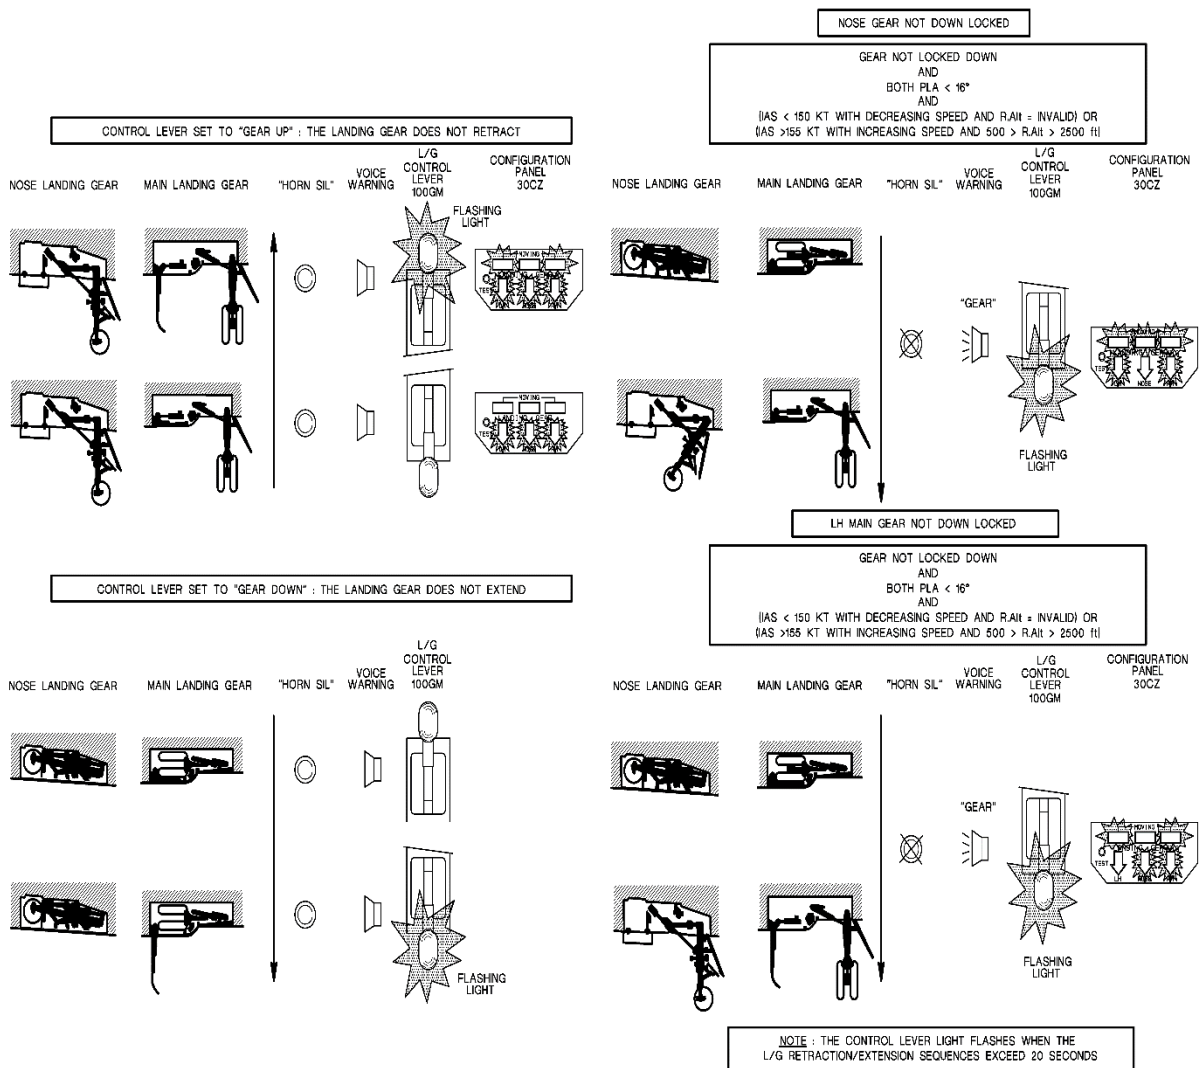
Aircraft FALCON 2000 has retractable L/G, executed after a three-support scheme with a nose L/G. The general view and the major components of the L/G are exhibited on Figures 1 to 4 from Appendix 1. Figure 5 of Appendix 1 shows the consequence of L/G retraction, and Figure 6 – problems with the normal functioning upon L/G retraction and drop-down.

Figure 6. Obstruction of the normal functioning upon L/G retraction and drop-down.

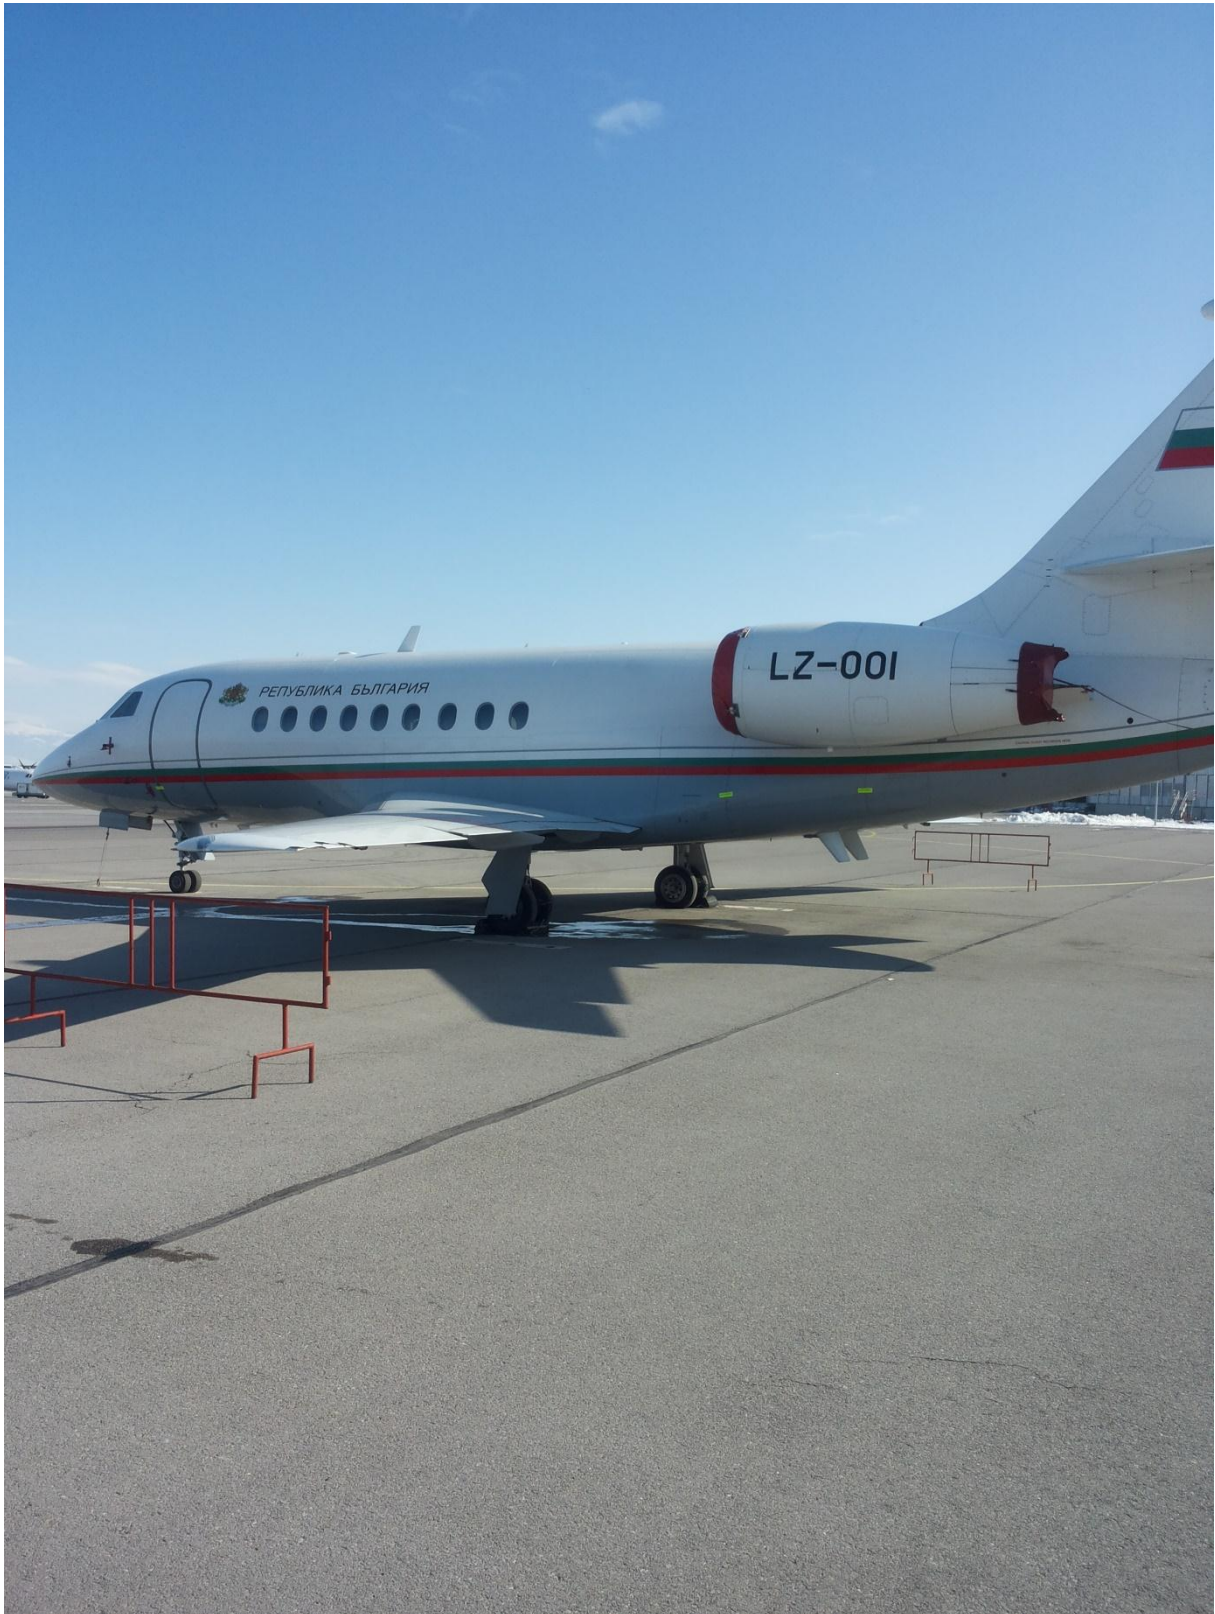
Upon the inspection of the aircraft L/G after its landing at Sofia Airport, it was established that the three stands are locked in a dropped-down position and that on the configuration panel three green lights are illuminated, which evidence for normal condition of L/G on the ground.

Figure 7. The aircraft at Sofia Airport on 12.02.2015.

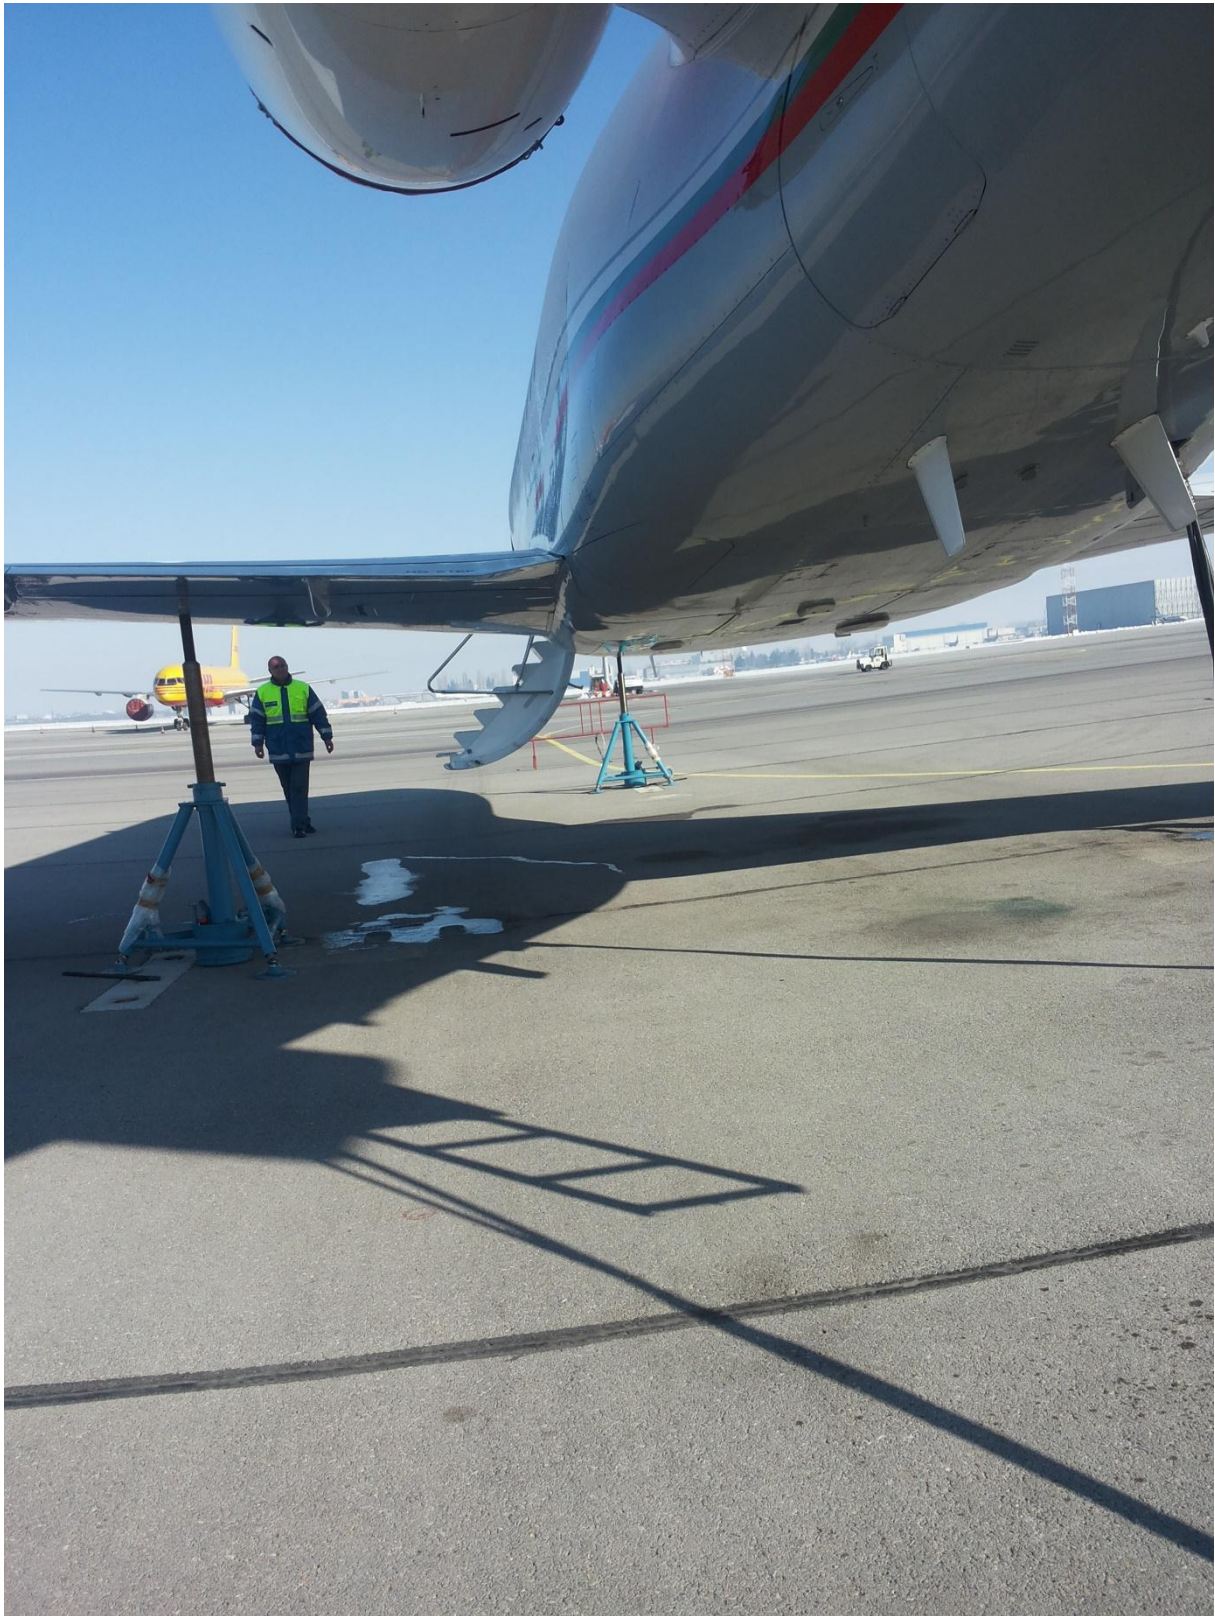
Figure 8. The aircraft with retracted L/G upon tests on 13.02.2015.

After replacement of aggregates, examinations on the ground were carried, whereupon the aircraft was put in a hoisted position by jackscrews. On 14.02.2015 a control flight of the aircraft was performed. Upon the tests on ground and during the control flight no deviations from the technical conditions were established.

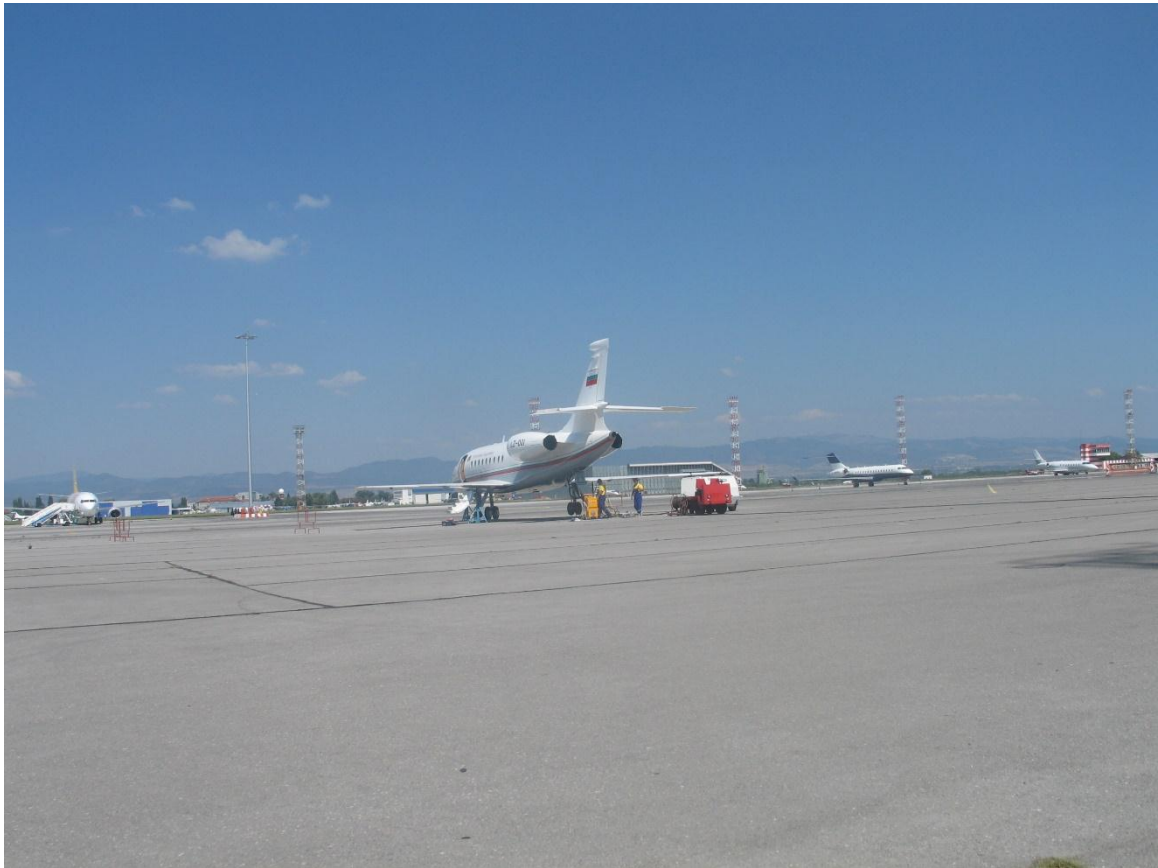
On 31.08.2015 after L/G examination and testing of the configuration panel, the aircraft performs technical flight with dropped L/G to the base Sofia Airport for investigating the cause of the defect. Figure 9, Appendix 1 exhibits the preparation of FALCON 2000 aircraft, SN 123, registration marks LZ-OOI, for functional tests of the L/G at Sofia Airport. Figure 10 shows the availability of signaling for L/G dropped-down position on the configuration panel. Control L/G retractions and drop-downs were performed which proved that the cause of the event, realized on 30.08.2015, was a defective lock for upper position of the nose L/G. Figure 12 from Appendix 1 shows the non-locked nose L/G upon position of the control lever, corresponding to retracted position, as exhibited on Figure 13, Appendix 1, where the three illuminating red lights on the configuration panel may be seen. Figure 11, Appendix 1 shows that the doors of the main L/G remain in open position. Figure 1 exhibits the failed lock of the nose L/G. Upon the performed works on searching malfunctions in conformity with working package Nr. 15 F212/31.08.2015, enclosed to the investigation materials, elaborated by Aviodetachment 28, the Technical Service Organization of the Air Operator established also that the nitrogen pressure in the nose stand is outside the permissible limits. The defective lock was replaced by a new one, as the defective lock was sent for investigation. The nose stand was charged with nitrogen by a TAG Aviation expert.

Figure 9. Preparation of the aircraft for L/G functional tests on 31.08.2015 at Sofia Airport.

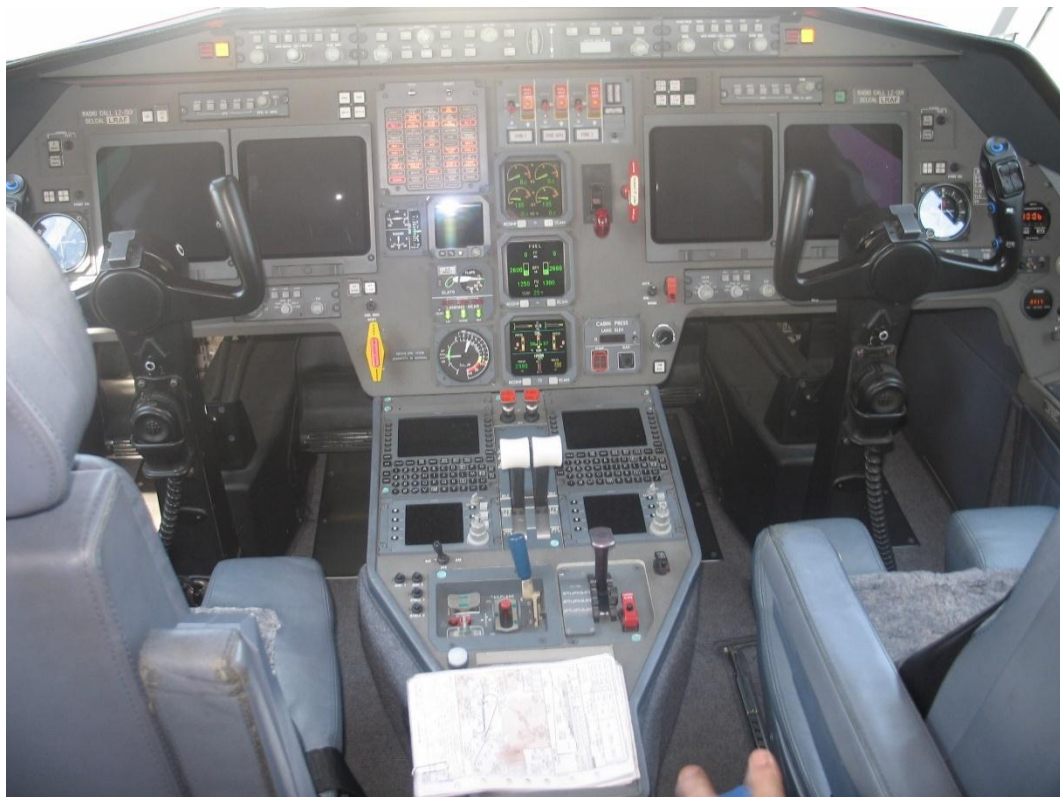
Figure 10. Signaling on the configuration panel for L/G down position.

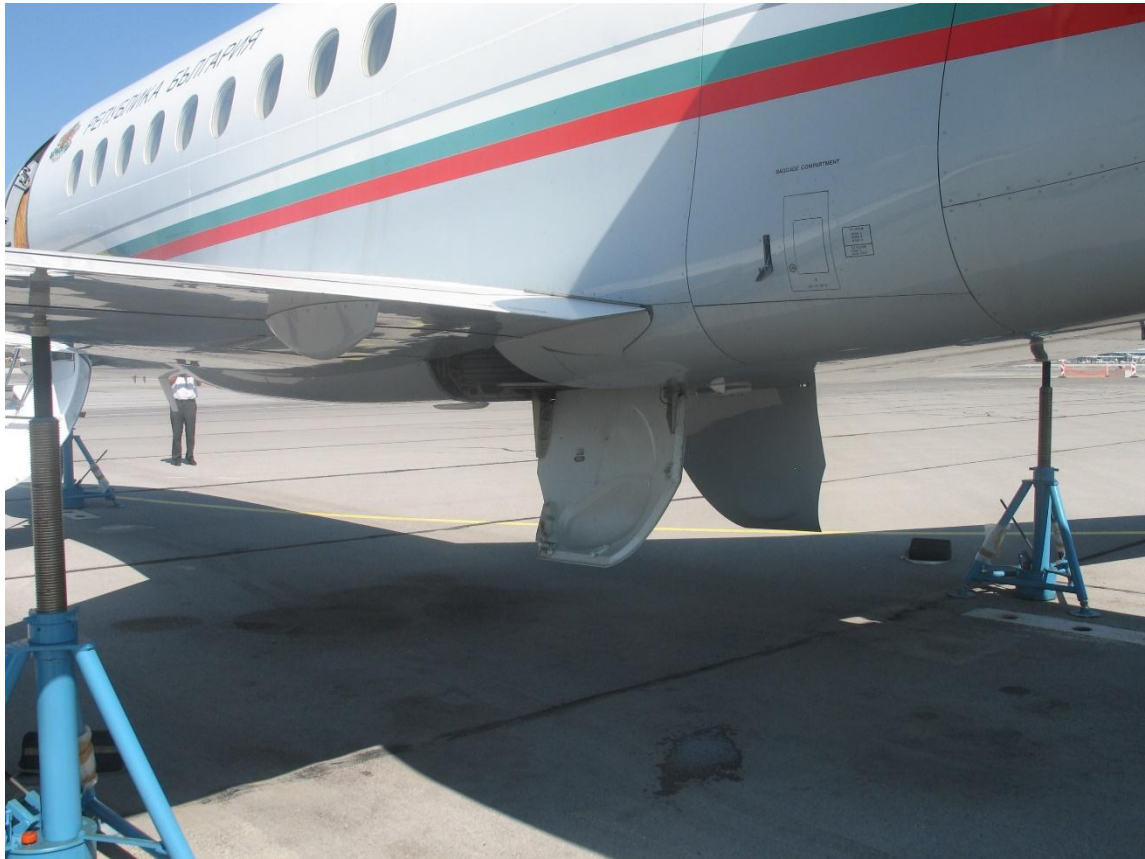
Figure 11. The lever is in “retracted” position, the doors of the main L/G remain in “down” position.

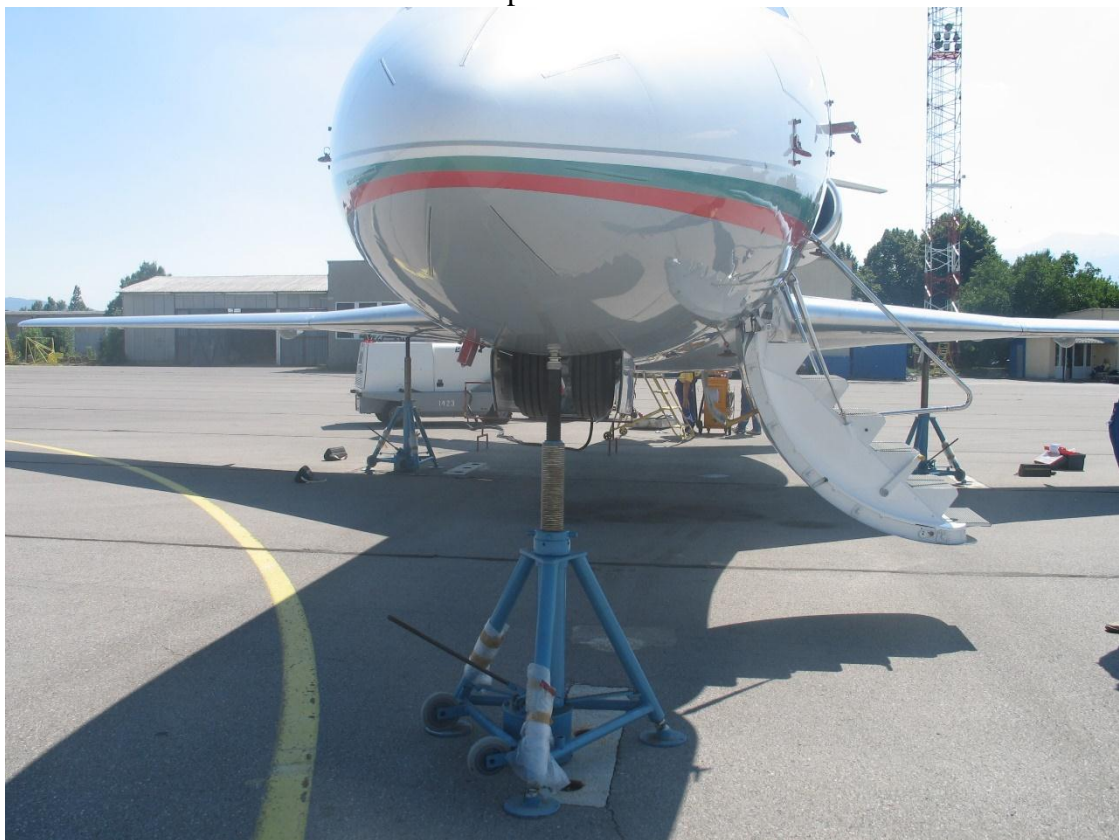
Figure 12. The lever is in “retracted” position, the nose stand is not closed in “retracted” position.

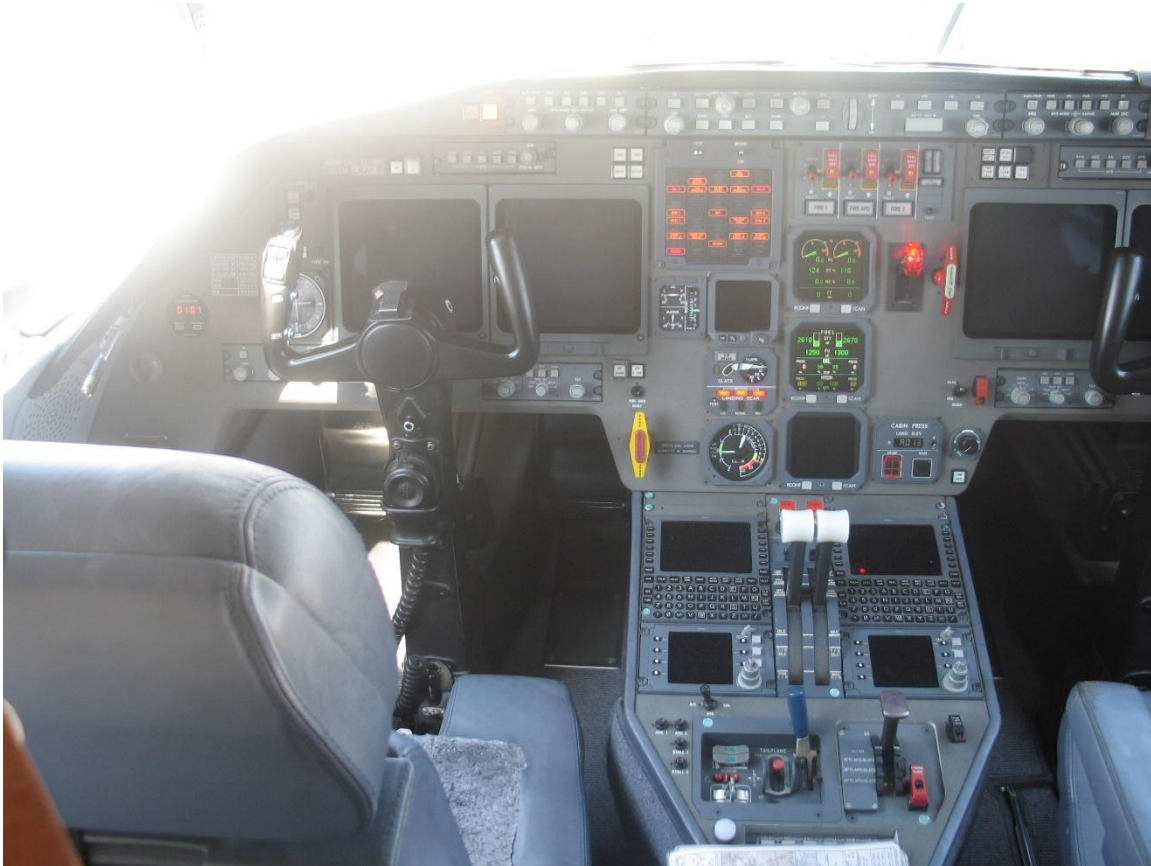
Figure 13. On the configuration panel, three red lights are illuminating.

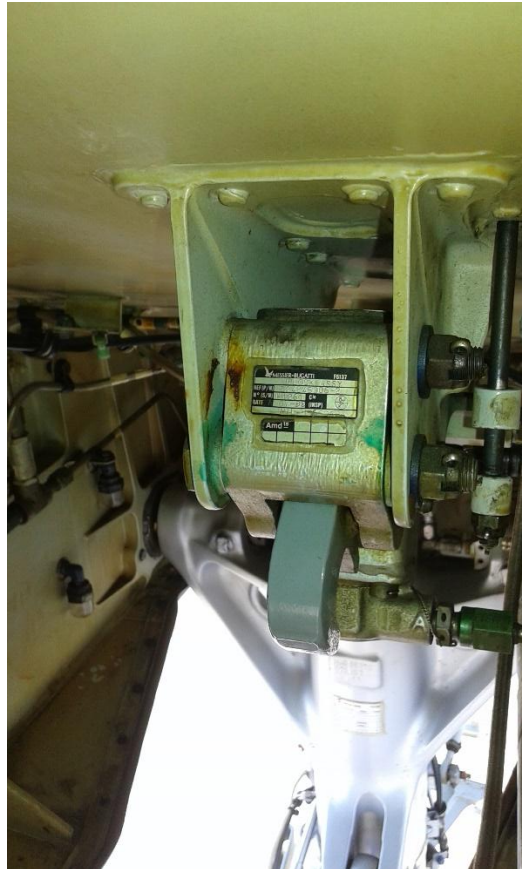
- The performed control retractions of the L/G show that the cause for the event, realized on 30.08.2015, is a defective lock for upper position of the nose L/G. The defective lock is replaced with a new lock, as the defective one is sent for investigation.

Figure 14. The failed lock of the nose L/G.

- Service bulletin of FALCON FSA-32-30-017-R02-A dt. 02.10.2014 provides review of anomalies in the functioning of the lock for retracted position of the nose L/G. Recommended is its replacement by a modified variant, the same is recommended also for the locks for retracted position of the main stands.

- On recommendation of the commission on investigation of events connected with L/G functioning, the locks of the main stands are also replaced.
