# FINAL REPORT

investigation of an aviation accident, realized on 27.07.2015 with aircraft P92-JS, registration marks LZ-DBV, in the region of Dolna Banya airfield

2015

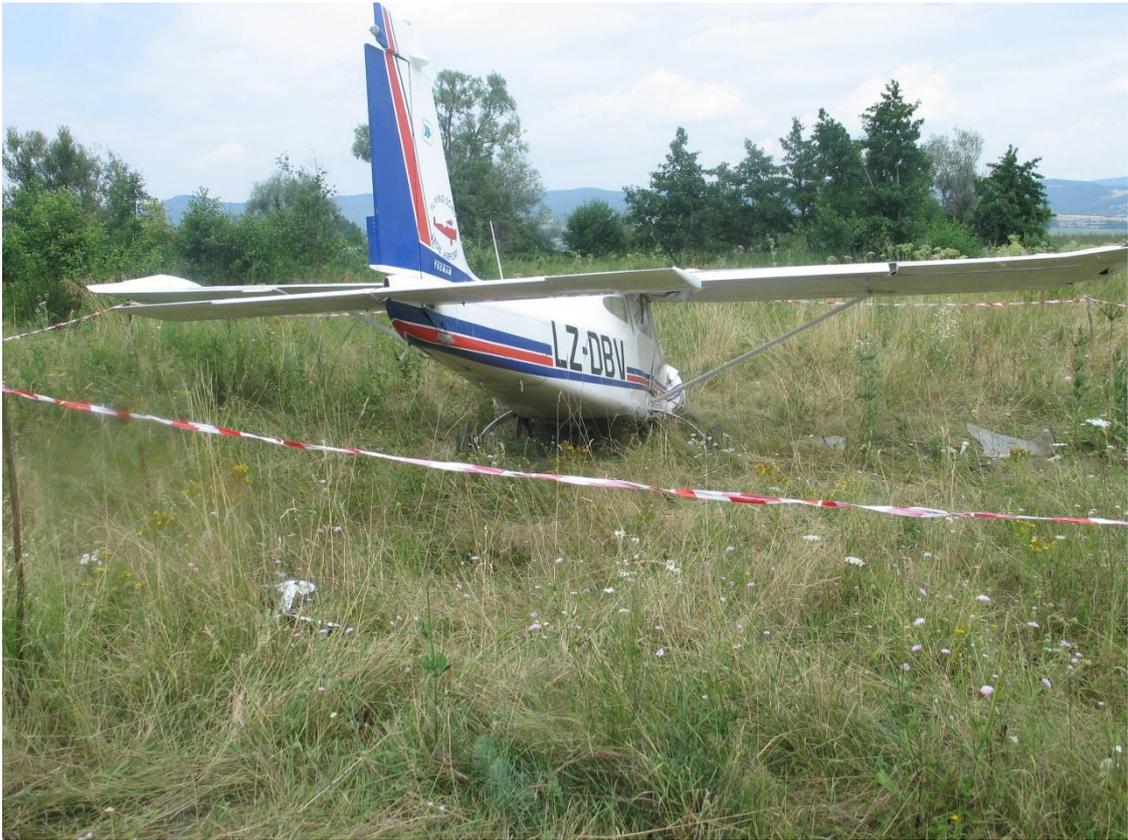
Figure 5.

- The nose stand knocked out, the nose wheel is found under the tail of the aircraft, Figure 5 of Appendix 1.
- The airscrew and the prop are destroyed, the axis of the airscrew is bended on the right, Figure 9 of Appendix 1.

- The nose stand knocked out, the nose wheel is found under the tail of the aircraft, Figure 5 of Appendix 1.
- The airscrew and the pap are destroyed, the axis of the airscrew is bended on the right, Figure 9 of Appendix 1.

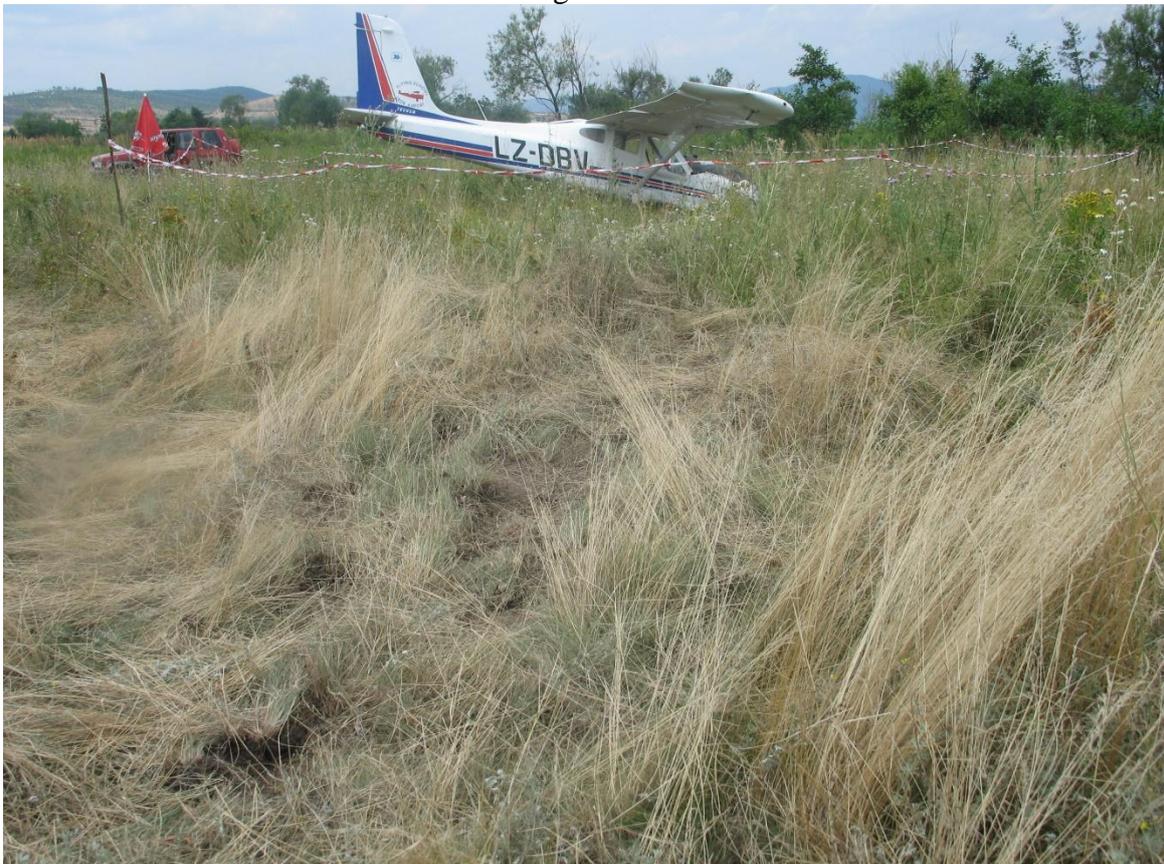
Figure 6.

Upon the initial touch of the aircraft with the earth surface, the nose L/G is destroyed and the airscrew leaves traces on the earth surface at a distance of 8,90 m in the south-eastern direction from the point whose coordinates are given above. The traces on the earth surface may be seen on Figure 6 of Appendix 1.

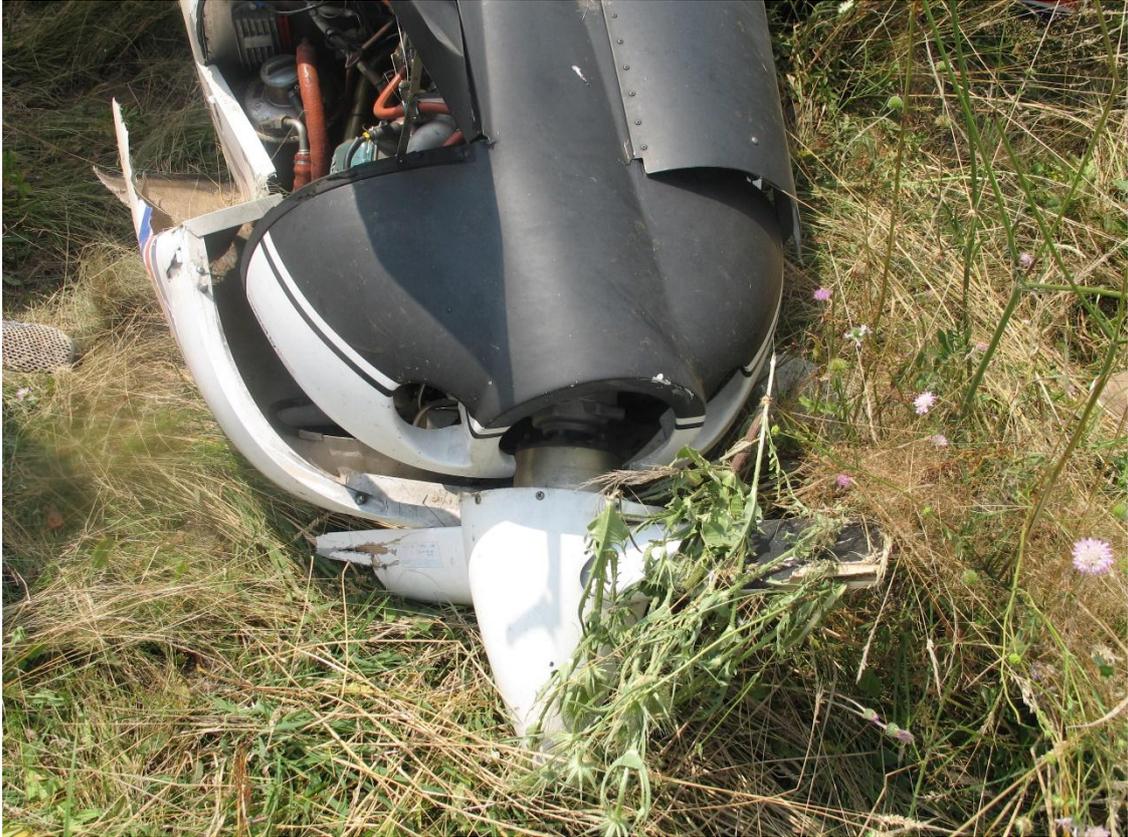
Figure 9.

left on the earth surface from the airscrew and the nature of airscrew damage evidence for engine operation at an increased rotation speed at the moment of impact.

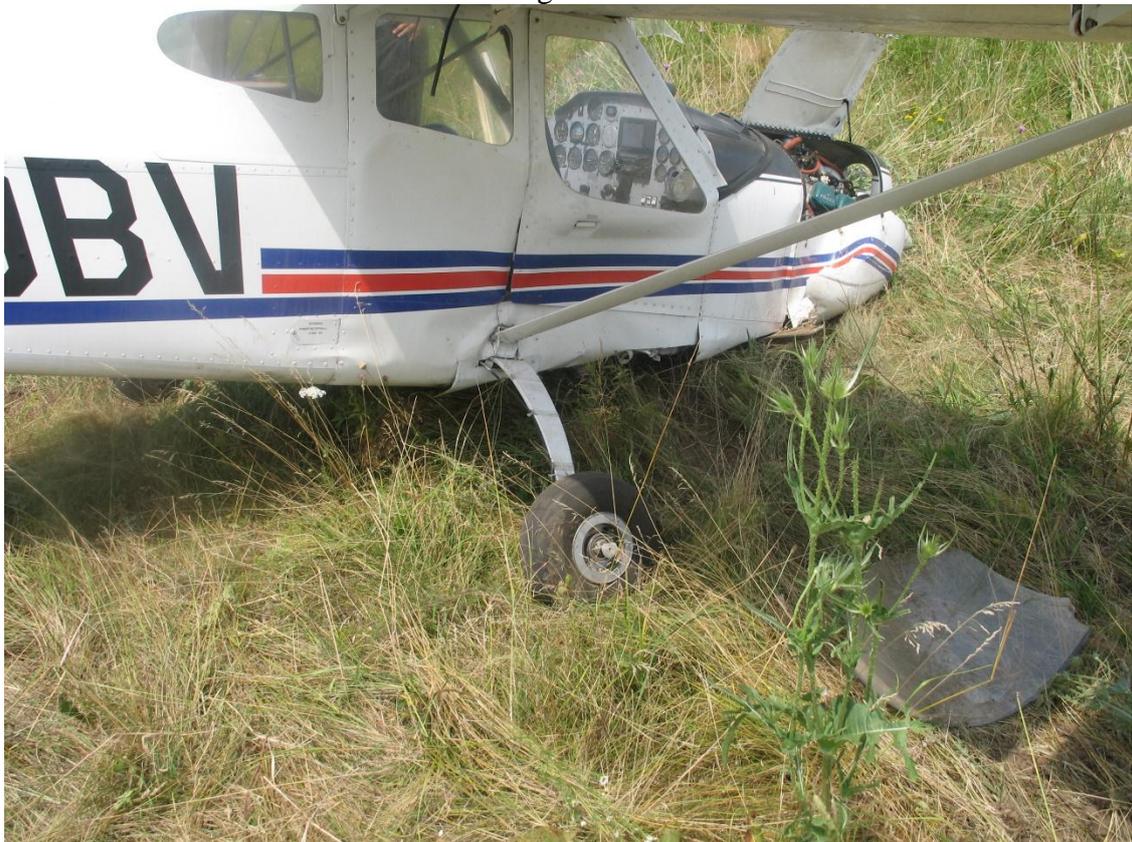
Figure 10.

- Bended motoframe.
- Deformed covers from the engine collapse.
- Destroyed front glass.
- Deformed cabin supporting frame, Figure 10, Appendix 1.
- The shield of the right semi-wing torn apart close to the connection surface to the body and back spar beam torn apart, Figure 11, Appendix 1.

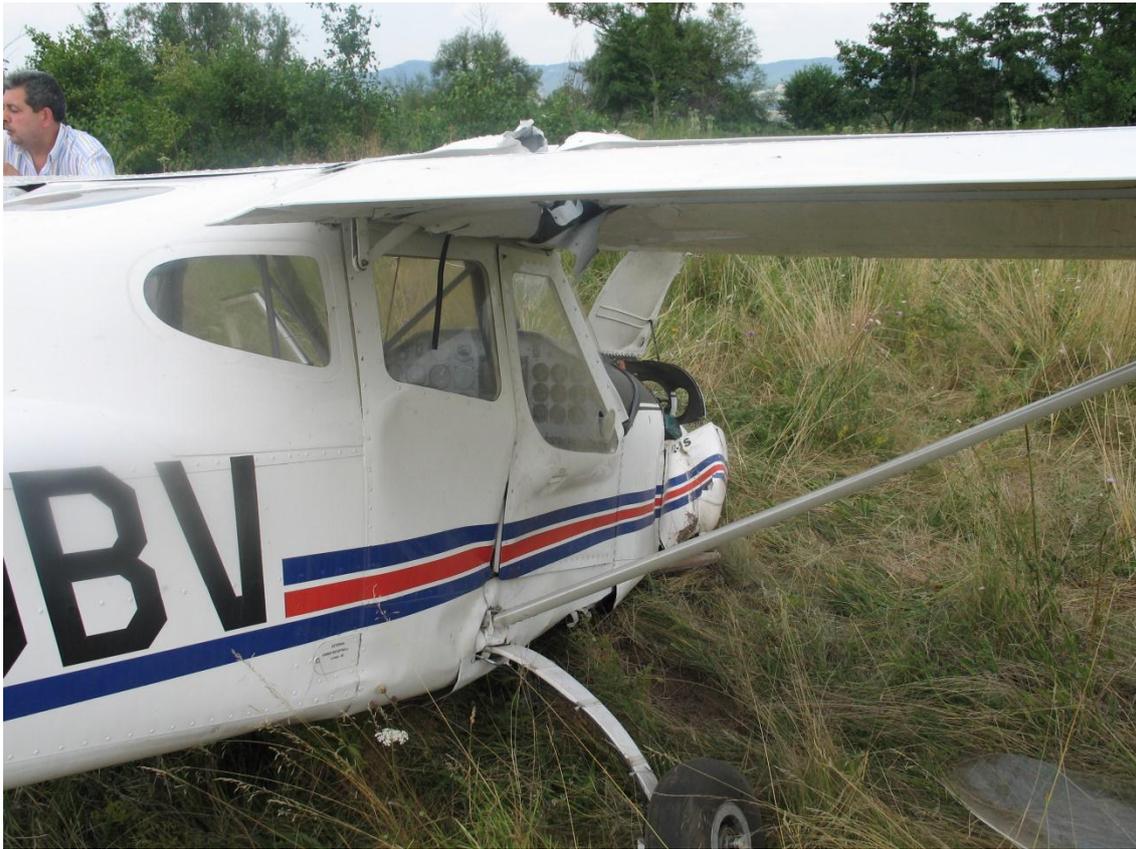
Figure 11.

- Bending and deformation of the right semi-wing.
- Collapsed right AHO.
- Deformed right aileron.
- Deformation of fixing units of right L/G and right strut, Figure 11, Appendix 1.

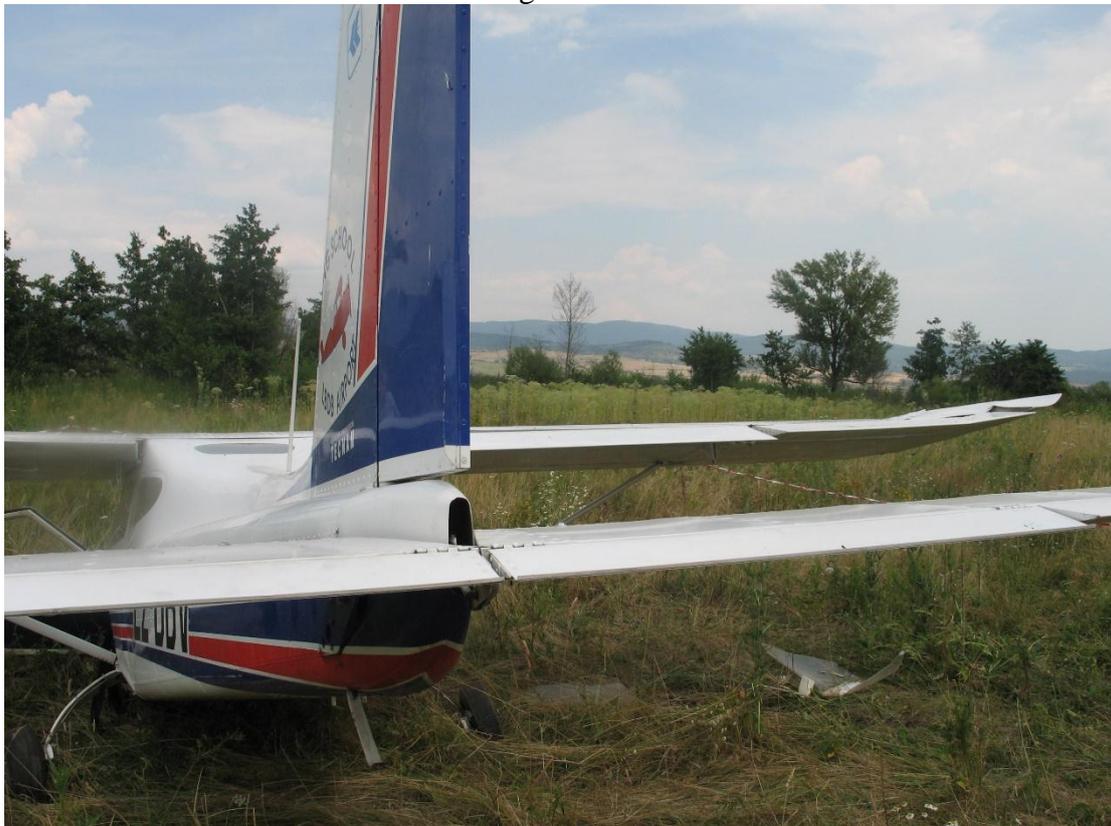
Figure 12.

- The trimmer of the horizontal stabilizer is deviated downwards at 2 cm on the exit edge, figure 12, Appendix 1.
- No damages on the vertical steering wheel, its aerodynamic compensator is deviated at 45°.

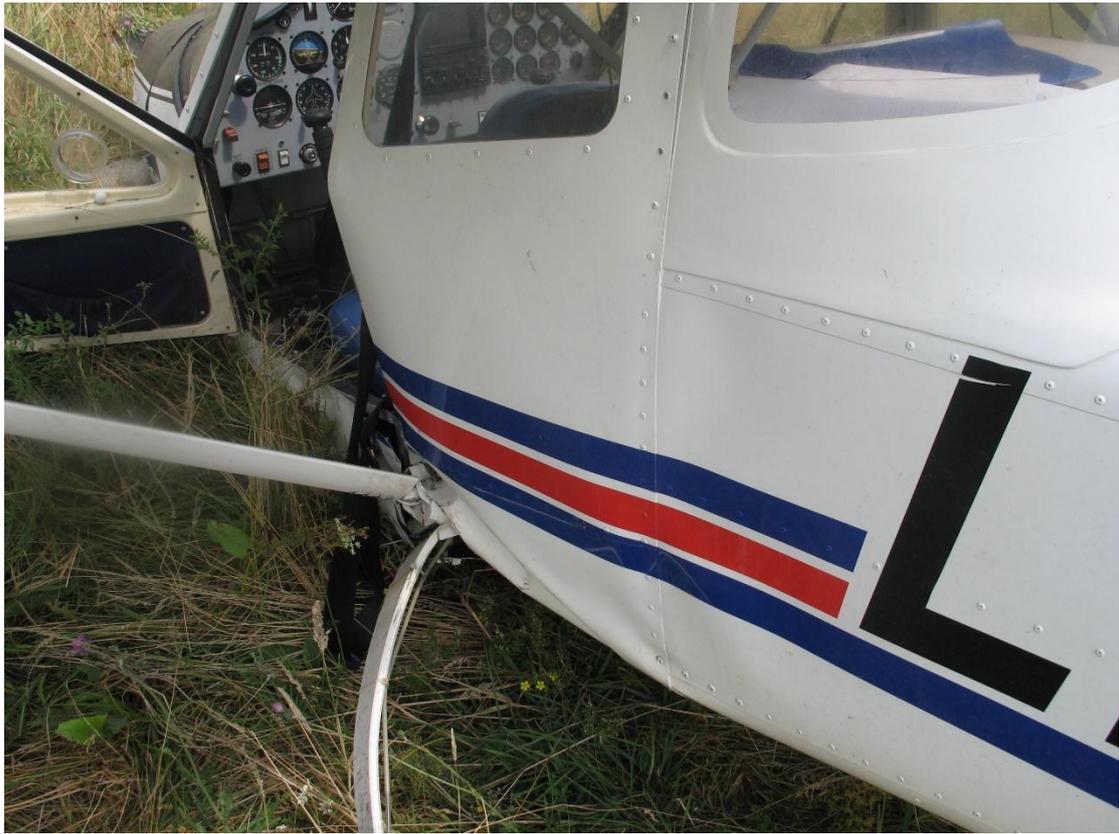
Figure 13.

- Deformation of the left end of the right wing flap.
- Deformed and blocked right door of the cabin.
- Deformation of fixing units of left L/G and left strut, Figure 13, Appendix 1.

- Deformation of fixing units of left L/G and left strut, Figure 13, Appendix 1.
- Deformation and destructions on the edge of the left semi-wing, the shielding is destroyed on its bottom side, Figure 14, Appendix 1.
- The stings controlling the valves of the left and right carburetors are not damaged, Figures 15 & 16, Appendix 1.
- There is no visible tearing of pipes in the engine compartment.
- Destroyed oil radiator.
- Oil in the engine is within the norms between 2 and 3 l.
- On the left side of the body in front of the horizontal stabilizer, aircraft identification panels are fixed, Figure 17, Appendix 1.

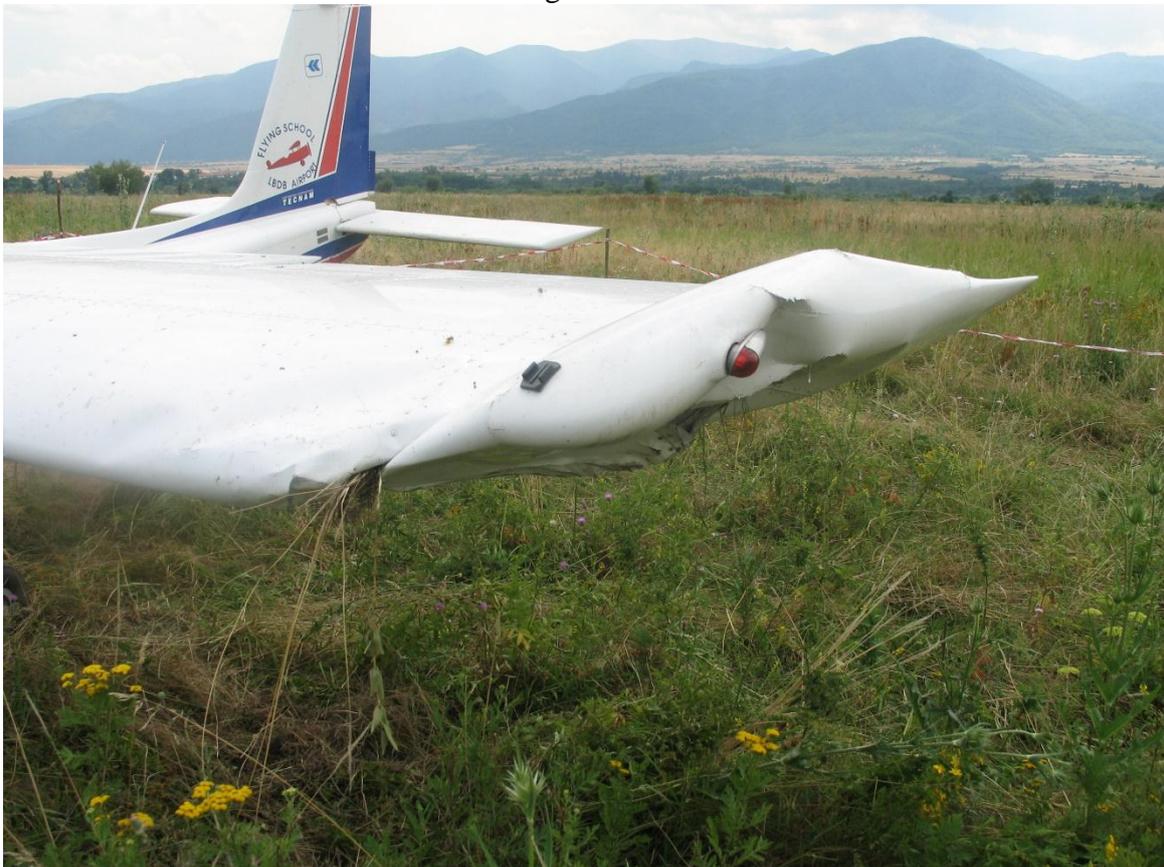
Figure 14.

- Deformation and destructions on the edge of the left semi-wing, the shielding is destroyed on its bottom side, Figure 14, Appendix 1.
- Destroyed oil radiator.
