FINAL REPORT

investigation of an aviation event, realized on 02.08.2015 with helicopter R22 BETA, without registration marks, operated by its owner, in the land domain of Uzundzhovo village, Haskovo district

2015

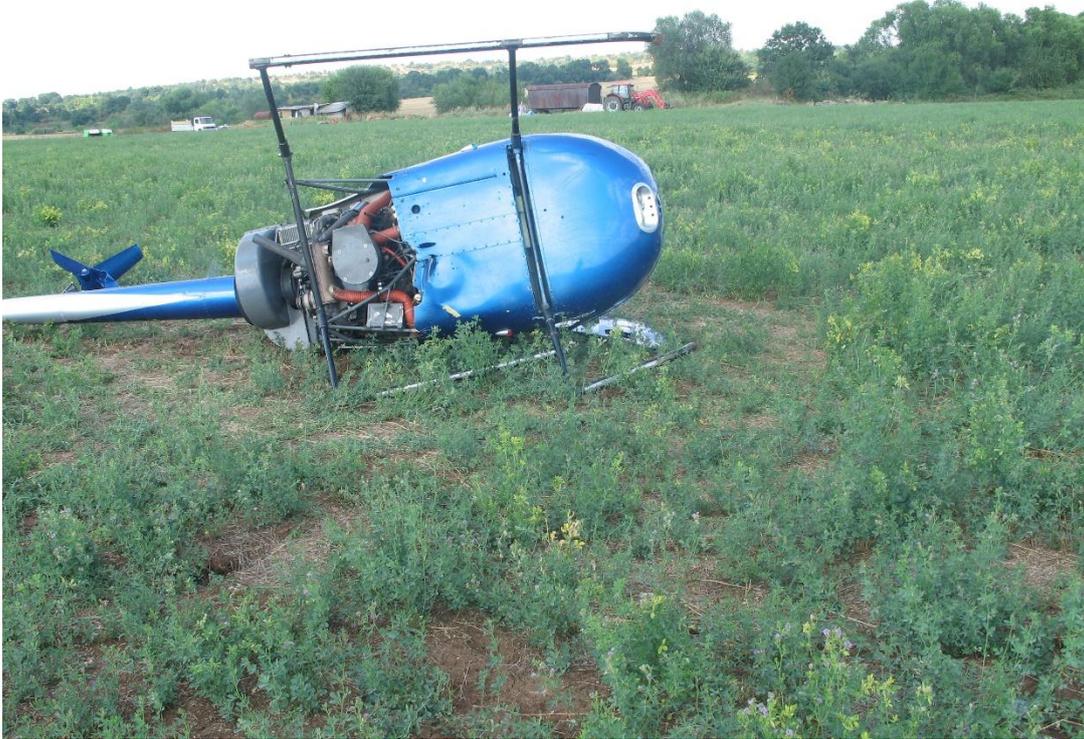
Фиг. 1.

An unregulated temporary platform in a lucerne field at 3,34 km in 54,29⁰ direction from the village of Uzundzhovo, with coordinates N 41⁰58'40.91", E 025⁰41'22,43" and an altitude of 199 m. Figures 1 to 4 from Appendix 1 exhibit photos of the place of the aviation event. The photos show also the helicopter's remnants.

- Destroyed supporting skis.
- Destroyed bearing screw.
- Destroyed automatic incliner.
- The tail screw and the stabilizer of the tail beam are torn apart.
- Destroyed glazing of the cabin.

During the try to take off from the place it is found at, upon a strong wind from the left and the back, the helicopter crushes down from a height of about one meter, the main propeller realizes contact with the earth surface, and the helicopter crashes. Thereupon destroyed are the tail beam, the blades of the main and the tail propellers and the cabin's glazing. The helicopter's body inclines, laying down on its left side. This is exhibited by photos on Figures 1 to 4. The helicopter has laid aside in a compass course of 128^0 .

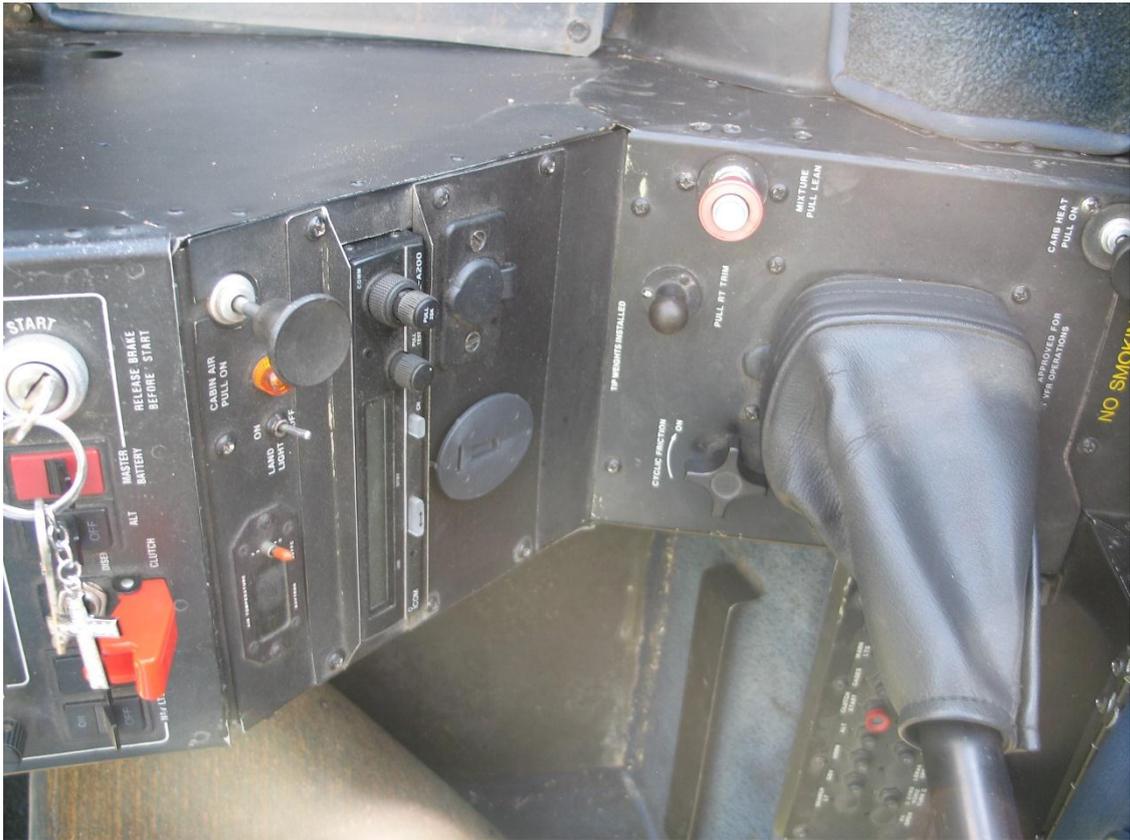
Фиг. 5.

- The switches of the accumulator battery and the alternator are switched off by the pilot upon starting of the helicopter, Figure 5, Appendix 1.
 - The magnets switch is in “off” position – switched off upon starting of the helicopter.

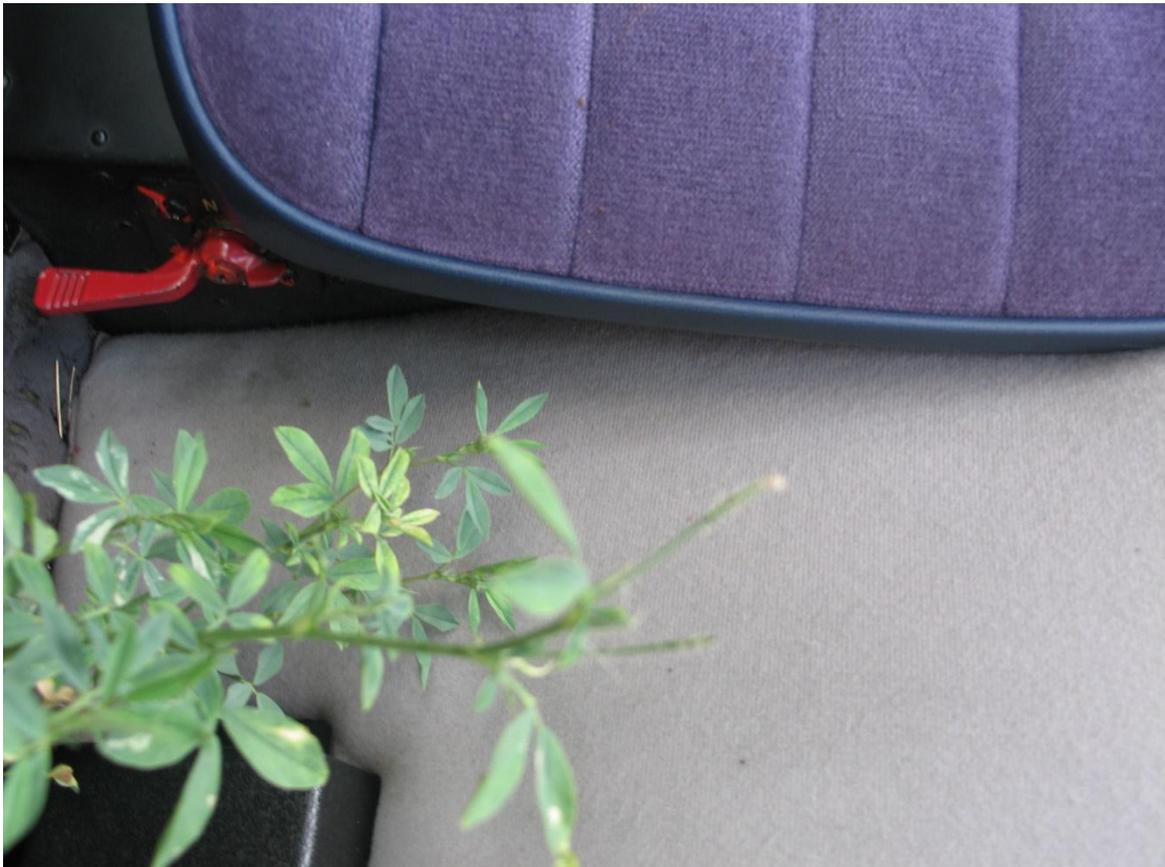
Фиг. 6.

- The admixture saturator is in position “saturated admixture”.
 - The carburetor’s heating is pulled to 0,5 cm.
 - Available fuel – immediately before takeoff the helicopter is tanked with 30 l automobile benzene 100 octane, a part of it has leaked at the place of the event after the crash. 1 l benzene was drained from the left reservoir for study. The fuel tap is in a closed position, Figure 6, Appendix 1.

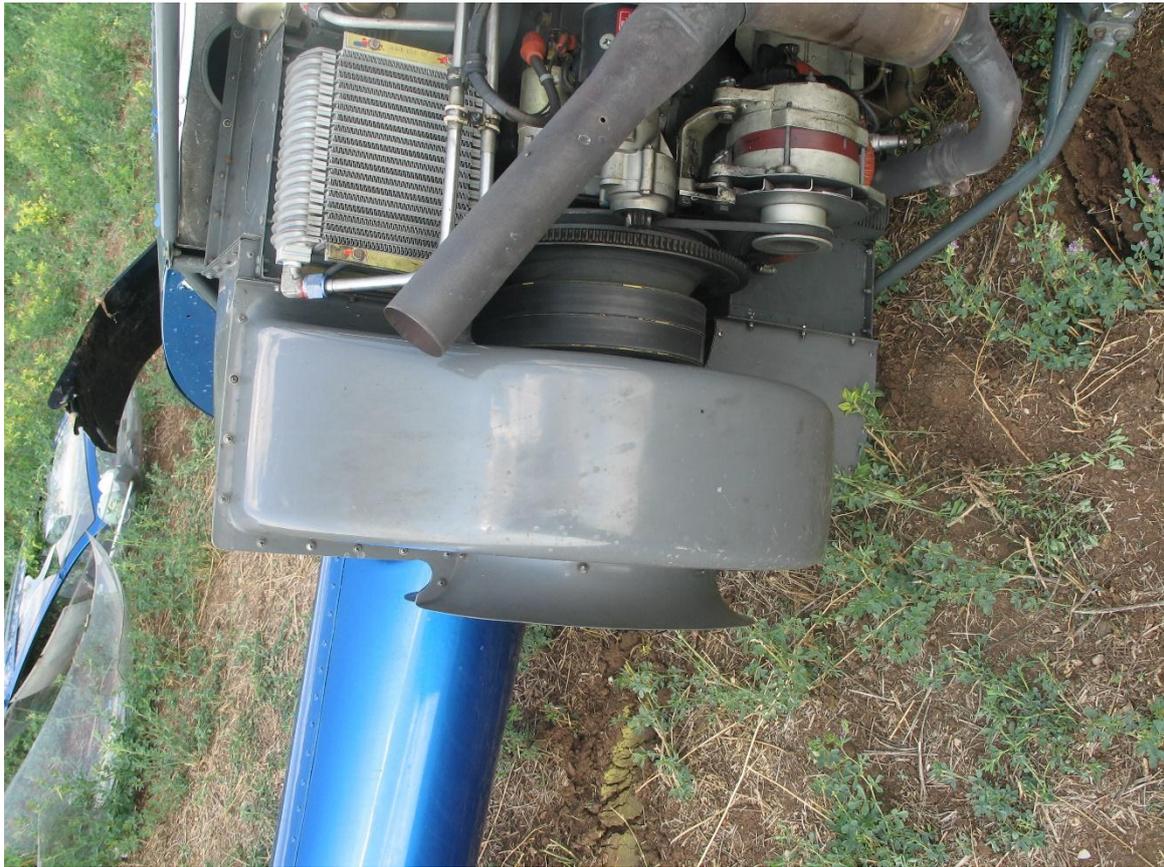
Фиг. 7.

- The belt reductor is in a good condition, Figure 7, Appendix 1.
 - On the central instrumentation panel of the helicopter an identification number N2364B is exhibited, Figure 8, Appendix 1.

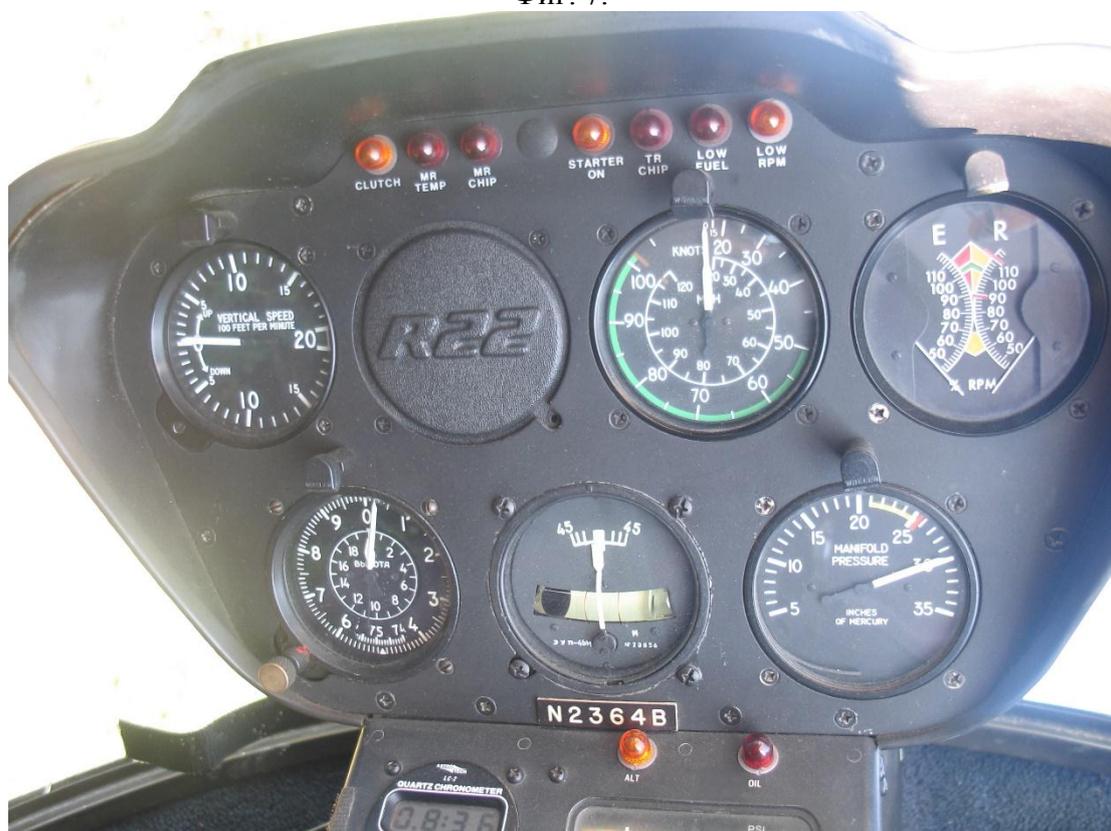
Фиг. 8.

The central instrumentation panel of the helicopter exhibits identification number N2364B. This may be seen on the photo on Figure 8 from Appendix 1. This number is from the register of the Federal Aviation Administration of the USA, where the number refers to helicopter Robinson R22 Beta, serial number 2362. A helicopter of such number is manufactured in 1993 and is deleted from the register on 13.05.2015 because of the expiry of time term.

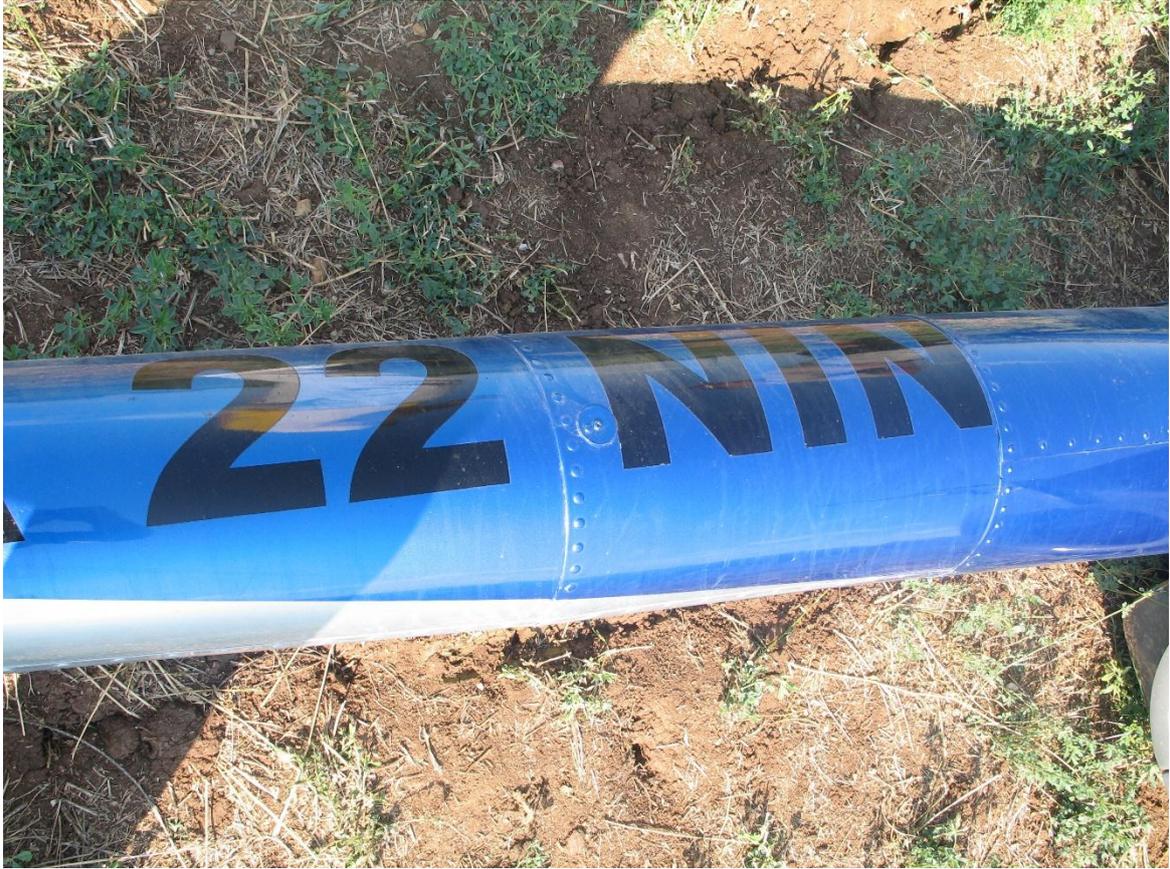
Фиг. 9.

- The helicopter’s motoclock reads 3018,1 h, Figure 9, Appendix 1.
 - The helicopter’s tail beam bears the inscription „22 NIN“
- Onboard there is no one document from the documents which according to the International Convention on Civil Aviation and the Civil Aviation Act of the Republic of Bulgaria have to be maintained onboard of each aircraft performing a flight in the air space of the Republic of Bulgaria.
