**REPUBLIC OF BULGARIA
MINISTRY OF TRANSPORTATION, INFORMATIONAL
TECHNOLOGIES AND COMMUNICATIONS**

**Directorate
„Unit for investigation of accidents in the aviation, maritime and rail
road transport”**

FINAL REPORT

**Investigation of very serious marine accident, occurred on 29.11.2010 in
Black Sea, in the territorial sea of Republic of Bulgaria, with motor
vessel “Karam 1” and motor tanker “Alessandro DP”**

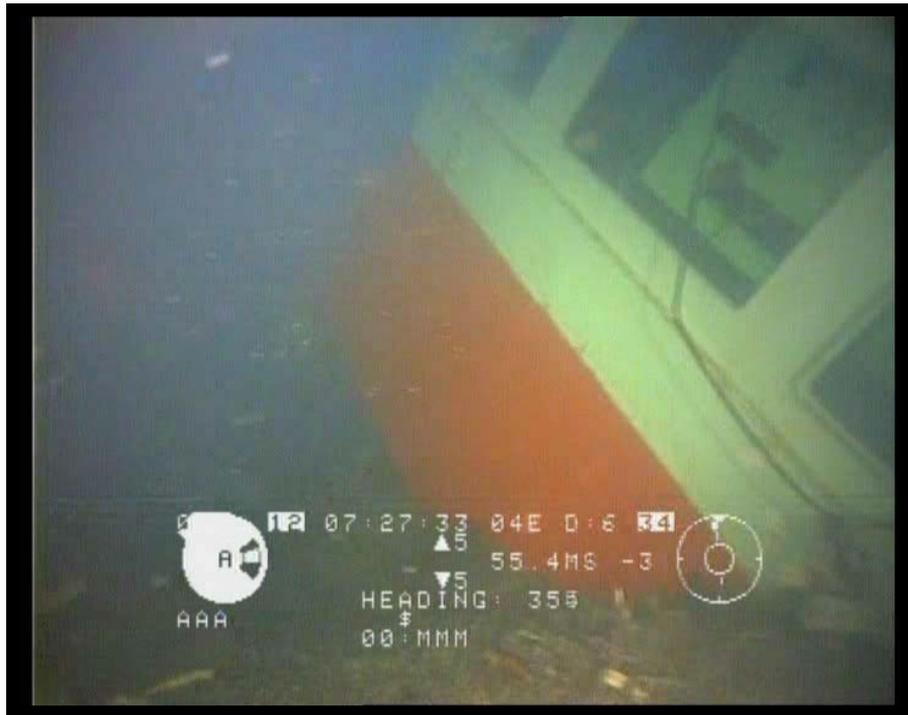
The navigation bridge of m/v "Karam 1"

Clearly is seen the broken window of the porthole.

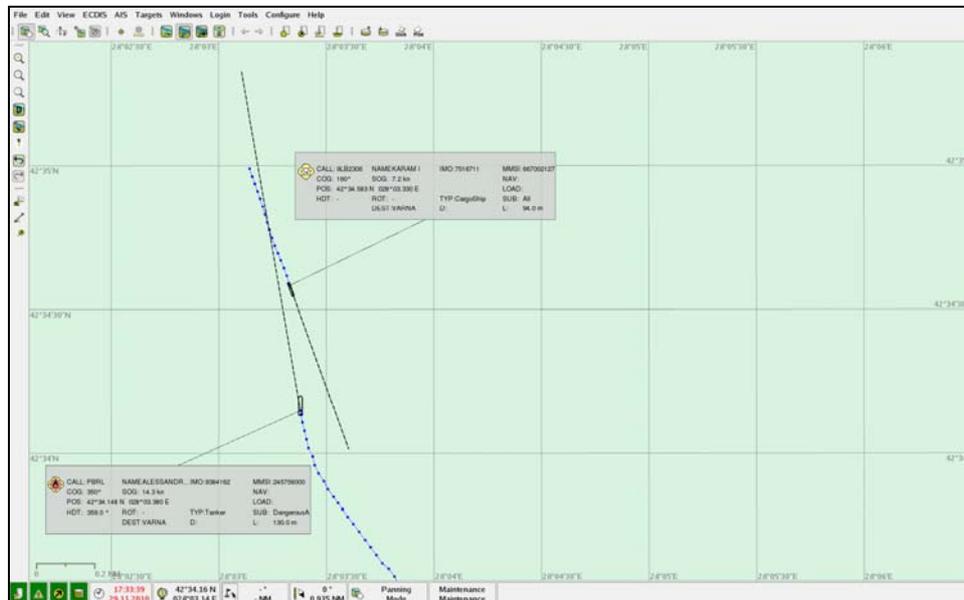
Fig. 5

At 17:32:33 h at distance of 8 cables as seen on Fig. 4, when from “Alessandro DP” were observing only the green board light of “Karam 1”, the on-duty officer on the watch started turn starboard, and the on-duty officer on board “Karam 1” changed the course with some degrees to portside as seen on Fig. 5. In such a case of approach under 1 nm its obligatory the change to manual control, that in fact was not performed in time.

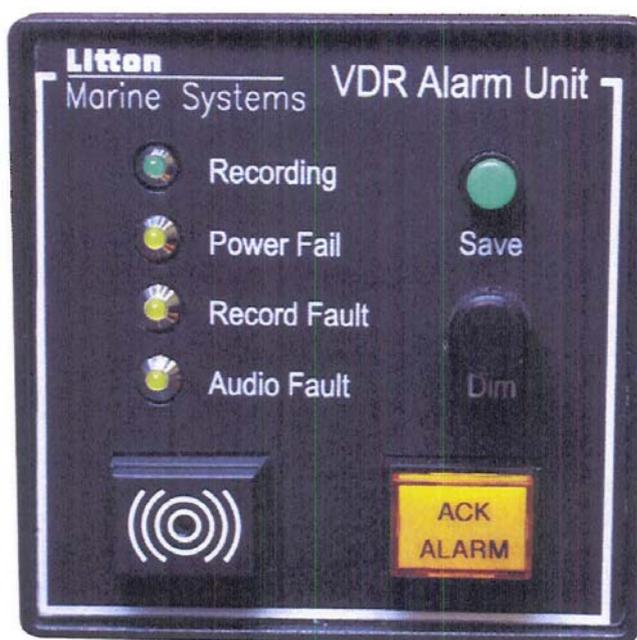
1.1. It can't be "entered" in the VDR system that means that the hard disk, respectively the programs on it could not be reached. As a result there is no access to the information recorded on the disk and it's not even possible to be evaluated what is the actual status of the VDR and more specifically the status of the recorded information. It seems that there is failure in the main computer. So there is no sense in providing to the Commission the reproducing (play back) software. **On the bases of order from the company its to be provided to the Commission in line with Resolution MSC.214(81) by IMO. On the base that there is not possibility the needed data to be extracted and to be checked with the reproducing (playback) software the Commission does not received the reproducing (playback).**

It was not found a access to the operational system of the extracted and sent for diagnostics in „Vlaardingen” original computer from the VDR. That means the whole VDR could not work, as its computer was not working;

- After that date there are no recorder data on the disk. The statement of the service was that the operational system Windows has defected after that date. That is the reason for the fact that there are no data in the capsule also;

„Improving the characteristics of the VDR and S-VDR for a reliable signalization for defects in the devices and in the software, and more specifically for adding the standards for technical realization (Performance Standards), with the aim for assuring of non stop availability of working device on the board of the vessels”.
