**NATIONAL AIR, MARITIME AND RAIL ACCIDENT
INVESTIGATION BOARD**

FINAL REPORT

**FIRE IN BALLAST TANK OF M/V "BELLONA" AND DEATH OF A
WORKER DURING SHIP REPAIRS ON 14.12.2021**

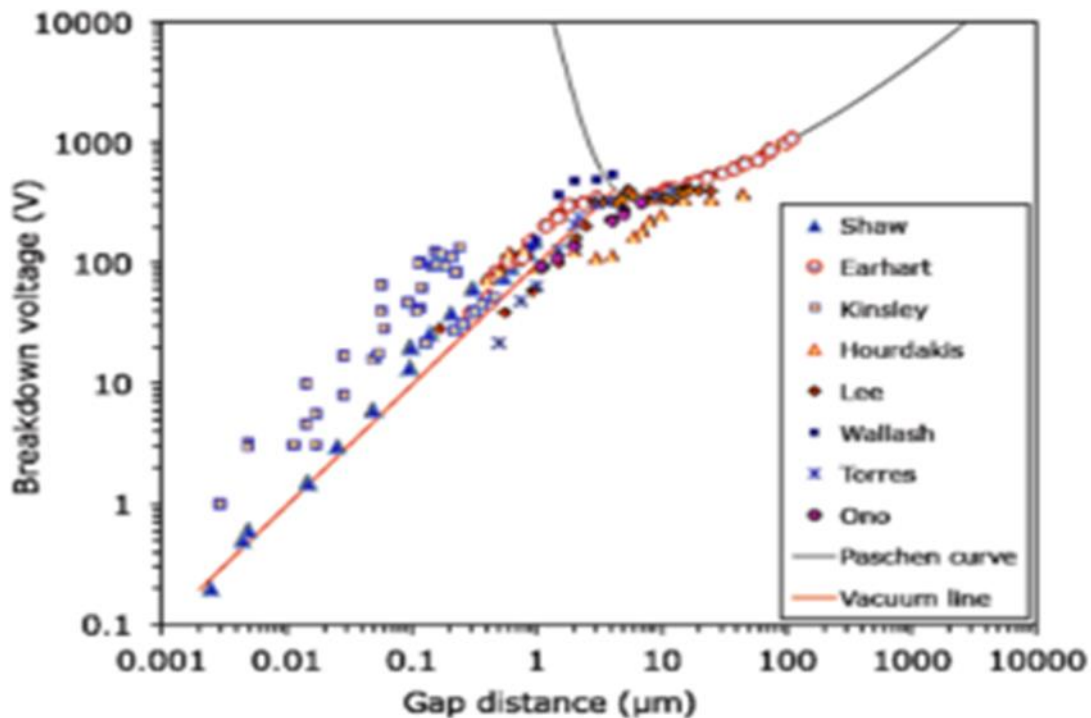
Fig.8. The dependence of the minimum breakdown voltage on the air gap.

According to research, electric arcing/sparking can occur even at low operating voltages. This can happen if, for example, the glass bubble of the light bulb is broken, even unintentionally. Then rapid oxidation of the filament and its destruction begins. At some point, it begins to fall apart into parts, with micro-gaps appearing between them. It is there that an electrical discharge leading to an arc/spark can occur. This scenario is most likely to be realized in practice. The dependence of the minimum breakdown voltage on the air gap is shown in **Fig.8.**

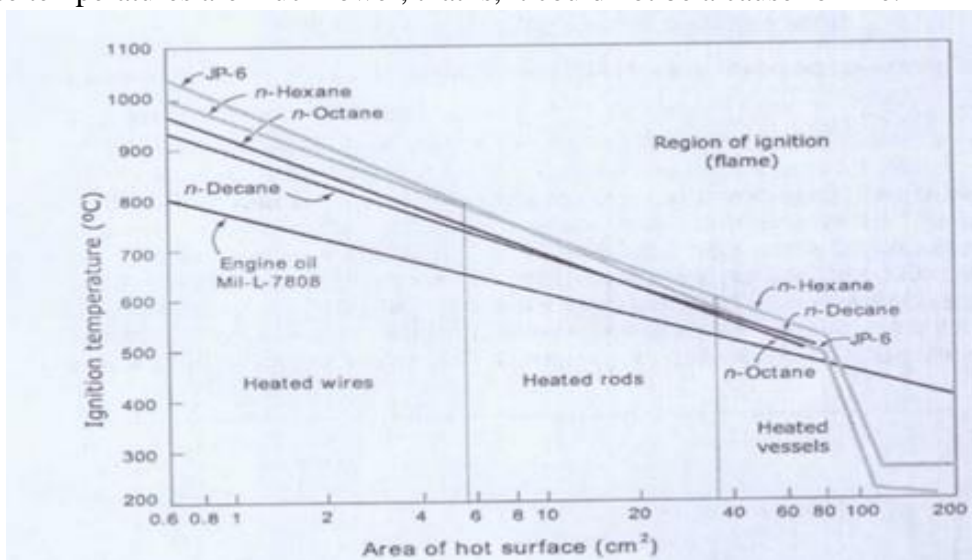
Fig.9. Effect of a hot surface area on the ignition of several types of fuel vapors

The heating temperatures of glass bulbs used in string lights are in the order of: 40 W - 145°C, 25 W - 100°C. Considering the dependence shown in the graph of **Fig.9**, it can be seen that these temperatures are much lower, that is, it could not be a cause for fire.
