**REPUBLIC OF BULGARIA**  
**NATIONAL AIR, MARITIME AND RAILWAY TRANSPORT, ACCIDENTS**  
**INVESTIGATION BOARD (NAMRTAIB)**

**FINAL REPORT**  
**from**

**investigation of railway accident – fire in fast train № 2613 during motion between the stations  
Kaspitchan and Provadiya on 03.11.2022**

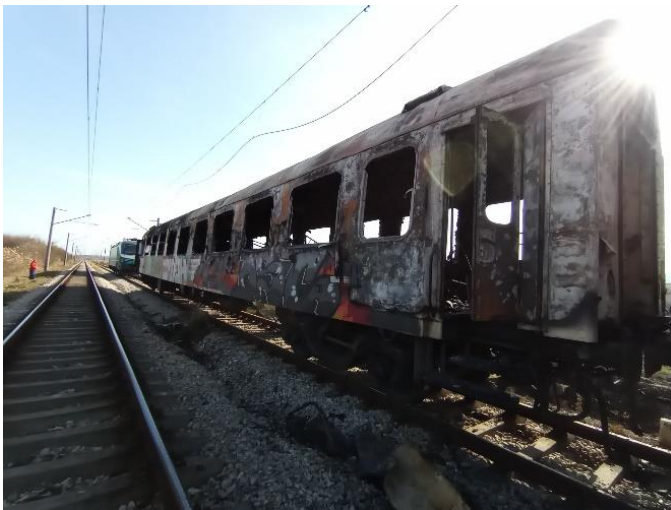
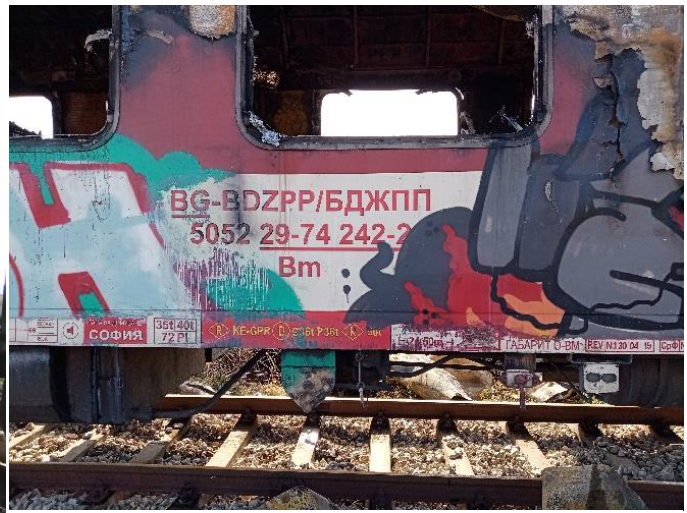
The transport crew that serviced the train (train master and conductor) provided assistance to the passengers in removing them with their personal luggage from the train. No passengers or staff were injured in the fire. Damage was caused to the catenary (overhead contact network, to the first two burned passenger coaches of FT No. 2613: No. 50522974242-2 B4 (fig. 1.3, 1.4, 1.5) and No. 50521974003-0 A4 (fig. 1.6, 1.7, 1.8). The fire did not affect the third and fourth coaches of the train.

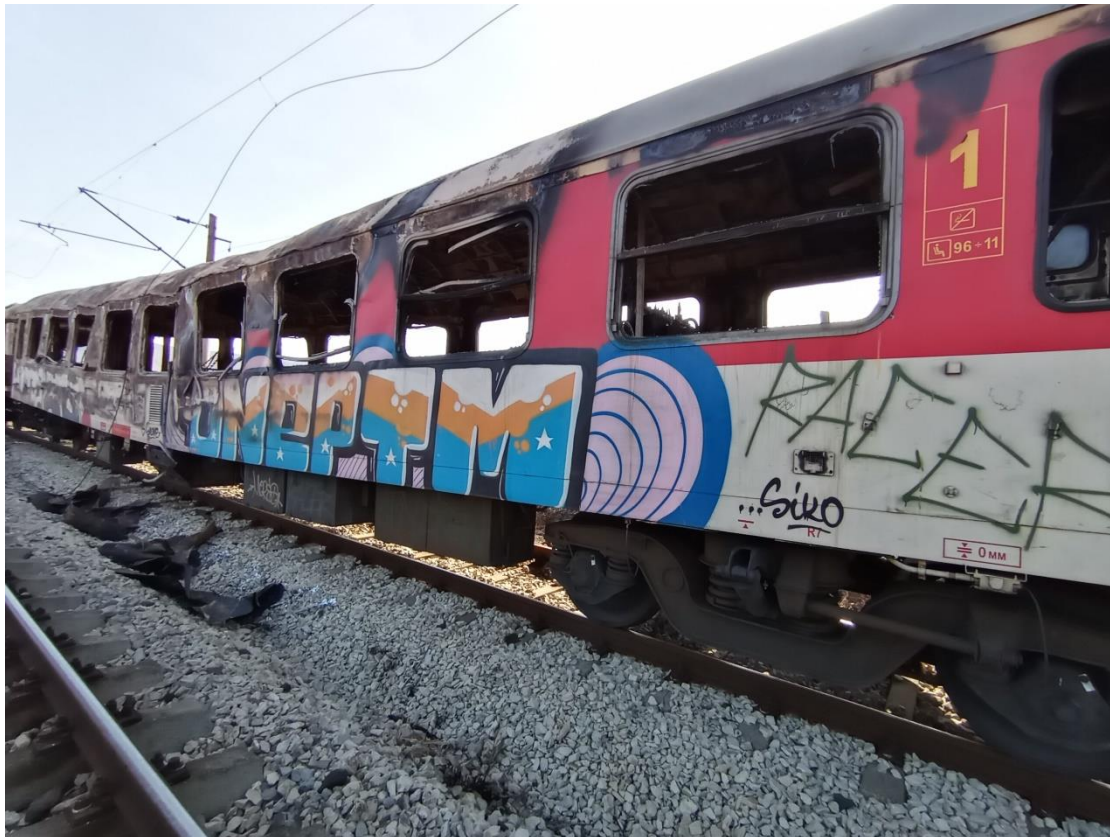
**Fig. 4.8.**

The Investigation Commission carried out several inspections of the burning coaches both at the place of the accident along Kaspitchan - Provadiya interstation at km 462+000 (fig. 4.8) and at the Gorna Oryahovitsa wagon depot, where they were settled in a garage (fig. 4.9 and 4.10 ).

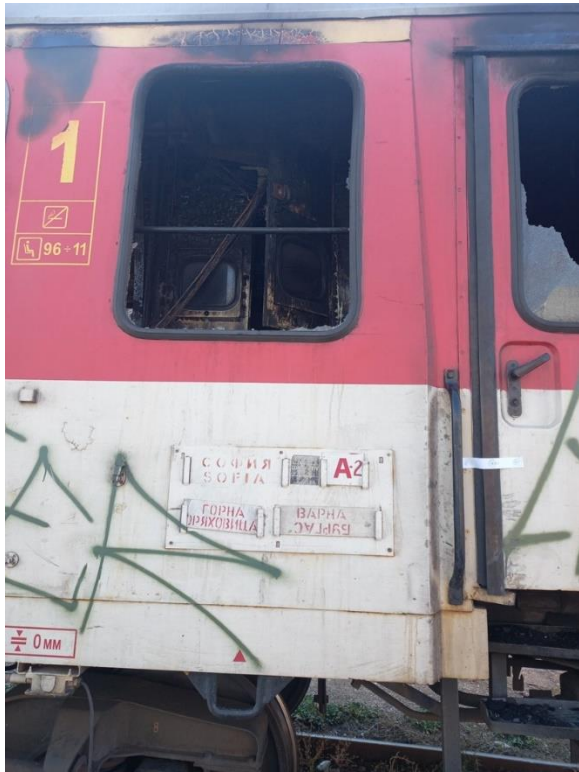
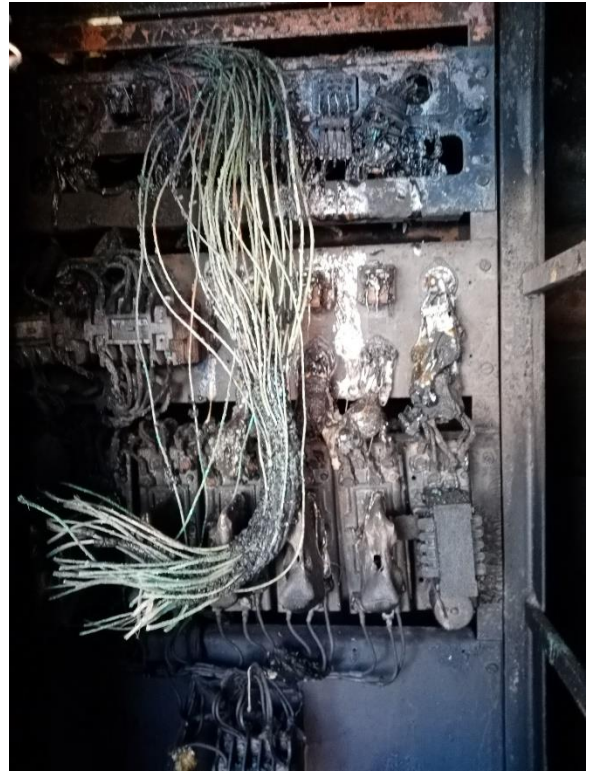
**Fig. 4.12.**

- **Apparatus cabinet** –the apparatus cabinet was burnt, but all indications were that it was due to smoke saturation and the burns caused by an elevated outside temperature, with all the fuses on, i.e. the possibility that it triggered one of the protections of the electrical system was ruled out, especially since the apparatus cabinet was located at the opposite end of the coach (fig. 4.12 and 4.13);

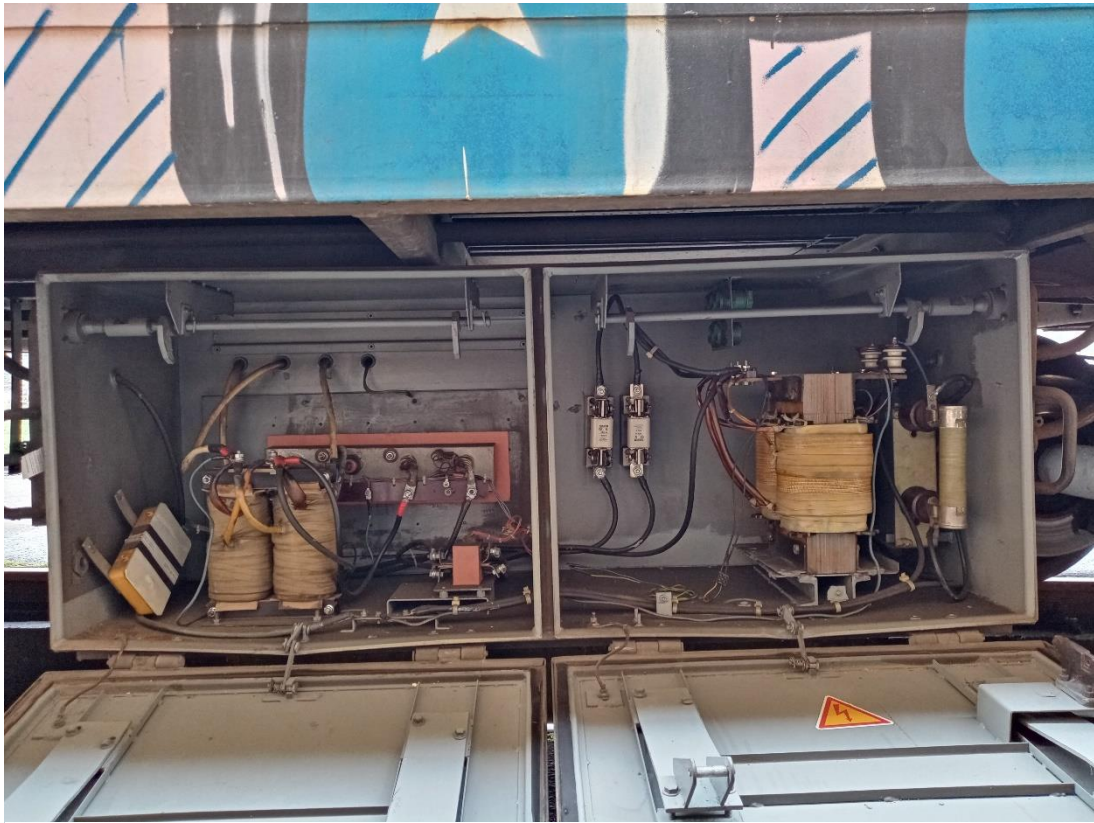
Fig. 4.15.

- **High voltage charge of the coach** – these cabinets are located under the frame of the coach, and are designed to provide primary power for the electrical system of the coach: for heating 1500 V and for lighting 24 V. During the inspections, it was found that the batteries providing power in the absence of external voltage were clean, were in working order and were not affected by the fire (Fig. 4.14). It was also found that the apparatus cabinet, which housed the apparatus for powering the electrical system of the coach, was in working order, clean and not affected by the fire (Fig. 4.15)

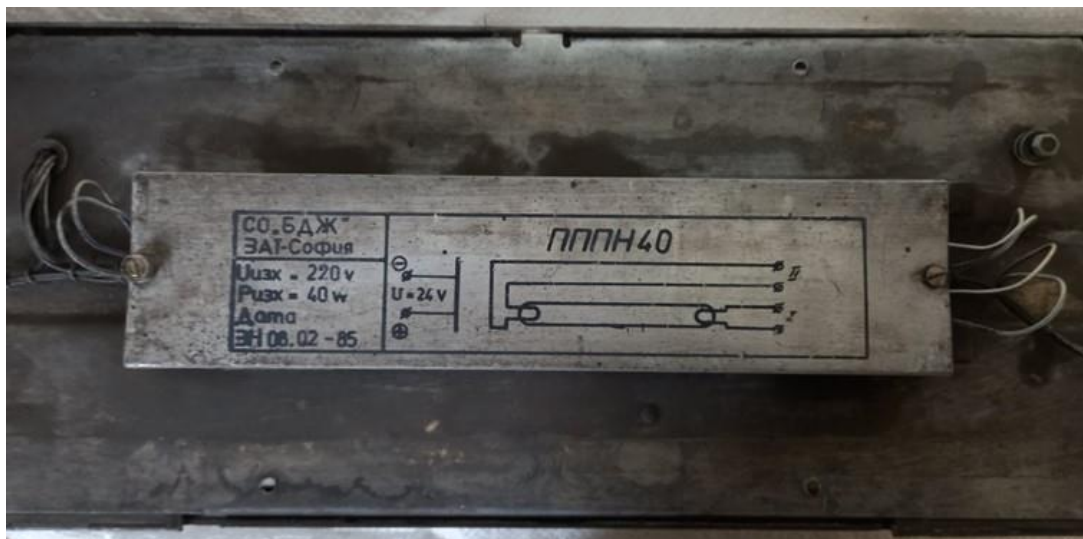
**Fig. 4.20. Inverter for powering the heating fixtures.**

A determining factor for the accident occurrence was the unsatisfactory technical condition of the power module of the lighting fixtures (inverter), installed in the fixtures in the corridor next to the coach exit. The inverter has a design defect between the circuit board and the power wires.

- **Lighting fixtures installed in the entrance part of the coach** - powered by 24 V direct current. The lighting fixtures themselves work with a voltage of 220 V alternating current. An inverter is used to convert the current and voltage (Fig. 4.20). It is necessary to emphasize that the accident occurred during the dark part of the day, which means that the lighting was working, i.e. the lighting fixtures were under voltage and their nominal current passed through them. The Investigation Commission carried out a detailed examination of the lighting fixtures located in the area of the initial ignition, as well as the same fixtures installed in other coaches. Since the diagrams of the power units and elements of the lighting fixtures were not found, they were made by members of the commission on
