**REPUBLIC OF BULGARIA**  
**NATIONAL AIR, MARITIME AND RAILWAY TRANSPORT, ACCIDENTS**  
**INVESTIGATION BOARD (NAMRTAIB)**

**FINAL REPORT**

**investigation of railway accident – fire in locomotive № 91520044202-7, serviced international fast train № 464 between the stations Zmeyovo – Tulovo on 01.12.2023**

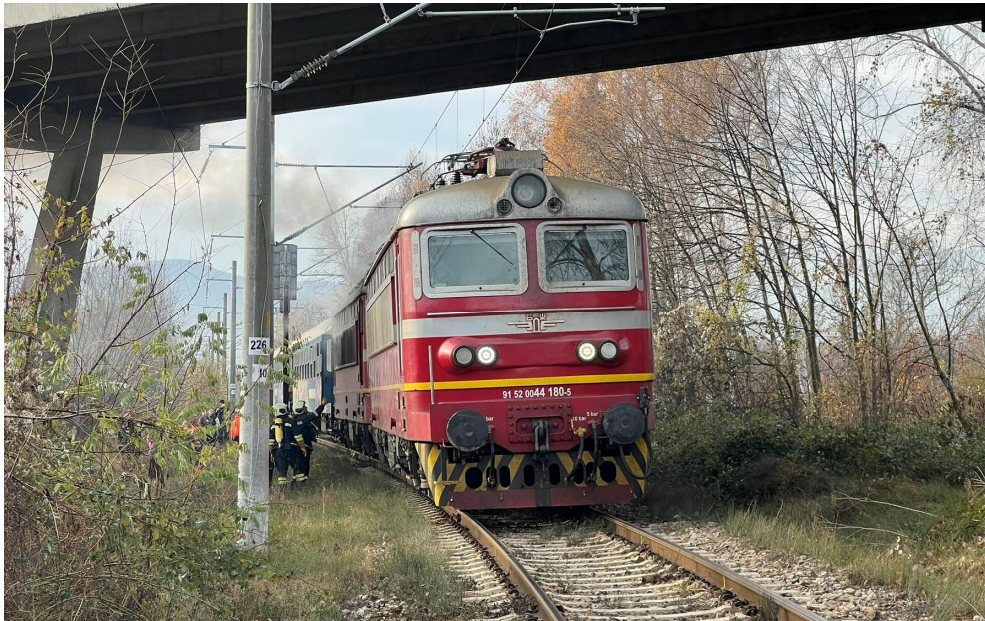
**Fig. 1.5. IFT № 464, towed at km 226+642 (entrance signal at Tulovo station) by auxiliary locomotive № 91520044180-5**

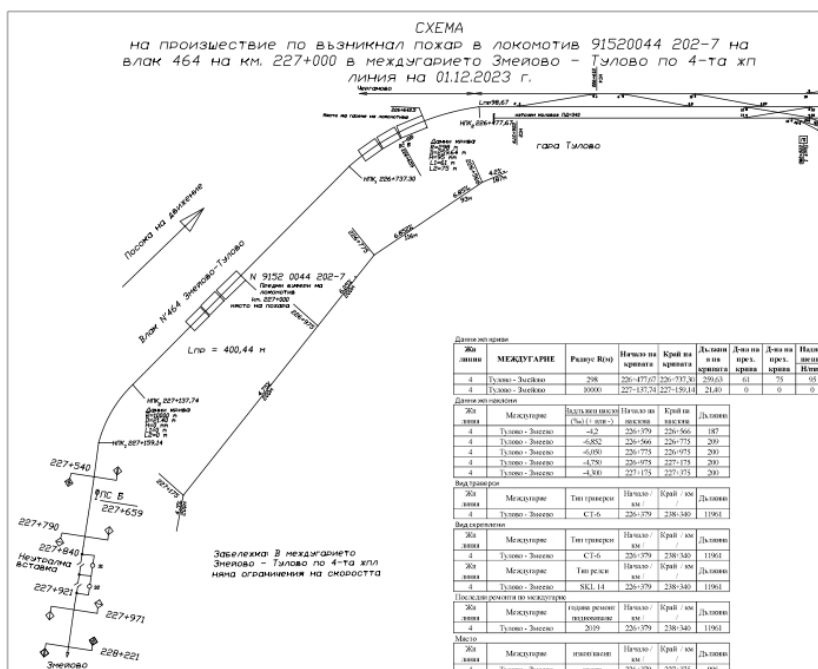
**Fig. 1.6. Scheme of the fire occurrence in locomotive № 91520044202-7 between the stations Zmeyovo and Tulovo**

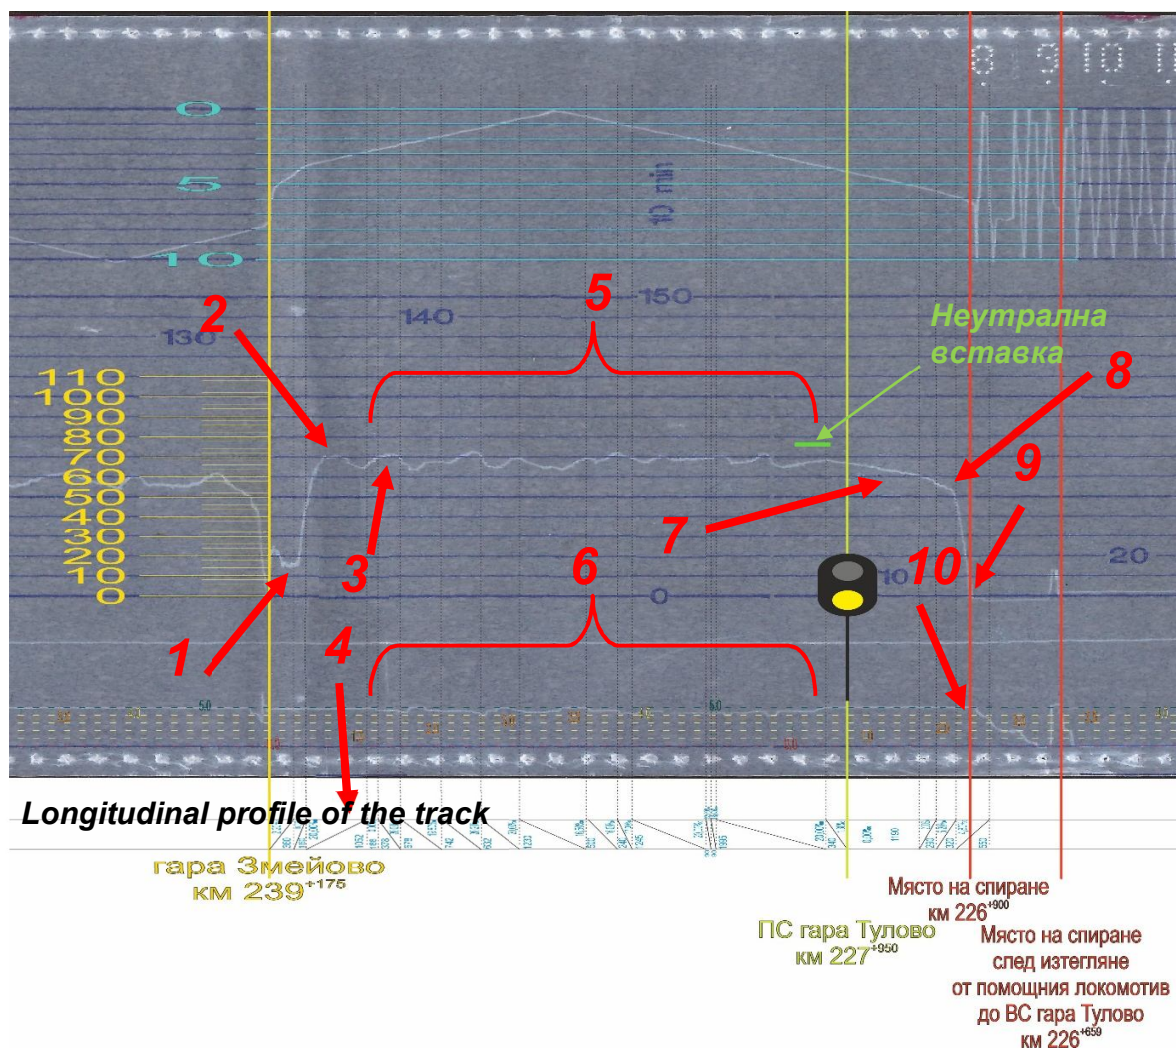
Fig. 4.3.

IFT No. 464 served by locomotive No. 91520044202-7 departed from Zmeyovo station at 07:33 a.m., accelerated to 22 km/h, then the speed decreased to 15 km/h and thus it travelled 300 meters in about 1 min. 50 sec. (fig. 4.3, item 1). After covering that distance, the speed started to increase again and in about 400 meters, it reached 70 km/h (Fig. 4.3, item 2). At that speed, it travelled about 400 meters, after which the speed decreased to 64 km/h and again increased to 72 km/h (Fig. 4.3, item 3). The train travelled about 1500 meters in 1 minute and 30 seconds in traction mode due to the profile of the rail track, which is uphill (fig. 4.3, pos. 4). From that moment on, the profile went downhill and the locomotive went into braking mode, traveling about 7,500 meters from 07:37 a.m. to 07:44 a.m. in 7 minutes (Fig. 4.3, item 5). During this time, the locomotive driver adjusts the speed with the help of the automatic train brake (pneumatic), (Fig. 4.3, pos. 6), and the speed changed from 62 to 73 km/h, with a

permissible speed of movement of 75 km/h in the interstation. About 340 meters before the warning semaphore (PS) at Tulovo station, the slope of the rail track decreased from 20 ‰ to 1.3 ‰, then became level (0 ‰) and followed a slight uphill with values of 2 ÷ 6 ‰. Therefore, the movement was carried out by inertia with a smooth decrease in speed from 68 to 54 km/h for 2100 meters in about 2 minutes (Fig. 4.3, item 7). At 07:46 a.m. the speed began to decrease at a much higher gradient, with a distinct

downward break on the bar graph (Fig. 4.3, item 8) without the automatic train brake applied (Fig. 4.3, item 9), and after about 30 seconds the train stopped at km 226+900 (fig. 4.3, item 10).

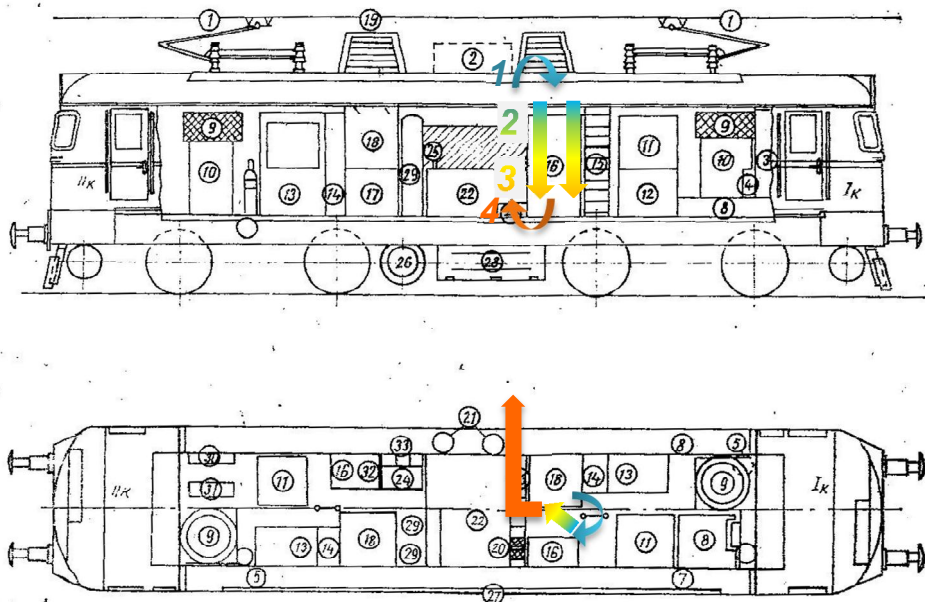
The cooling of the blocks is forced by air, which is sucked from the engine compartment (Fig. 4.6, item 1), enters through the upper opening of the cabinet, passes through it downwards, taking away part of the heat released by the drawbridge valves (Fig. 4.6, pos. 2), the already heated air passes down to cool the valves of the auxiliary bridges (fig. 17, pos. 3) and exits through the suction pan horizontal fan into the atmosphere (fig. 4.6, pos. 4). The side of the block is not cooled. With the scheme described in this way, the way in which the operation is carried out is particularly important, because when the fans of the cooling system are turned off, overheating of the rectifier unit occurs, and especially in its lower part, where the rectifier bridges of the auxiliary machines are located - fans and compressors. When the locomotive goes into traction mode, the valves heat up, give off a large amount of heat, and when the air passes through, they cool down. The same air, instead of cooling, additionally heats the rectifier bridges of the auxiliary machines, whose operation is not synchronized with that of the traction rectifier bridges. After switching the locomotive out of traction mode and into inertia moving mode, it is the practice of locomotive drivers to turn off the ventilation with the button on the locomotive control panel and stop the cooling of the rectifier units. Heat removal from the traction rectifier bridges continues, but without cooling. At the same time, the rectifier bridges of the auxiliary machines (compressors that consume a sufficiently large amount of energy) continue to work, because the auxiliary

machines work in a different mode than the traction motors. As a result, on insufficiently cooled auxiliary bridges, they continue to heat up, due to the heat emitted by the drawbridges, along with the heat they themselves emit during operation. All this affects the temperature in the side of the block and heats the capacitors located in this area. Their housing bursts, the electrolyte ignites and becomes a catalyst for igniting the entire block.

The findings of the Investigation Commission not only in this but also in other previous investigations and analyses lead to the conclusion that this is the main cause of many of the realized fires of locomotives of this series of locomotives in the recent years.

**Fig. 4.6. Scheme of the movement of the air for cooling one of the rectifier blocks. By arrows is shown the direction of air passing through the rectifier blocks. The colors illustrate the passing through them and the changing temperature: cool, heated, warm, and hot.**
