NATIONAL AIR, MARITIME AND RAILWAY TRANSPORT, ACCIDENTS INVESTIGATION BOARD (NAMRTAIB)

FINAL REPORT

investigation of significant railway accident – run over of two employees by locomotive №98522051522-7, between Inspection point № 4 and Iliyiantsi station on 07.11.2023

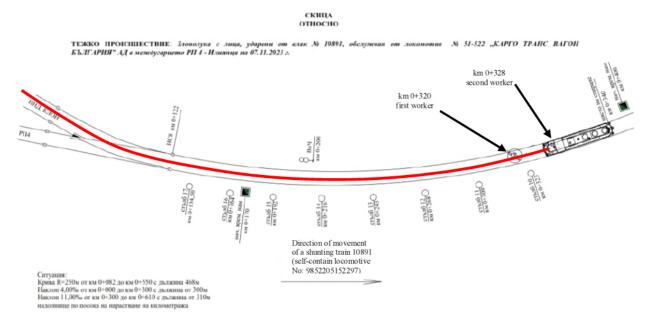
Fig. 1.2. Scheme of the area where the accident with locomotive №98522051522-7

The event occurred between Inspection point № 4 and Iliyantsi station at around 10:12 a.m. at km 0+320 in the left curve with radius 250 meters with inclination 4 ‰ in downhill in the area with movement speed restriction up to 25 km/h. ST № 10891 (locomotive № 98522051522-7) hit and killed one after another two workers of the railway infrastructure manager (SE NRIC) (fig.1.2).

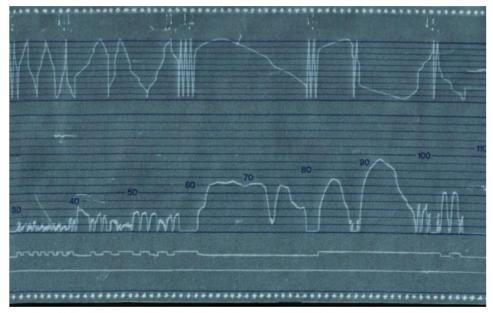
Fig. 2.1. Speedometer tape of locomotive № 98522051522-7 from the performed tests in Iliyantsi station.

On 13.11.2023 the Investigation Commission of NAMRATIB performed test movements from third track in Iliyantsi station with the same locomotive № 98522051522-7, in order to establish the the serviceability of the speedometer installation, registering the movement parameters. The segment of the speedometer tape was downloaded for performing of expertise in a specialized laboratory of "BDZ Cargo" EOOD (fig. 2.1). From the figure is evident that the speedometer installation of the locomotive is functional and all the registrations of the speedometer tape are correct and legible.

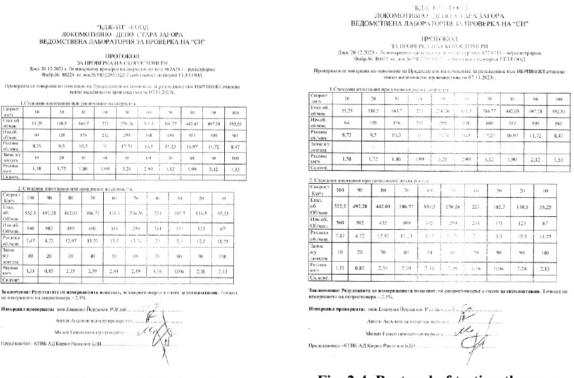
Fig. 2.3. Protocol of testing the registering speedometer.

speedometer check in the "Departmental Laboratory for Checking Information Systems" at the Stara Zagora Locomotive Depot. A committee of experts carried out the measurements of speedometer type 662A514 - registering with factory no. No. 88224. A speedometer type 672A313 was also checked - non-registering with factory No. 86051. The measurement accuracy of both speedometers is 2.5% (typical) (Fig. 2.3 and 2.4). The results of the measurements show that the speedometers are serviceable.

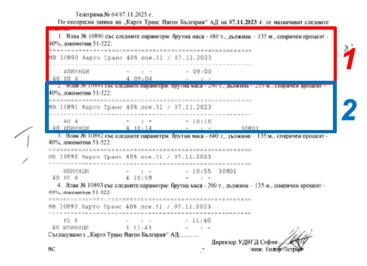
Fig. 3.1. Schedule of the movement of ST №№ 10890, 10891, 10892, 10893 from Iliyantsi station to IP 4 and vice versa.

- 1. ST No. 10890 with the following parameters: gross weight 480 tons, length 135 meters, brake percentage 40% with locomotive No. 98522051522-7, departed from Iliyantsi station at 09:00 a.m. and arrived at IP 4 at 09:04 a.m. (fig. 3.1, item 1);
- 2. ST No. 10891 with the following parameters: gross mass 290 tons, length 225 meters, brake percentage 40% with locomotive No. 98522051522-7, departed from IP 4 at 10:10 a.m. and arrived at Iliyantsi station at 10:14 a.m. (fig. 3.1, item 2).
- 1. ST №№ 10892 and 10893 were cancelled as a result from the accident.

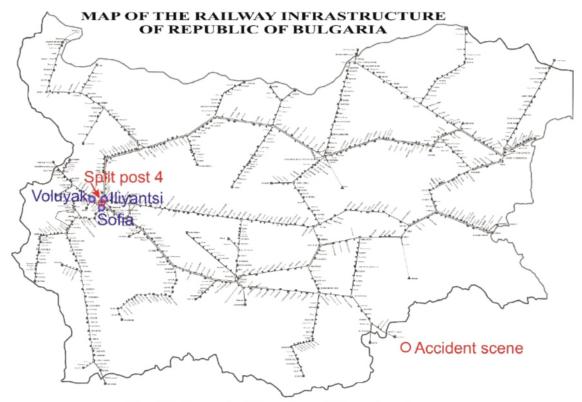
Fig. 3.2. Layout of the place of the rail network.

On 07.11.2023, at around 10:02 a.m., locomotive No. 98522051522-7, after completion of the shunting activity, departed from the industrial branch of "Toplivo" JSC to IP4 (fig. 3.2). The locomotive driver used the radio station in the locomotive to notify the traffic manager on duty in IP 4 to move the locomotive to IP 4. The traffic manager on duty in IP 4 prepared the route to receive the locomotive on the third track and opened the entry and exit signal. The locomotive passed without stopping at IP 4 at 10:10 a. m. ST No. 10891 was moving towards the Iliyantsi station and at km 0+320 in the siding it hit the worker, working with a chainsaw and after 2-3 meters it hit the back of the second worker standing in the siding.

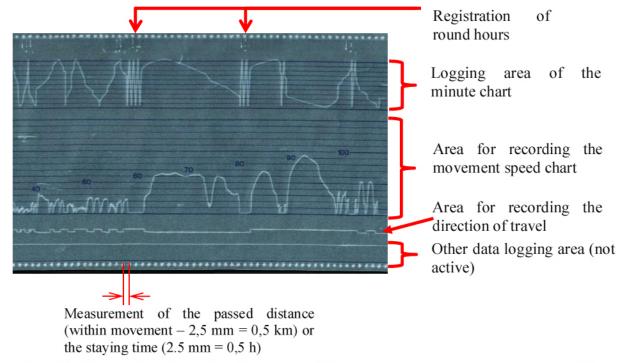
Fig. 4.5. Illustrating the registering areas of the separate movement parameters of the speedometer installation of locomotive № 98522051522-7.

As it has been already noted, the clock of the recording apparatus was not calibrated and the time registrations did not correspond to the actual astronomic time (fig. 4.5, fig. 4.7, pos. 7). In addition, the minute diagram (see Fig. 4.5) does not record the time when the locomotive is moving.

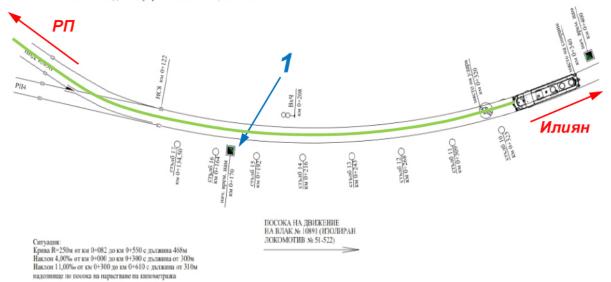
Fig. 4.6. Passed track of locomotive № 98522051522-7 from IP 4 to the place of the accident.

The analysis of the train movement has been performed from Inspection point N_2 4 in the area of industrial branch of "Toplivo" JSC to the place of the accident occurrence (fig. 4.6).
