**Aircraft, Maritime and Railway Accident Investigation Directorate
Maritime Accident Investigation Unit**

FINAL REPORT

**Investigation of very serious marine casualty –
capsizing and sinking of *m/v „ELLAND”***

on 08.02.2014

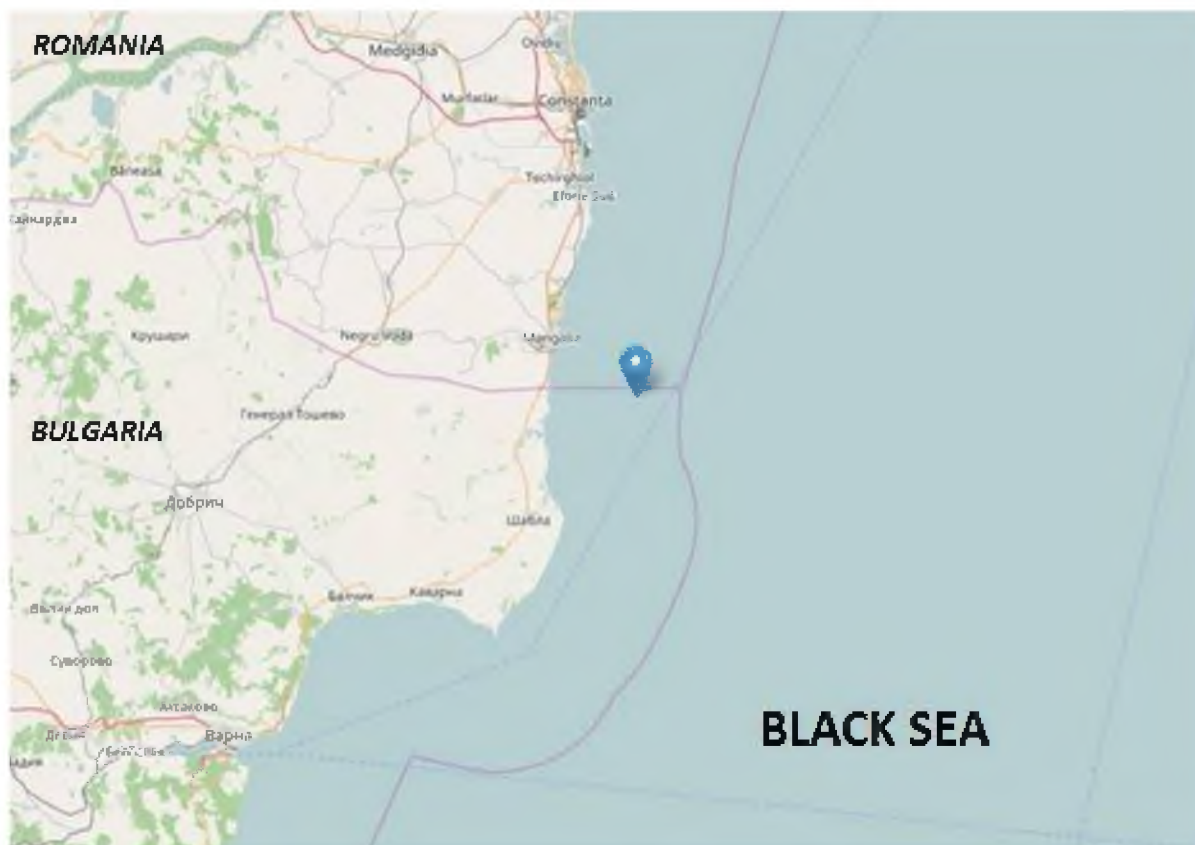
Fig. 5. Ship's position at the time of the accident.

The captain went to the forecandle, started the emergency fire moto-pump and began taking ballast in the starboard wing ballast tank № 6, nearest to the bow. 20 minutes later the heel decreased to 2-3° to the portside. The anchor was dropped out - 7 anchor chain keys, in position: latitude 43°43',69 N and longitude 028°45',55 E (**Fig. 5**).
