REPUBLIC OF BULGARIA
NATIONAL AIR, MARITIME AND RAILWAY ACCIDENTS
INVESTIGATION BOARD

FINAL REPORT

**Investigation of railway accident – derailment of direct freight train
№ 30610 between the stations Shivatchevo – Tvarditsa on 12.03.2021**

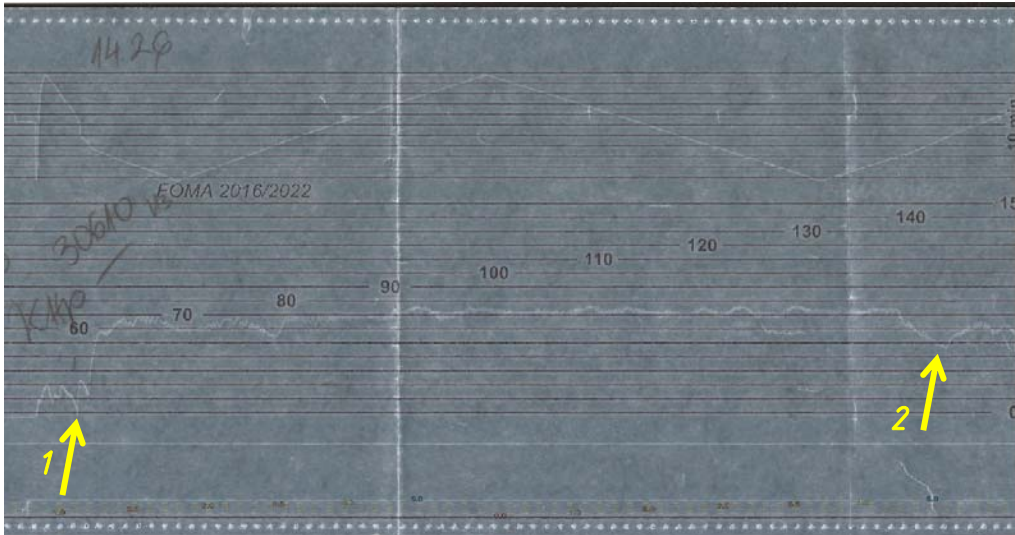
Fig. 4.1. Registration of movement of locomotive № 46032 (as DFT № 30610) from Karnobat to Zimnitsa station.

Locomotive № 46032 performs its first movements in Karnobat locomotive depot at 14:11 p. m. with speed to 10 km/h, and then it increased to 20 km/h, and after another several shunting movements to 20 km/h and at 14:25 p.m. it is placed on station track in Karnobat Western District station (fig. 4.1, pos. 1). After stopping for one minute, it departed at 14:26 p.m. from Karnobat

Western District station, and develops 22 km/h, then decreases to 12 km/h, passes through the exit switches of Karnobat station, and then increases to 70 km/h. So, moving at a speed of up to 77-78 km/h, the

locomotive passes 31,7 km, where at 14:52 p.m. the speed of 73 km/h starts to decrease smoothly and after 1800 meters at 14:54 p.m. reaches 47 km/h (fig. 4.1, pos. 2). The place corresponds to Zimnitsa station.

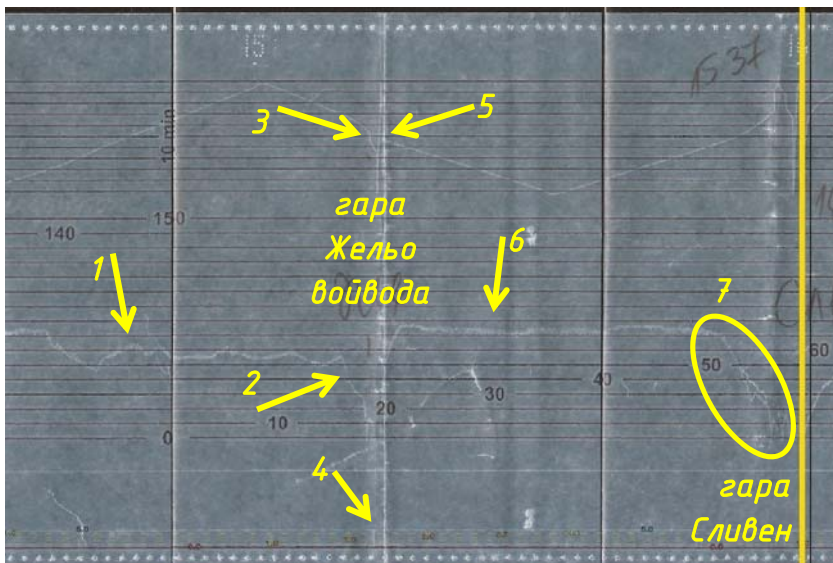
Fig. 4.2. Registration of movement of locomotive № 46032 (as DFT 30610) from Zimnitsa to Sliven station.

Then the speed starts to increase again to 64 km/h (Fig. 4.2, pos. 1). It changes smoothly between 64 km/h and 50 km/h, and thus the locomotive moves to Zhelyo Voyvoda station. After passing 8900 meters at 15:03 p.m., the speed is 56 km/h and begins to decrease - initially at a faster pace to reach a value of 40 km/h, after which the rate of descent becomes slower and reaches 28 km/h it intensifies again until the complete stop of the locomotive at Zhelyo Voyvoda station at 15:04 p.m. (Fig. 4.2, pos. 2). Apparently, the locomotive driver initially held the locomotive with the direct brake of the locomotive until it reaches a speed of 40 km/h, then he loosens it, the reduction continues due to the natural resistance in its movement and when it reaches 28 km/h, it holds it again until it reaches 0 km/h. After the locomotive stopping at 15:05 p.m., there is a stop for about 30 seconds (Fig. 4.2, pos. 3). A departure follows, in which the locomotive develops 11-12 km/h, travels about 300 meters and stops again at 15:06 p.m., this time it stays until 15:25 p.m. for 21 minutes (Fig. 4.3, items 1 and 2). During the second stop at Zhelyo Voyvoda station, a pressure drop of up to 0 bar is noted in the area of pressure registration in the main air duct, which means that most likely the locomotive driver checked the registration of the speedometer by opening its cover (fig. 4.2, item 4).

At 15:26 p.m. locomotive № 46032 departs from Zhelyo Voivoda station and develops a speed between 78 and 70 km/h (Fig. 4.2, items 5 and 6). At this speed, the locomotive travels 12.2 km. At 15:34 p.m. the speed of 71 km/h began to decrease gradually, after 1250 meters it reaches 25 km/h, then briefly increases to 31 km/h, it decreases again to 0 km/h after 700 meters and at 15:37 p.m. it is established at Sliven station (Fig. 4.2, pos. 7). During its movement from Karnobat station to Sliven station the locomotive driver observes the section speeds and the reductions on the track.

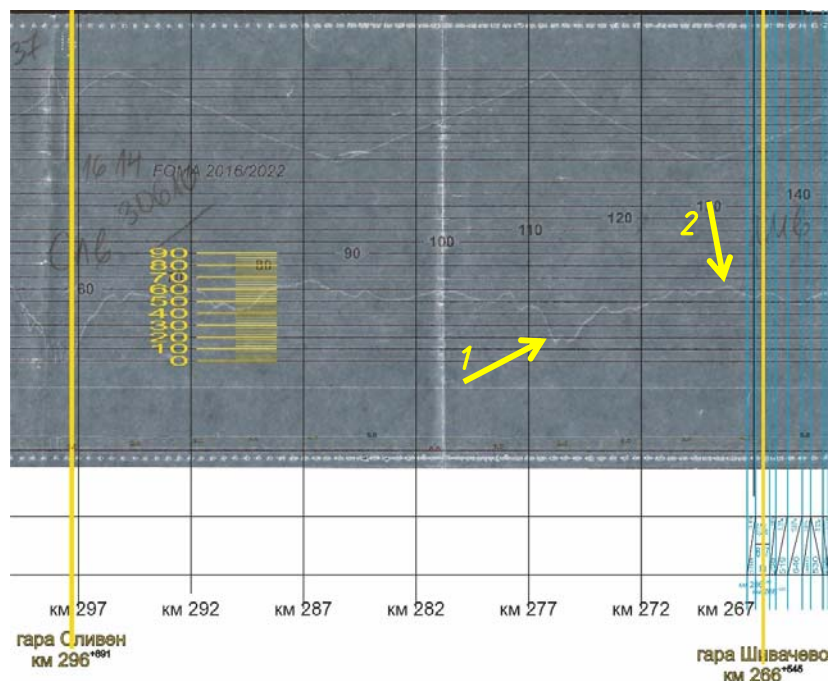
Fig. 4.4. Registering the movement of DFT 30610 from Sliven station to Shivatchevo station.

DFT № 30610 led by locomotive № 46032 departs from Sliven station at 16:14 p.m. (speedometer time). The speed varies between 42 and 78 km/h and thus the train travels 21.4 km (Fig. 4.4). At this point (Fig. 4.4, pos. 1) at 16:40 p.m. the speed decreases to 16 km/h and for 1000 meters in 2.5 minutes it changes between 16 and 22 km/h. After passing this section, the speed increases, and its maximum value reaches 63 km/h (Fig. 4.4, pos. 2).
