REPUBLIC OF BULGARIA
NATIONAL AIR, MARITIME AND RAILWAY ACCIDENTS
INVESTIGATION BOARD

FINAL REPORT

**Investigation of railway accident – fire in electric locomotive № 44094.8,
occurred while servicing fast train № 3621 between the stations Chernograd –
Aytos on 28.09.2020**

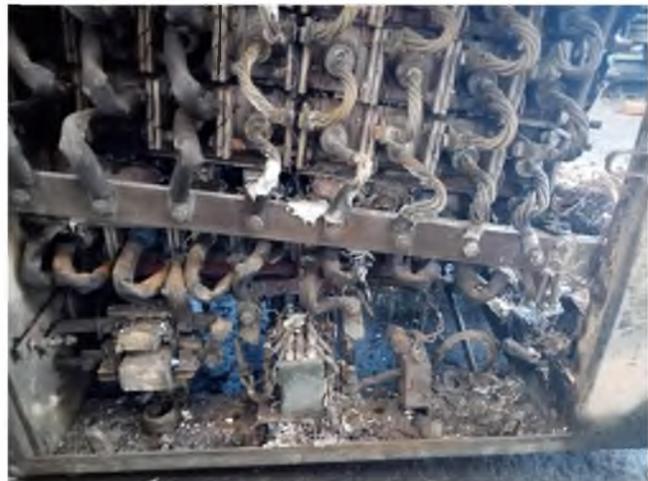
Fig. 2.3

- Auxiliary rectifier 220 power supply engine compressor - badly destroyed. Most likely, the temperature there was the highest. It is very likely that the source of the fire was from the rectifier 220 (Fig. 2.3);
- Auxiliary rectifier 221 power supply engine fans is less affected. The power cables of the horizontal fan 230 are strong;
- The rectifier unit 022 - in good condition. After the inspection it was found that a wedge was placed on the relay U3 (relay for voltage control of the rectifier 221, supplying the fans (Fig. 2.4). There is a damaged lacquer insulation of the R-groups of the compressors rectifier (strongly blackened);
- Relays 491, 492, 493 and 494 – functioning;

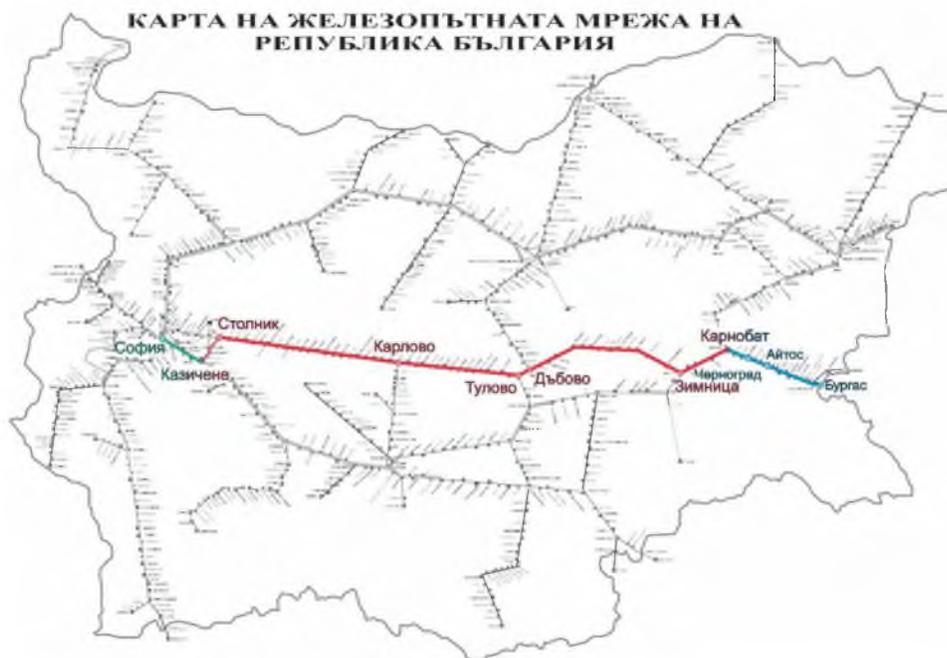
Fig. 3.1

Chernograd and Aytos stations are located on the eighth main railway line in the direction Plovdiv - Stara Zagora - Karnobat - Bourgas. The eighth main railway line is conventional with a speed of up to 130 km / h. The event occurred in a section of a double-track electrified railway line with a profile - 9.3 ‰ downhill (Fig. 3.1).

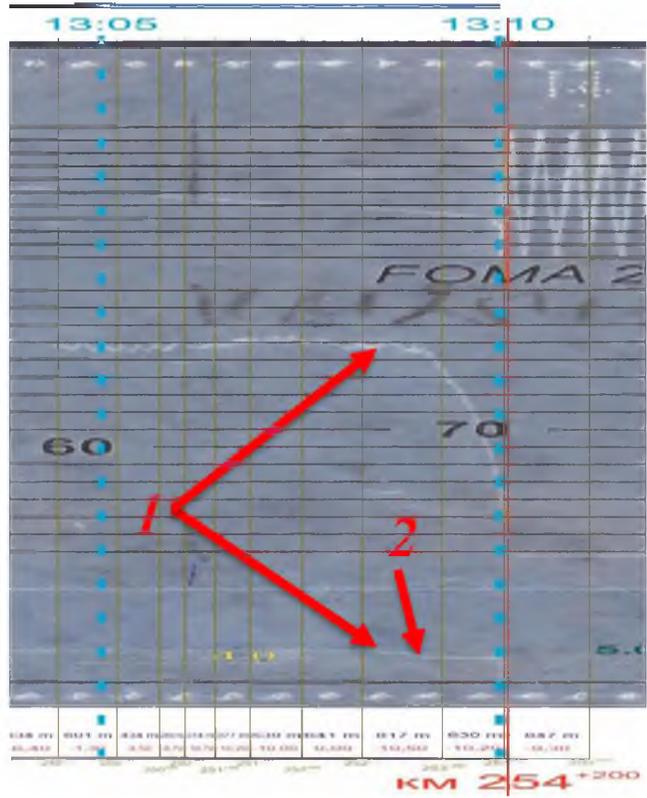
Fig. 4.5

At 13:06 p.m. at km 252⁺⁸⁰⁰ the locomotive driver applies the automatic train brake, reducing the pressure in the main air duct by 0.4 bar (Fig. 4.5, pos. 1). After traveling 250 meters for about 5 seconds, the pressure was restored to 5.0 bar. Almost immediately afterwards, the brake was applied again, reducing the pressure in the main air conduct by 1 bar and reaching 4.0 bar in 500 meters and 10 seconds. After another 10 seconds, the holding rate with the automatic train brake is increased by reducing the pressure in the main air conduct to 3.5 bar, i.e. complete detention has taken place. The speed starts to decrease steeply and the train stops at km 254⁺²⁰⁰ after traveling 1200 meters in 1 minute and 30 seconds.
