RAILWAY ACCIDENT INVESTIGATION UNIT
AT THE MINISTRY OF TRANSPORT, INFORMATION TECHNOLOGY AND
COMMUNICATIONS

FINAL REPORT

technical investigation of railway accident –
derailing of freight train Nr. 90570 on point Nr. 5 upon entrance in
Hitrino station on 10.12.2016

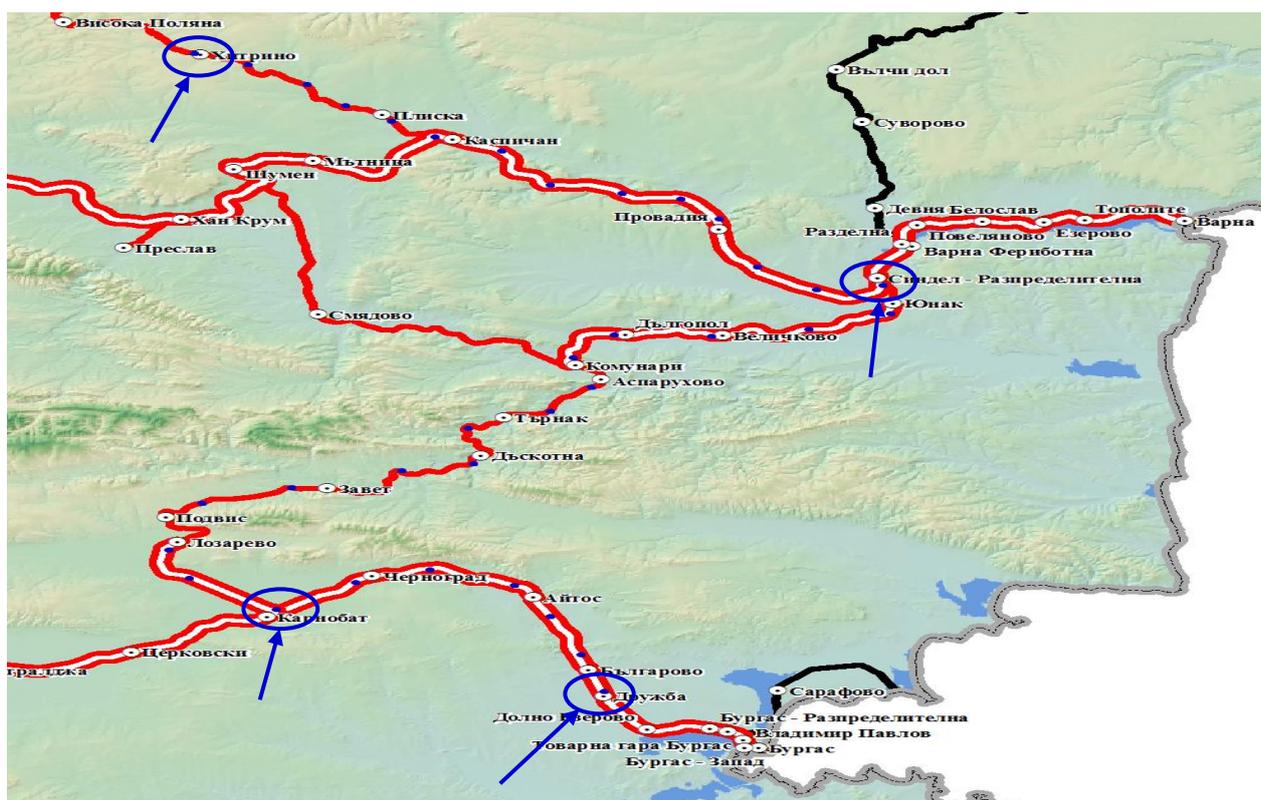
Figure 9

From Druzhba station to Hitrino station freight train Nr. 90570 travelled, being composed of two electric locomotives – supportive one ahead of the train – Nr. 86003.4, and train one – Nr. 87025.0, and 26 wagon-cisterns, including 20 ones full of propylene, 3 ones full of propane-butane, 2 empty ones as front guard and 1 empty cistern transported for repair, 104 wheel axes

and gross mass weight of 1756 tons (Figure 9).

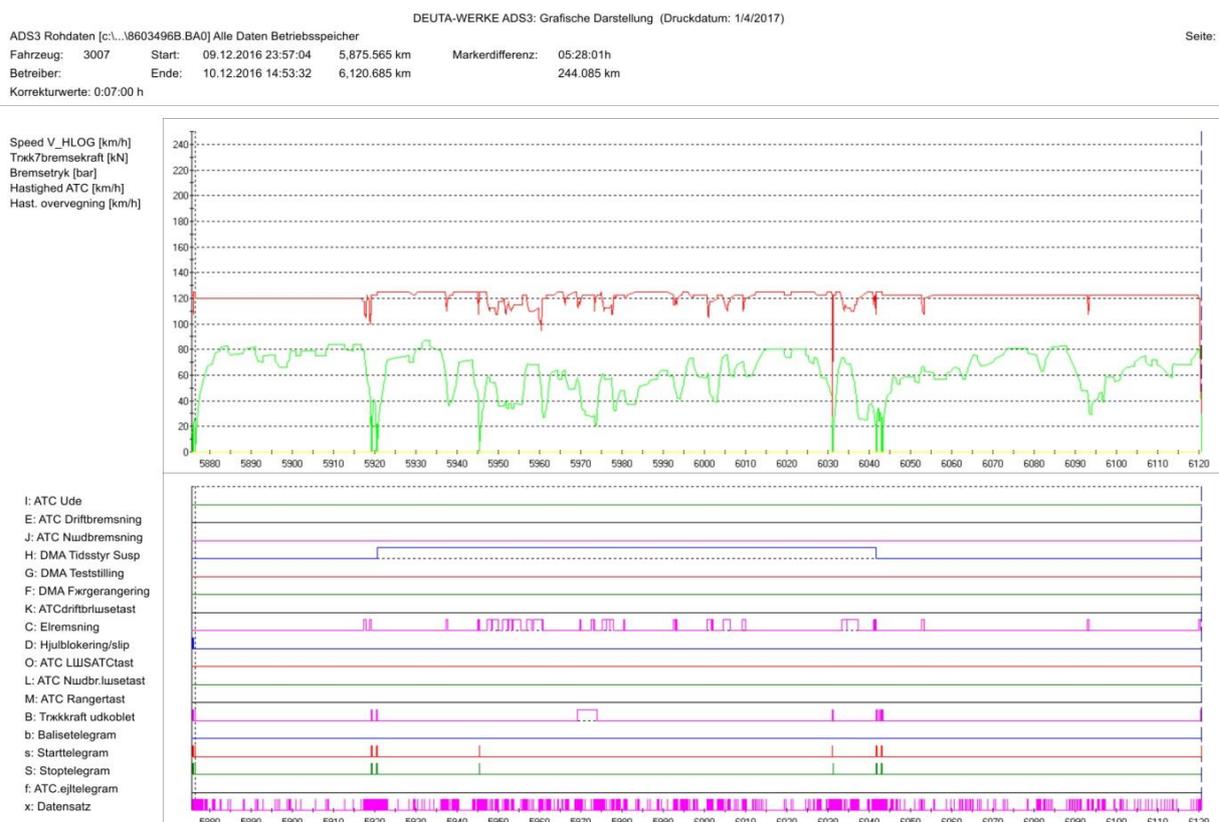
Figure 10, upper part, exhibits the diagrams of changing of the speed (in green color) and the pressure in the main air duct (in red color) as function from the travelled road.

The lower part of Figure 10 exhibits the digital parameters of the movement of the

locomotive.

It was established that the alertness maintenance device of the locomotive was switched off from Karnobat station to Sindel-razpreditelna station (in this section locomotive Nr. 86003.4 travelled as a second locomotive in the composition of the train, and at that time locomotive Nr. 87025.0 was positioned ahead of the train). The digital parameter with designation „H:DMA Tidsstyr Susp” (designated with blue color at the lower part of Figure 10) has “zero” value from Druzhba station to Karnobat station, thereafter an increase is registered (rectangular impulse) to Sindel-razpreditelna station, and after that the parameter again drops down to “zero” value up to Hitrino station.

The recorded parameters of the train’s trafficking were surveyed and analyzed in detail in the last 3000 meters before entering of the train at Hitrino station (point Nr. 1). Figure 10 exhibits in graphics the recorded parameters from km 200,320 to km 203,320 (provisional kilometers, the last 3000 meters before the occurrence of the derailling accident). According to the trafficking schedule of train Nr. 90570, the permitted maximum speed at the section between Pliska and Hitrino stations is 70 km/h.

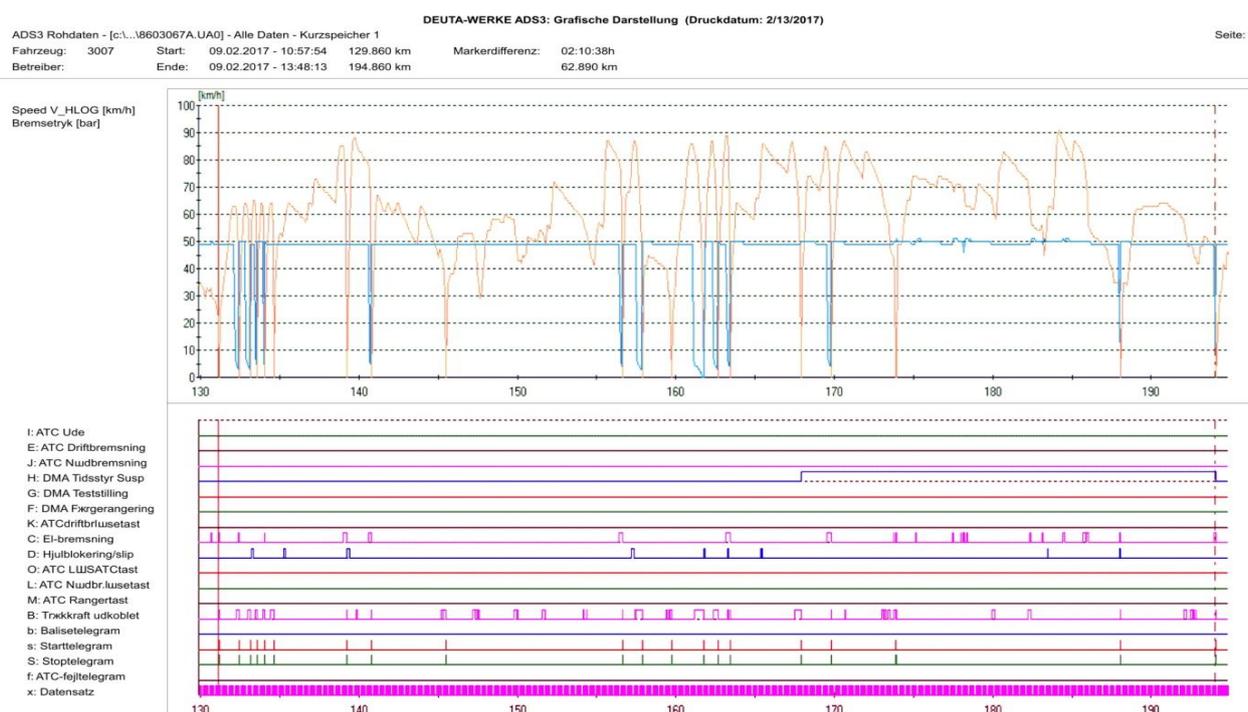
Figure 12

Figure 12, upper part, exhibits the schedules of changing of the speed (in red color) and

the pressure in the main air duct of the train (in light blue color) as a function from the travelled road.

Figure 12, lower part, exhibits the registered digital parameters of the locomotive’s movement.

The digital parameter, designated with „H:DMA Tidsstyr Susp” (depicted in blue color in the lower part of Figure 12) is of “zero” value up to km 167,900, after which an increase is registered (rectangular impulse) to Poduyane-passenger station (km 194,065), where the alertness maintenance device is switched on again.

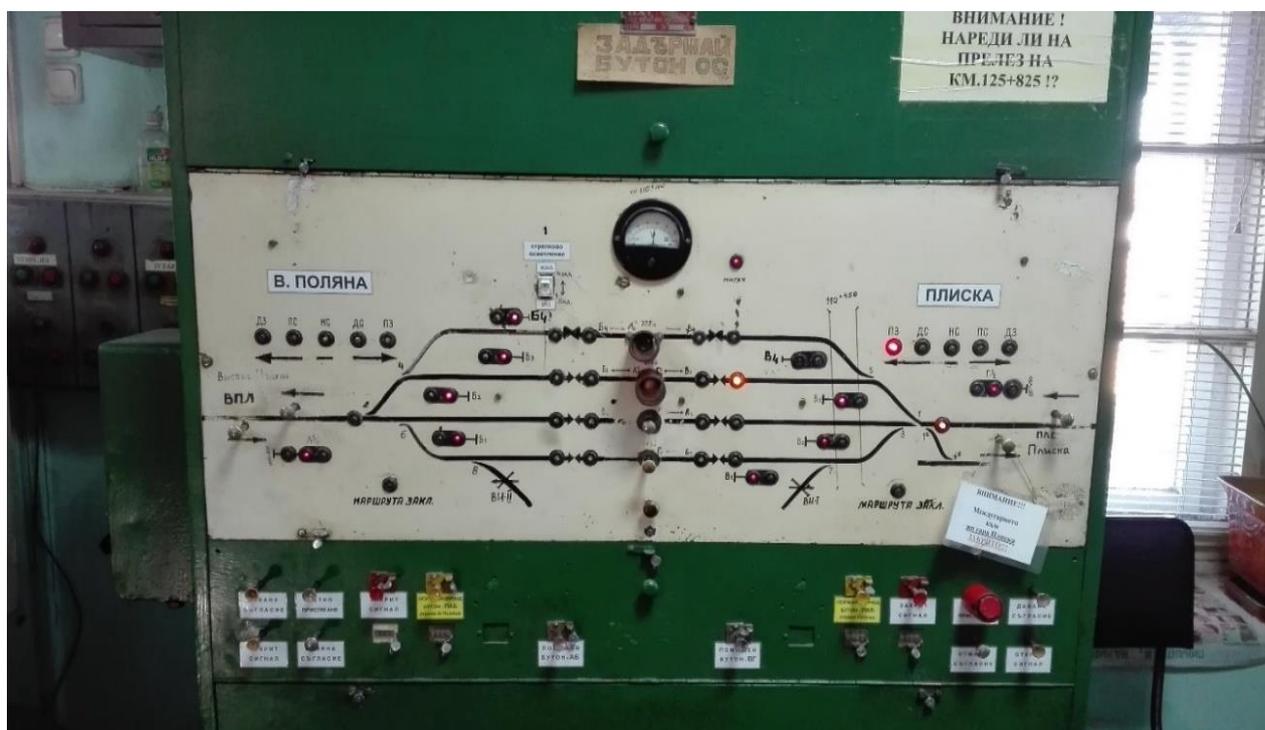
Figure 17

Hitrino station is provided with Relay Key Dependence System with Control unit found in the premises of the traffic controller at the reception building of the station, and Executive units found at the points' Posts Nr.1 and Nr. 2 in the two throttle places of Hitrino station. On 14.12.2016 the Investigation Commission at the MTITC performed survey of the external and

internal equipment in the presence of a mechanic - “safety provision equipment”, to register the condition of the prepared route with the installation in the station and at Post Nr. 2, of the partaking in the route entrance points Nr. 1 and Nr. 5, and the position of the switch rails locked with locks of “Kolben-Danek” type. As evidenced by the control panel of the Control unit in the station (Figure 17) and the position of the keys inserted in the sockets of the Executive unit at Post Nr. 2 (Figure 18) and the dropped barriers of the railway level crossing, the Commission found that the route was properly aligned and the installation was in a faultless state at the moment of the accident.
