Maritime Accident Investigation Unit

FINAL REPORT

Investigation of serious marine casualty – a collision of motor vessel „Lady Gul” with motor vessel „St. Catrien”, occurred on 07.03.2013 in Black Sea, in the territorial waters of Republic of Bulgaria

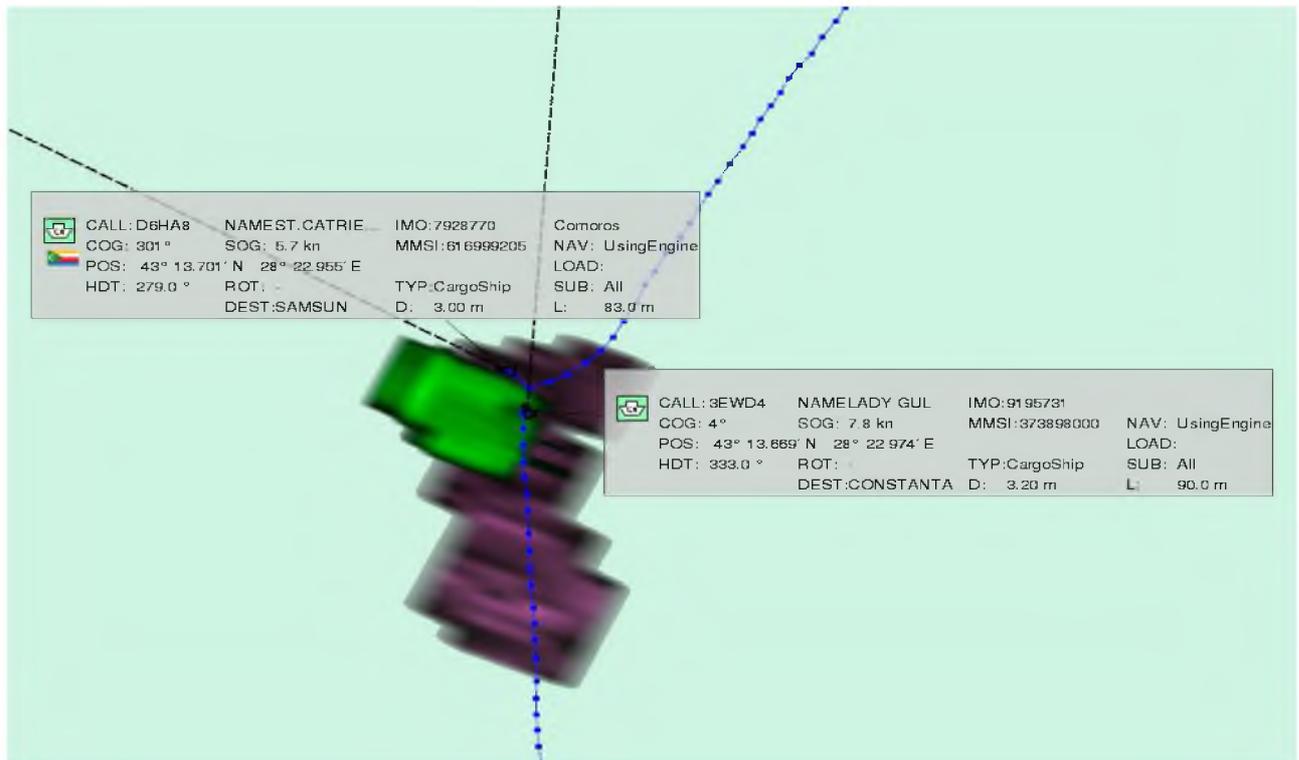
17:21:41 A moment of the collision. Radar image provided by CD Border Police at MI.

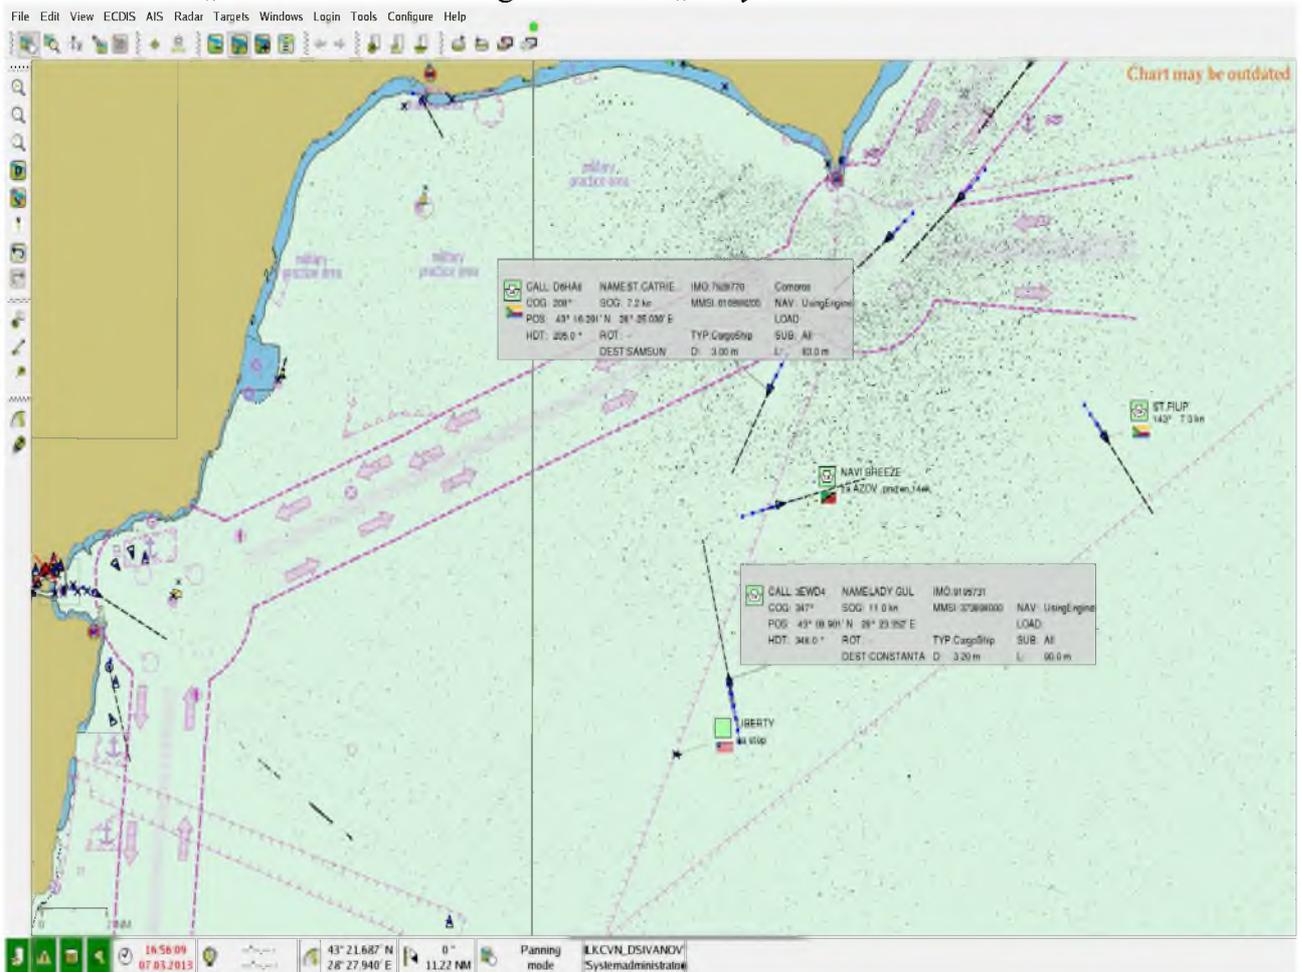
16:56:09 on 07.03.2013 M/v, „Lady Gul” COG=347°, V=11,0 kt M/v, „St. Catrien” COG=208°, V=7,2 kt
CD Border Police at MI

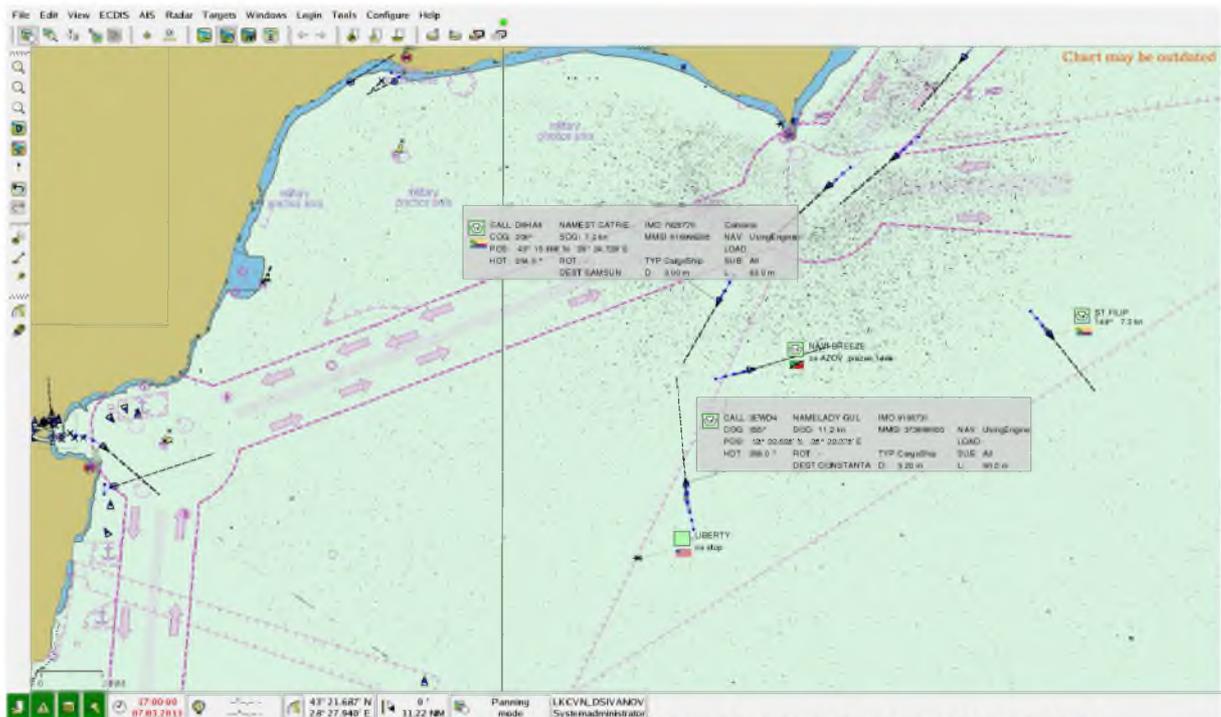
17:00:00 on 07.03.2013 M/v „Lady Gul” COG=355°, V=11,2 kt M/v „St. Catrien” COG=208°, V=7,2 kt CD Border Police

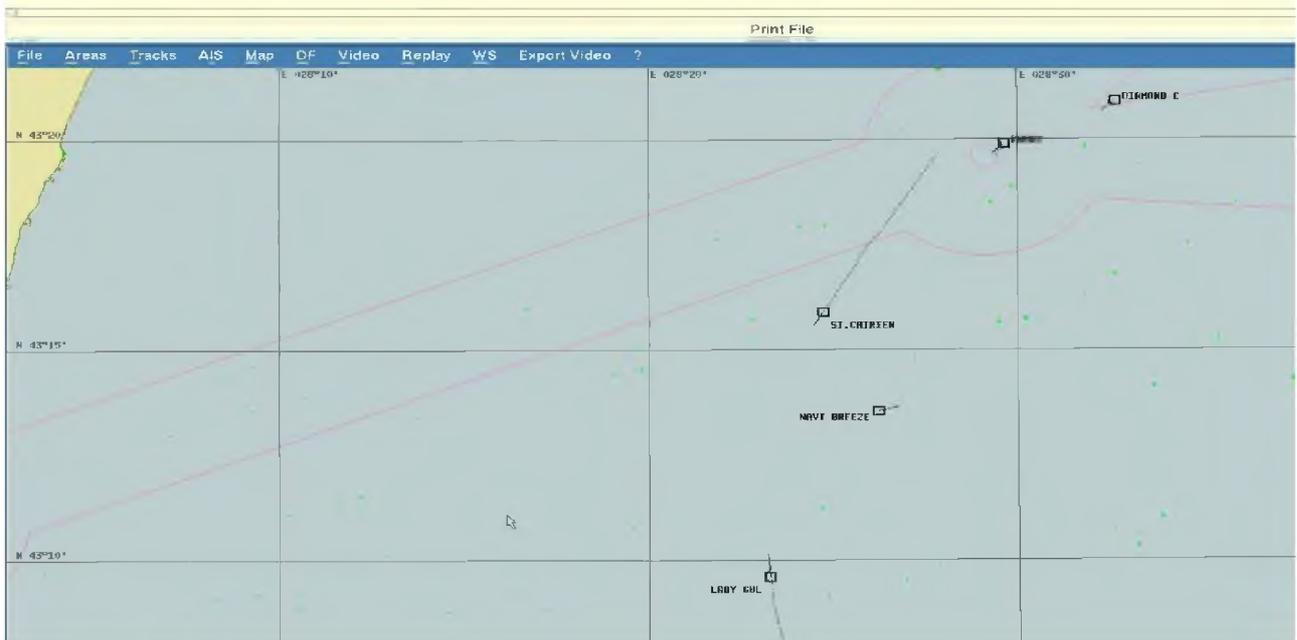
17:00:00 on 07.03.2013 M/v „Lady Gul” - Bearing to m/v „St. Catrien” = 010°; D = 64 cables.

M/v „St. Catrien” - Bearing to m/v „Lady Gul” = 190°; D = 64 cables.

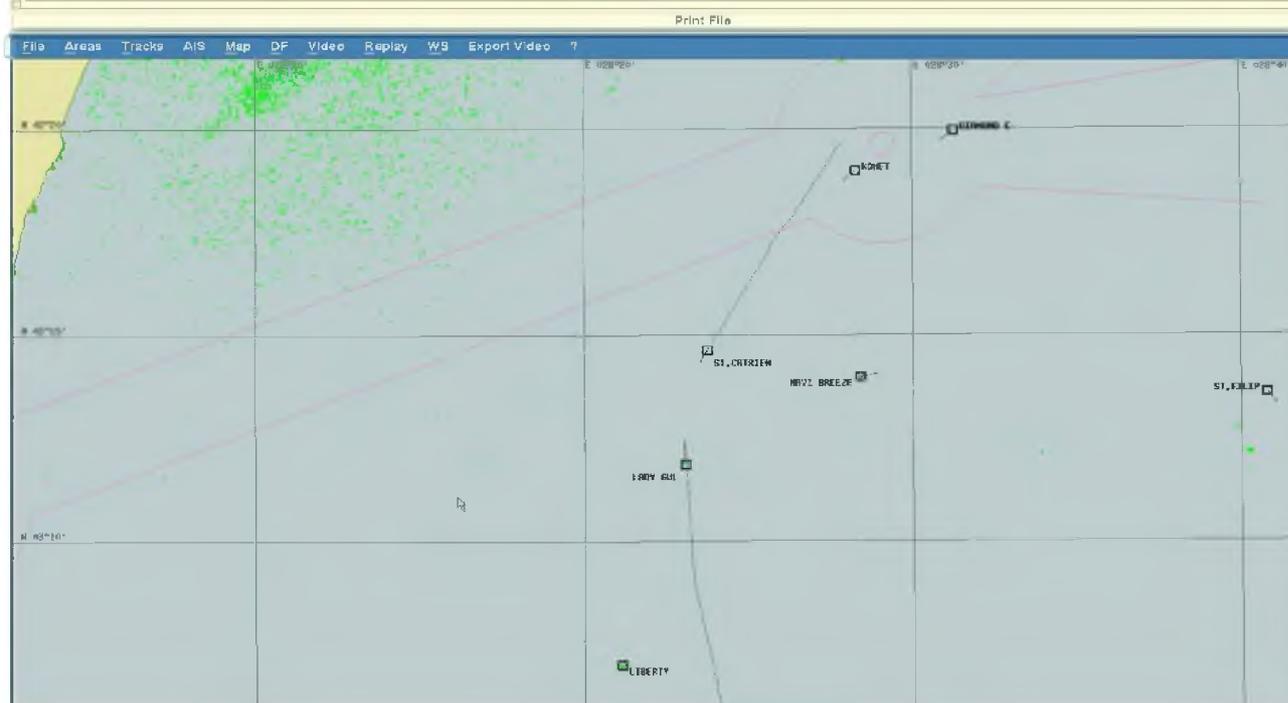
17:12:07 on 07.03.2013 M/v „Lady Gul” - Bearing to m/v „St. Catrien” = 010°; D = 28 cables.

M/v „St. Catrien” - Bearing to m/v „Lady Gul” = 190°; D = 28 cables.

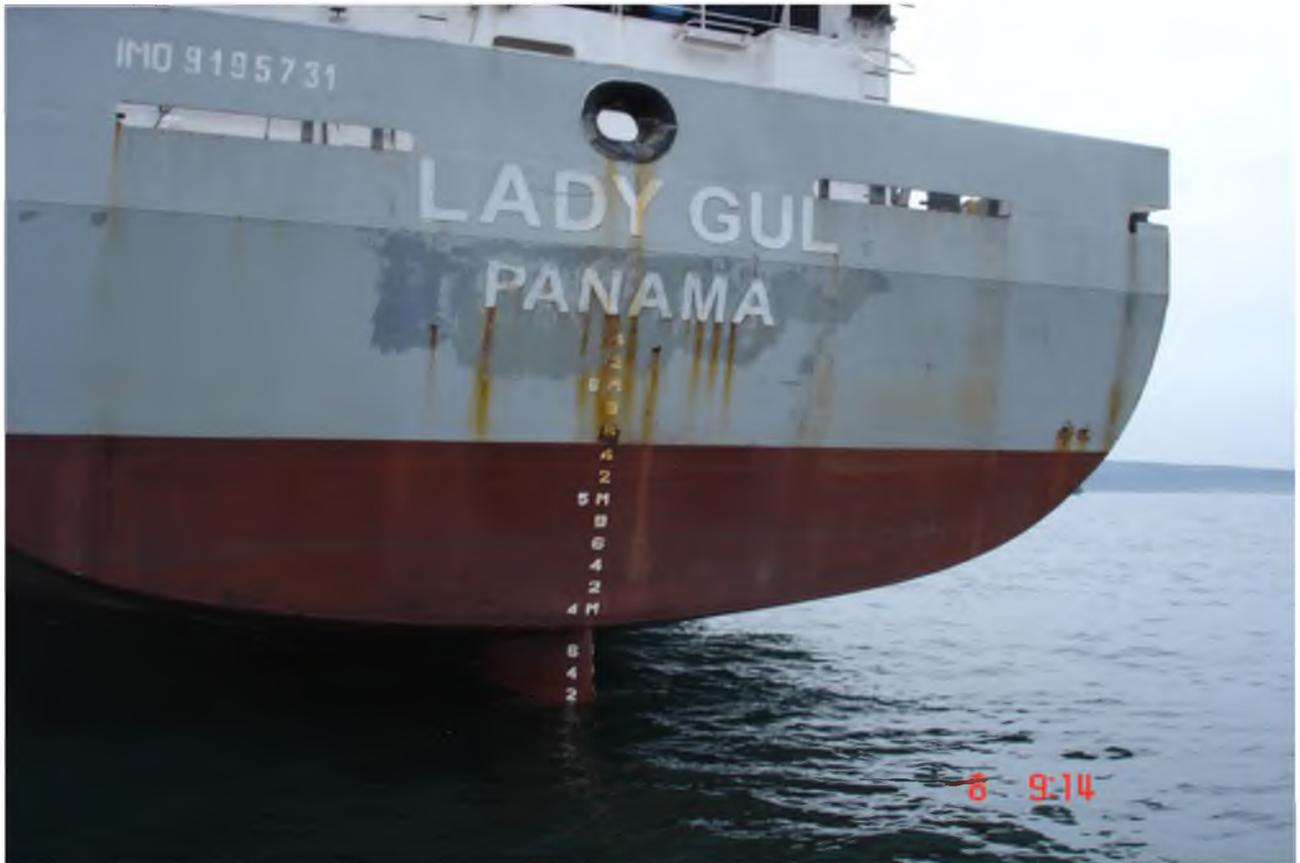
On 08.03.2013 at berth No. 1 in Varna, after the collision, the draft of the *m/v "Lady Gul"* was captured (after pumping out the ballast from the forepeak in order to make an inspection of the hull breach) to be as follows: 1.40 m at the nose; 2.30 m at the middle, 3.20 m at the stern.

M/v „Lady Gul” at berth anchorage No. 1 – Varna on 08.03.2013 Max draft 3,20 m

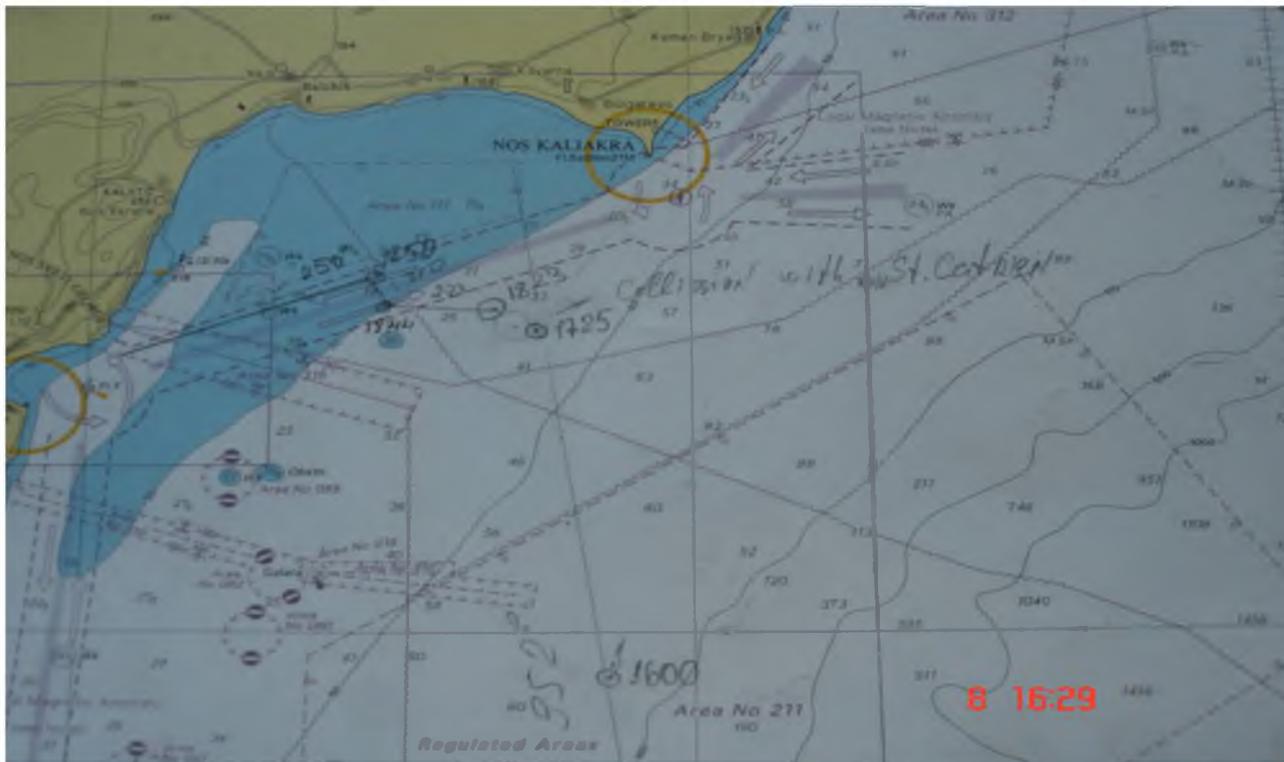
The route of the m/v „Lady Gul” to anchor west from Cape Kaliakra: True course = 352°. British admiralty chart 2285.

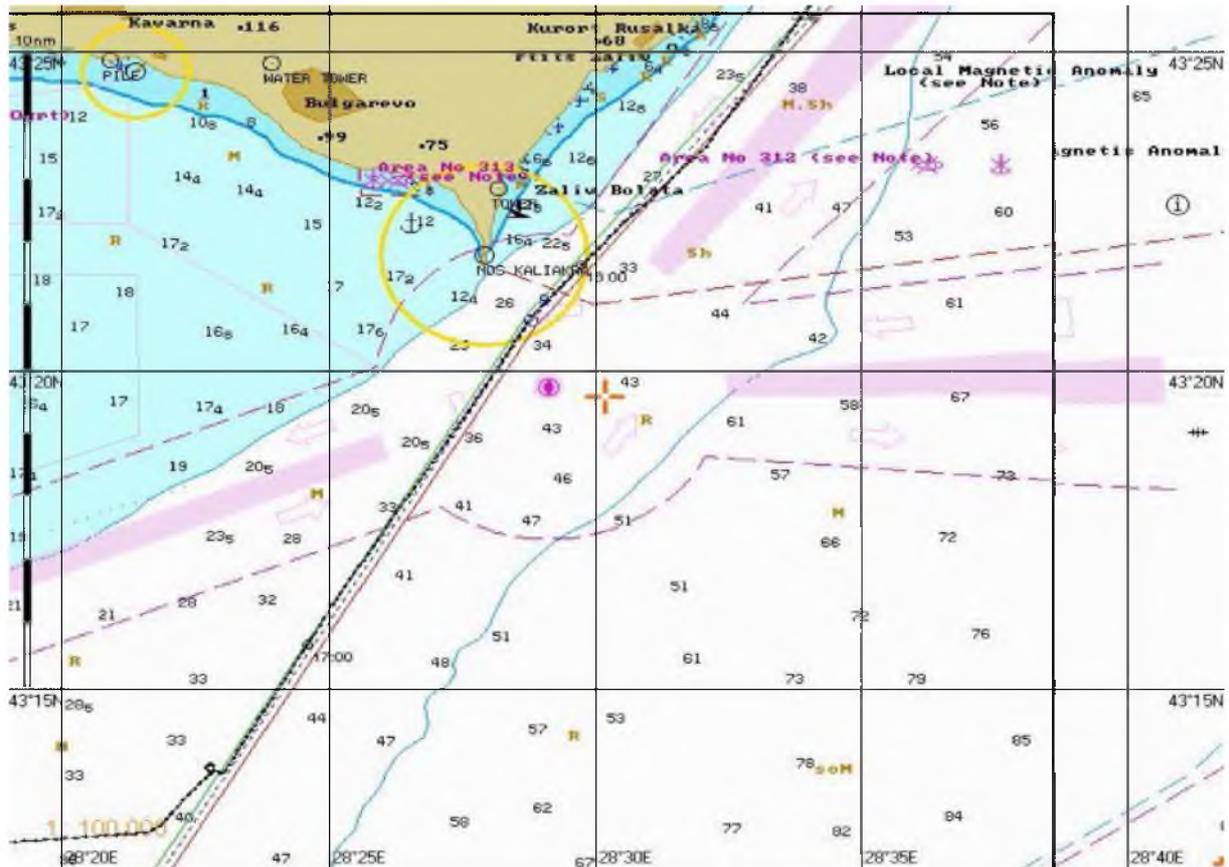
Planned and actual route of the m/v „St. Catrien” from Cape Kaliakra to the collision point with the m/v „Lady Gul” and actual route to Varna – berth No. 1. Data from the vessel’s ECDIS.

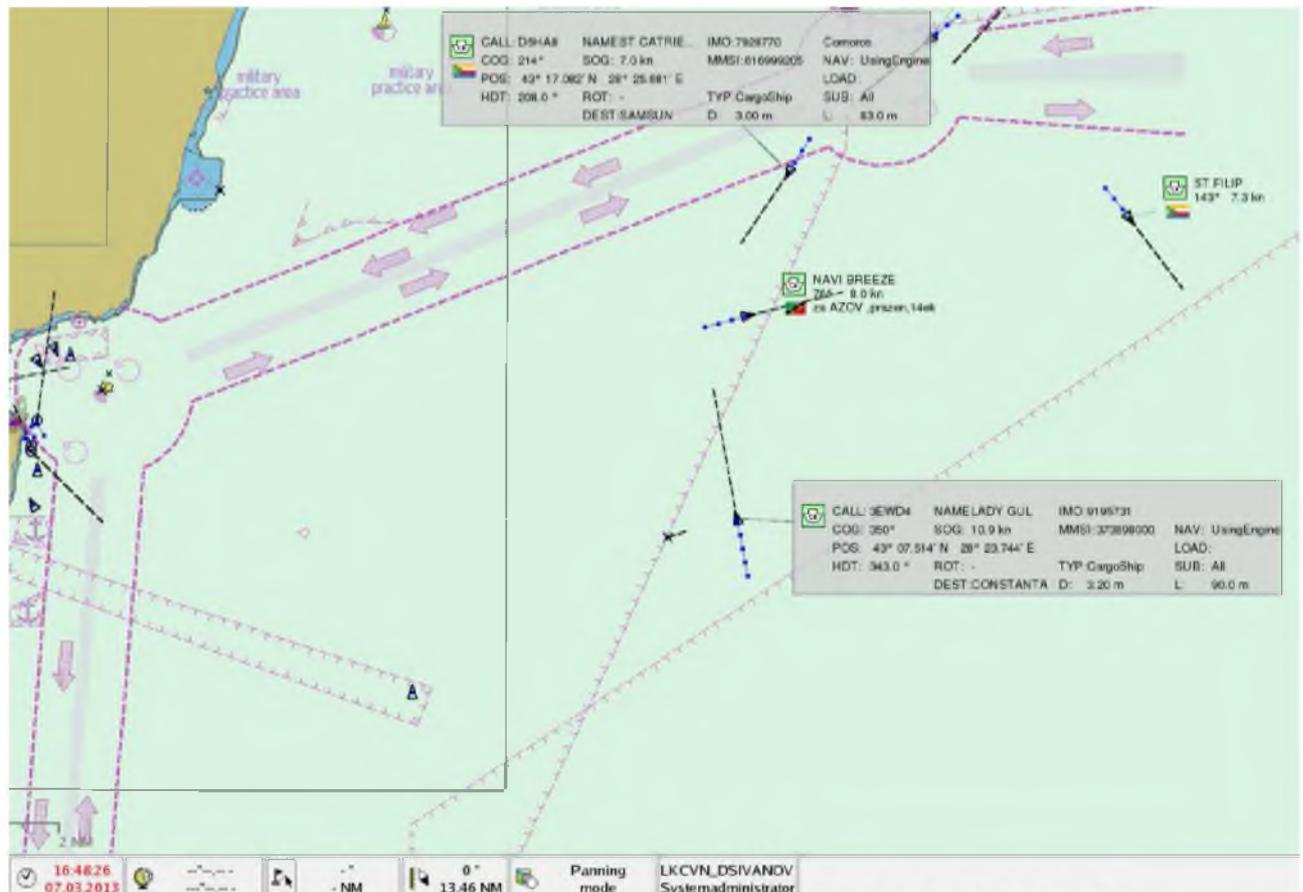
16:48:26 on 07.03.2013 *m/v „Lady Gul“* COG=350°, V=10,9 kt *m/v „St. Catrien“* COG=214°, V=7,0 kt CD Border Police

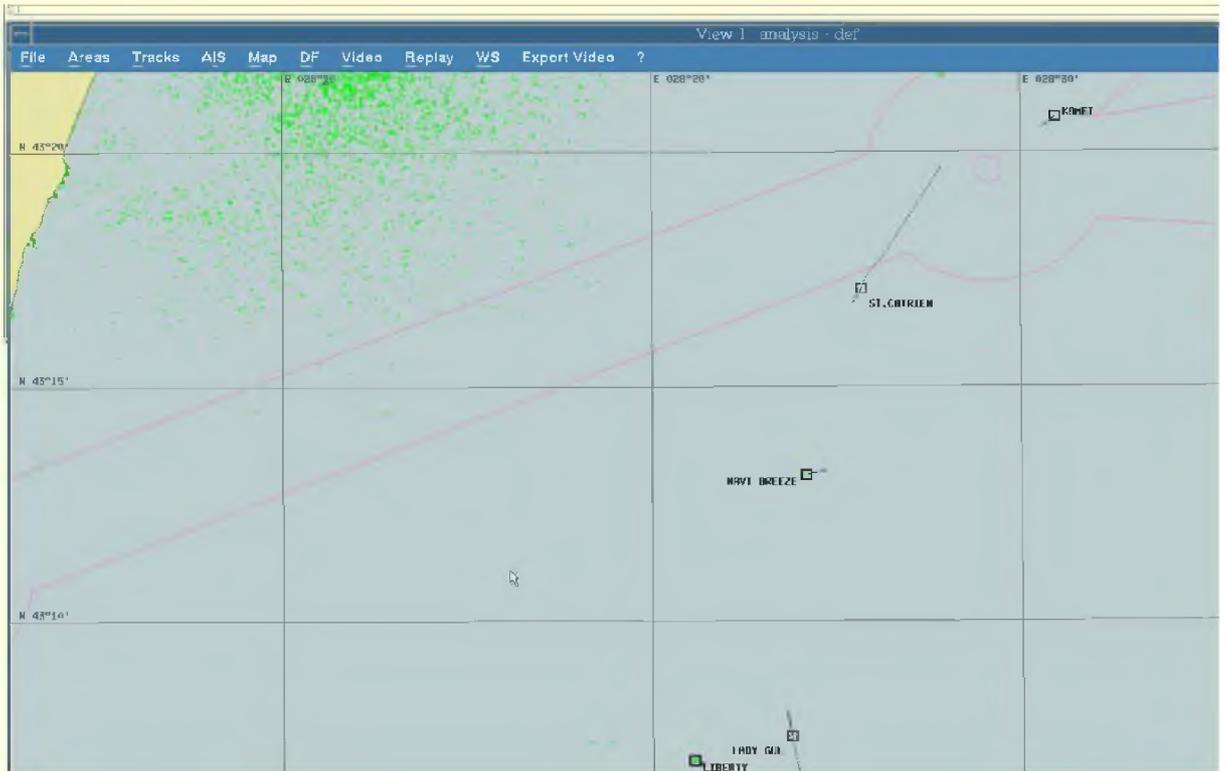
16:48:26 on 07.03.2013 m/v,,Lady Gul" - bearing to m/v,,St. Catrien" = 008,2°; D = 96 cables.
m/v,,St. Catrien" - bearing to m/v,,Lady Gul" = 188,2°; D = 96 cables.

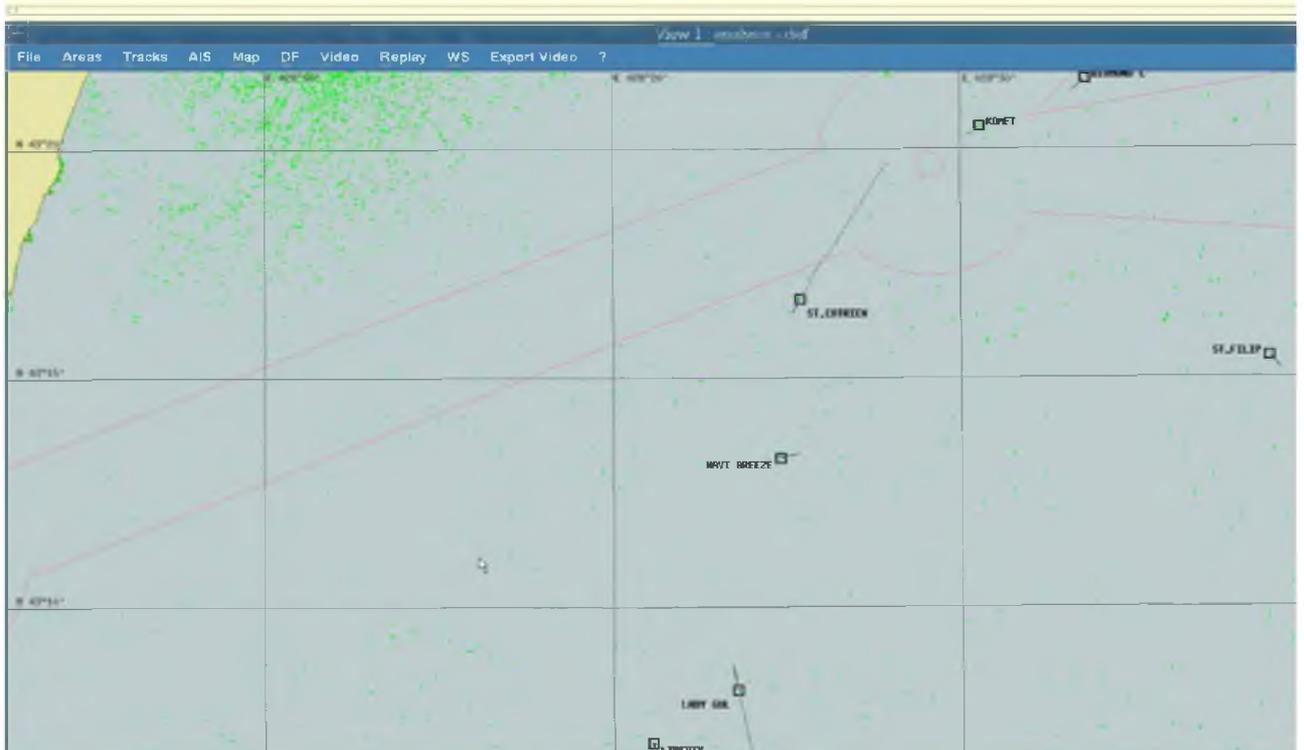
16:52:03 on 07.03.2013 m/v,,Lady Gul" - bearing to m/v,,St. Catrien" = 009°; D = 86 cables.
m/v,,St. Catrien" - bearing to m/v,,Lady Gul" = 189°; D = 86 cables.

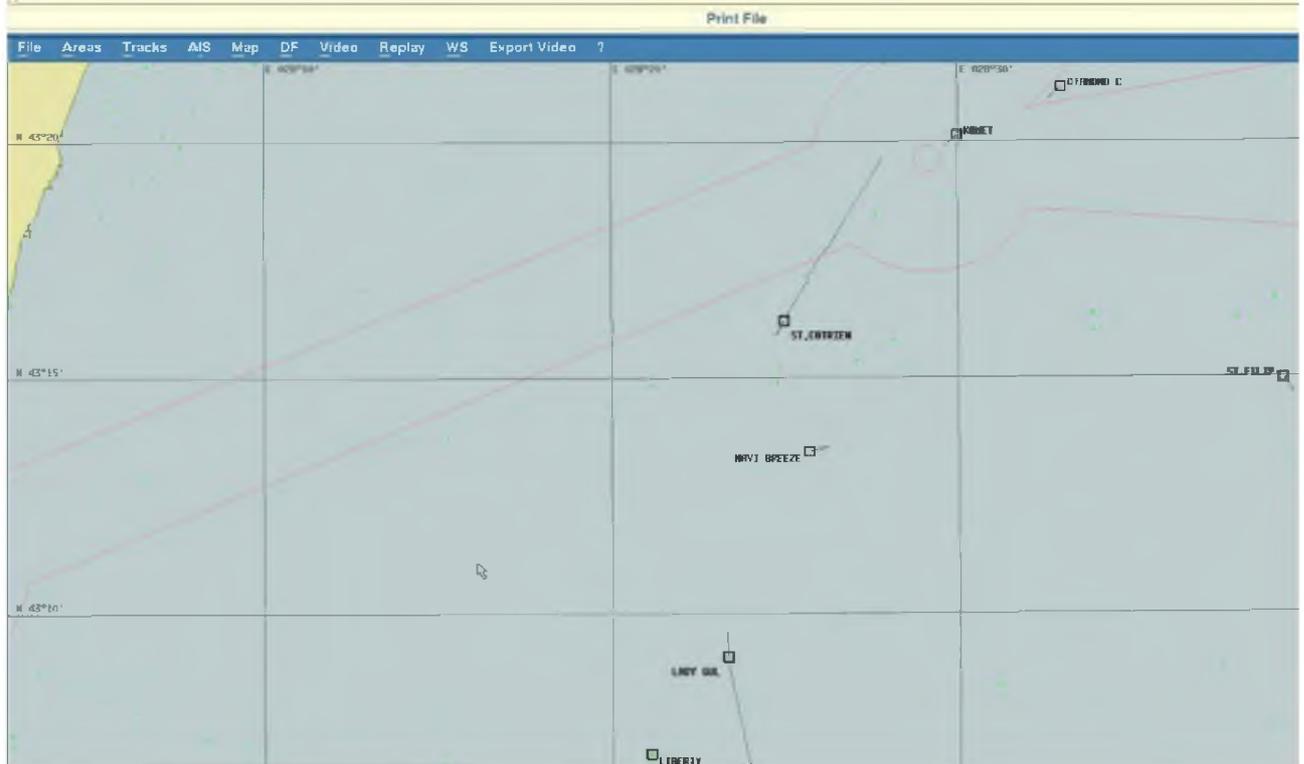
At 16:57 ч.:

M/v "Lady Gul" layed on the gyrocompass heading 354° and already sailed on COG = 357,2°. The speed was 11.0 knots.

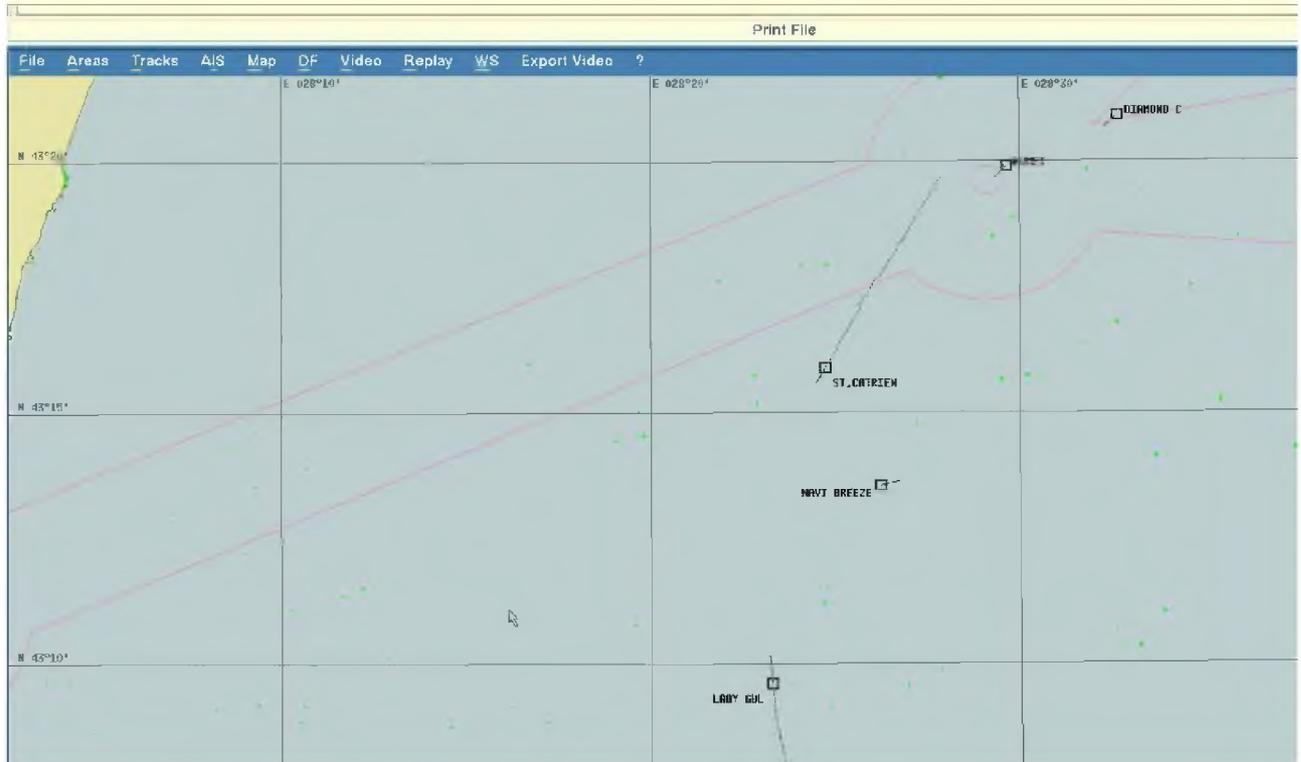
17:00:00 on 07.03.2013 m/v,,Lady Gul" - bearing to m/v,,St. Catrien" = 010°; D = 64 cables.
m/v,,St. Catrien" - bearing to m/v,,Lady Gul" = 190°; D = 64 cables.

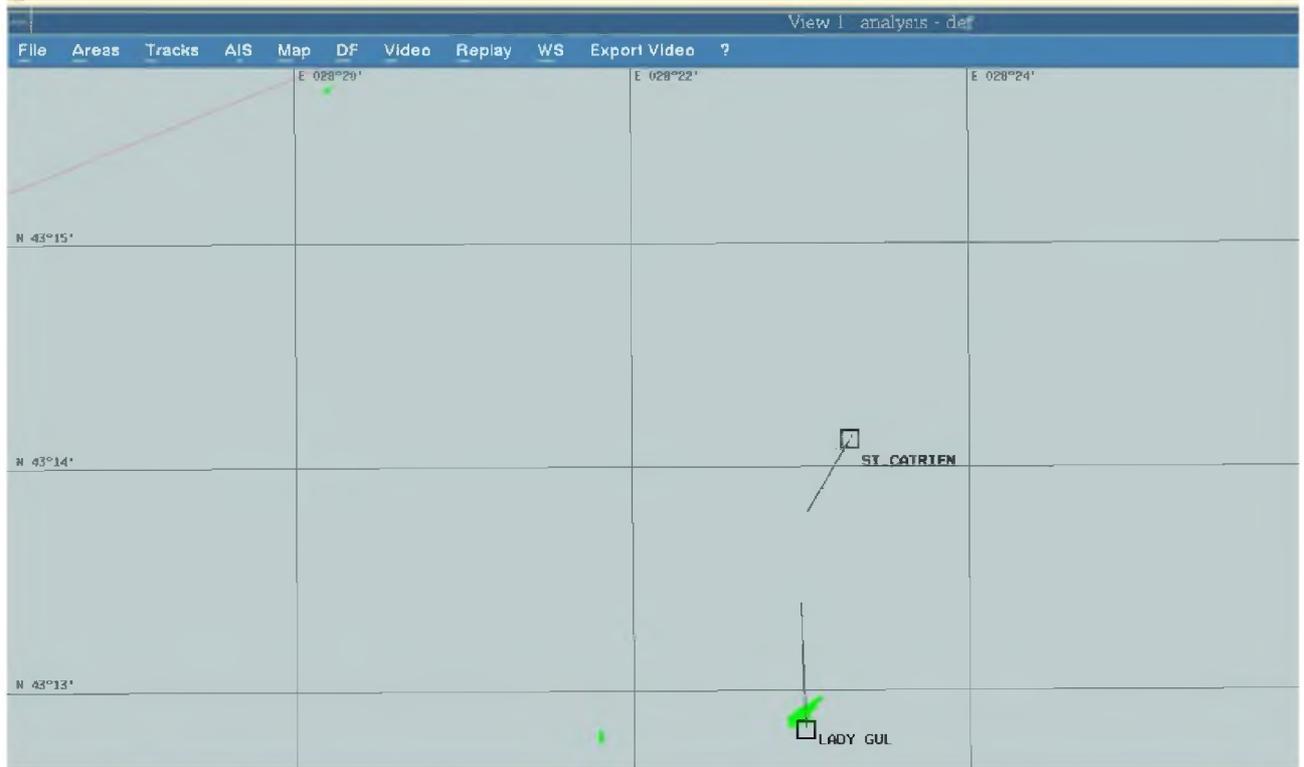
17:17:08 on 07.03.2013 m/v,,Lady Gul" - bearing to m/v,,St. Cathrien" = 009°; D = 13,2 cables.
m/v,,St. Cathrien" - bearing to m/v,,Lady Gul" = 189°; D = 13.2 cables.

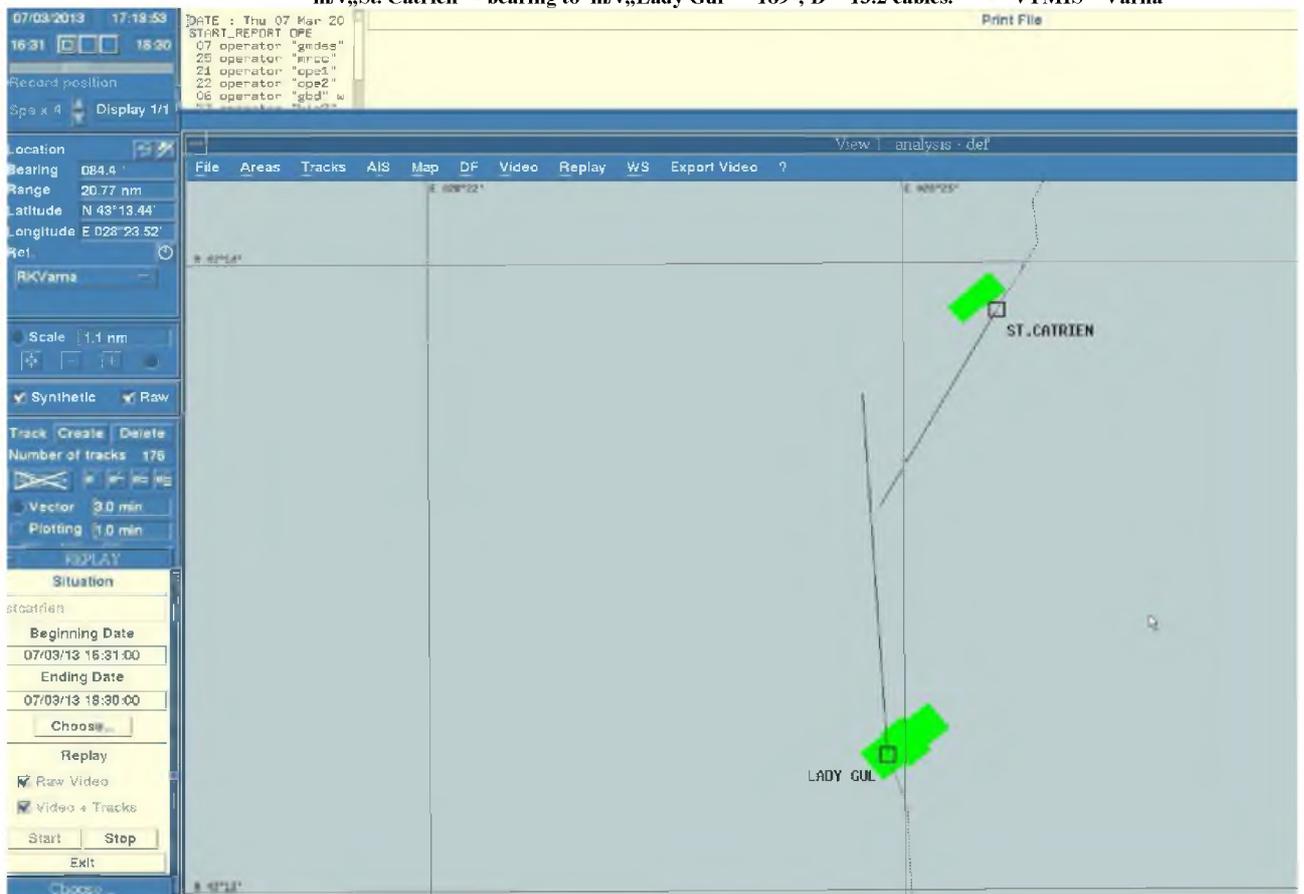
17:18:53 on 07.03.2013 m/v,,Lady Gul" - bearing to m/v,,St. Cathrien" = 013,8°; D = 8 cables.
m/v,,St. Cathrien" - bearing to m/v,,Lady Gul" = 193,8°; D = 8 cables.

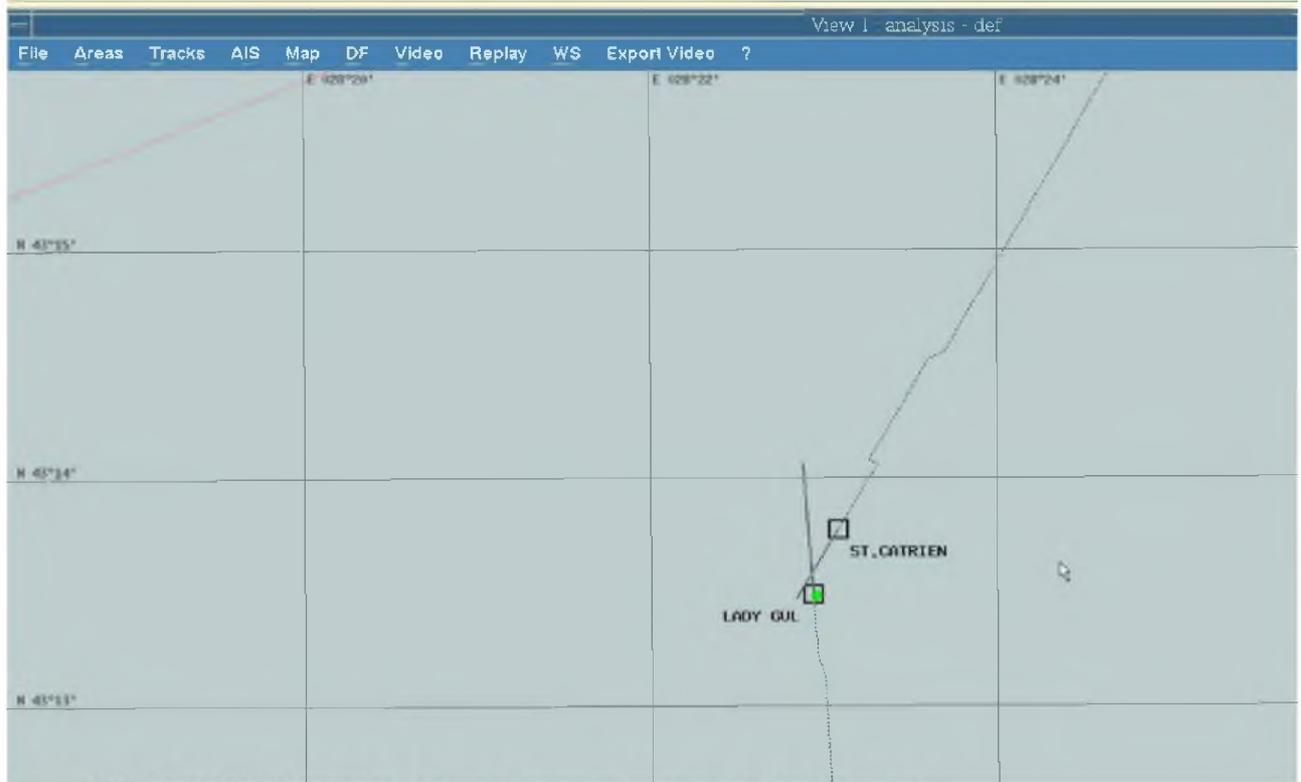
17:20:20 on 07.03.2013 m/v.,Lady Gul" - Bearing to m/v.,St. Catrien" = 20°; D = 3 cables.
 m/v.,St. Catrien" - Bearing to m/v.,Lady Gul" = 200°; D = 3 cables.

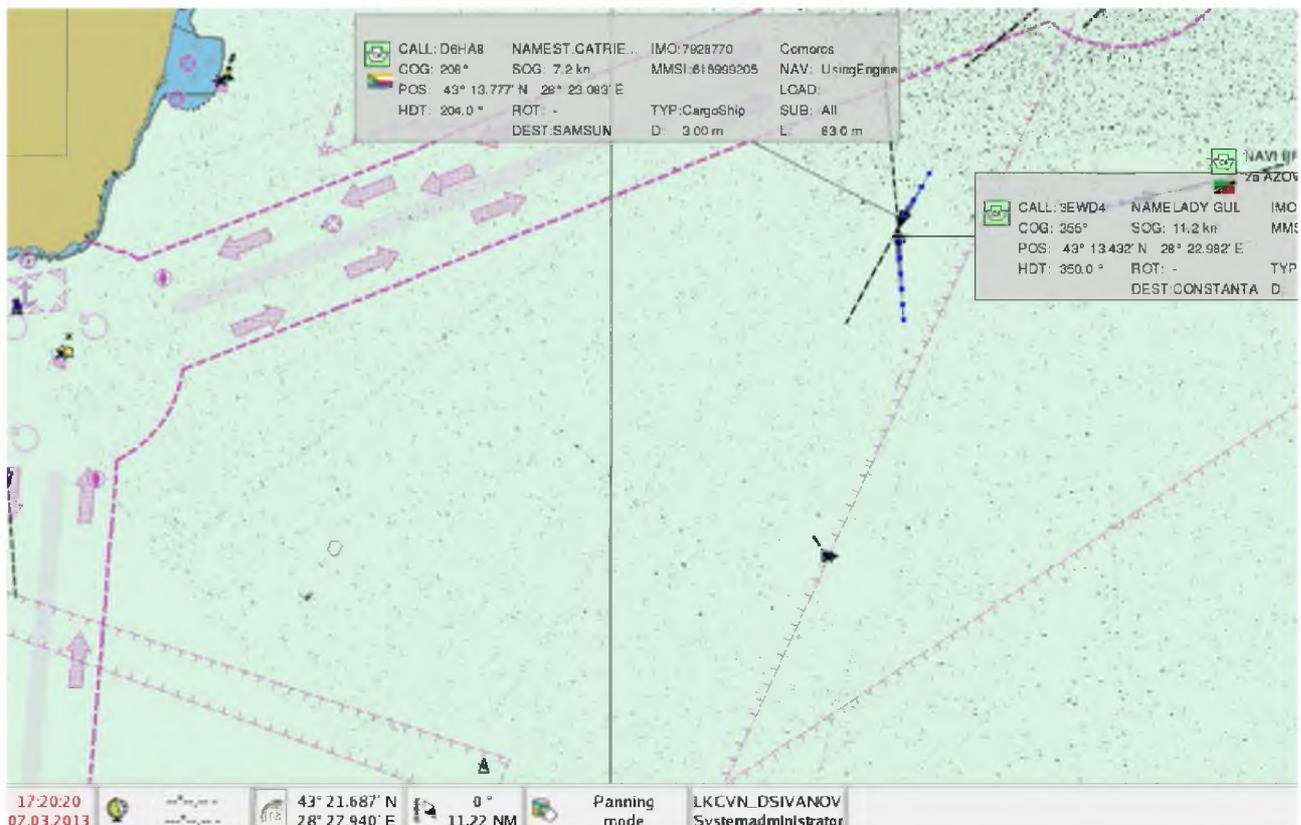
17:20:20 on 07.03.2013 m/v.,Lady Gul" COG=355°, V=11,2 kt m/v.,St. Catrien" COG=208°, V=7,2 kt CD Border Police

The *m/v "St. Cathrien"* began to circulate to the right in order to avoid the collision and according to the chief mate the set deviation angle of the rudder blade was 25-30° starboard. The *m/v "Lady Gul"* did not react until the collision and sailed at full speed, $V = 11,2$ kt, $COG = 358^\circ$.

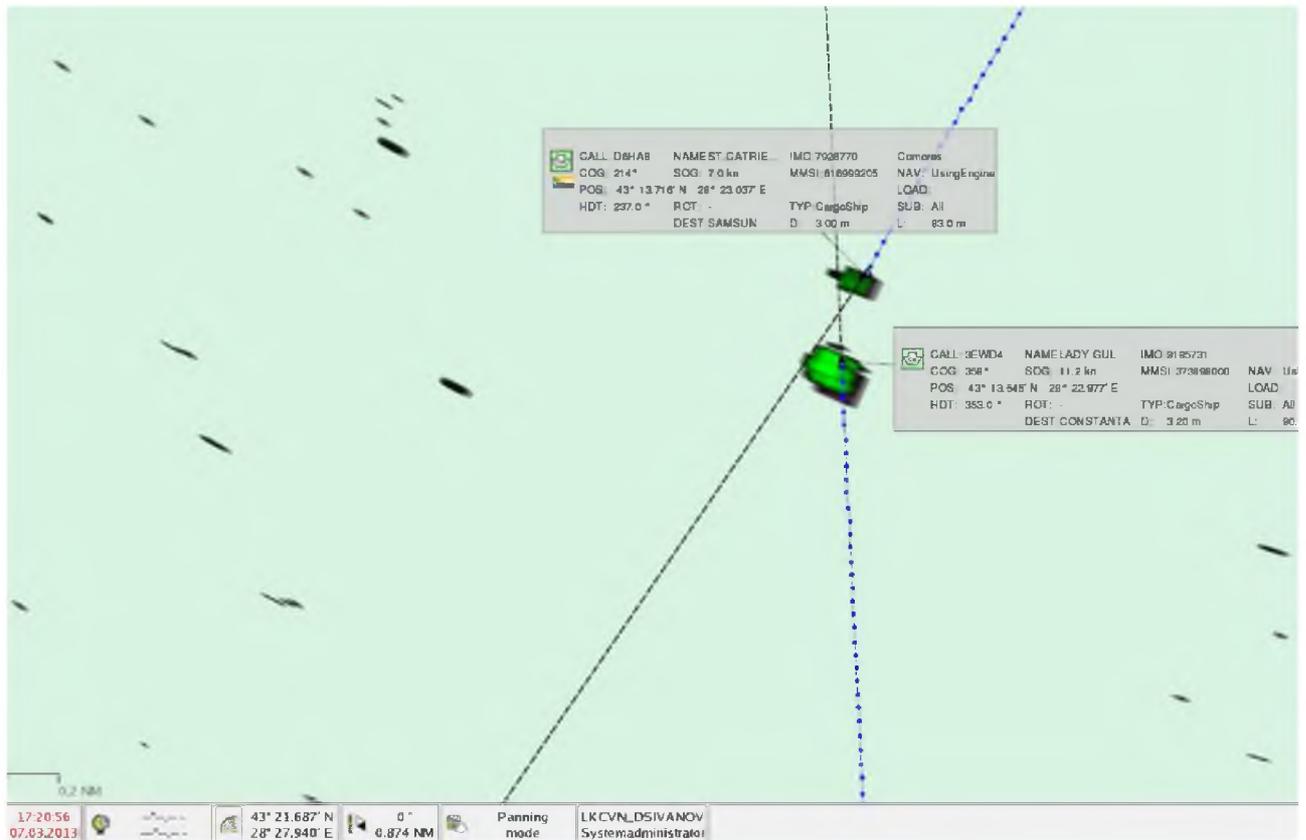
17:20:56 on 07.03.2013 *m/v „Lady Gul”* COG=358°, V=11,2 kt *m/v „St. Cathrien”* COG=214°, V=7,0 kt CD Border Police
 Lady Gul and St. Cathrien disposition at 17:20:56 (15:20:56 GMT).

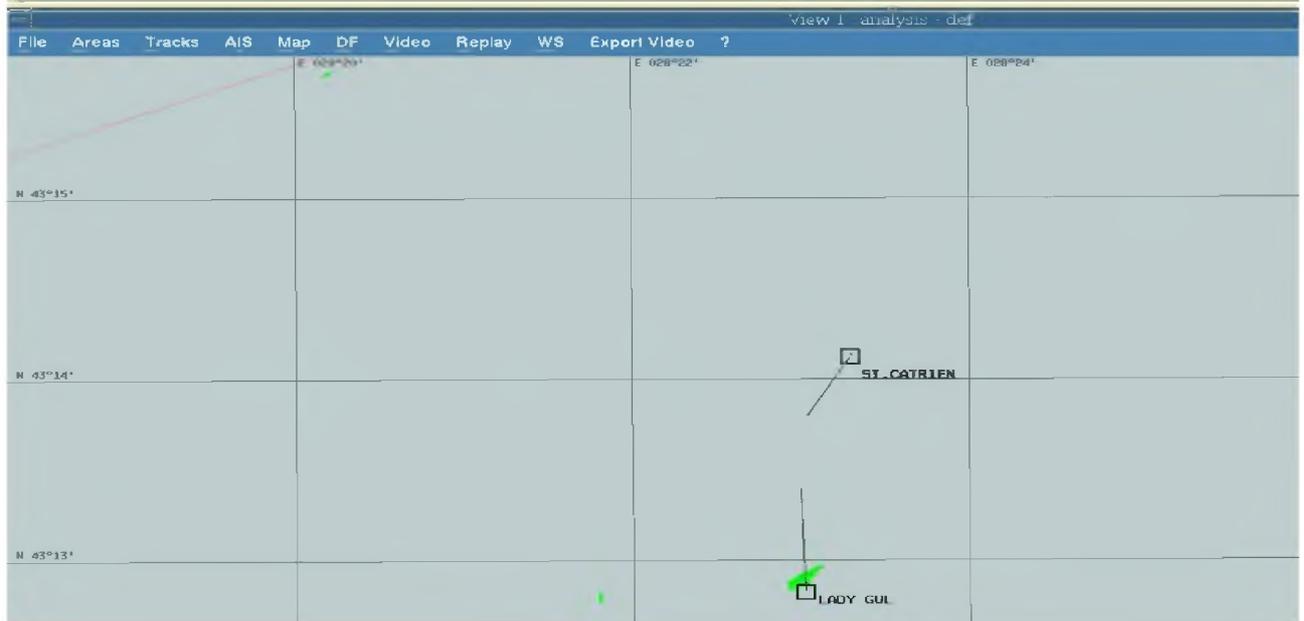
17:17:08 on 07.03.2013 m/v, "Lady Gul" - bearing to m/v, "St. Cathrien" = 009°; D = 13,2 cables.
 m/v, "St. Cathrien" - bearing to m/v, "Lady Gul" = 189°; D = 13,2 cables.
