# FINAL REPORT

The investigation of a serious incident occurred on June 30, 2017 related to a bird strike of AIRBUS A321-211 aircraft, registration marks D-AIAC, in the controlled air space of the Republic of Bulgaria.

2018

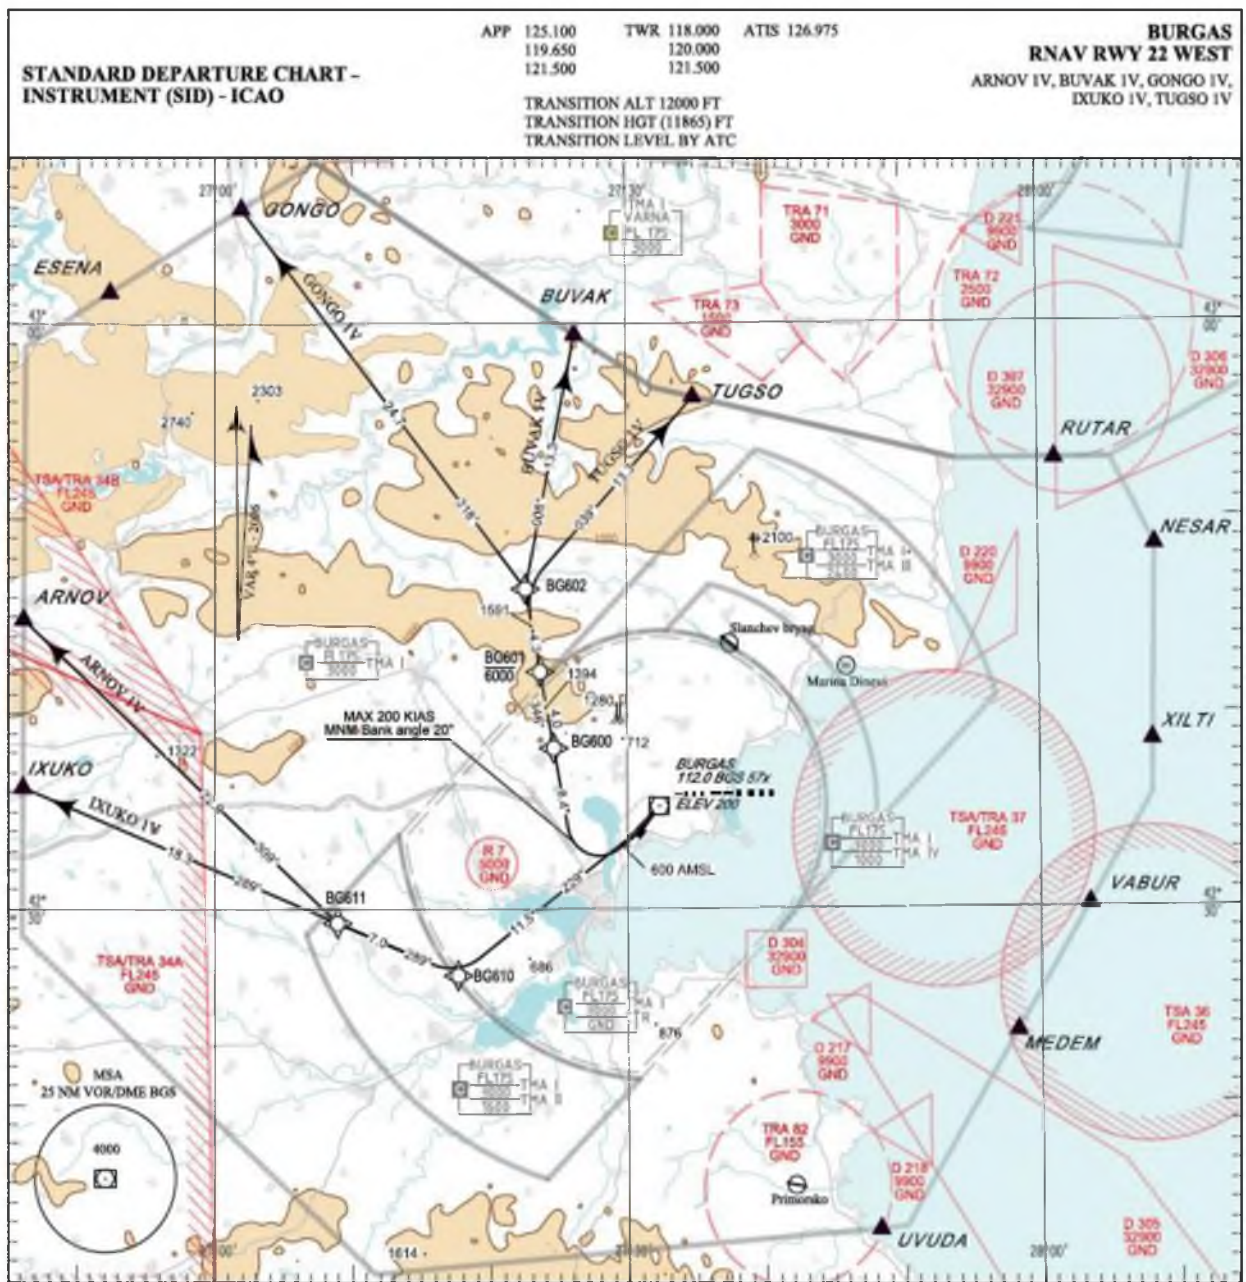
Fig. 1

At 07:09:03 h, the aircraft A321-211 took off from Burgas airport and started initial climb according to a standard instrument departure route of ARNOV1V. (See Fig. 1)

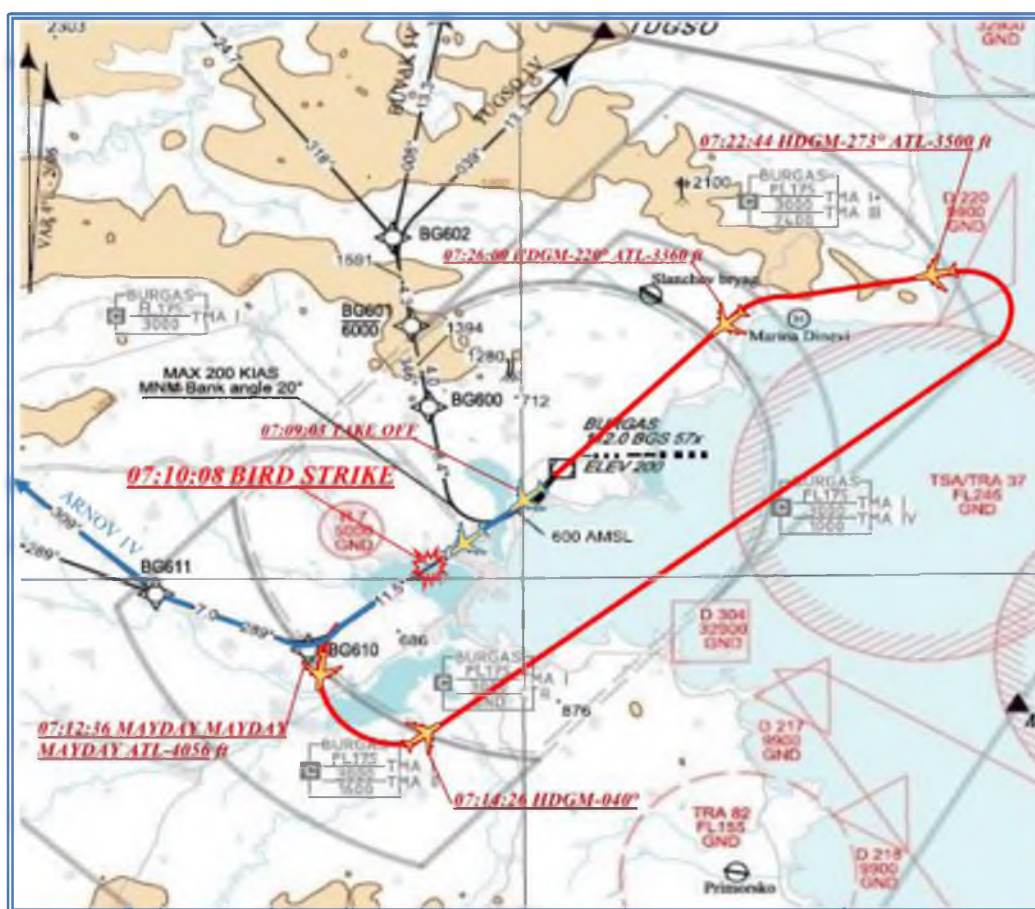
Fig.2

At 07:22:12 h, the flight crew started to descent from 4000 ft.

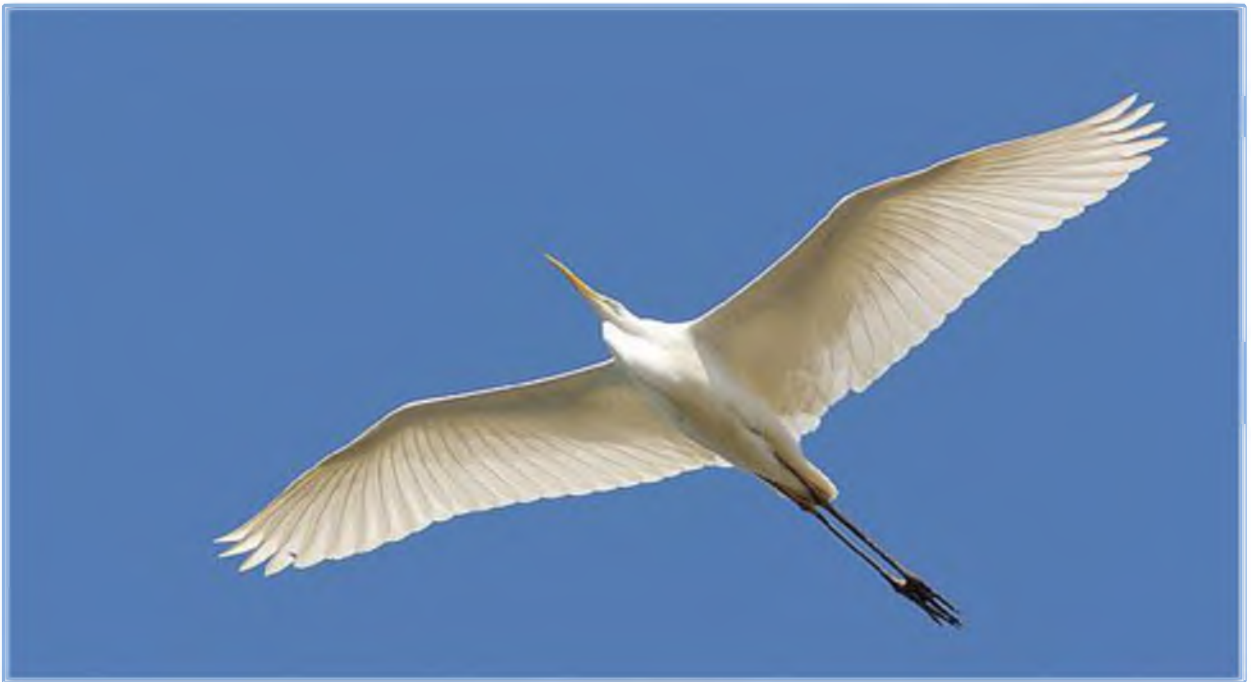
Fig.8

2. *Ardea alba* is a large heron with all-white plumage. Body length 0.9 to 1m, wingspan of 1,4 to 1,9 m and its body mass can be from 0.7 to 1,6kg. (See Fig. 8) or

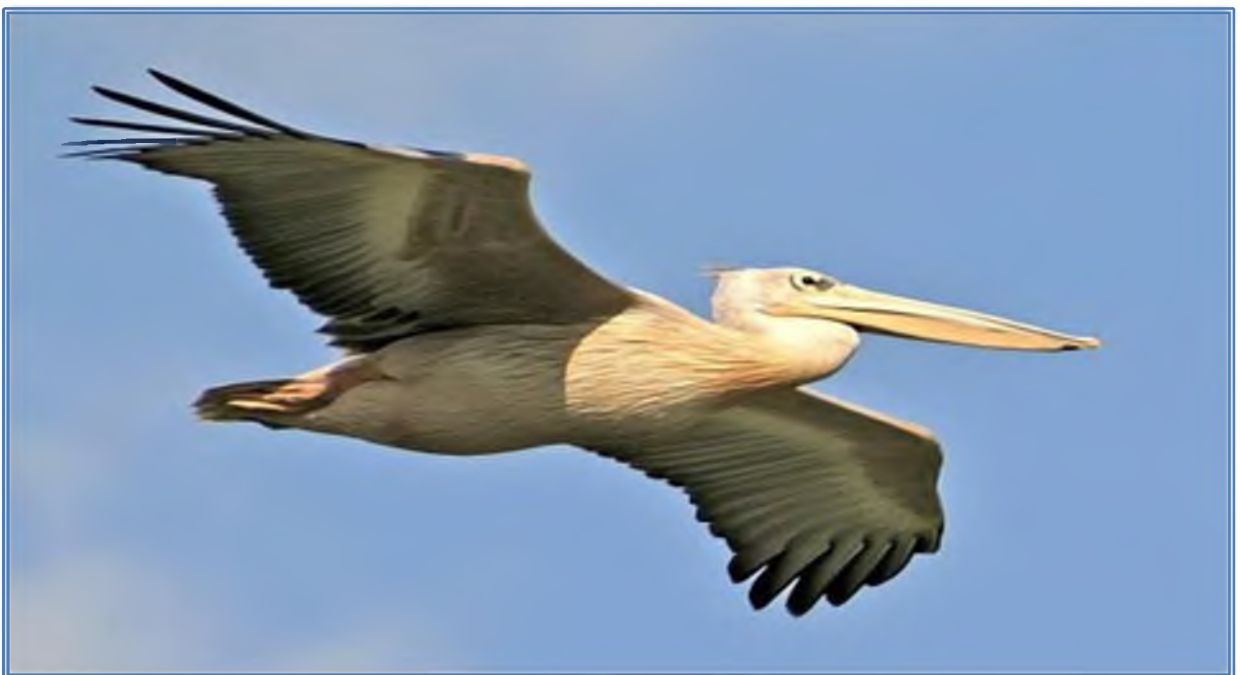
Fig. 9

3. *Pelecanus onocrotalus* is a large bird with white plumage. Body length is 1,40 to 1,75 m, wingspan of 2,45 – 2,85 m and body mass can range from 5 to 8kg. (See Fig. 9)
