FINAL REPORT

Investigation of a serious incident, realized on 09.09.2017 with A320-231 aircraft, registration marks LZ-LAD, operated by Bulgarian Air Charter AO Jsc, in a ferry flight from Bratislava airport to Sofia airport.

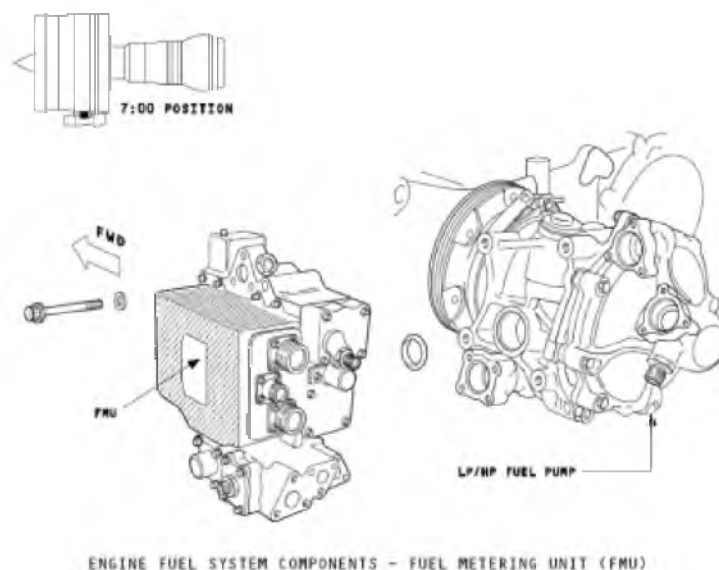
Bolted onto the body of Fuel Pumps Unit at the rear left side of the engine accessories drive gearbox at 7:00 o'clock position (See Fig. 1 and Fig. 3)

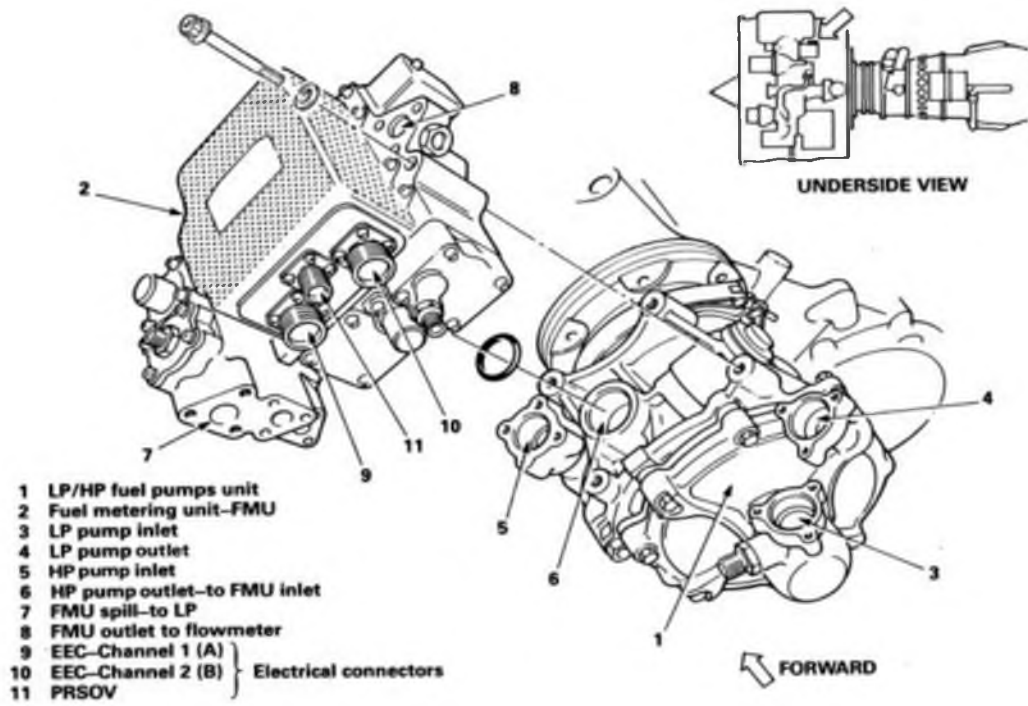
Fig. 2

FMU primary components include Fuel Metering Valve, Overspeed Valve (OSV) and Pressure Rising and Shut-off Valve (PRSOV) situated in series on the main fuel stream inside. All these three valves are Torque Motor operated (no solenoid valves installed in this unit). The FMU has dual windings modulating torque motor, while the OSV and PRSOV are equipped with discrete open-close ones. The other two valves inside FMU, servo fuel regulating valve and the spill valve play also significant role, but for the purpose of that short explanation they will be deliberately omitted. (See Fig. 2)
